CALIFORNIA CLEAN VESSEL ACT PUMPOUT AND DUMP STATION PERFORMANCE REPORT 2023

This California Clean Vessel Act Pumpout and Dump Station Performance Report highlights findings on the condition and operational status of pumpout and dump stations during 2023. Discharging sewage overboard creates environmental and human health problems, especially in California, a state with more than four million recreational boaters. To reduce the negative impacts of discharging sewage overboard, all boaters are encouraged to use sewage management facilities such as pumpout stations, dump stations, floating restrooms, and mobile pumpout services.

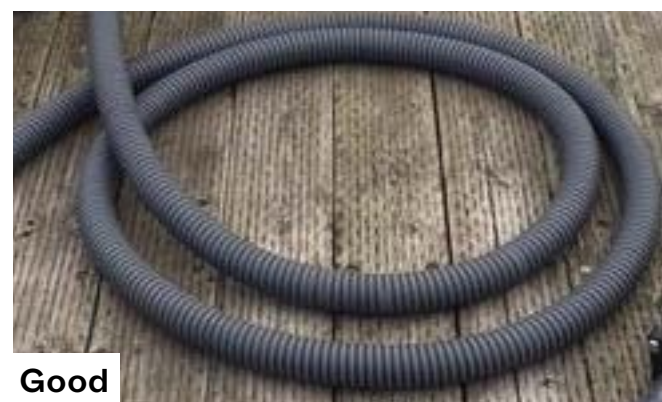
Preventative maintenance is the best solution for avoiding problems. Marina operators should inspect the pump and pump enclosure on a weekly basis and, when possible, daily. These inspections should check for leaks, cracks, unusual wear and missing equipment.

Good

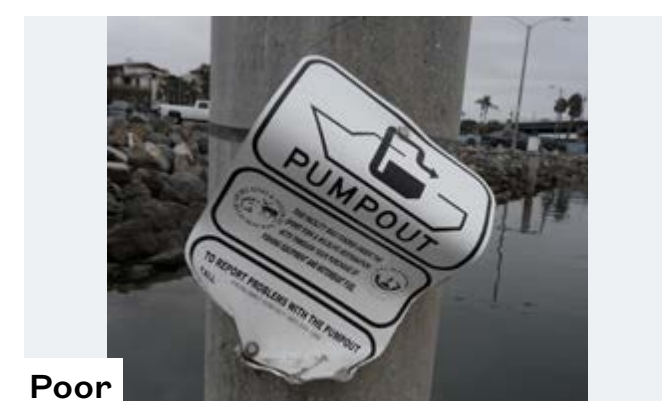
Poor

HOSE
Look for damage that could affect performance of the system, like tears or a collapsed hose wall. To keep repair costs down, sections of hose can be repaired rather than replacing the entire hose. The number of repairs on one hose should be limited as performance will degrade over time.

SIGHT GLASS
Look for cracks and make sure the movement of effluent is visible through the sight glass.

NOZZLE
Look for signs of wear, including cracks and tears. Ensure that the tip has not been cut off and there is a backflow flap in place.

BALL VALVE
Check that handles are not broken and can be easily rotated.

HOUR COUNTER
Ensure that the hour counter is not broken and functions properly.

UNUSUAL NOISES
Turn the pump on and listen for unusual noises including squeaking, rattling, and grinding. Also listen for air leaks especially around threaded connections.

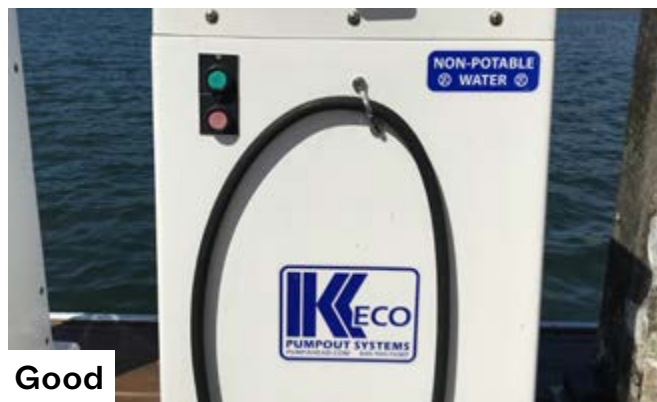
Dump station maintenance is also key for ensuring consistent operation. These units are often connected to the same motor as a pumpout machine, so any issue seen with a dump station can be indicative of a larger problem. Marina operators should regularly inspect the hose connections and internal housing for wear and tear on the machine.

Good

The housing of the machinery should be intact, structurally sound, and clean. Make sure the encasing around the machine is not dented, punctured, or broken in a way that would damage the mechanisms inside. Also, ensure that there is no debris or garbage inside of the dump station.

Make sure that the lid closes completely, can be secured, and is not broken or damaged. A lid that does not close could allow sewage to be expelled out while the machine is running.

Ensure that the hinges connecting the lid to the housing are not rusty, broken, or missing.

Check that handles are not broken and can be easily rotated.

Turn the machine on and listen for unusual noises including squeaking, rattling, and grinding. Also, listen for air leaks especially around threaded connections.

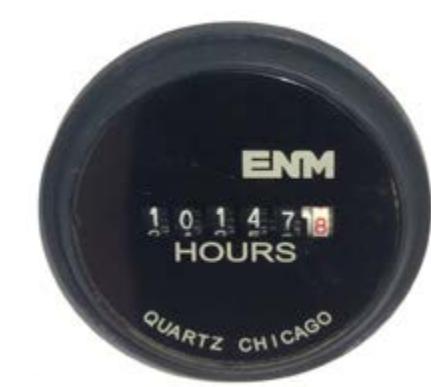
0 = absent, 1 = needs repair, 2 = worn, 3 = excellent

Hour counter
Photo by TBF

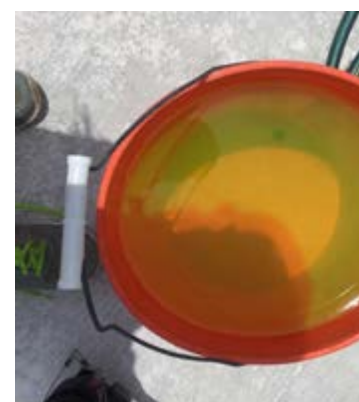
As a courtesy, Morro Bay National Estuary Program, San Francisco Estuary Partnership, and The Bay Foundation offer complimentary dye tablet testing. This test can help identify leaks in the plumbing of a sewage pumpout system. The results of this test are not presented in this report.

Dye tablet dissolving in 5 gallon bucket of water
Photo by TBF

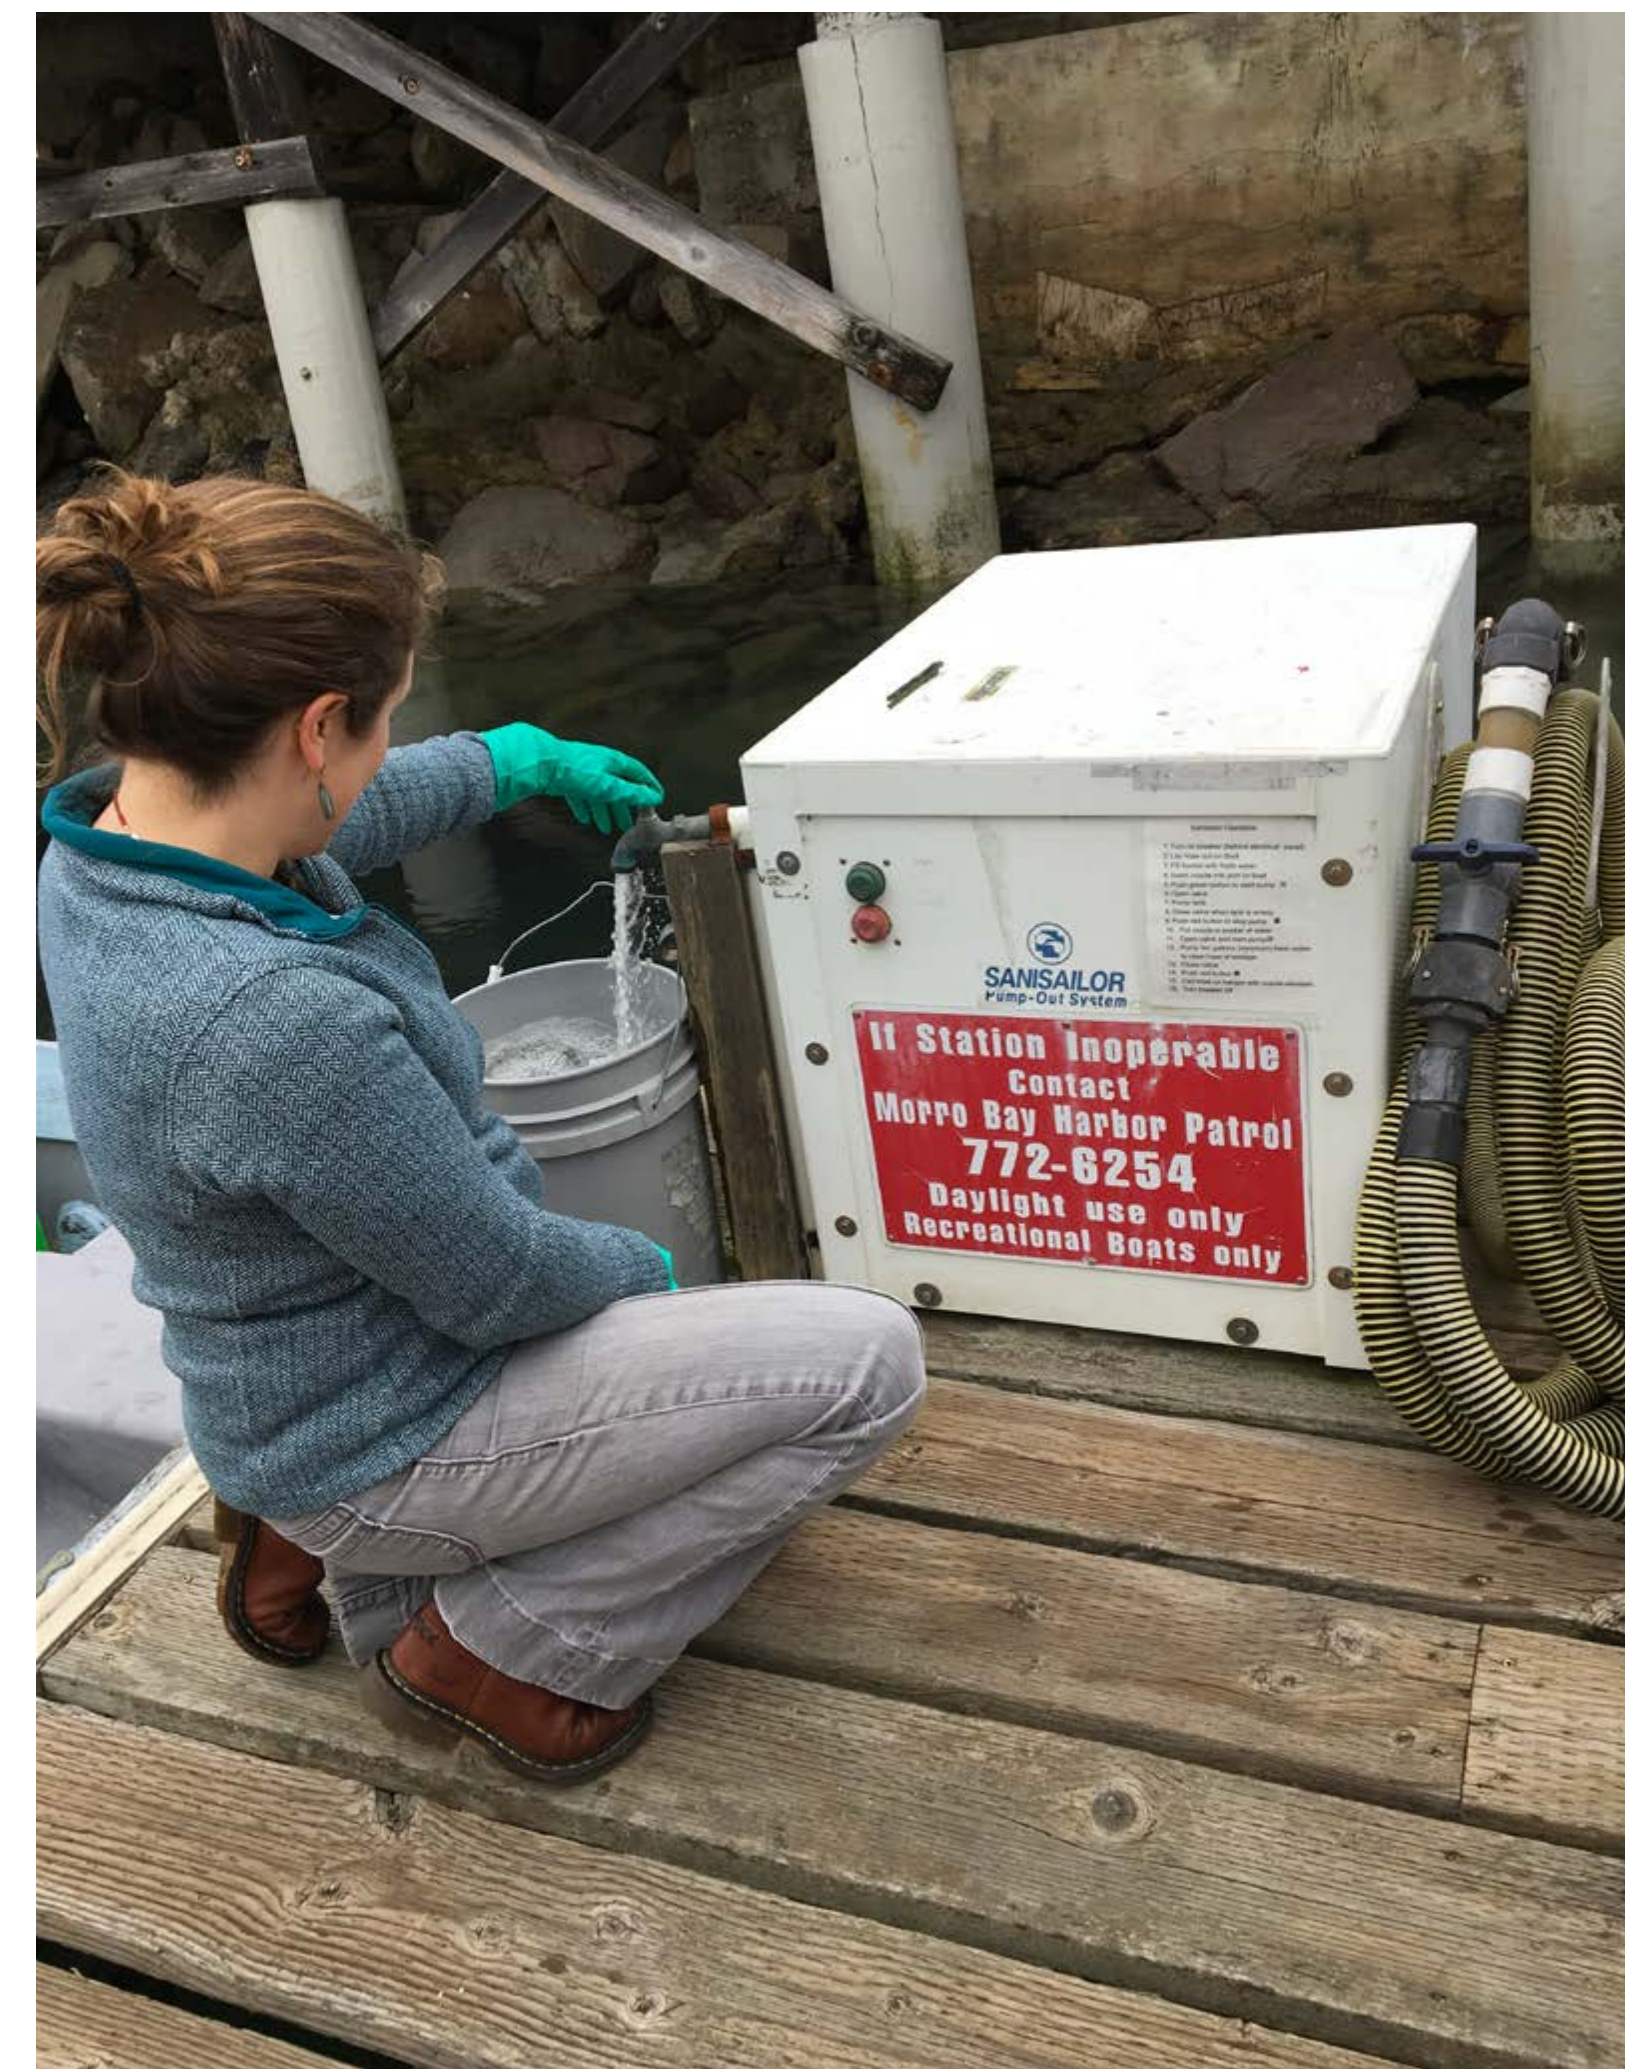
In order to standardize the analysis throughout the state for direct comparisons, three parameters are used to determine percentages: vacuum pressure, vacuum time, and condition of parts (specifically hose and nozzle). These three parameters are considered equally important and therefore each parameter represents 33.33% of the total percentages.

MBNEP staff filling 5-gallon bucket in order to test vacuum time
Photo by MBNEP
