REPAIRING ALUMINUM WIRING

U.S. Consumer Product Safety Commission
Bethesda, MD
www.cpsc.gov
www.SaferProducts.gov

Publication 516

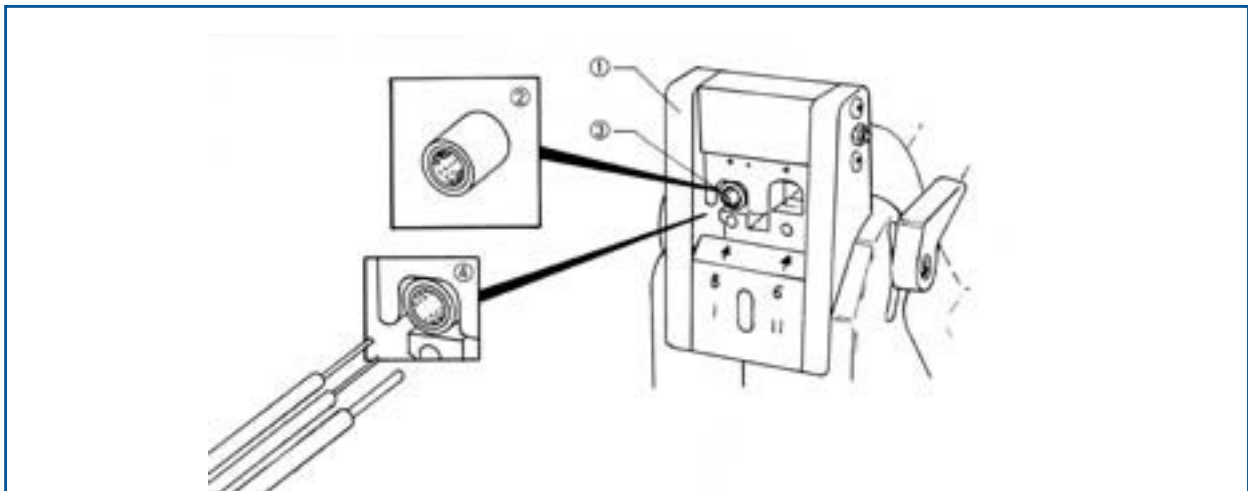
The COPALUM connector is a specially designed system that includes a metal sleeve intended to be installed only with a dedicated power tool and crimping die to make a permanent connection, that is, in effect, a cold weld (the precision dies in the COPALUM tool compress the connector and wires using upwards of 10,000 pounds of force, as required to make the permanent aluminum wire connection).

The tool is shown in the illustration below. An insulating sleeve is placed around the crimp connector to complete the repair. The copper wire pigtail is then connected to the switch, receptacle, or other termination device. An example of a repaired receptacle outlet is also illustrated below.

COPALUM Crimp Connector and its Specialized Installation Tooling

Only electricians who are trained by the manufacturer to use the tool properly are authorized to install COPALUM connectors. CPSC staff emphasizes that this training is necessary to ensure that the electrician uses the careful, professional workmanship and thoroughness required to make the crimp connector repair safe and permanent.

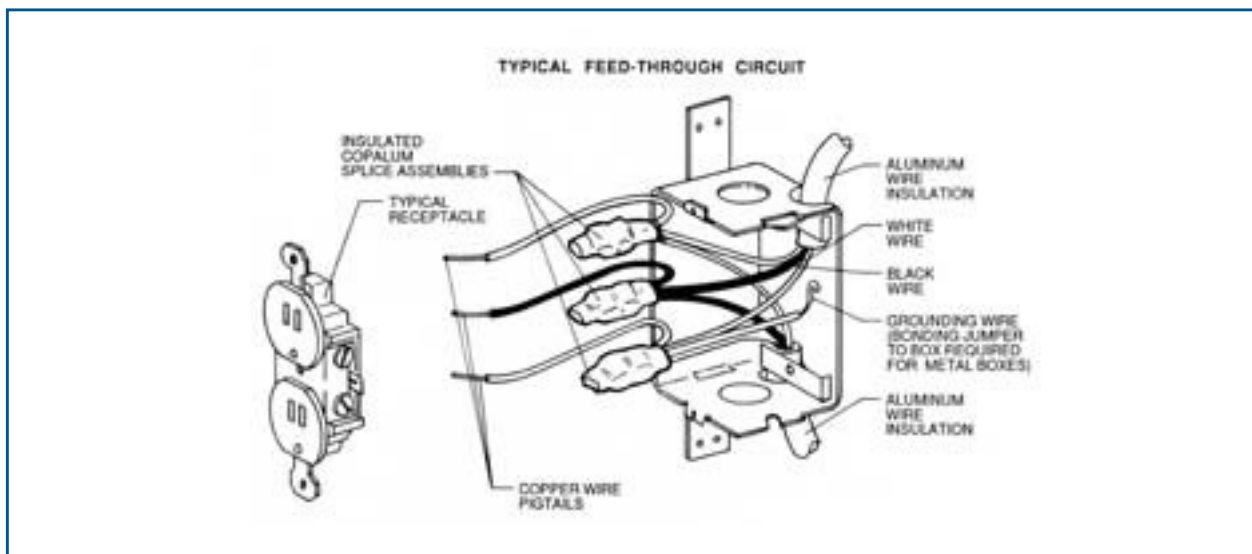
Recommended COPALUM Connector Repair

As an alternate to rewiring with copper, CPSC recommends attaching a short section of copper wire to the ends of the aluminum wire at connection points (a technique commonly referred to as “pig-tailing”), using a special connector named COPALUM to join the wires. CPSC staff considers pig-tailing with a COPALUM connector to be a safe and permanent repair of the existing aluminum wiring. The repair should include every connection or splice involving aluminum wire in the home, including outlets, dimmers, switches, fixtures, appliances, and junction boxes. The repaired system, with short copper wire extensions at every termination throughout the home, permits the use of standard wiring devices, including receptacles and switches.

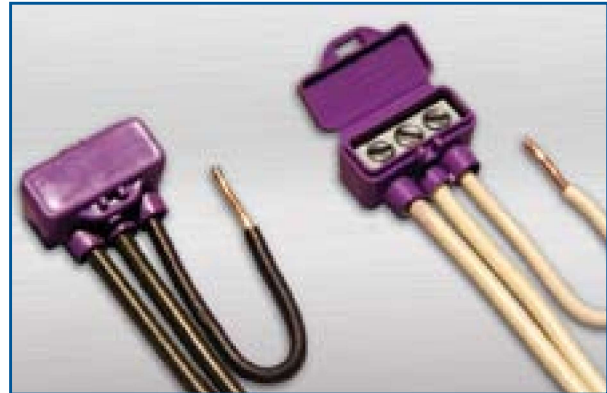
CPSC staff recognizes that copper replacement may be cost prohibitive and that the COPALUM repair may be unavailable in a locality. Based upon an evaluation that was, in part, CPSC supported,⁵ consumers are advised that, if the COPALUM repair is not available, the AlumiConn connector may be considered the next best alternative for a permanent repair. This repair method involves pigtailing using a setscrew type connector instead of the COPALUM crimp connector in the repaired connections.

The AlumiConn Connector

The AlumiConn connector has performed well in initial tests, but is too new to have developed a significant long-term safe performance history as the COPALUM repair. The repair should be conducted by a qualified electrician because careful, professional workmanship and thoroughness are required to make the AlumiConn connector repair safe and permanent.

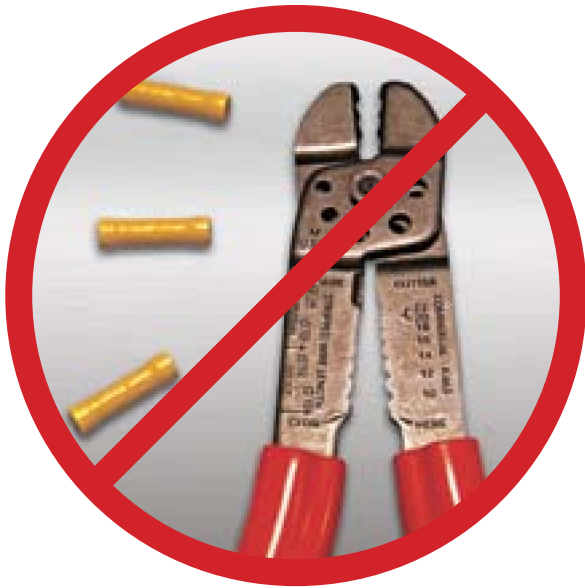
There are many other brands and types of crimp connectors – including those intended to be installed with a pliers-type of handtool – which are readily available to consumers at common retailers.

No other crimp connectors have been evaluated for connecting copper and aluminum conductors. CPSC staff strongly recommends against their use as a repair method.

Do Not Use Common Hand-Crimped Connectors with Aluminum Wire

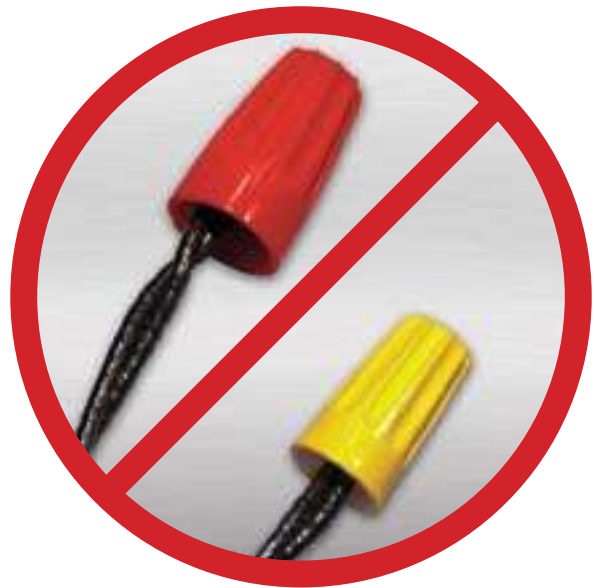
The first temporary repair involves pigtail with a twist-on connector. The effectiveness of “pigtail” using twist-on connectors has been evaluated by CPSC staff. In CPSC-sponsored laboratory testing and life tests, substantial numbers of these connectors overheated severely.

of twist-on connectors with aluminum wire. It is possible that some pigtail “repairs” made with twist-on connectors may be prone to even more failures than the original aluminum wire connectors. Accordingly, CPSC staff believes that this method of repair does not solve the problem of overheating present in aluminum-wired branch circuits.

“Pigtail” with Twist-on Connectors Is Not a Recommended Repair
