BEFORE & AFTER

RESTORATION MASTERPIECE

■ Restore entry ceiling in 1936 home, using authentic and appropriate style and materials.

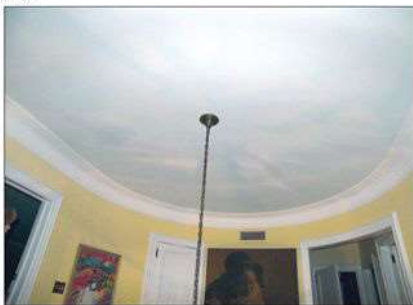
AFTER

■ Repair extensive water damage to molding, walls and 12-by-14-foot oval ceiling, which had 4-foot-diameter hole.

■ Replaster, prime and paint walls and ceiling.

■ Secure new molding sections in place, prime and paint to match original areas.

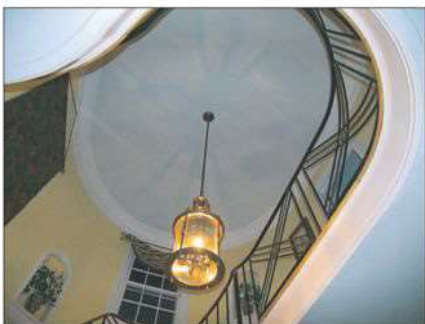
AFTER

■ Give existing wall niches more importance with decorative relief molding.

■ Add new relief molding around decorative niches.
