NEW SURGICAL SALMON CLEANER
HIGHER ROE RECOVERY, LESS FISH DAMAGE, MANNING & WATER

RYCO Equipment, the World Leader in Salmon Gutting Machines, introduces the revolutionary #645 Gutter.

OVERLEAF: D4827-A1

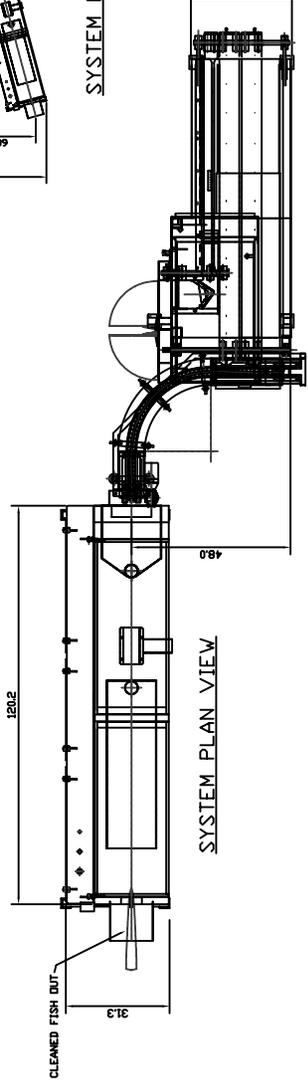
D4827-A7 120918

SYSTEM LAYOUT EXAMPLE

SYSTEM PLAN VIEW

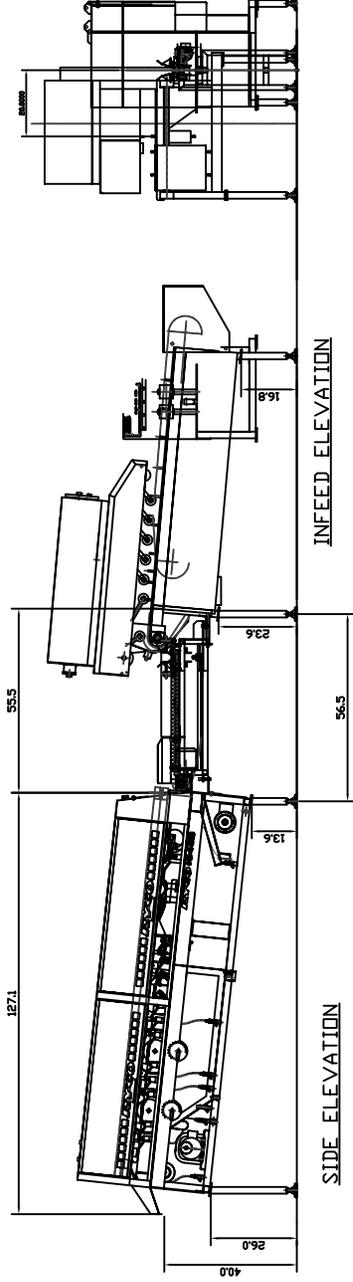
SIDE ELEVATION

INFEED ELEVATION

NOTE:
 1. HEADER D4803, GUTTER D4827
 2. LEG W/FDOT A1456-02, ANGLE AS SHOWN.

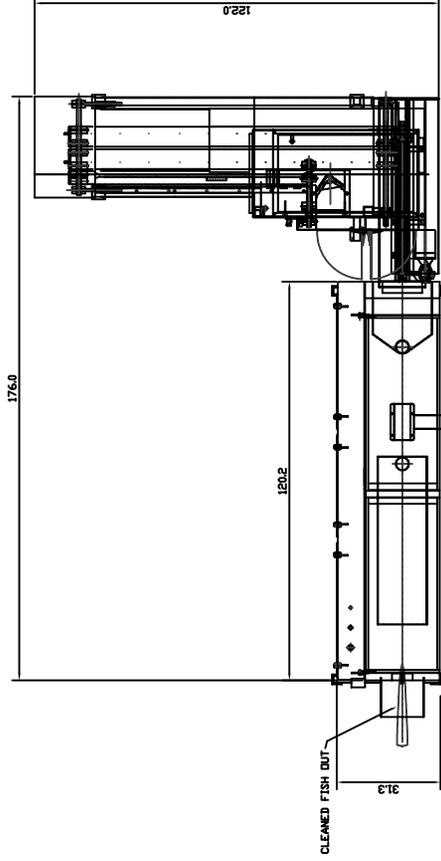
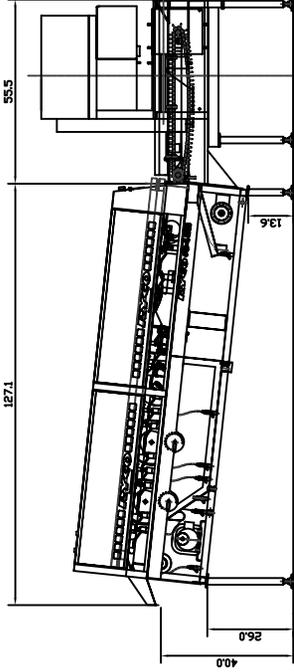
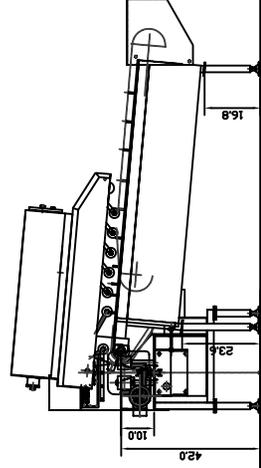
D4827-C2 120922

#645: AUTOFEED FROM #226, 90 DEG CHAIN ARRANGEMENT

SYSTEM PLAN VIEW

OUTFEED ELEVATION

SIDE ELEVATION

INFEED ELEVATION

NOTE:
 1. HEADER D4803, GUTTER D4827
 2. LEG W/FDOT A1456-02, ANGLE AS SHOWN.

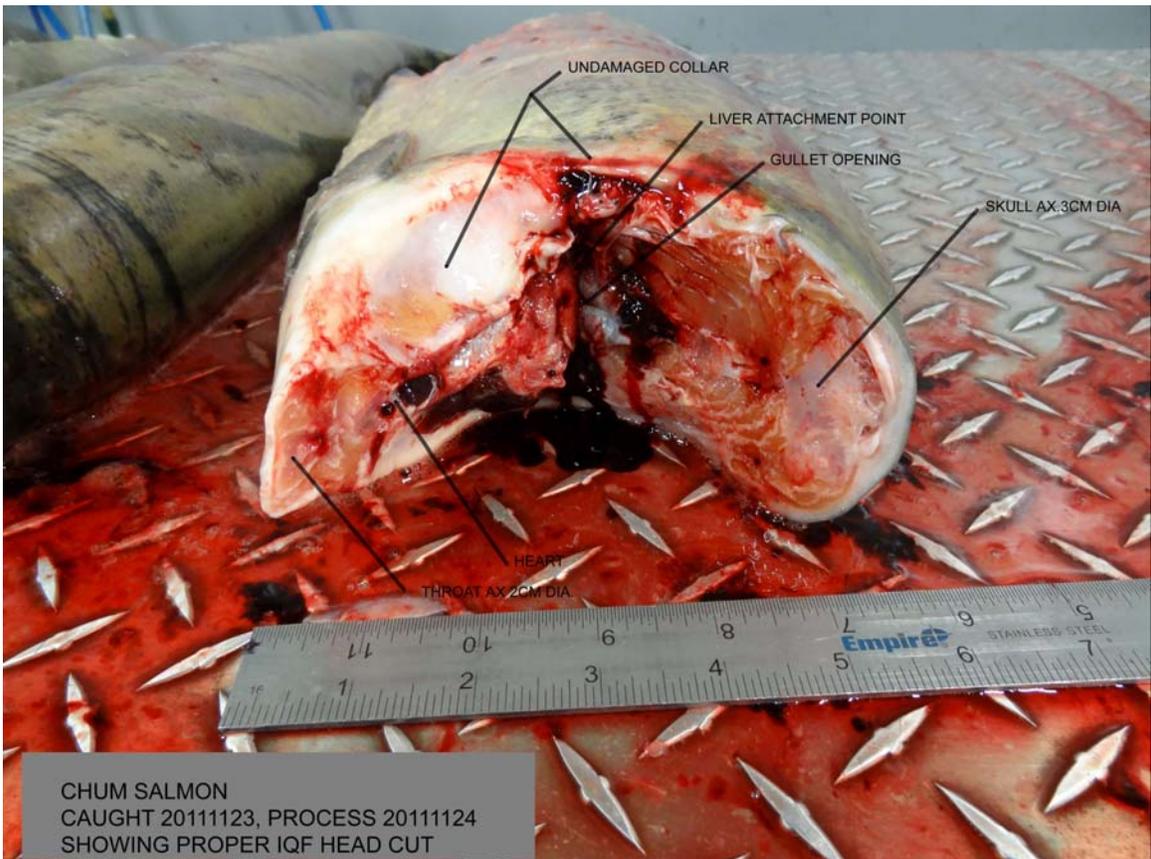
02.2 Proper Headcut.jpg

CHUM SALMON
CAUGHT 20111123, PROCESS 20111124
SHOWING PROPER IQF HEAD CUT

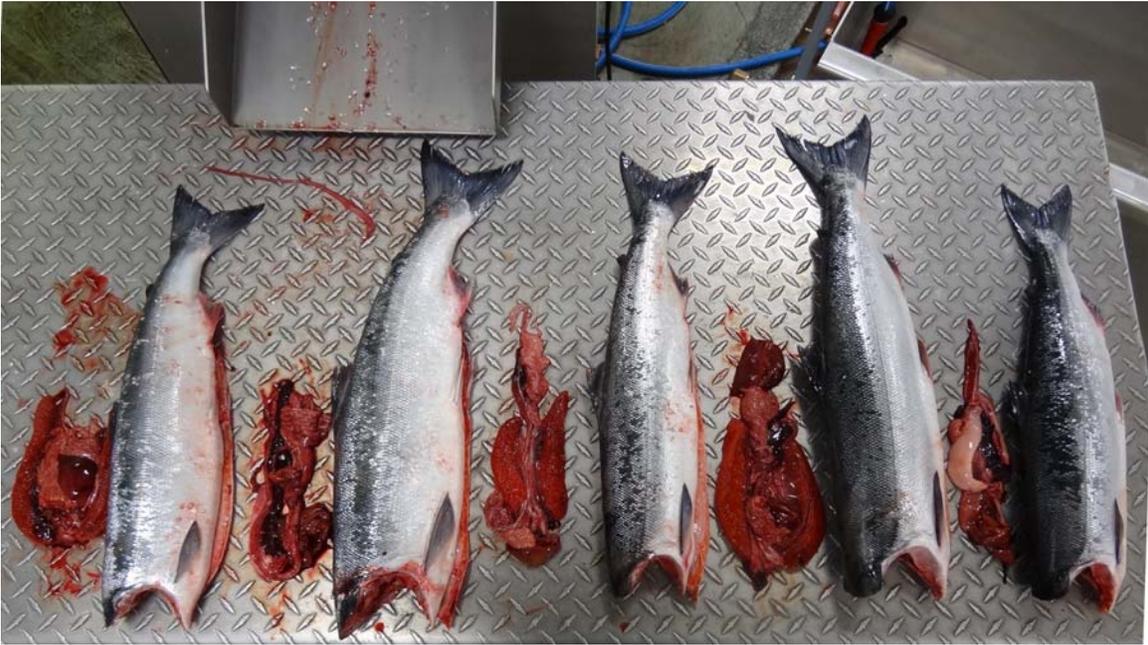
04.5 Cleaned Without Water.JPG

Kidney can be removed in one piece, without water. The machine has been successfully operated with only a small amount of water to lubricate the belly knife.

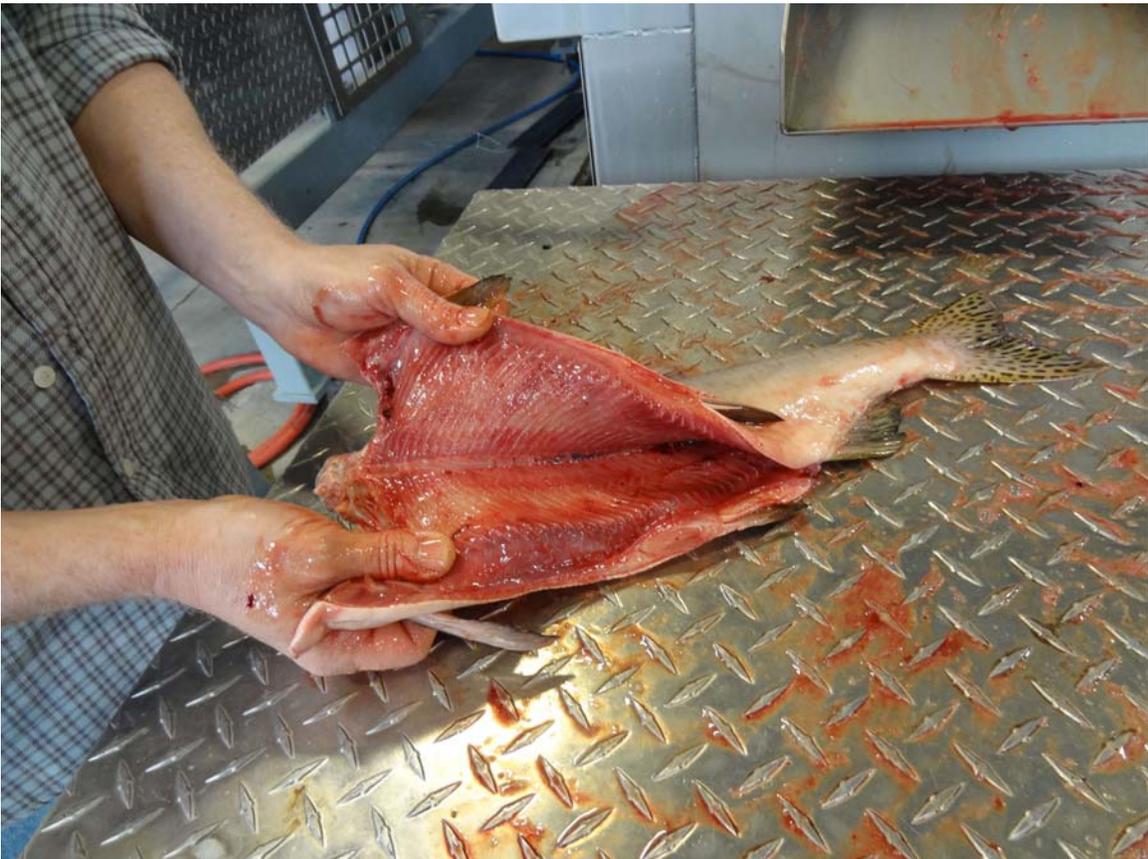
04.6 river humpy cleaned.JPG

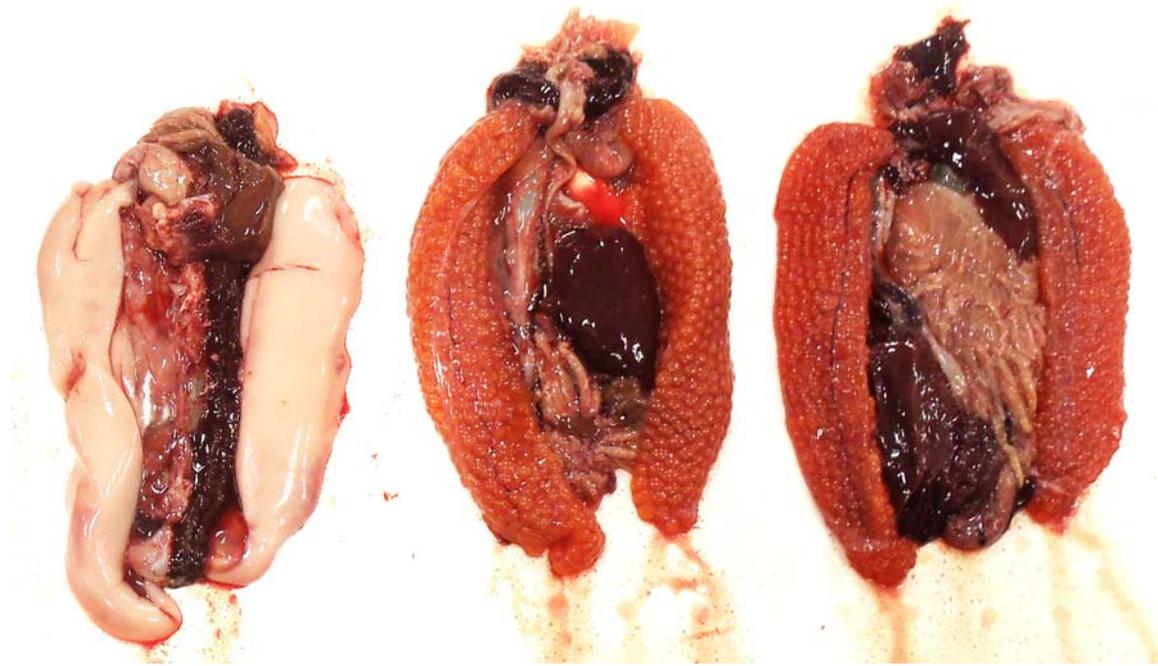
05.3 Perfect Gut Packages.JPG

Does not require a prior gullet cut. Gut package is removed without damage, with all viscera attached to the gullet.
