# Case Study Summary - Inverter Replacement and Upgrade of Faulty Unit

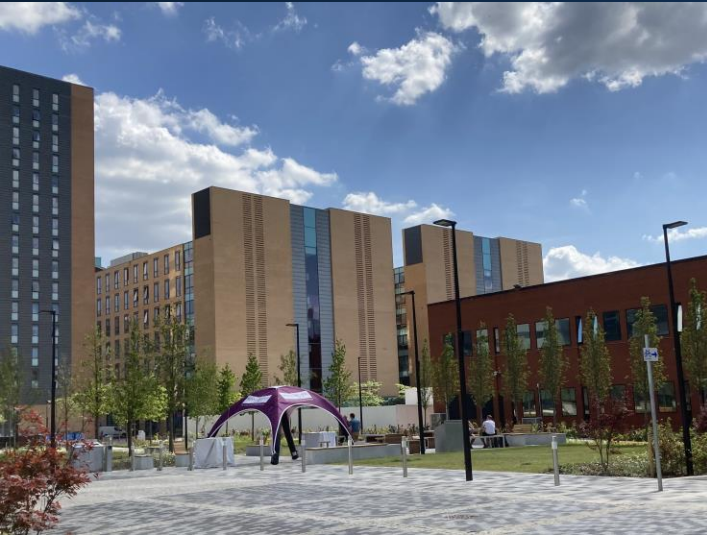
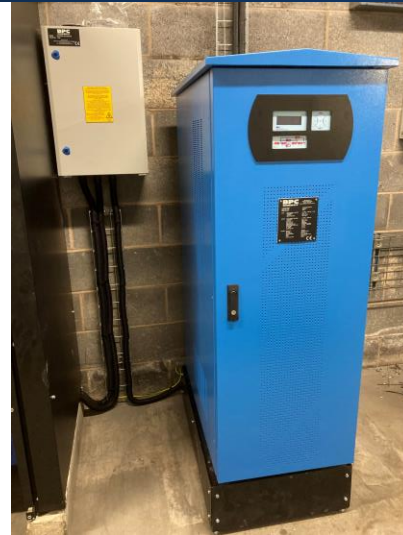
- The scope of the project was to replace a faulty inverter system used with battery back-up to illuminate lights and exit signs on all floors of a University building in Manchester on mains failure to allow safe evacuation of the building should there be a mains supply failure. Also, since the University had begun replacing older style lighting with more energy efficient LED versions, then they needed the any replacement inverter system to be compatible with the new lighting

- We rated a 3-phase 22kVA Power-Pro inverter system from BPC suitable to manage the existing lighting load in addition to the extra in-rush current requirements from the upgrade to LED lighting

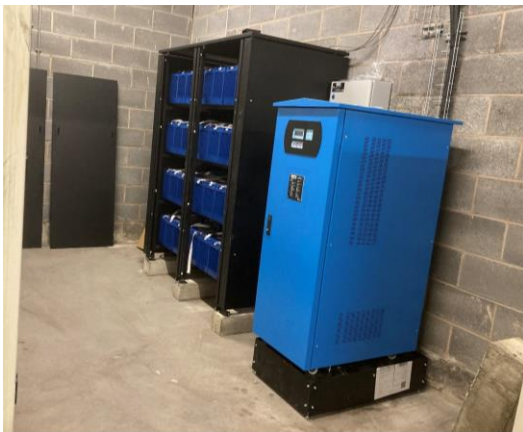
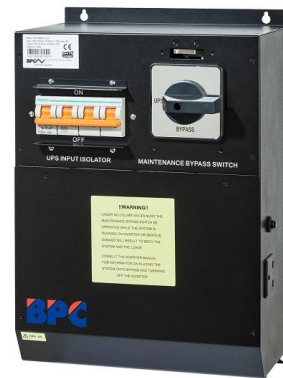
- A battery rack housing 60 maintenance-free sealed lead-acid PowerStor batteries rated with a 10-year design life was provided with all battery build, cabling and commissioning provided by RDF Lighting Power and Control engineers.

- To allow the University's maintenance team to isolate the inverter during maintenance, a suitably rated 3-phase maintenance bypass switch was also provided and fitted.
