Graffiti Removal

By Trail End State Historic Site Superintendent Cynde Georgen; from *Trail End Notes*, May 2005

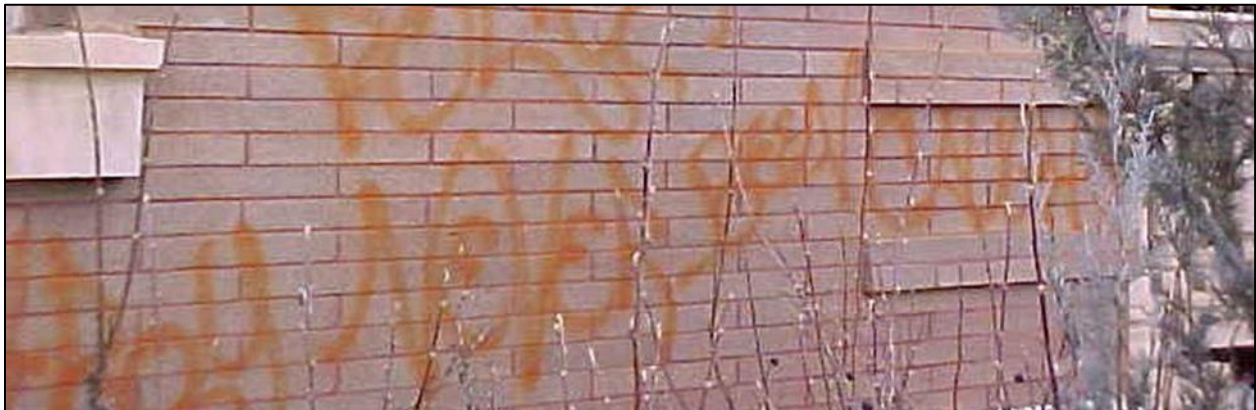
In January 2005, several young “gentlemen” set out to make their mark in Sheridan. Unfortunately, they decided to do it with a spray can. The result was over \$4,000 worth of graffiti damage to the exterior of the Kendrick Mansion.

Trail End Graffiti, 2005 (TESHS Collection)

In April, Courtney Murdock, Project Testing Coordinator for Masonry Stabilization Services Corporation of Lawrence, Kansas, came to Trail End to test the properties of the spray paint used on the building (not only do different paints have differing removal techniques, different surfaces absorb the paint's pigment differently!). Wearing gloves and safety goggles, Courtney spent two days testing a variety of products on the brick and limestone surfaces, hoping to find the most appropriate product for removing the bright orange “tags,” taunts and obscenities from the building. By the time she finished, Courtney had identified a multi-step process - using three different products, a power washer and lots of time - that looked like it would remove almost all of the paint.

In early May, Trail End staffers Rod Adams and Nancy McClure followed Courtney's recommendations and began work on the graffiti removal. Step one of the process called for the application of a thick paste-like stripper that had to be covered with a protective paper film and left on for twenty four hours.

The next day, the paper was removed and the remaining stripper scraped off. Following a good rinse with the power washer, an “after wash” was brushed on which essentially neutralized the stripper. Three minutes later, that product was also washed off. At that point, things did not

look too good, as quite a bit of the paint still remained, especially on the limestone columns. But, assured by the results of Courtney’s testing, Rod and Nancy did not give up hope.

In the next step, a “fast acting” paste was applied and allowed to dwell on the masonry for twenty minutes, all the time being agitated with a stiff bristle brush. Following a final rinse with the power washer, it quickly became apparent that the process worked: The graffiti was gone!
