This note explains why Infrared heating systems should not be used to attempt to provide heating for earth station antenna anti-icing. Infrared (IR) heating problems are especially troublesome for Ku or Ka-Band.

### INFRARED HEATING?

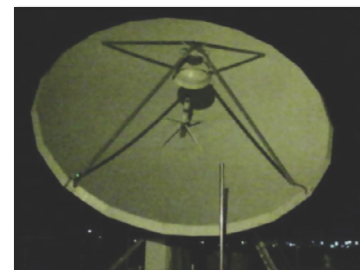
Figure 1: 8m Antenna

**Figure 2** below shows a thermal image of the same 8-meter antenna shown in the photo to the right in **Figure 1**. The thermal image was taken as ten (10) residential grade Infrared Heaters were placed inside the antenna's rear enclosure structure and activated in an attempt to perform anti-icing. The temperatures of different spots on the Infrared-Heated Dish in **Figure 2** correspond to their colors in the thermal image. The vertical color spectrum/legend on the right of the image shows the range of temperatures from 20 °F to 60 °F. **Table 1** shows temperature measurements at 12 spots (*Sp1, Sp2...Sp12*) on the antenna reflector. For example, Spot 4 (*Sp4*) is 48.4 °F, while spot 5 (*Sp5*) is 30.7 °F, below freezing.
