Why You Should Think Twice About Putting a Single-Ply Roof on a Metal Building

By Charlie Smith and Terrence E. Wolfe, PE

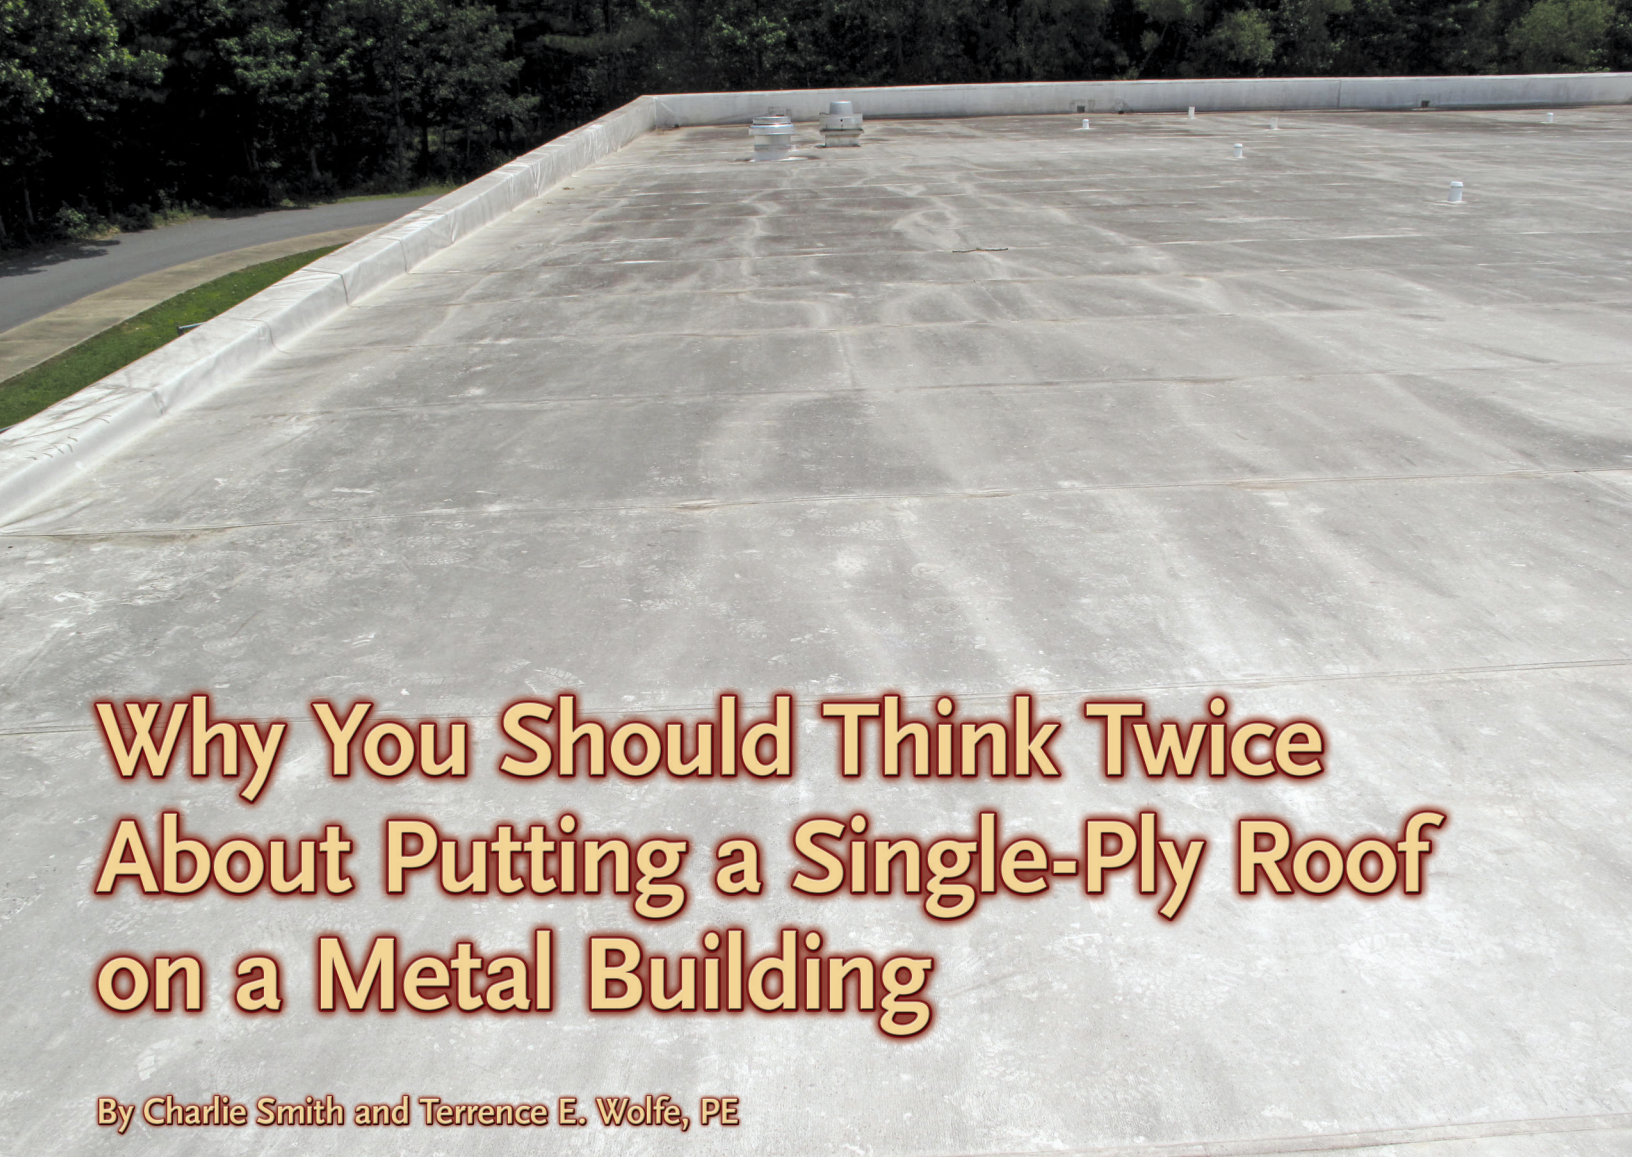
Figure 1 - This low-slope metal building with a trapezoidal standing seam was re-covered with a single-ply membrane. Water tends to flow in the deflection mid-span on the purlins.

When there is a ribbed metal roof in place, water flows down between the ribs of individual panels to the gutter. This ensures equal loading on the purlins and confinement of that water to an individual bay. If one chooses to recover a low-sloped, metal roof on a metal building using single-ply membranes, the water flow is changed. Since there are no ribs to confine the flow as the water moves downslope to the gutter, the water will naturally flow towards the mid-span of the purlins where maximum deflection occurs. This can be seen clearly in *Figure 1*.

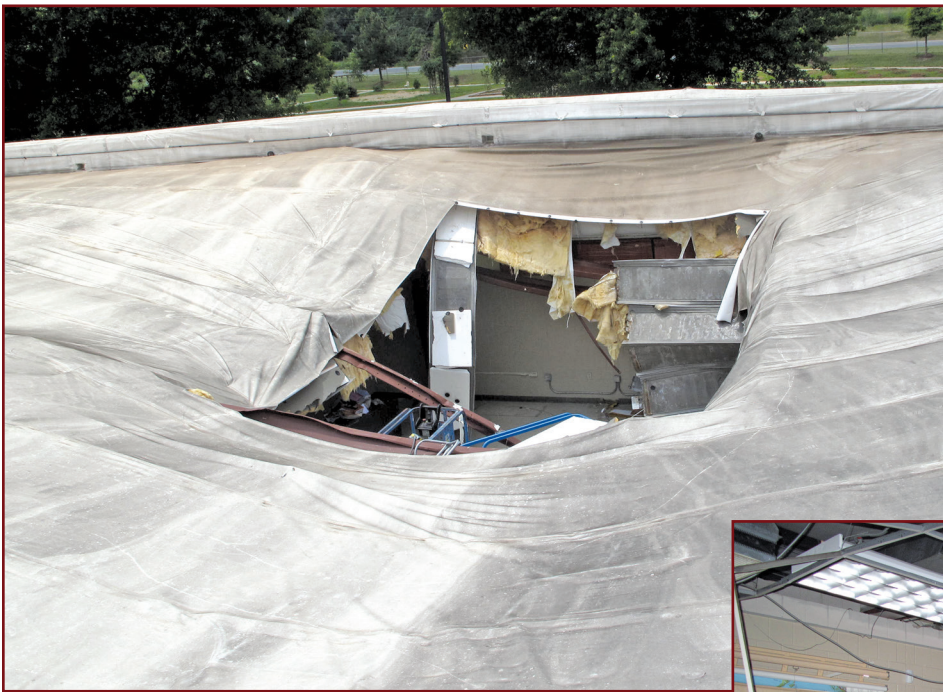
Figure 2 – This same building roof collapsed due to several factors related to a single-ply re-cover.

4. **A clogged scupper or drainpipe.** During a single-ply retrofit of the building in *Figure 3*, the internal gutters were filled, and scuppers were added to handle the water flow out of the parapet wall. This is a very common practice when re-covering existing internally drained metal buildings, and it creates the worst possible scenario on a metal building structure. A clogged scupper outlet caused the initial backup of water onto the first purlin up from the eave in the widest-span bay. As the first purlin was being pushed down or deflected with the additional weight of the water, the purlins in the adjacent

bays rose and forced the water from the two adjacent bays into the wider span bay where the low spot occurred. It also prevented water from reaching the overflow and adjacent scuppers because the eave strut had not deflected along the parapet wall. As a result, it took a matter of minutes for the roof to collapse.

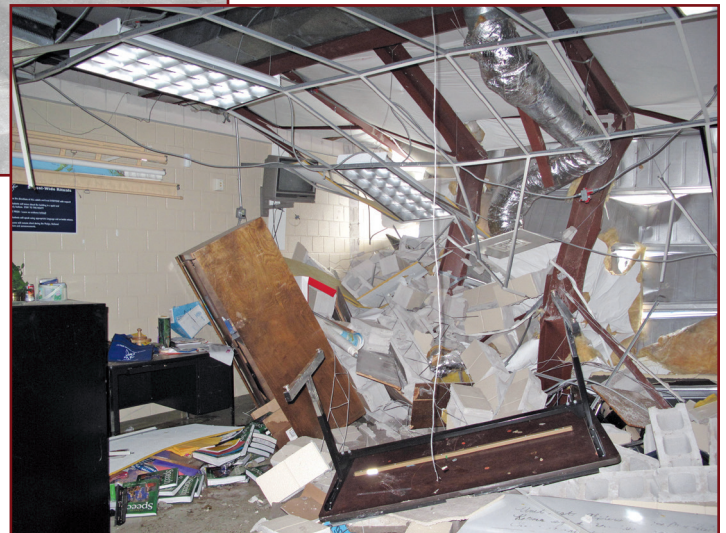
Figure 3 – Interior shot of collapse.

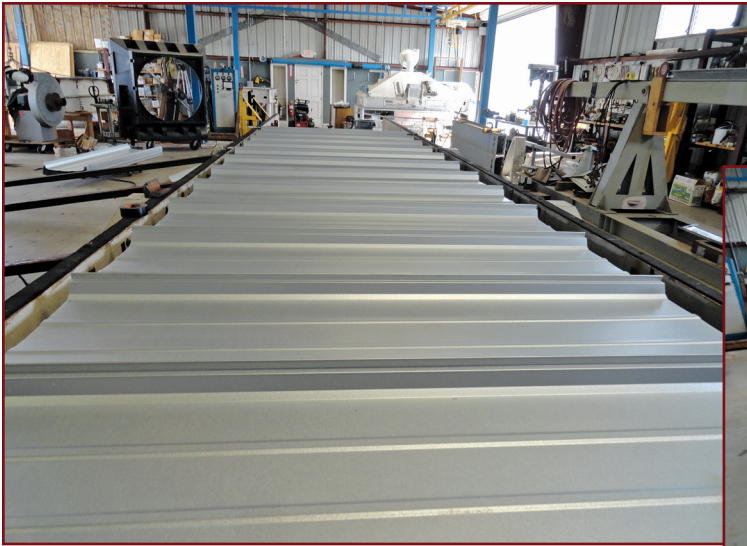
Figure 4 – Roof panels mounted on purlins prior to base testing.

A couple of years ago, we did some base testing to determine what effect doing metal-over-metal retrofit had on purlin strength. A base test is where you take two full-length purlins in a single-span condition, with a metal roof attached to them, and push down on the purlins until they buckle. The first test was done over a typical low-slope metal building installation: 8-in.-tall by 16-gauge by 25-ft. long purlins with a 24-gauge, 3-in. by 24-in. trapezoidal standing-seam roof to establish a baseline for the retrofit tests. (See Figures 4 and 5.)

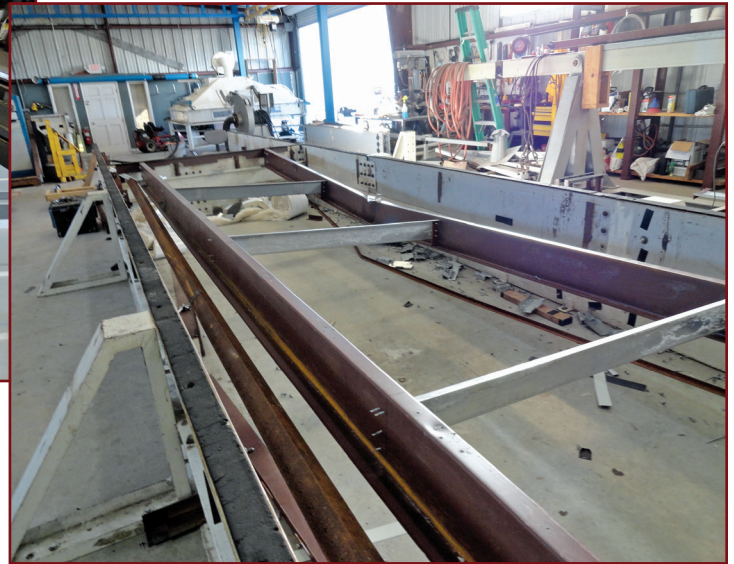
Figure 5 – Purlins after base test failed at 23.5 psf.

Without the retrofit, the purlin buckled at 23.9 psf. One inch of water weighs 5.2 pounds per square foot. That means in this case, the purlin would have failed with 4.6 inches of water on it.
