OPW Engineered Systems specializes in the engineering, designing and manufacturing of systems for the safe and efficient loading and unloading of critical hazardous materials: loading systems, swivel joints, instrumentation, quick and dry disconnect systems and safety breakaways.

LYNX Series Datasheet

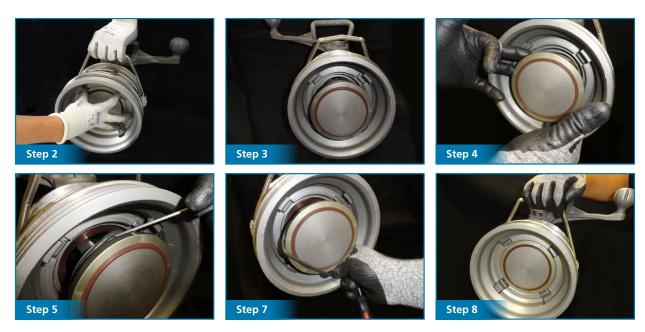
- 1. Isolate loading arm to prevent product flow. Drain off fluid in the loading arm and ensure LYNX is clean and dry.
- 2. Squeeze the handle (API555-6) and push all four latches in at once. While holding the latches in, slowly release the handle to allow the collar to slide forward.

- **3.** Turn the operating handle (API800-11 or API800-15) to open the poppet (API800-9)
- 4. Pull the poppet adaptor ring (API800-4) forward.
- 5. Remove the outer O-ring (0203 or 0203VG) without damaging the poppet adaptor ring.

- 7. Grease the new outer O-ring using solvent-resistant grease and install the O-ring onto the poppet adaptor ring.
- ◆ NOTE: During insertion, minimize O-ring twist and do not overstretch or damage the O-ring. Do not roll the O-ring into place, as this will shorten the life of the O-ring.

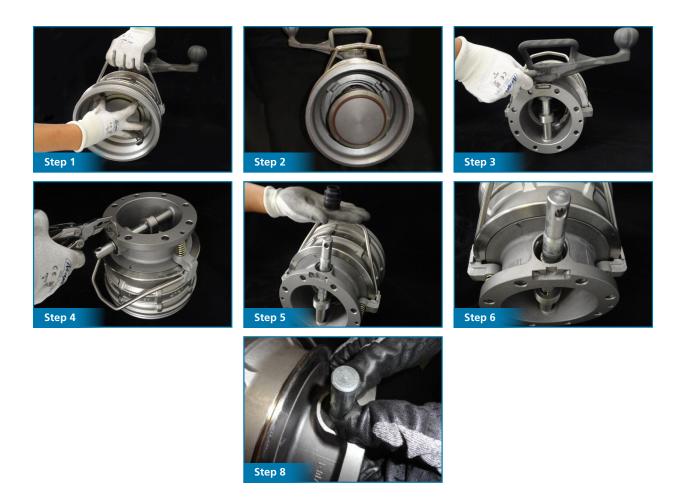
9. Install the U-pin and ensure it is secure.

- 10. Refit the operating handle as per the orientation shown and refit the cap screw & nyloc nut (4399), ensuring the handle is secured in placed by tightening the cap screw/nyloc nut.
- ◆ NOTE: 1. Ensure a new nyloc nut is used each time. Do not re-use old nyloc nut.
 - 2. When refitting the handle bolt, the recommended torque is 3-4 N m (this is the torque required to screw through the nyloc nut, but excessive force may damage or strip the nut threads).
 - 11. Close the coupler operating handle and pull back the latch release handle allowing the collar to retract and click into place.

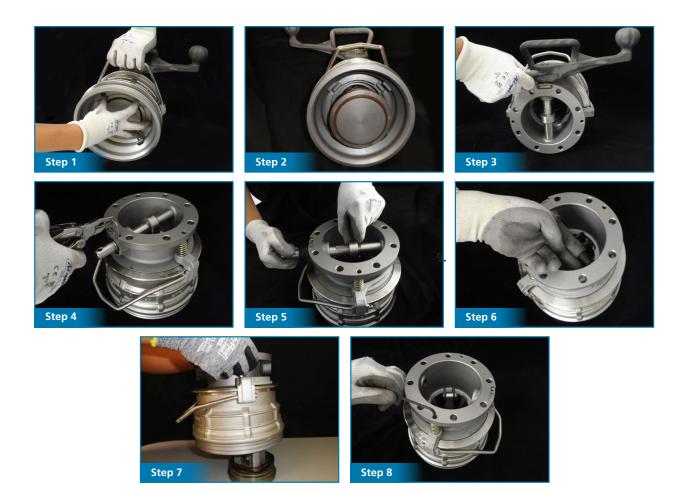
- 9. Turn the unit so the flange faces down and the pins (API800-13) should slide out.
- **10.** Turn the unit so the flange faces up.
- 11. Remove the springs (4497). If they are damaged, replace them as required.

- 12. Remove split pin (0762) from the latch release handle (API555-6) and lever (LIQAPI800-18).
- 13. Pull the latch release handle.
- 14. Lift and slide out the lever.
- 15. Lift the collar off the body (API800-2).
- 16. Inspect the collar for wear. If wear is evident, contact your local OPW Engineered Systems representative.
- **17.** Inspect wave spring (6182) for damage. If it is damaged or broken, replace as per Section 6.1.2 Disassemble and Reassemble Procedure (page 14).

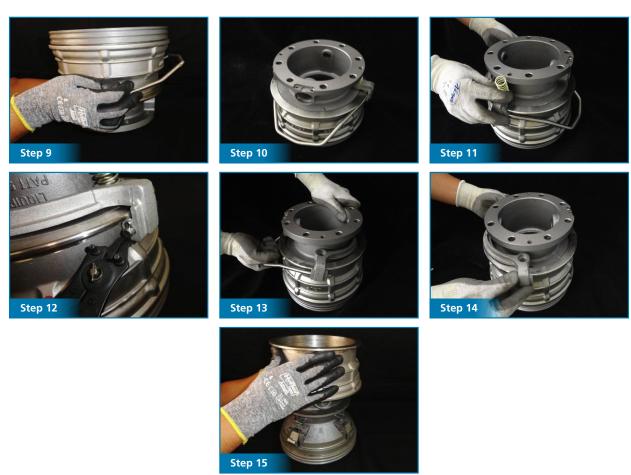
- **1.** Sit body on bench with the flange facing down.
- **2.** If any of the springs (6171) came out during the disassemble procedure, inspect them for wear and replace as required. Refit the springs into the drilled holes in the body.
- ◆ NOTE: If latches do not move or operate freely, replace them or contact your local OPW Engineered Systems representative.
 - 3. Sit body assembly on bench with flange facing up.

- 4. Place the collar over the body. Ensure all latches are pressed in so that the collar drops flush with the front face.
- 5. Place lever (LIQAPI800-18) on the bottom of the coupler as per the orientation shown below.
- **6.** Place springs (4497) into the recess of the lever, lining them up with the holes for the grub screws.
