The Bighill Creek Project

The 2010 Ranch House Spring Creek Project!

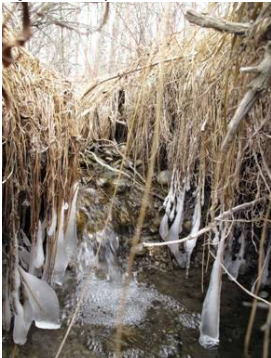
The juvenile trout were found in numbers below a small waterfall that was located approximately 100 metres upstream of the mouth. The small waterfall prevented any trout from migrating upstream and occupying good habitat that existed up from the barrier.

The waterfall had been created by huge volumes of flow from a storm drain that entered the stream approximately 80 metres upstream of the waterfall. The storm drain's source was a new development built on the north side of the Bighill Creek valley.

Above: This is a photo of the small waterfall that was taken from a position near the surface of the stream, directly below the barrier.

In 2010, BVHD obtained funding from the ACA Grant Program and all of the necessary permits and permissions, to remove the small waterfall and enhance the stream channel with boulder habitat that would allow juvenile trout to migrate upstream of the existing barrier.

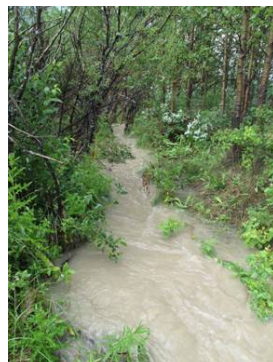
The problem with the storm drain is something that needs to be addressed in the near future. The volume of run-off that enters the Ranch House Spring Creek during freshets is too much for the existing stream channel to handle. Future erosion problems will continue to develop downstream of the inflow area on the stream channel.

Above: This is a photo of the stream channel in Ranch House Spring Creek, below the culvert, during a run-off event. You can see from the turbulence created in the creek channel that erosion on the stream banks is occurring and future bank collapse is imminent!

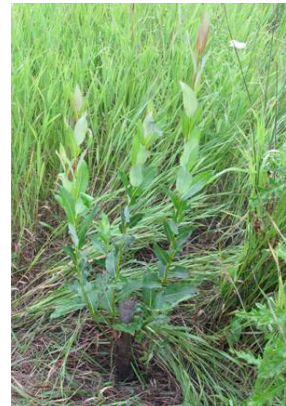
A gas powered augur is used to prepare a hole of a larger sized diameter into the ground and more mud slurry is required to fill the remaining hole once the cutting is planted. The cuttings are also planted deeper than the smaller variety which makes the deep root systems more advantageous in drier conditions!
