Check Cracking

“Check Cracks” or “Shrinkage Cracks”

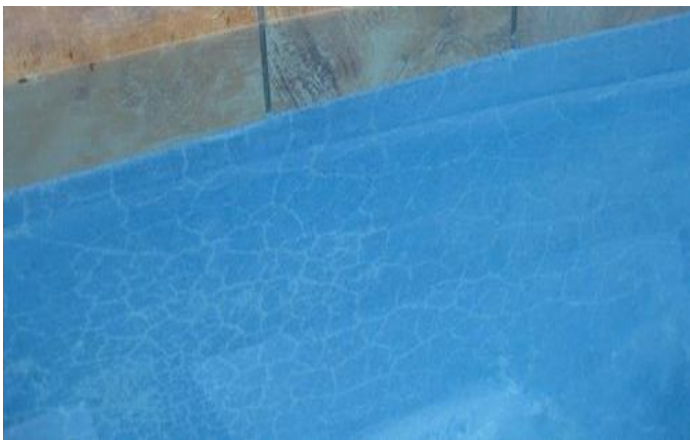
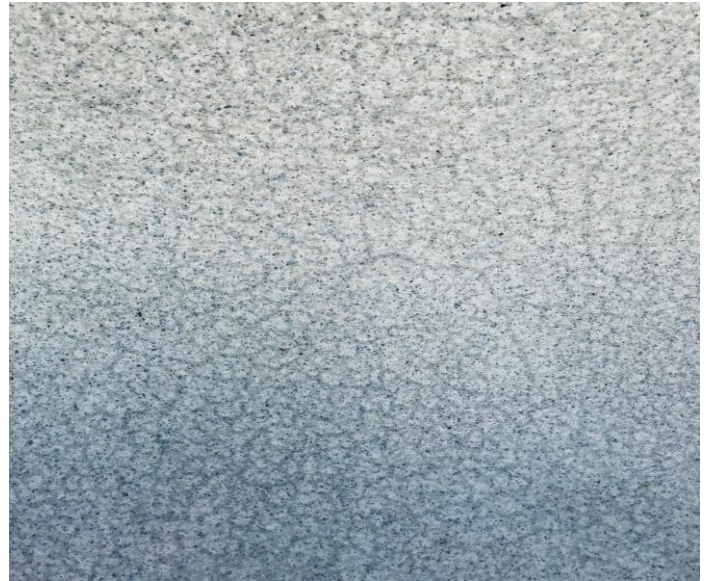
“Check Cracks” or “Shrinkage Cracks” are inherent to some degree in all cement mortar mixes, and are not considered a material defect.

Commonly, “Check Cracks” or “Shrinkage Cracks” are minor surface cracks. It is virtually impossible, without draining the pool’s water and cutting out a sample of the plaster, to determine whether or not this is a structural crack in the concrete shell or just a normal shrinkage crack.

To repair minor “Check Cracks” or “Shrinkage Cracks” in the plaster, fill the pool with water and allow plaster to be submerged completely. In certain instances the minor voids due to the cracking will expand and become difficult to detect.

In some slight cases, polishing the pools finish may also reduce the visibility of these cracks. In a more severe case, using a concrete saw, make cuts approximately $\frac{3}{4}$ ” deep on either side of the crack. Keep the saw cuts as straight as possible while following the crack. Remove the plaster between the saw cuts carefully. Roughen the now exposed surface and fill this section with matching Diamond Brite.
