Case Study: 2000KVA Generator aboard Research Vessel

MV Western Patriot: docked at Loyang Offshore Supply Base: April 23, 2013.

This article will describe some recent Electrical Diagnostic Engineering that was performed in the generation spaces of a very important research vessel.

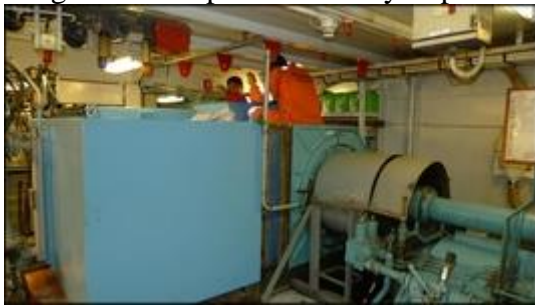
Background: Temperature alarms were triggered on one of the two 2000KVA shaft generators aboard the vessel. After discussions, the decision was made to put into harbor for diagnostics.

A modern Surge/Hipot/Resistance motor tester was in the shipyard inventory, and was deployed by the Electrical Diagnostic Engineer. Surge testing revealed that the stator coils are showing signs of insulation deterioration and may fail at some time in the near future if allowed to operate in its present condition.

Summary: It was recommended that the stator in this generator be scheduled for reconditioning, before it could completely fail in service. In this case, a failure in service would reduce the capability of the vessel while at sea, and removed redundancy for generation. Loss of the second generator could have resulted in further risks. As an additional bonus, the motor/generator technician received the very best training possible, providing for better job and equipment performance.

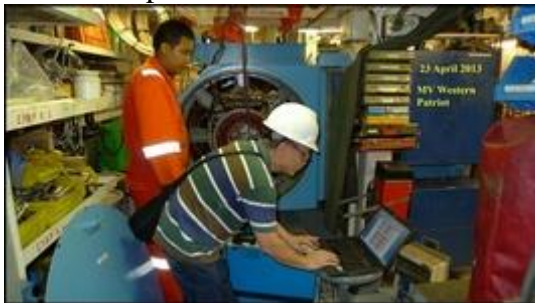
See the suspect Generator at left:
