STAIR #56-ROOF FRAMING PLAN

STAIR #56-UPPER LEVEL FRAMING PLAN

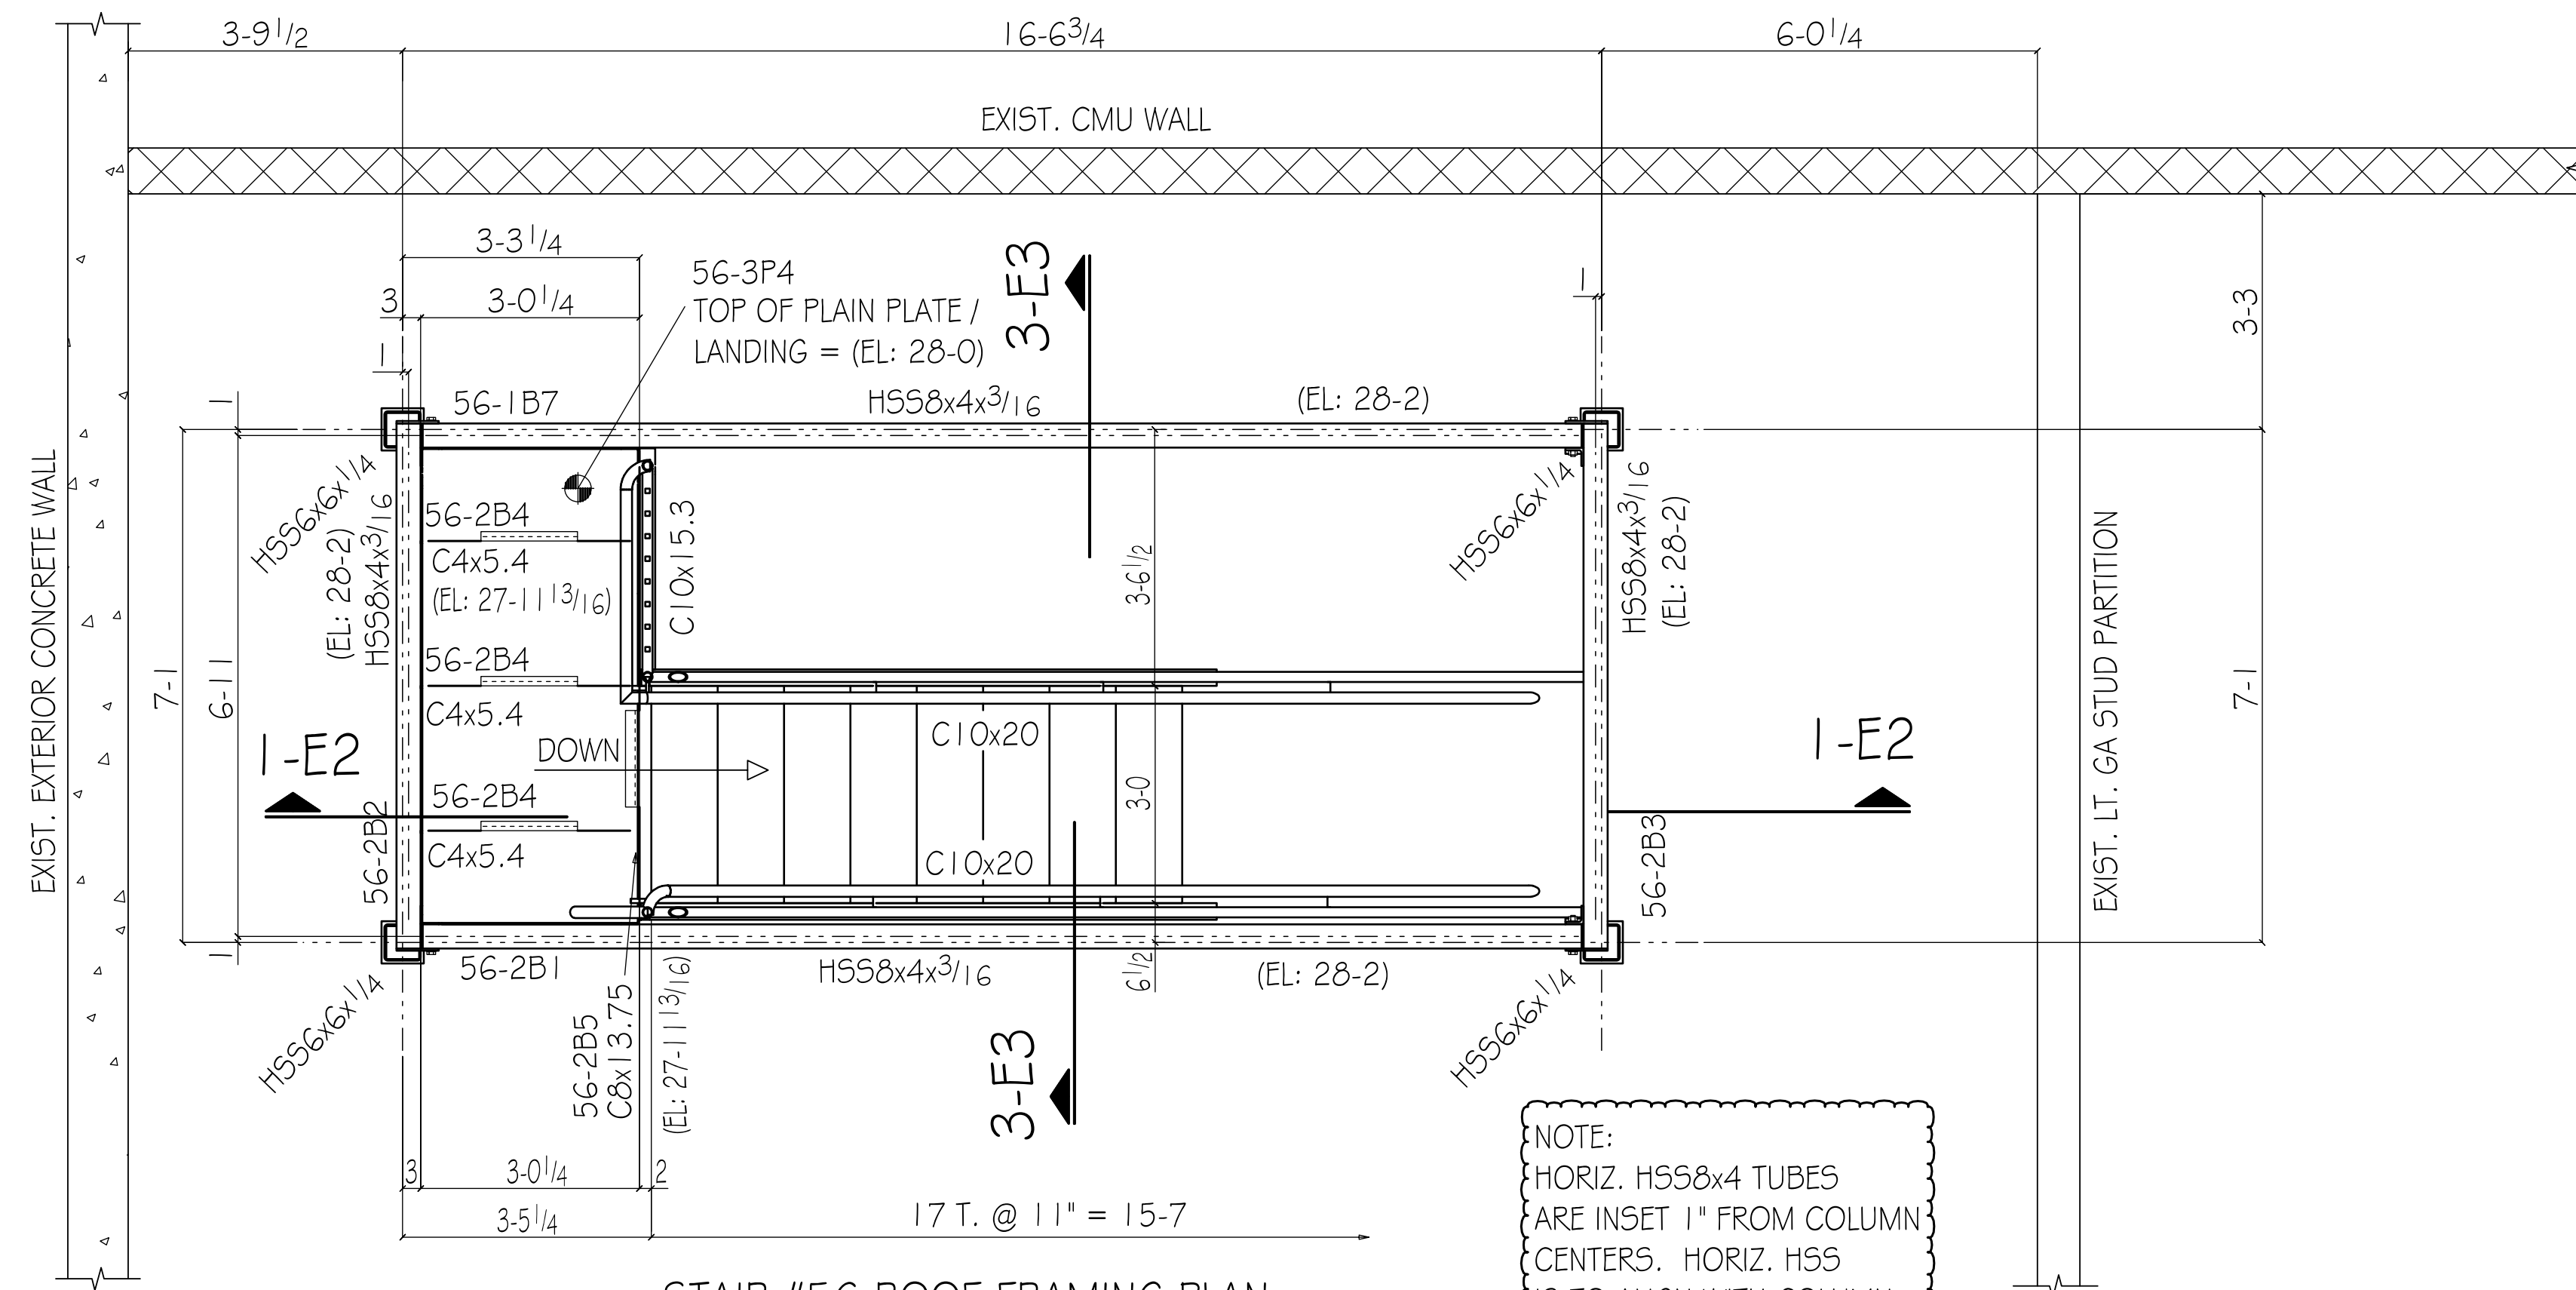
NOTE:
 HORIZ. HSS8x4 TUBES
 ARE INSET 1" FROM COLUMN
 CENTERS. HORIZ. HSS
 IS TO ALIGN WITH COLUMN
 INSIDE CORNERS.
