# Night Walk Test Report

BC Axiom Squamish Axiom – Sea & Sky

Weather Condition: Cloudy, 5° Time: 10:25 A.M. March 14, 2023

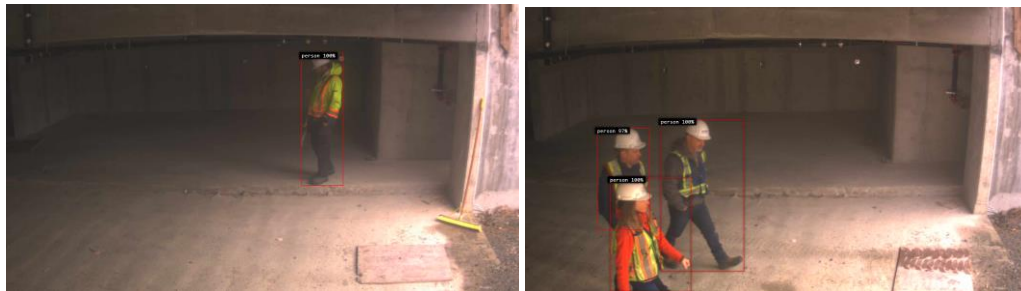
## 2. RD1

| CSO Feedback | | | | |
|---|---|---|---|---|
| ReconEyez Detector | RD1 | <input checked="" type="checkbox"/> | <input type="checkbox"/> | <input type="checkbox"/> B Box <input type="checkbox"/> Too Dark <input type="checkbox"/> Reflections <input type="checkbox"/> Blind Spots <input type="checkbox"/> No Triggers <input type="checkbox"/> Bright |
| Triggered well through the day and at Night | | | | |
| Bridge connection is at -85dBm which is poor, but alarms are going through. Highly recommend an additional Bridge. | | | | |
| Covers the Parkade entrance really well to detect all incoming and outgoing people and vehicles. | | | | |

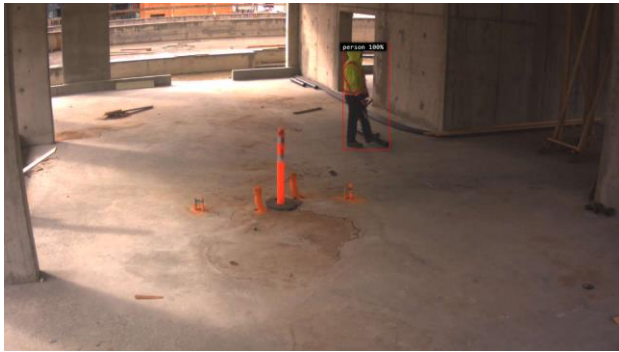
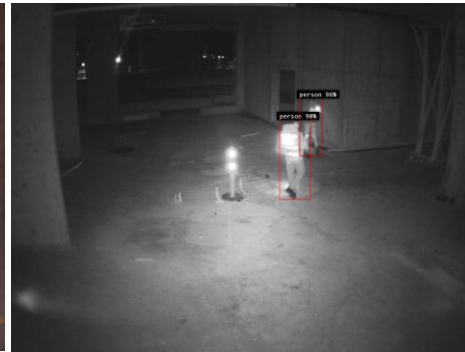
## 3. RD2

| CSO Feedback | | | | |
|---|---|---|---|---|
| ReconEyz Detector | RD2 | <input checked="" type="checkbox"/> | <input type="checkbox"/> | <input type="checkbox"/> B Box <input type="checkbox"/> Too Dark <input type="checkbox"/> Reflections <input type="checkbox"/> Blind Spots <input type="checkbox"/> No Triggers <input type="checkbox"/> Bright |
| Triggered well through the day and at Night. | | | | |
| All Good. Bridge connection is -58 dBm which is acceptable. | | | | |
| Maybe point this camera to the stairwell. However, it will pick up anyone coming up the ramp in the background or going towards the stairwell. | | | | |

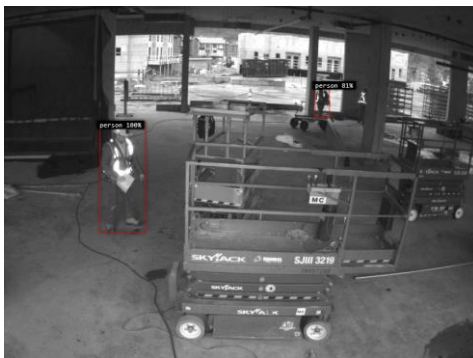
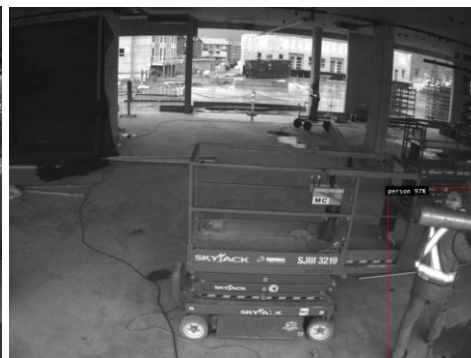
## 4. RD3

| CSO Feedback | | | | |
|---|---|---|---|---|
| ReconEyz Detector | RD3 | <input checked="" type="checkbox"/> | <input type="checkbox"/> | <input type="checkbox"/> B Box <input type="checkbox"/> Too Dark <input type="checkbox"/> Reflections <input type="checkbox"/> Blind Spots <input type="checkbox"/> No Triggers <input type="checkbox"/> Bright |
| Triggered well through the day and at Night. | | | | |

| Equipment | Camera | Possible Actions |
|---|---|---|
| All Good. Bridge connection is -10 dBm which is really good. | | |
| Too early to tell, but we should consider perimeter placement. | | |

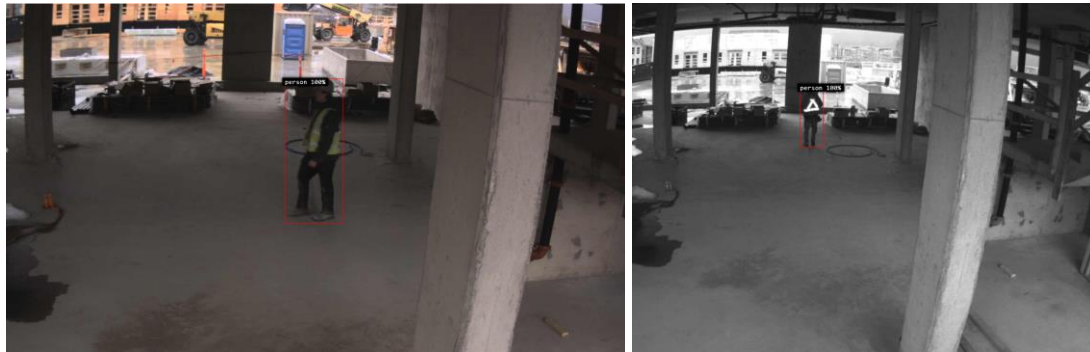
### 5. RD4

| <b>CSO Feedback</b> | | | | |
|---|---|---|---|---|
| <b>ReconEyez Detector</b> | RD4 | <input checked="" type="checkbox"/> | <input type="checkbox"/> | <input type="checkbox"/> B Box <input type="checkbox"/> Too Dark <input type="checkbox"/> Reflections <input type="checkbox"/> Blind Spots<br><input type="checkbox"/> No Triggers <input type="checkbox"/> Bright |
| Did not receive many alarm triggers. | | | | |
| All Good. Bridge connection is -73 dBm which is really poor. I recommend an additional Bridge as mentioned earlier. | | | | |

| <b>CSO Feedback</b> | | | | |
|---|---|---|---|---|
| Too early to tell, but we should consider perimeter placement. | | | | |

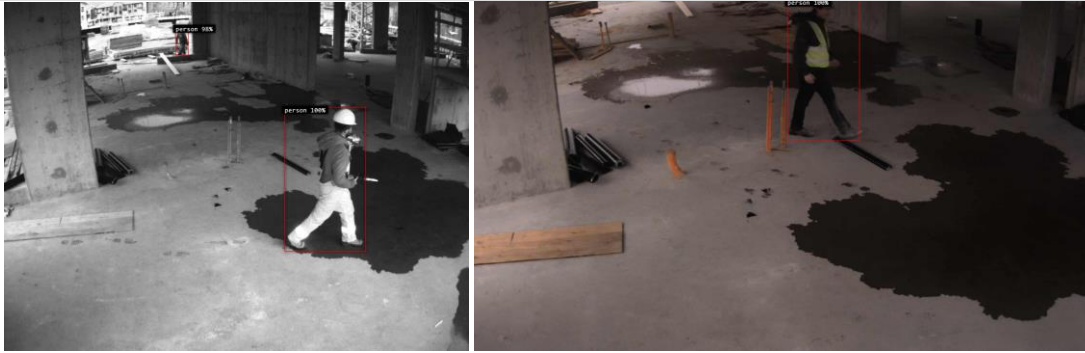
### 6. RD5

| CSO Feedback | | | | |
|---|---|---|---|---|
| ReconEyz Detector | RD5 | <input type="checkbox"/> | <input checked="" type="checkbox"/> | <input type="checkbox"/> B Box <input type="checkbox"/> Too Dark <input type="checkbox"/> Reflections <input type="checkbox"/> Blind Spots <input type="checkbox"/> No Triggers <input type="checkbox"/> Bright |
| Did not receive many alarm triggers. Camera has been hit between 8:10 am to 8:20 am since we tested and has moved. | | | | |
| All Good. Bridge connection is -58 dBm which is acceptable. | | | | |

| CSO Feedback | | | | |
|---|---|---|---|---|
| This camera was placed in a good position and seeing some impressive alarm triggers. We must send a technician back to reposition the Detector. | | | | |

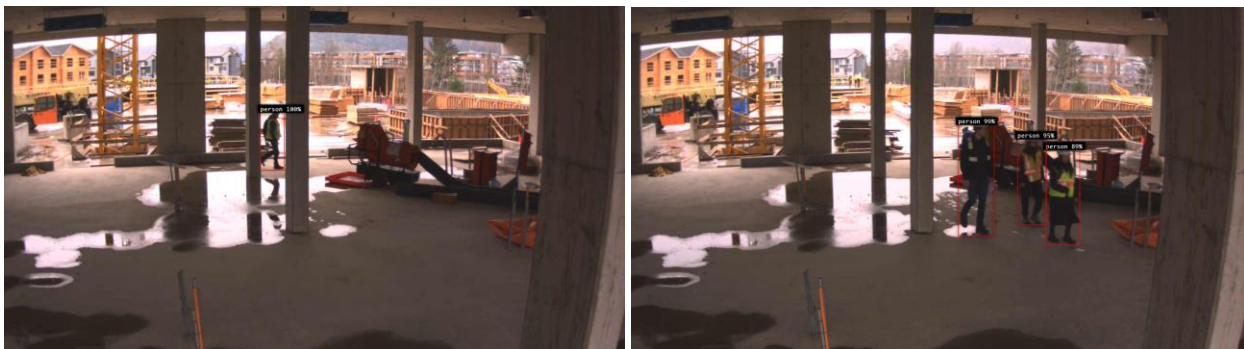
## 7. RD6

| CSO Feedback | | | | |
|---|---|---|---|---|
| ReconEyz Detector | RD6 | <input checked="" type="checkbox"/> | <input type="checkbox"/> | <input type="checkbox"/> B Box <input type="checkbox"/> Too Dark <input type="checkbox"/> Reflections <input type="checkbox"/> Blind Spots <input type="checkbox"/> No Triggers <input type="checkbox"/> Bright |
| Many alarms received. | | | | |

| Equipment | Camera | Possible Actions |
|---|---|---|
| All Good. Bridge connection is -13 dBm which is good. | | |
| Great placement of the Detector. | | |

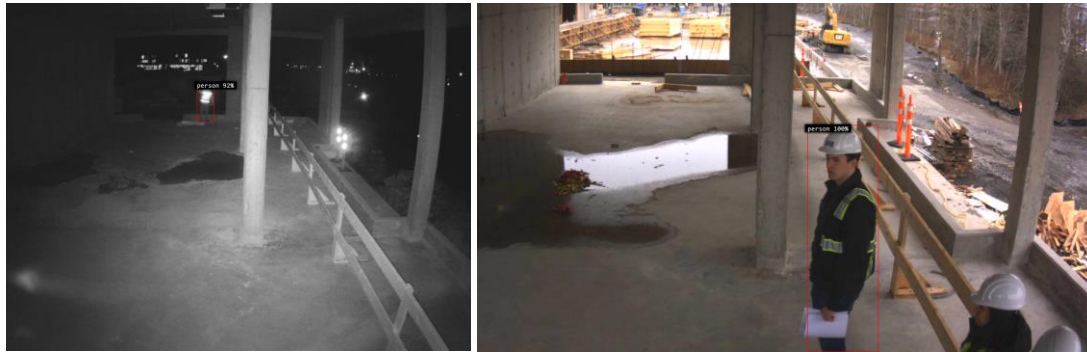
### 8. RD7

| CSO Feedback | | | | |
|---|---|---|---|---|
| <b>ReconEyez Detector</b> | RD7 | <input checked="" type="checkbox"/> | <input type="checkbox"/> | <input type="checkbox"/> B Box <input type="checkbox"/> Too Dark <input type="checkbox"/> Reflections <input type="checkbox"/> Blind Spots<br><input type="checkbox"/> No Triggers <input type="checkbox"/> Bright |
| Did not receive many alarm triggers. Due to not many people triggering the alarm. | | | | |
| All Good. Bridge connection is -61 dBm which is just acceptable. | | | | |

| CSO Feedback | | | | |
|---|---|---|---|---|
| Consider moving this detector to a more productive location. The roadway will trigger alarms each time a vehicle passes by. | | | | |
