DOMESTIC WATER DISTRIBUTION
SYSTEM
CONSTRUCTION PLANS
LAS ACEQUIAS DE PLACITAS
PLACITAS, NEW MEXICO
JUNE 2025

Topographic Map
for
Portions of State
Highway 165 (aka NM 44),
Paseo de San Antonio Rd,
Camino del Campo Santo,
Paseo San Antonio Road
and Camino Los Altos
Right of Ways and
Portions of Tracts Within
Sections 32 and 33,
T. 13 N., R. 5 E.,
N.M.P.M., as projected into
the San Antonio de Las
Huertas Grant
Placitas,
Sandoval County, New Mexico
September 2024

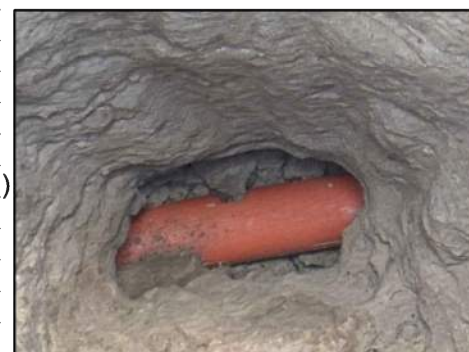
TOP

A. Northing	<u>1568242.36</u>
Easting	<u>1585894.49</u>
B. Depth of Utility	<u>4.84'</u>
C. Reference Marker (RM)	<u>Rebar / Cap</u>
Elevation @ RM	<u>5834.68</u>
D. Elev. @ Top of Utility	<u>5829.84</u>
E. Elev. @ Bottom of Utility	<u>5829.64</u> (Calc.)
F. Width or Dia. of Utility	<u>0.20'</u>
G. Material of Utility	<u>Conduit</u>
H. General Condition	<u>Good</u>
I. Thickness of Pymt.	<u>N/A</u>
Pymt. Material	<u>N/A</u>
J. Description of Soil	<u>Sand / Rock</u>

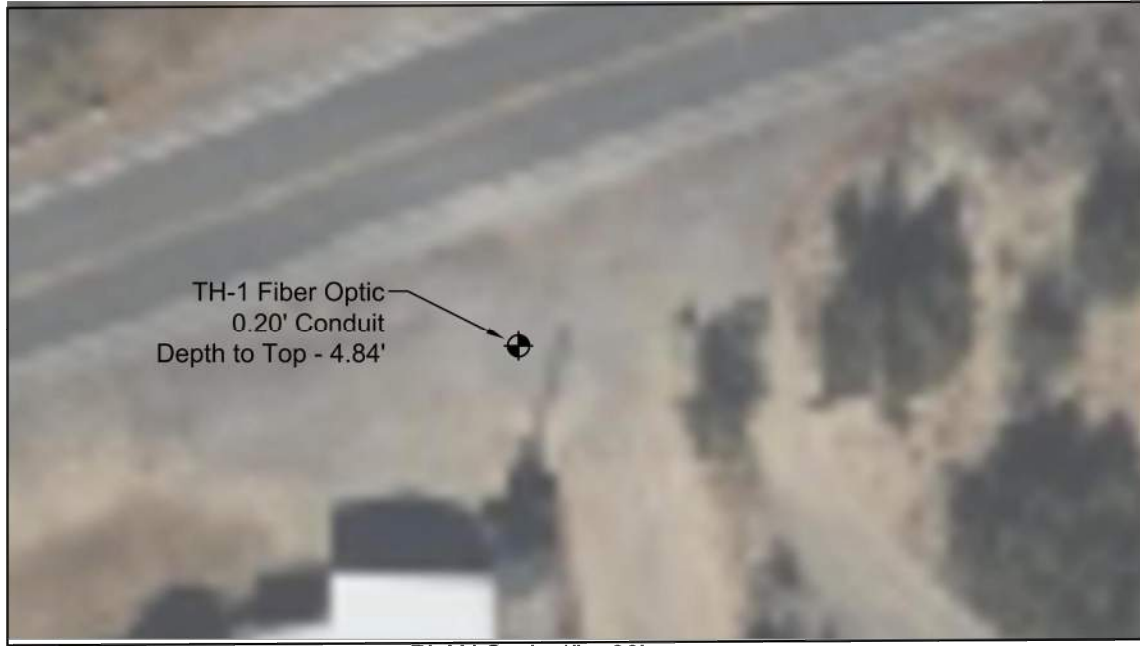
PLAN Scale 1" = 30'

TH-1 Fiber Optic
0.20' Conduit
Depth to Top - 4.84'

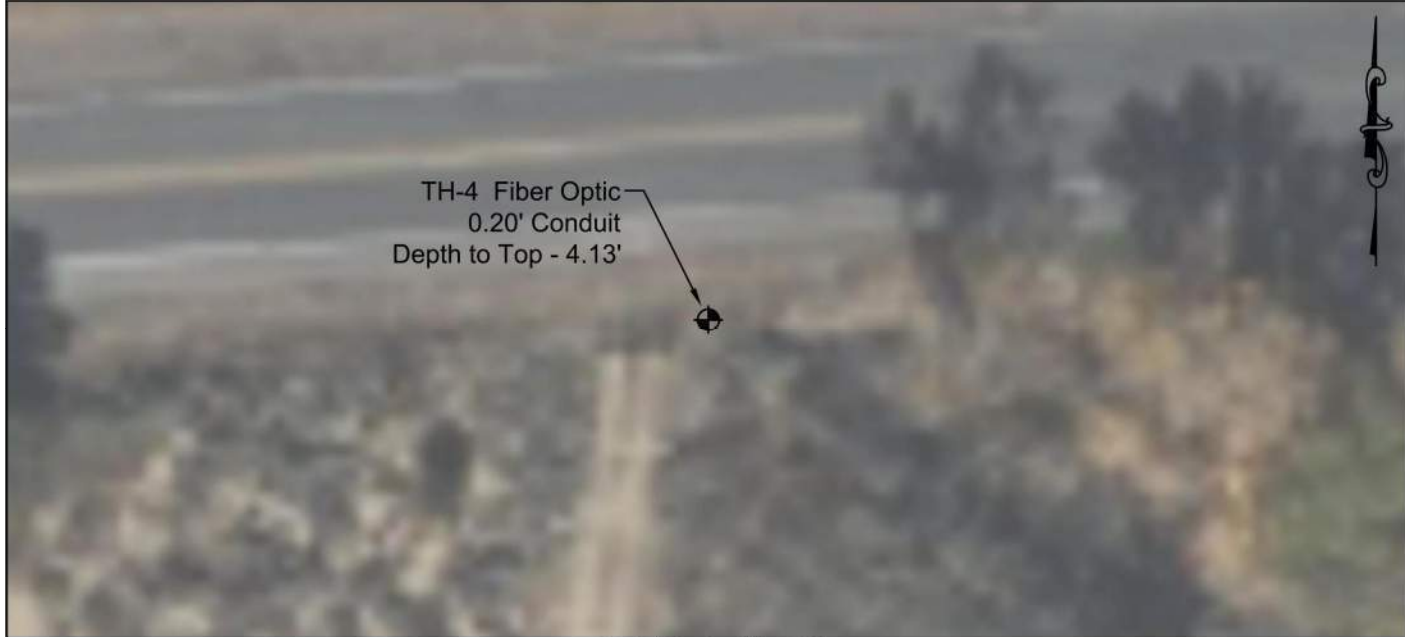
PLAN Scale 1" = 30'

A. Northing 1568405.84

C. Depth of Utility 4.13'

TH-4 Fiber Optic
0.20' Conduit
Depth to Top - 4.13'

Remarks Cleared 6.5 feet. Target utility (water) not found.

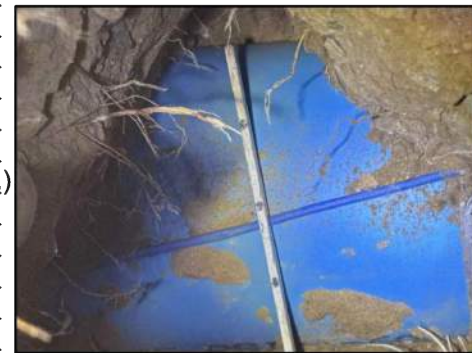
TOP

A. Nothing	1586462.87	
B. Easting	1587046.96	
C. Depth of Utility	3.84'	
D. Reference Marker (RM)	Rebar / Cap	
E. Elevation @ RM	5857.63	
F. Elev. @ Top of Utility	5853.79	
G. Elev. @ Bottom of Utility	5853.46	(Calc.)
H. Width or Dia. of Utility	0.33'	
I. Material of Utility	PVC	
J. General Condition	Good	
K. Thickness of Pmnt.	N/A	
L. Pmnt. Material	N/A	
M. Description of Soil	Sand / Rock

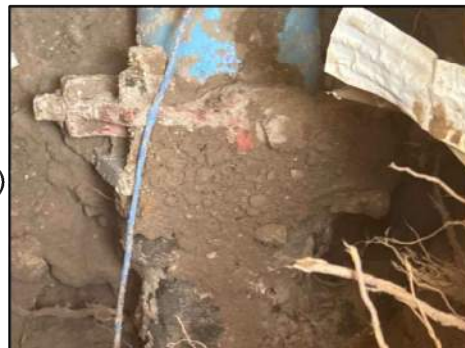
TOP

A. Northing	1568402.26	
B. Easting	1587056.30	
C. Depth of Utility	3.03'	
D. Reference Marker (RM)	Rebar / Cap	
E. Elevation @ RM	5858.95	
F. Elev. @ Top of Utility	5855.92	
G. Elev. @ Bottom of Utility	5855.59	(Calc.)
H. Width or Dia. of Utility	0.33'	
I. Material of Utility	PVC/Steel	
J. General Condition	Good	
K. Thickness of Pvmnt.	.40'	
L. Pvmnt. Material	Asphalt	
M. Description of Soil	Sand / Rock

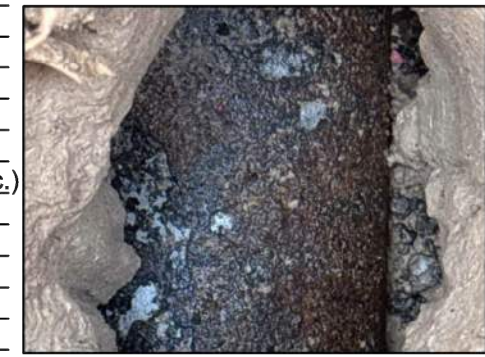
TOP

A. Nothing	1568574.96	
Easting	1568411.03	
B. Depth of Utility	3.60'	
C. Reference Marker (RM)	Nail / Disc	
Elevation @ RM	5907.69	
D. Elev. @ Top of Utility	5904.09	
E. Elev. @ Bottom of Utility	5903.59	(Calc.)
F. Width or Dia. of Utility	0.50'	
G. Material of Utility	PVC	
H. General Condition	Good	
I. Thickness of Pymt.	N/A	
Pymt. Material	N/A	
J. Description of Soil	Sand / Rock

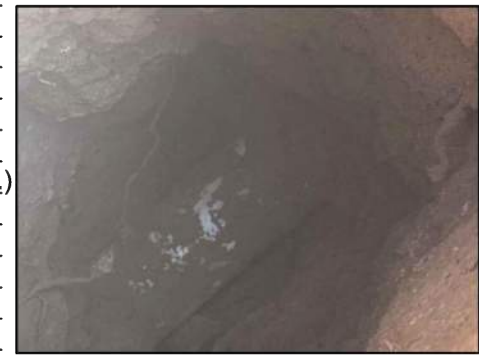
TOP

A. Nothing	1588517.31
Easting	1588425.64
B. Depth of Utility	3.72'
C. Reference Marker (RM)	Rebar / Cap
Elevation @ RM	5909.03
D. Elev. @ Top of Utility	5905.31
E. Elev. @ Bottom of Utility	5894.98 (Calc.)
F. Width or Dia. of Utility	0.33'
G. Material of Utility	PVC
H. General Condition	Good
I. Thickness of Pvmt.	N/A
Pvmt. Material	N/A
J. Description of Soil	Sand / Rock

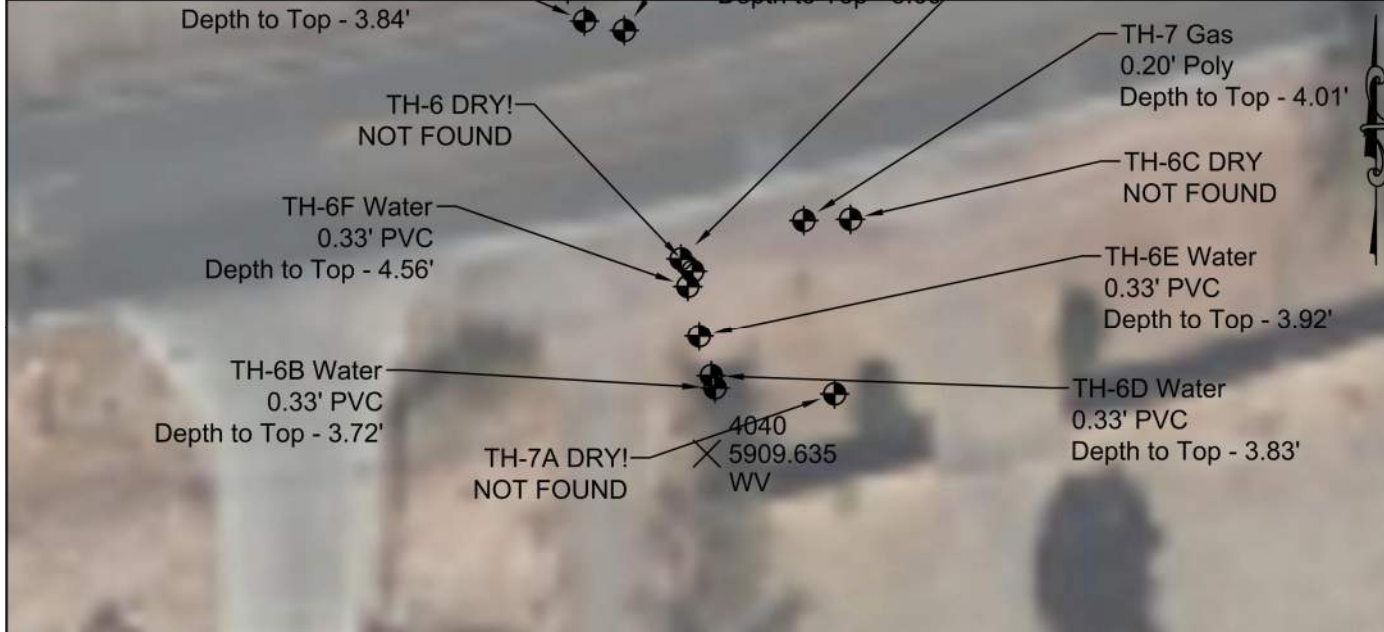
PLAN Scale 1" = 30'

Remarks **Cleared 6.6 feet. Utility not found. Electronic depth of 8.11'**

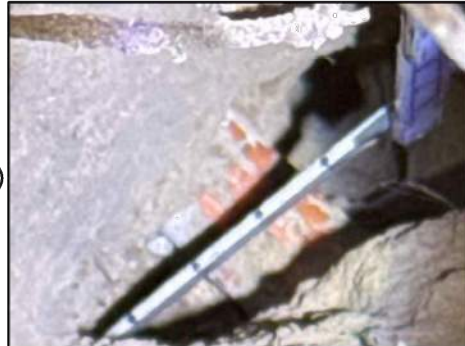
TOP

A. Northing	<u>1588608.90</u>
Easting	<u>1588666.66</u>
B. Depth of Utility	<u>4.95'</u>
C. Reference Marker (RM)	<u>Rebar / Cap</u>
D. Elevation @ RM	<u>5919.26</u>
E. Elev. @ Top of Utility	<u>5914.31</u>
F. Elev. @ Bottom of Utility	<u>5914.11' (Calc.)</u>
G. Width or Dia. of Utility	<u>0.20"</u>
H. Material of Utility	<u>Conduit</u>
I. General Condition	<u>Good</u>
J. Thickness of Pmnt.	<u>N/A</u>
Pmnt. Material	<u>N/A</u>
K. Description of Soil	<u>Sand / Rock</u>

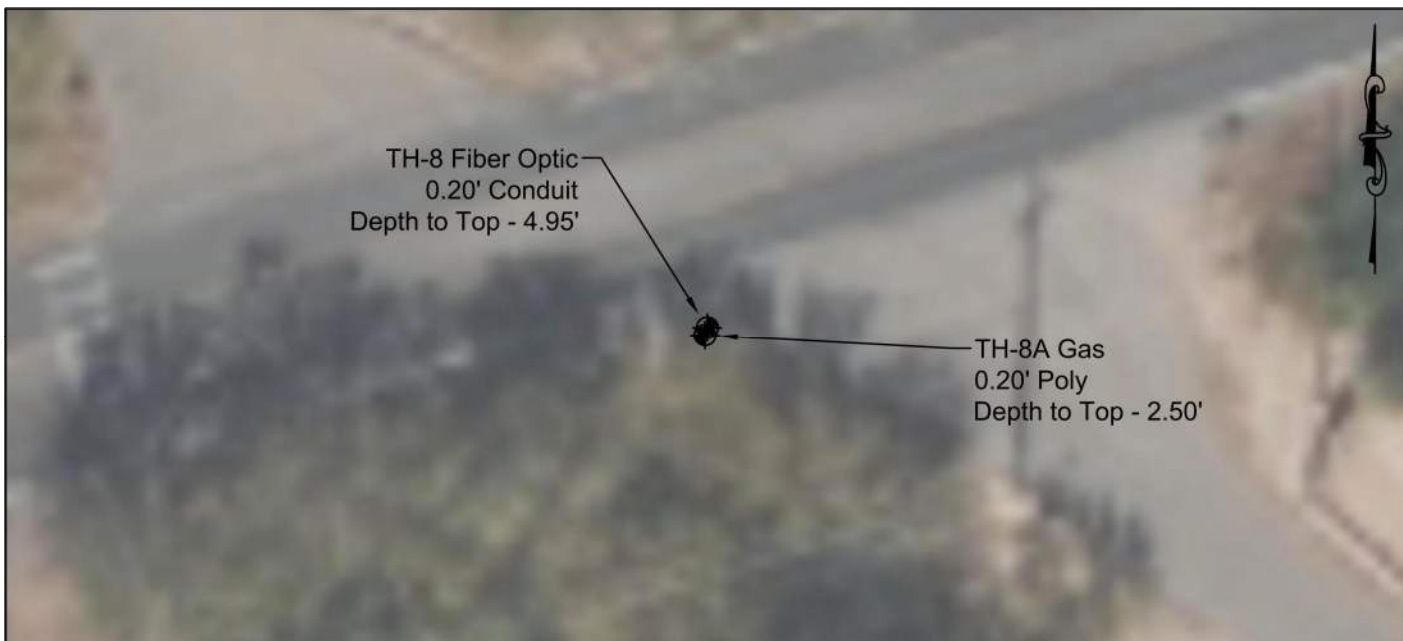
PLAN Scale 1" = 30'

TH-8 Fiber Optic
0.20" Conduit
Depth to Top - 4.95'

TH-8A Gas
0.20" Poly
Depth to Top - 2.50'

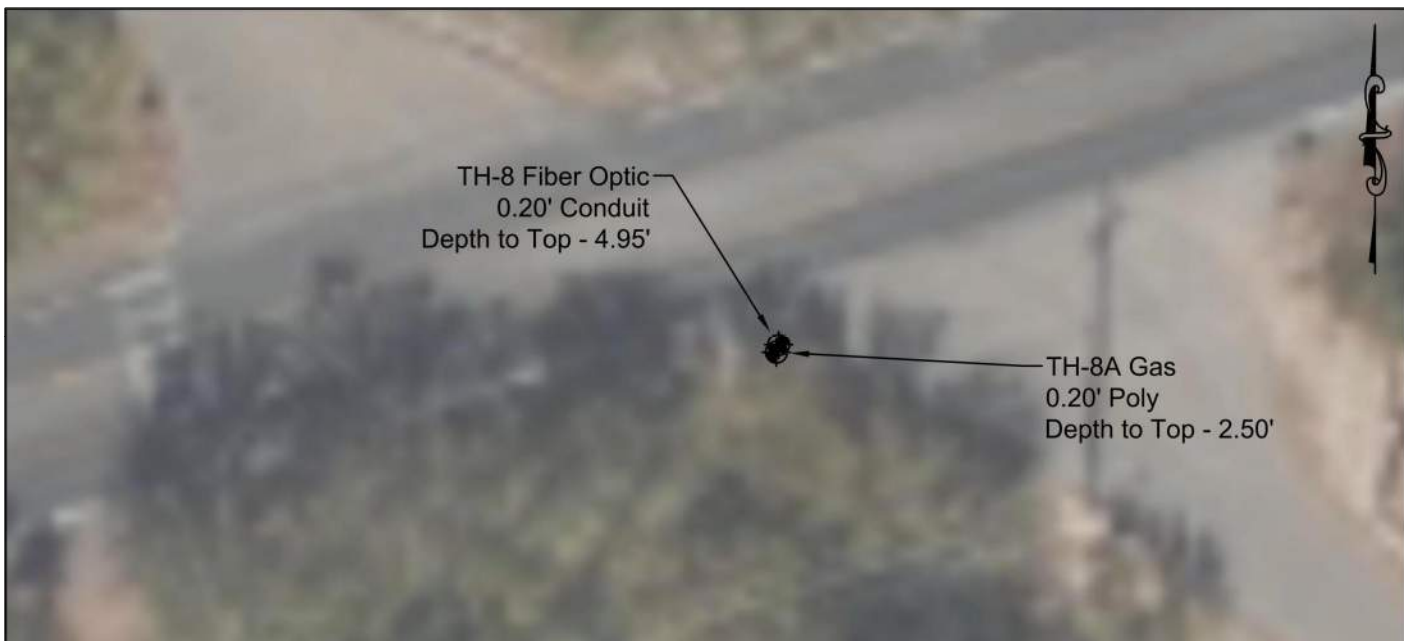
TH-8 Fiber Optic
0.20' Conduit
Depth to Top - 4.95'

TH-8A Gas
0.20' Poly
Depth to Top - 2.50'

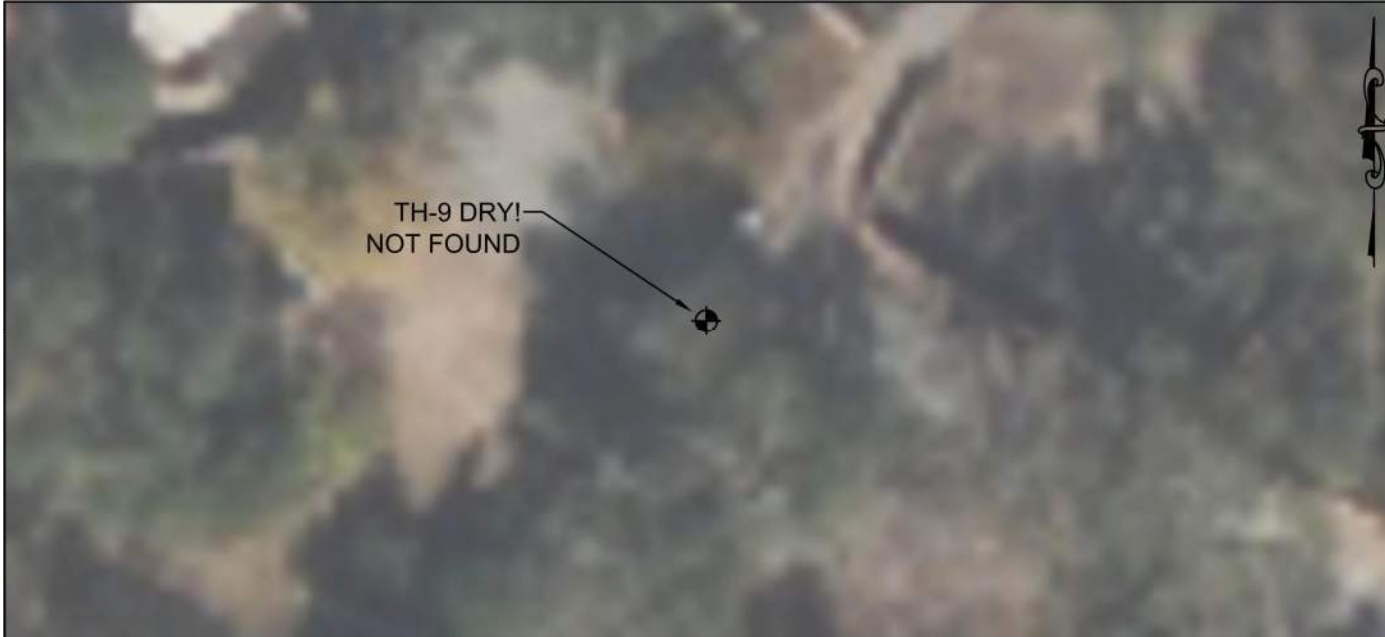
PLAN Scale 1" = 30'

Easting	1589482.33		
B. Depth of Utility	N/A		
C. Reference Marker (RM)	N/A		
Elevation @ RM	5963.64		
D. Elev. @ Top of Utility	N/A		
E. Elev. @ Bottom of Utility	(Calc.)		
F. Width or Dia. of Utility	N/A		
G. Material of Utility	N/A		
H. General Condition	N/A		
I. Thickness of Pvmt.	40"	TOP	
Pvmt. Material	Asphalt		
J. Description of Soil	Sand / Rock	PROFILE FACING N

B.M. CP-10	Elev. = 5941.69	Description #5 Rebar CFA Control Point
Northing: 1568861.38		Easting: 1589264.90
B.M.	Elev. =	Description:
Northing:		Easting:
Remarks Cleared, Utility not found.
