# Inspection Report

## SAMPLE REPORT

**Property Address:**  
YOUR HOUSE  
YOUR TOWN, PA

<b>Date:</b> 2/4/2010	<b>Time:</b> 8:55 AM	<b>Report ID:</b> FILE NUMBER
<b>Property:</b> YOUR HOUSE YOUR TOWN, PA	<b>Customer:</b> SAMPLE REPORT	<b>Real Estate Professional:</b>

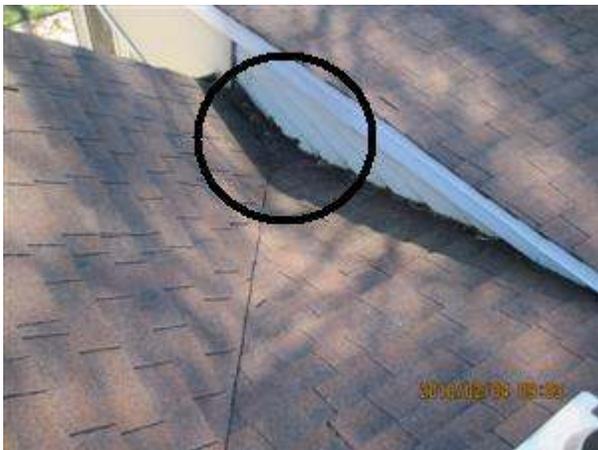
1.0 Picture 1

1.0 MULTIPLE LAYERS OF ROOFING NOTED.

HEAVY MOSS AND LICHEN GROWTH NOTED.

RESTRICTED VALLEY OUTLET NOTED: BETWEEN PORCH ADDITION AND GARAGE. CLEAN OUT FREQUENTLY TO PREVENT DEBRIS DAMS AND PLAN FOR EVENTUAL REBUILDING OF ROOF TO BROADEN OUTLET AREA.

PLAN FOR AGE-RELATED REPLACEMENT.

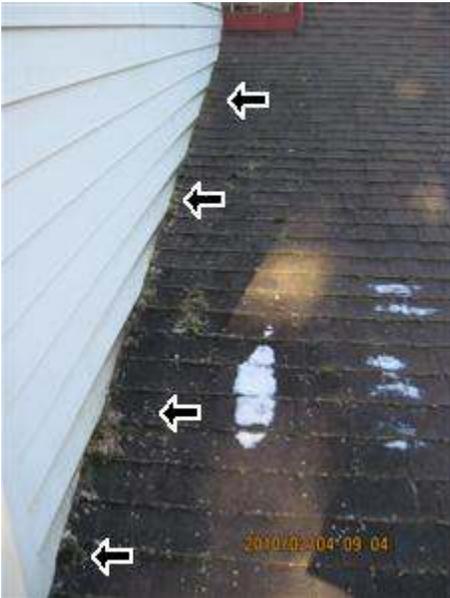
1.3 Picture 1

SEAL OR REPLACE ( 3 ) TORN PLUMBING VENT COLLAR(S).

NOT REFLASHED WITH ROOF-OVER. RE-SEAL AT SIDING EDGES

1.3 SEAL FLASHINGS EVERY 3 TO 5 YEARS.

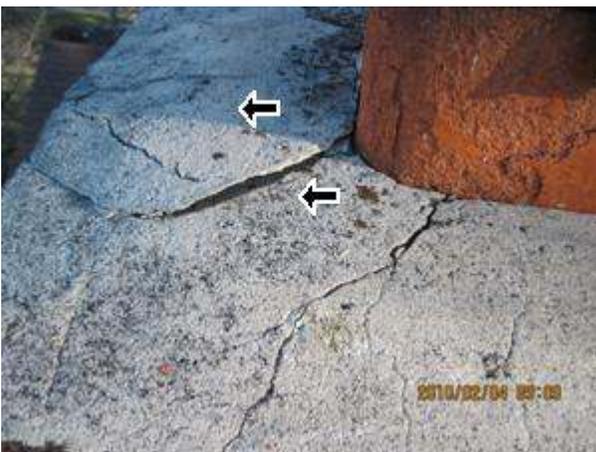
1.4 Picture 1

1.4 CHIMNEY INTERIOR CAN ONLY BE INSPECTED BY A SERVICE COMPANY. RESEAL/REBUILD CHIMNEY CROWN.

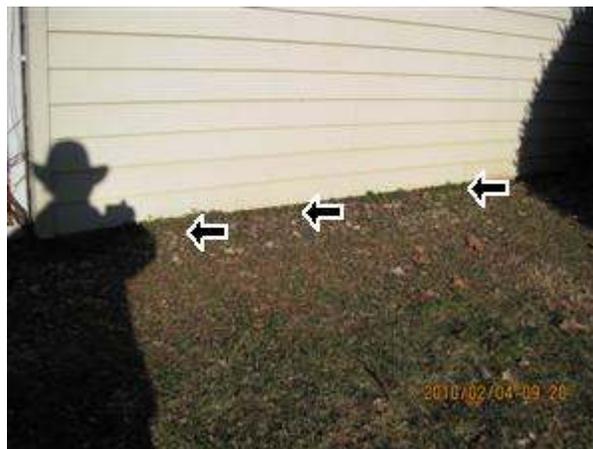
2.0 Picture 1

2.0 CAULK/SEAL GAPS AT CHIMNEY-SIDING JOINTS NOW.

WOOD-SOIL CONTACT NOTED. LOWER MULCH/SOIL LEVELS.

THE BRICKWORK IS APPLIED WITHOUT BENEFIT OF WEEPHOLES OR VISIBLE FLASHING. THIS IS A COMMON DEFECT, AND USUALLY DOES NOT CAUSE PROBLEMS, BUT OCCASIONALLY CAN ALLOW A BUILD-UP OF MOISTURE BEHIND THE BRICK VENEER THAT CAN CAUSE HIDDEN DAMAGE/DETERIORATION TO DEVELOP.

SEAL ALL PENETRATIONS FOR WIRING AND PLUMBING.

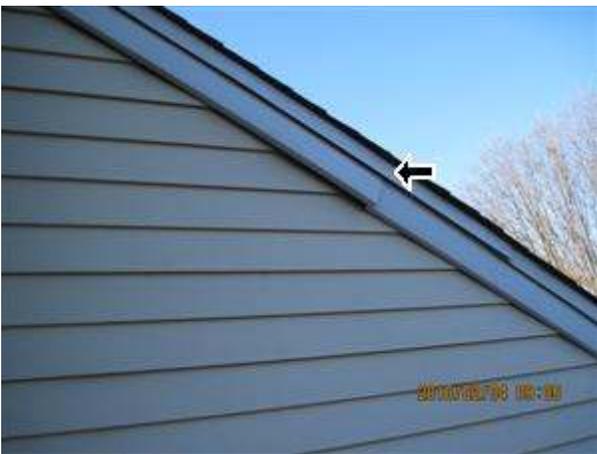
2.1 Picture 1

RESET ALL LOOSE CAPPING NOTED: UPPER LEFT SIDE.

2.1 KEEP ALL EXTERIOR HOUSE WOOD ELEMENTS PAINTED OR SEALED.

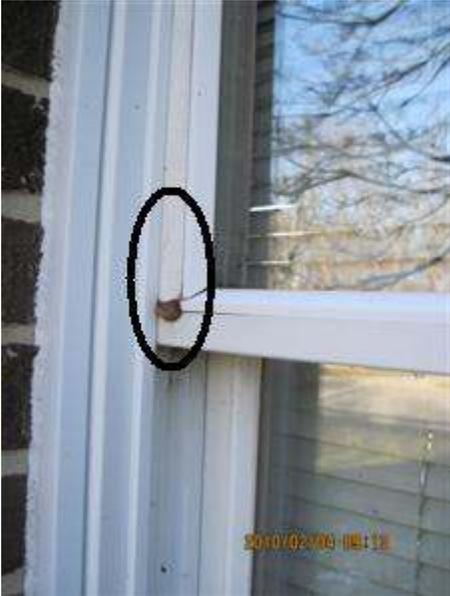
2.3 Picture 1

REPLACE DETERIORATED WINDOW SASH NOTED: (2) AT GARAGE

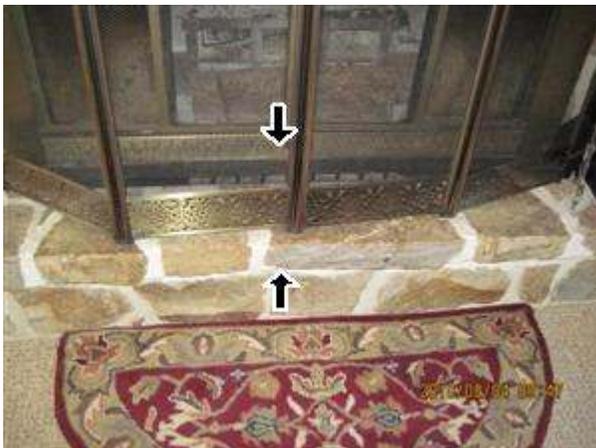
5.7 Picture 1

5.7 HAVE FIREPLACE EVALUATED BY CERTIFIED CHIMNEY SWEEP FOR SAFETY. SOOT AND CREOSOTE BUILD-UP NOTED.

SHALLOW HEARTH NOTED. EXTEND HEARTH OR USE FIRE-RETARDANT HEARTH MAT TO PROTECT FLOOR.

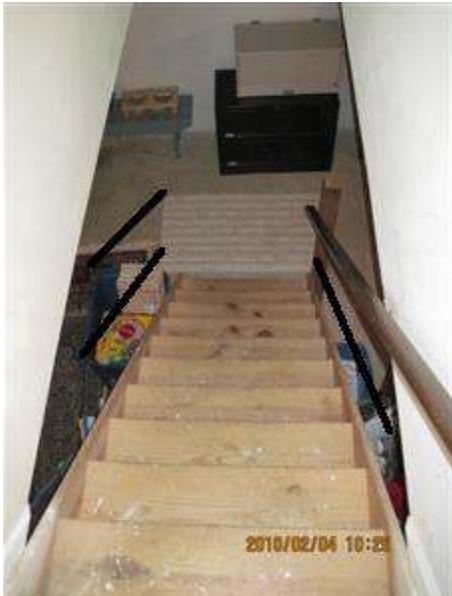
10.3 Picture 1

**10.3** ADD GUARD RAILING(S) AT OPEN SIDE(S) FOR SAFETY.

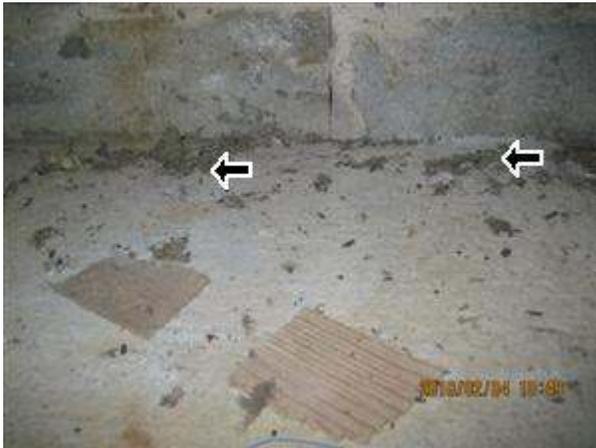
11.1 Picture 1

MINOR OLD INSECT DAMAGE NOTED: SILL PLATE AT REAR. NO APPARENT NEED FOR REPAIR IS NOTABLE.

PREVIOUS INSECT TREATMENT NOTED.

CONTACT SPECIALISTS FOR FURTHER EVALUATION AND TREATMENT AS NEEDED

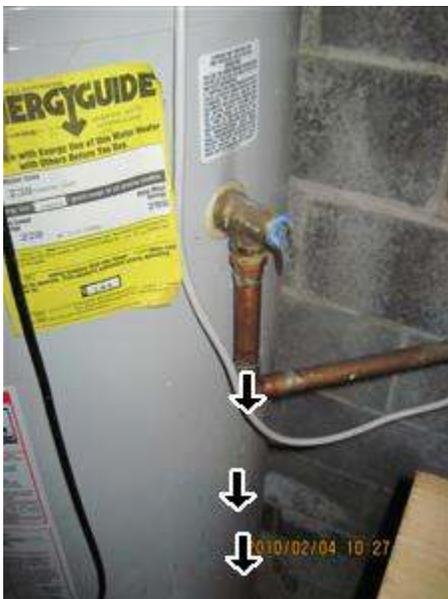
13.5 Picture 1

**13.5** PIPE RELIEF VALVE WITHIN 6" OF FLOOR. PLAN FOR AGE-RELATED REPLACEMENT.

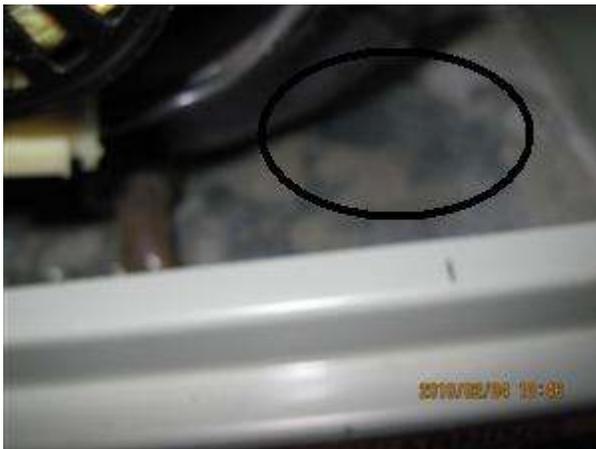
14.0 Picture 1

EVIDENCE OF CONDENSATE LEAKAGE NOTED IN HIGH-EFFICIENCY FURNACE.

-- HAVE SERVICE COMPANY CLEAN, ADJUST AND EVALUATE UNIT PRIOR TO SETTLEMENT.

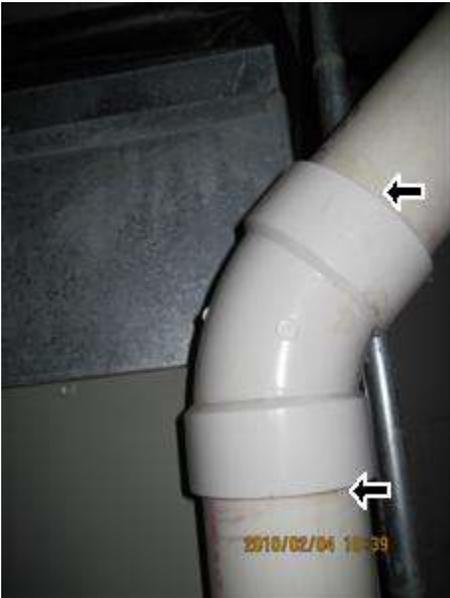
14.3 Picture 1

**14.3** VENT PIPING WAS NOT PRIMED BEFORE GLUING PER MFR. SPECIFICATIONS. REPIPE AS NEEDED.

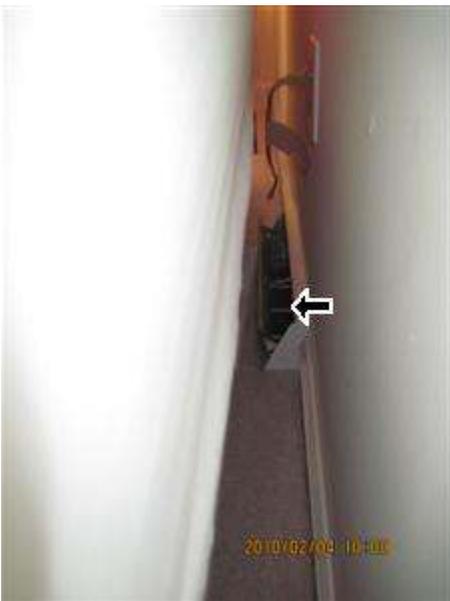
14.5 Picture 1

**14.5 DUCT CLEANING IS RECOMMENDED. REMOVE HUMIDIFIER. INSTALL ALL MISSING DUCT REGISTERS.**
