# Northern Terrace Homeowners Association

## Annual Review With Site Visit

Start Date: 01/01/2020

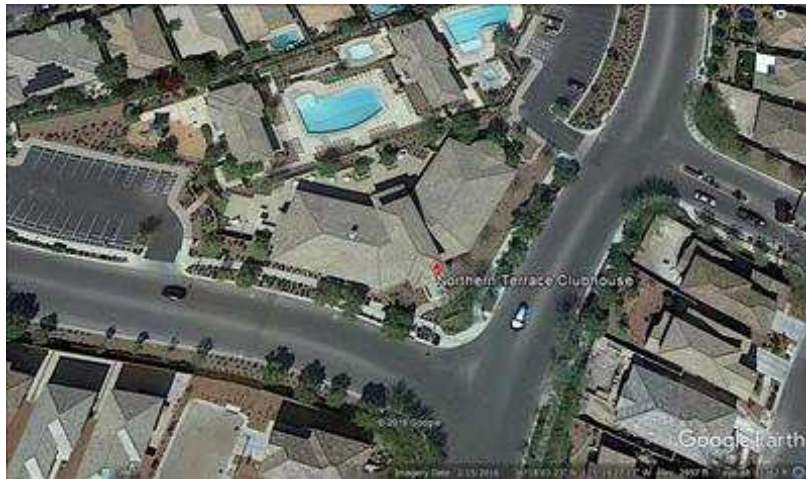
The Roof Replacement Costs are based on Replacing the Tile Underlayment with a Tile Re-Stack. This Cost is an estimation only.

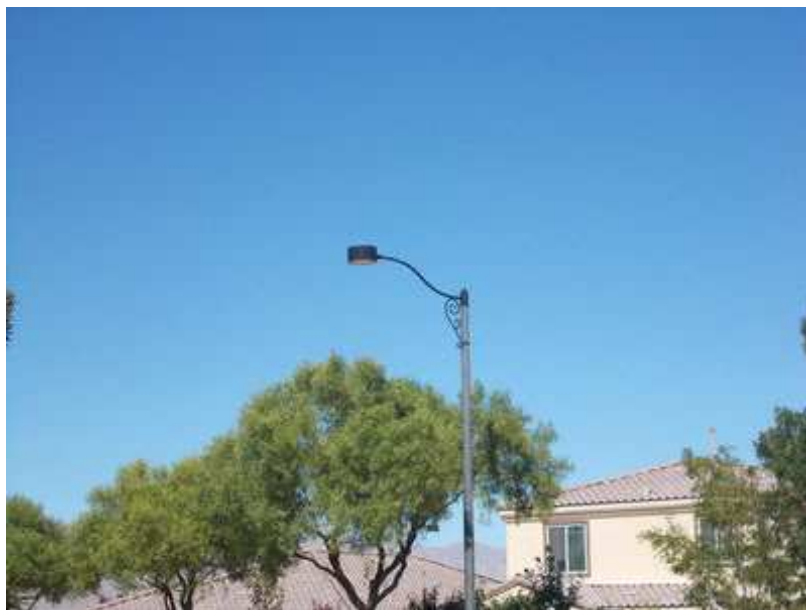
An allowance for Street Light Repair has been included in the Study to be done as needed. The Street Lights are not supported properly. Complete replacement has not been included in the Study. Further evaluation is recommended.

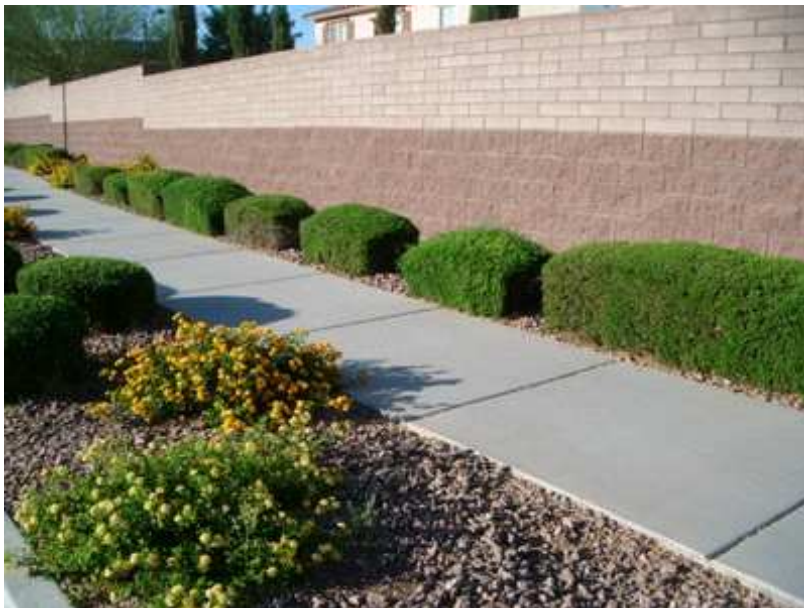
Complete replacement of all Concrete has not been included in the Study. Instead, repair and replacement has been scheduled as a contingency to be done as needed.

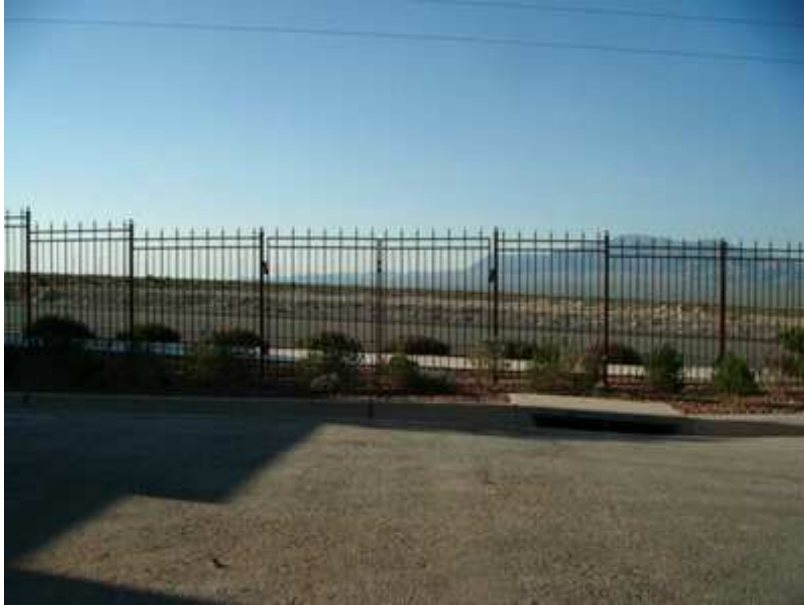
Complete Replacement of the Wrought Iron Fencing has not been scheduled. Instead, Repair and Replacement as needed, has been included in the Study.

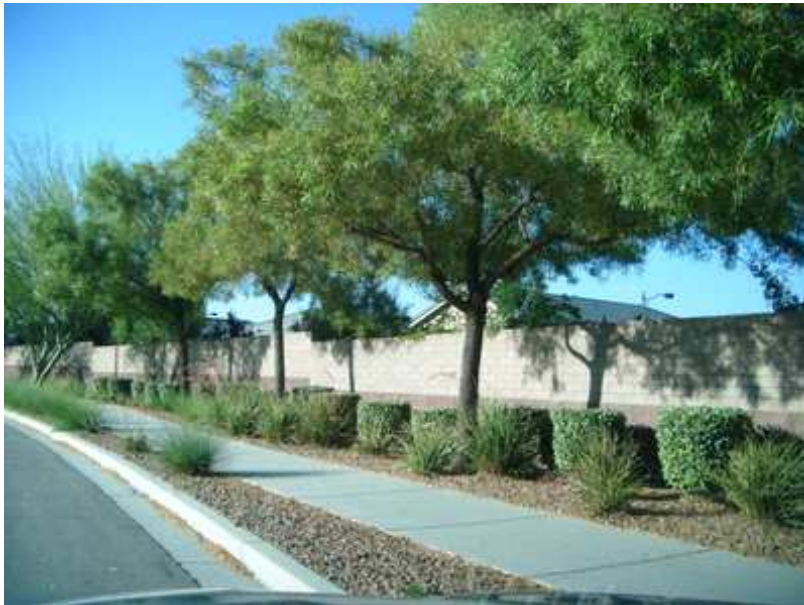
Major Landscaping Renovation and Rock Replenishment have been included as components in the Study.

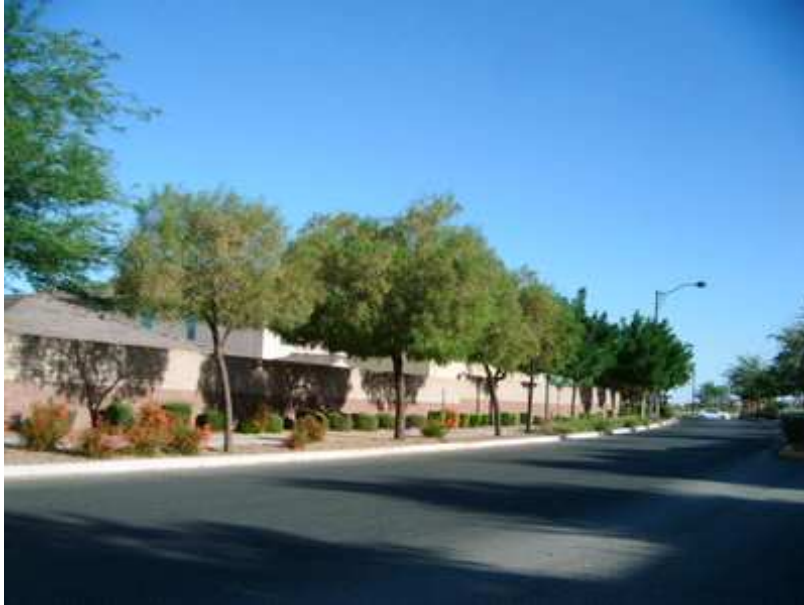
The Component Major Landscaping and Irrigation includes: Tree and Bush Removal and Replacement, Major Irrigation Repairs, Rock or Landscaping Renovation to be done as needed. Day-to-day Landscaping is considered an Operational Expense and has not been included in this Study.

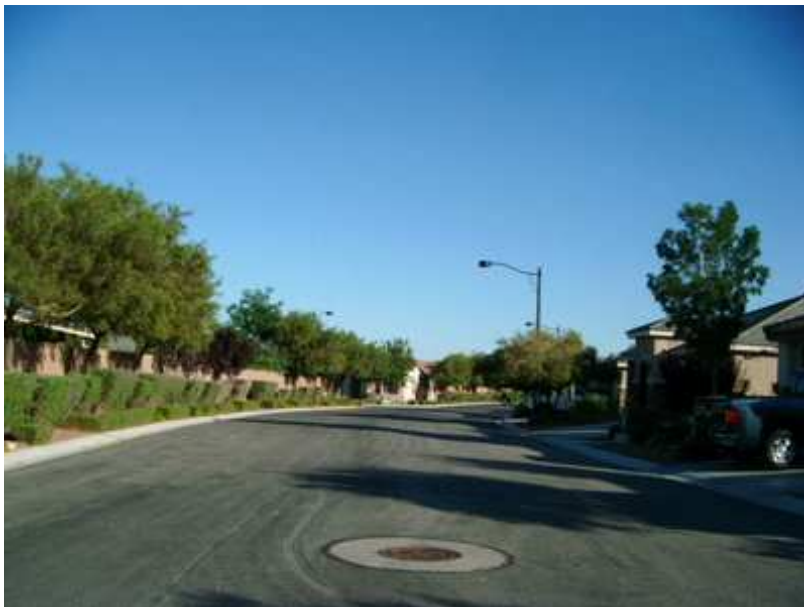
The Asphalt Road Maintenance Schedule includes the Surface Maintenance Treatment, Overlay, Crack Seal, Concrete Curbing Repairs and Striping and Curb Painting. This Schedule was provided by Bryce Schall, Holbrook Asphalt, Las Vegas, Nevada.

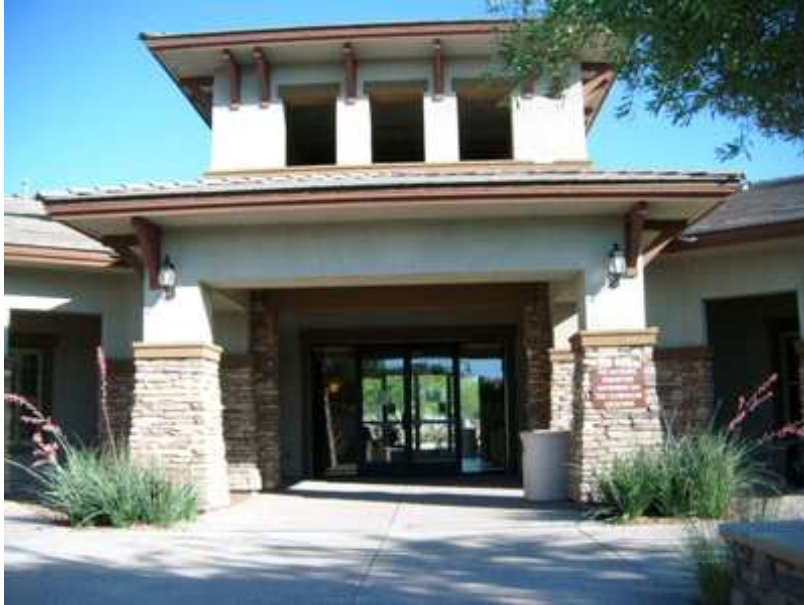
The Clubhouse Exterior Components include Tile Roof Underlayment Replacement, Exterior Painting and Stucco and Stone Facade Repairs, Lighting and Electrical and Windows and Doors Replacement.

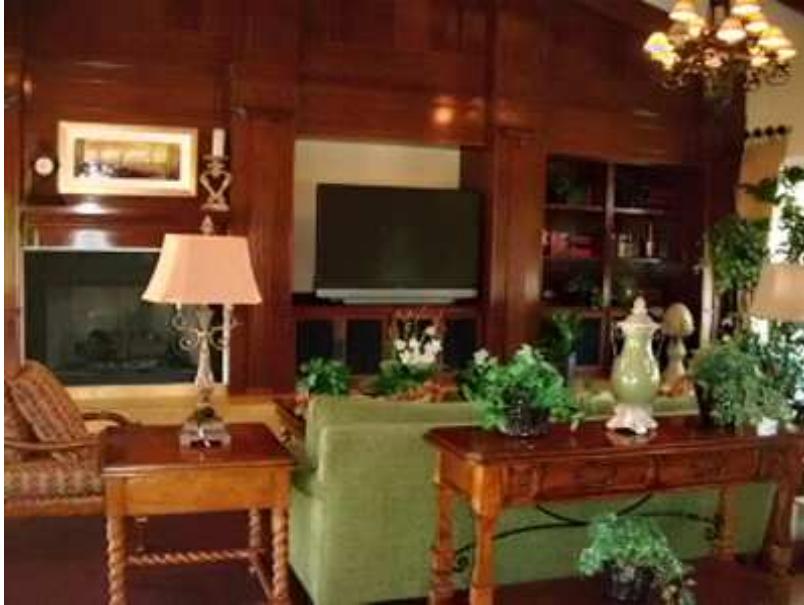
The Clubhouse Interior Components include Furniture, Flooring, Restroom Remodel, Kitchen Remodel, Lighting and Electrical, HVAC Units, Windows and Doors Replacement. The Timeframes and Estimated Remaining Useful Life are an estimation only.

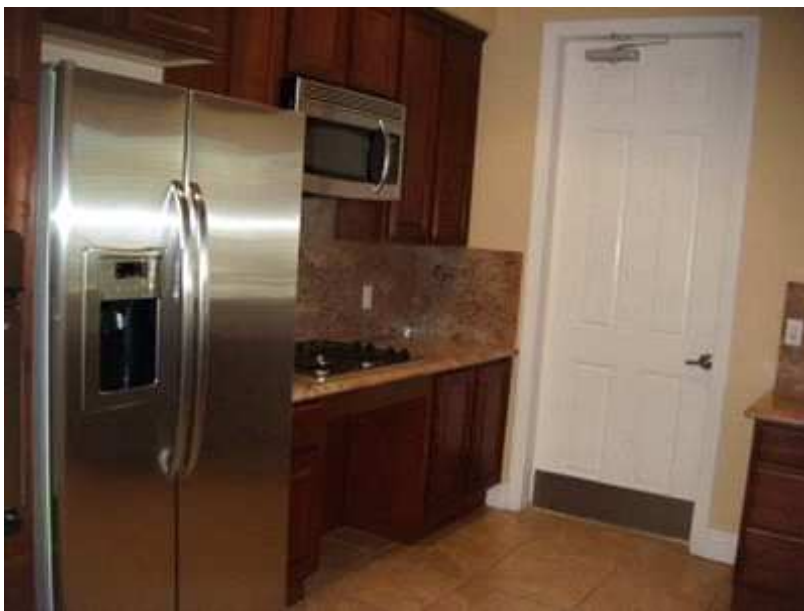
The Kitchen Remodel includes new Cabinets, Fixtures, Appliances and Renovation. The Appliances are scheduled to be replaced as needed through a Contingency Fund.
