Bearing failures and their causes

Introduction

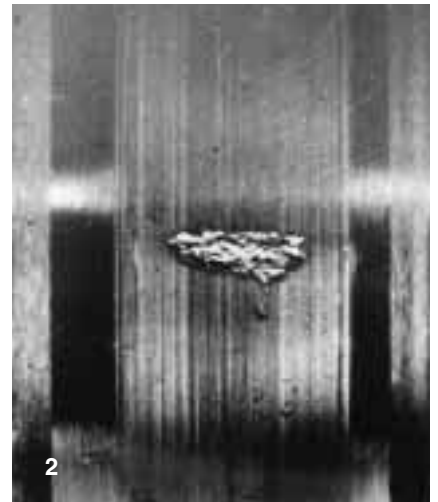
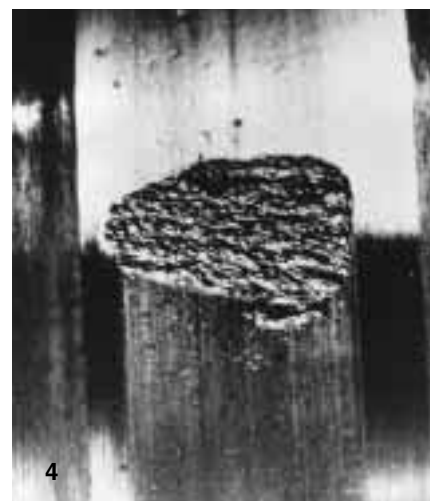
Figs 1–4 Progressive stages of flaking

magnitude of the load. Fatigue is the result of shear stresses cyclically appearing immediately below the load carrying surface. After a time these stresses cause cracks which gradually extend up to the surface. As the rolling elements pass over the cracks fragments of material break away and this is known as flaking or spalling. The flaking progressively increases in extent (figs 1 to 4) and eventually makes the bearing unserviceable.

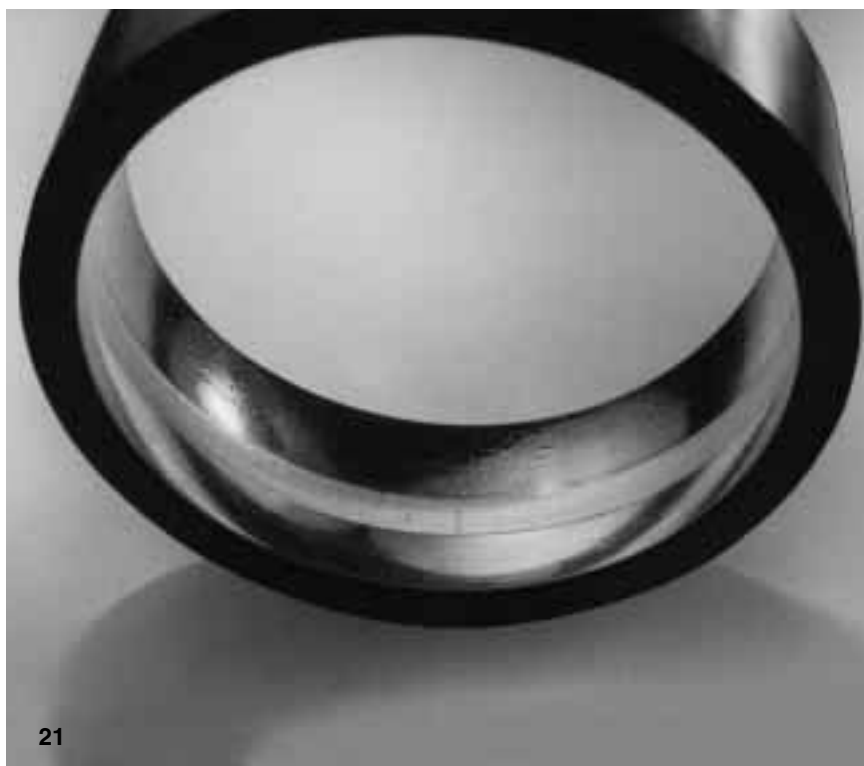
Fig 20 Cylindrical roller with mirror-like surface on account of lubricant starvation

Worn, frequently mirror-like, surfaces; at a later stage blue to brown discolouration.

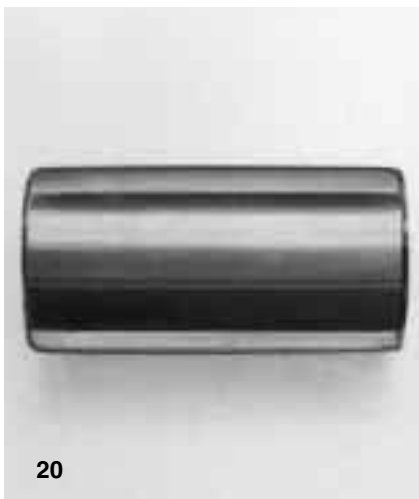
Fig 21 Outer ring of a spherical roller bearing that has not been adequately lubricated. The raceways have a mirror finish

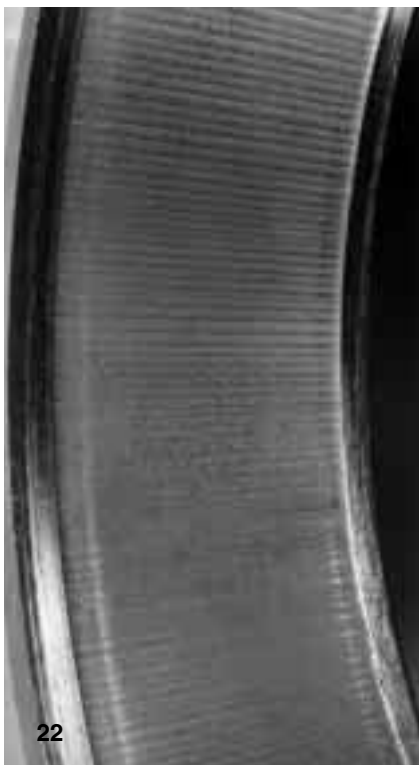
Fig 22 Outer ring of taper roller bearing damaged by vibration during operation

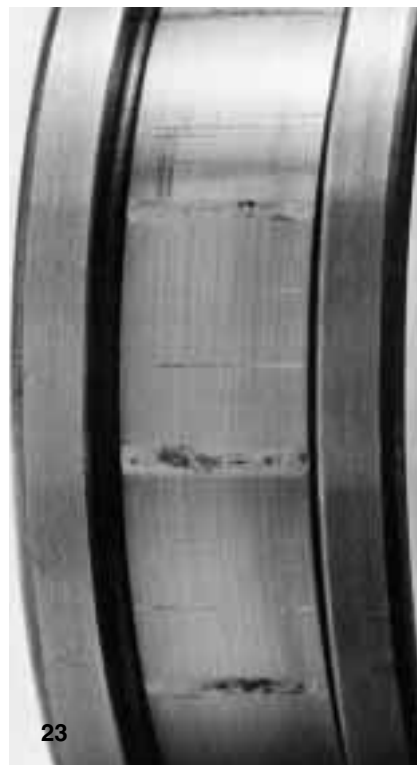
Fig 23 Vibration damage to the ring of cylinder roller bearing. The damage has arisen while the bearing was not running. It is evident, from the fainter fluting discernible between the pronounced depressions with corrosion at the bottom, that the ring has changed position for short periods

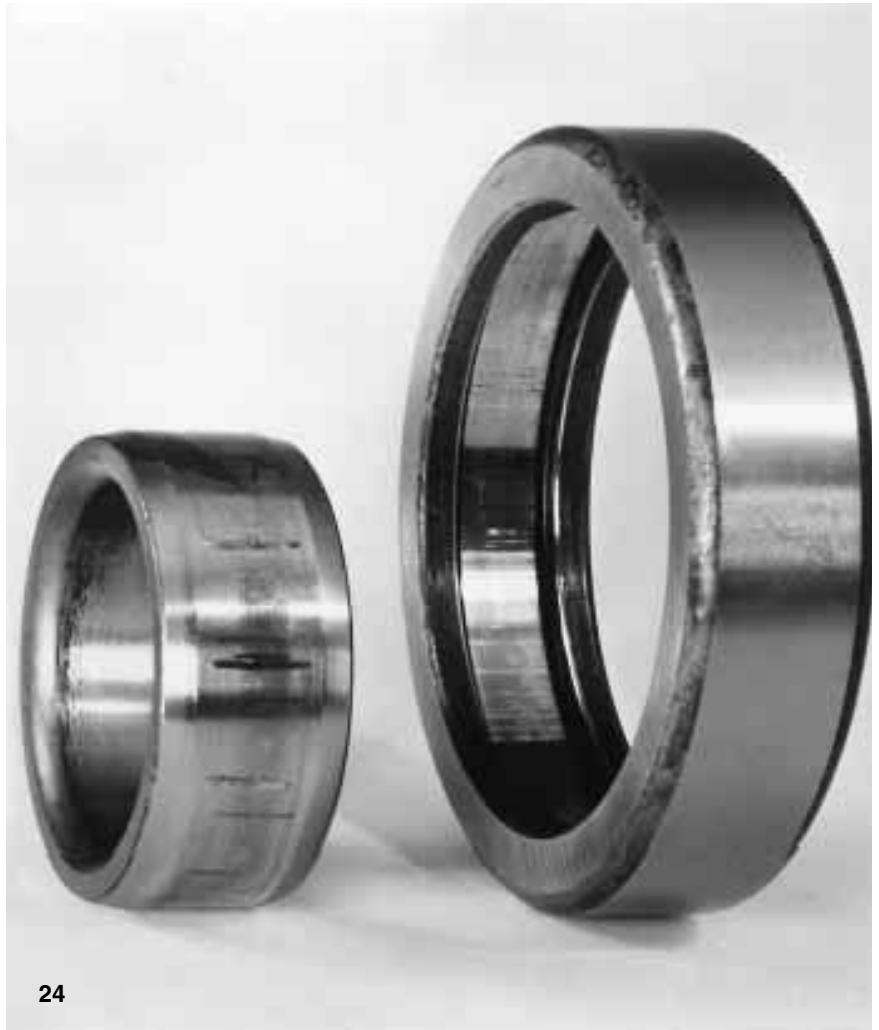
Fig 24 Inner and outer ring of a cylindrical roller bearing exposed to vibration. The inner ring has changed position

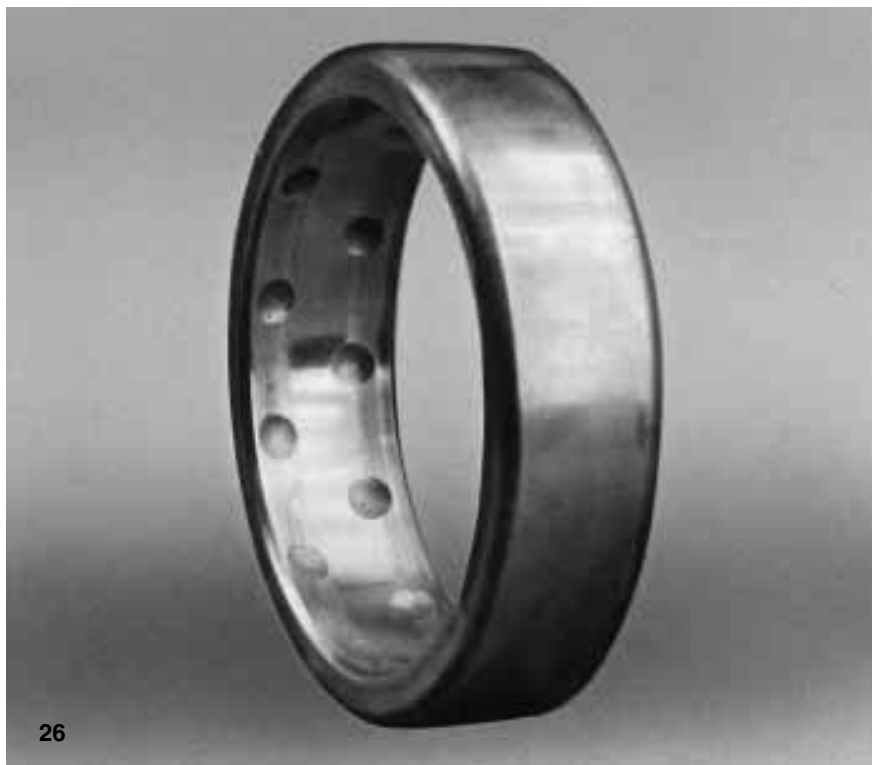
Fig 26 Outer ring of a self-aligning ball bearing damaged by vibration. The bearing has not rotated at all

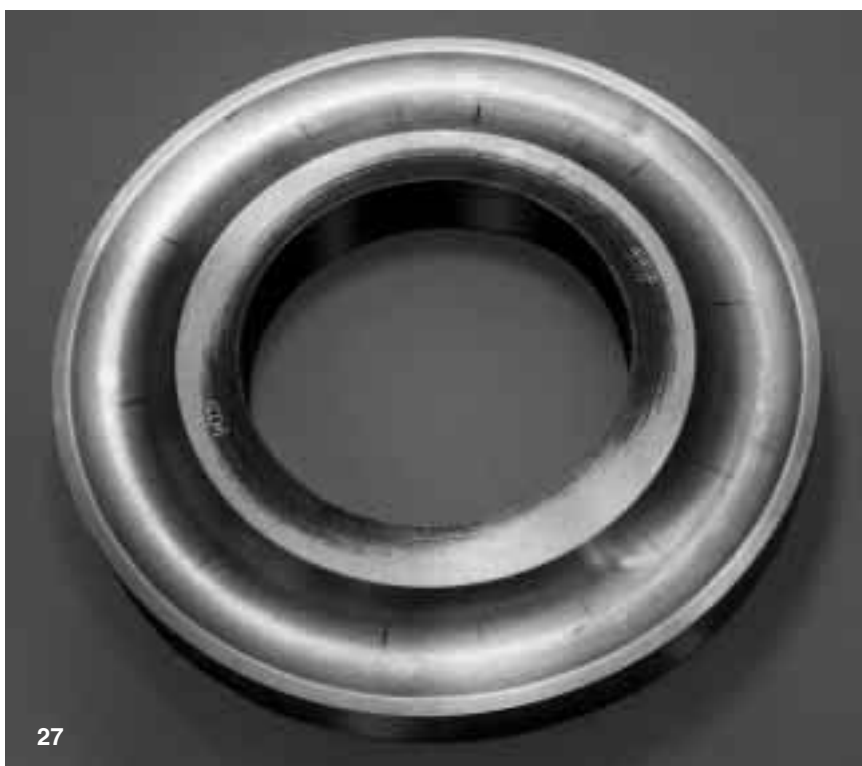
Fig 27 Washer of a thrust ball bearing subjected to overloading while not running. The indentations are narrow and radially aligned, not sphered as in radial ball bearings

Appearance	Cause	Action
Indentations in the raceways of both rings with spacing equal to the distance between the rolling elements.	Mounting pressure applied to the wrong ring.	Apply the mounting pressure to the ring with the interference fit.
	Excessively hard drive-up on tapered seating.	Follow carefully the SKF instructions concerning mounting bearings on tapered seating.
	Overloading while not running.	Avoid overloading or use bearings with higher basic static load ratings.

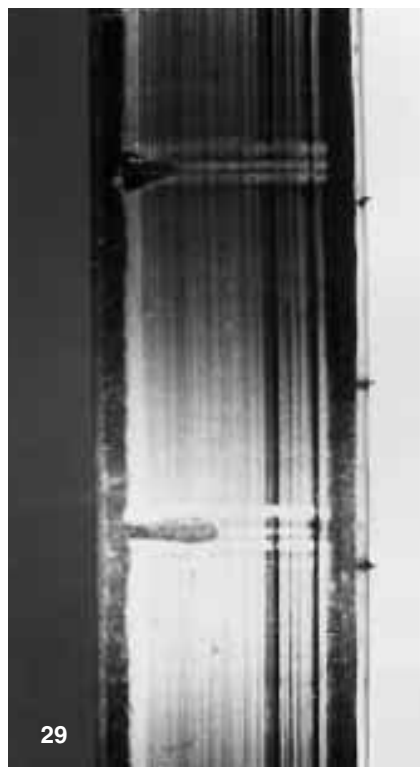
Figs 28–30 An example of the results of improper handling. A roller in a double row cylindrical roller bearing has suffered impact (fig 28). A periphery camera view of the roller shows two diametrically opposed indentations (fig 29). The roller has, in turn, dented the inner ring raceway (fig 30)

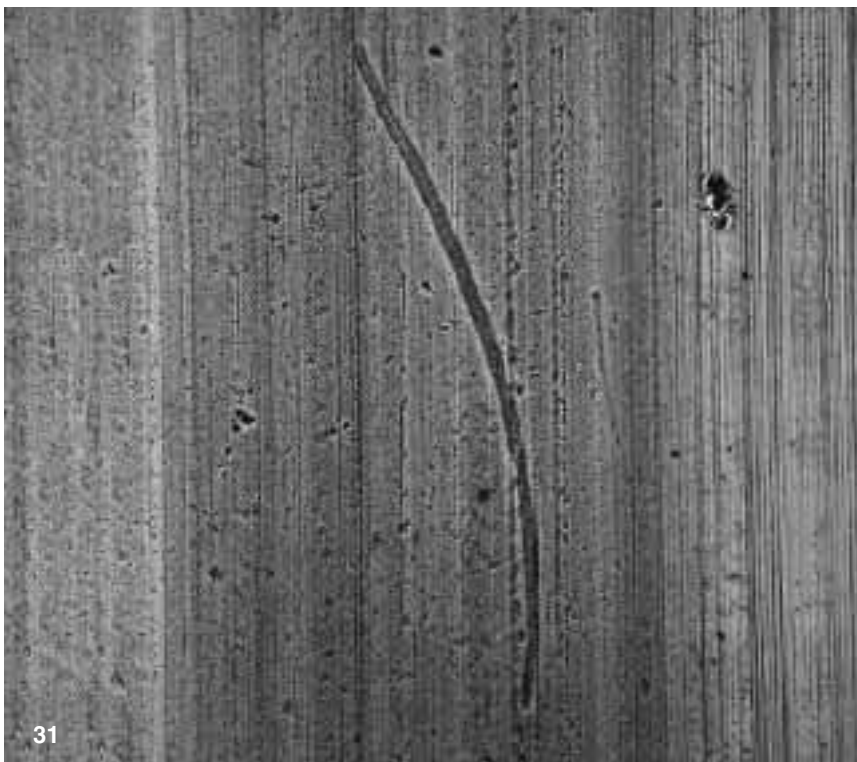
Fig 31 Indentations, caused by dirt, in one of the raceways of a roller bearing – 50 × magnification

Cleanliness to be observed during the mounting operation.
Untaminated lubricant.
Improved seals.

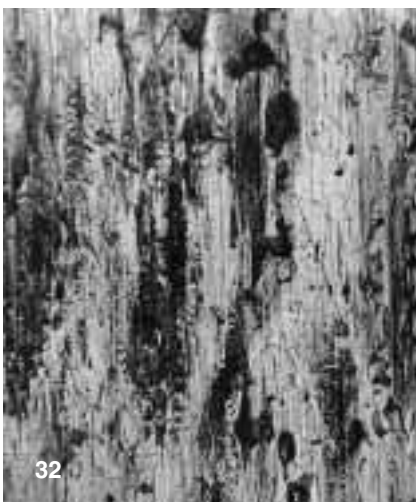
Fig 32 Smearing on the surface of a roller from a spherical roller bearing – 100 × magnification

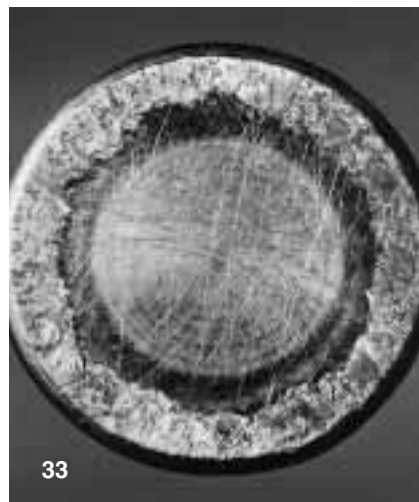
Fig 33 A cylindrical roller with end smearing caused by heavy axial loading and improper lubrication

Sliding under heavy axial loading and with inadequate lubrication.

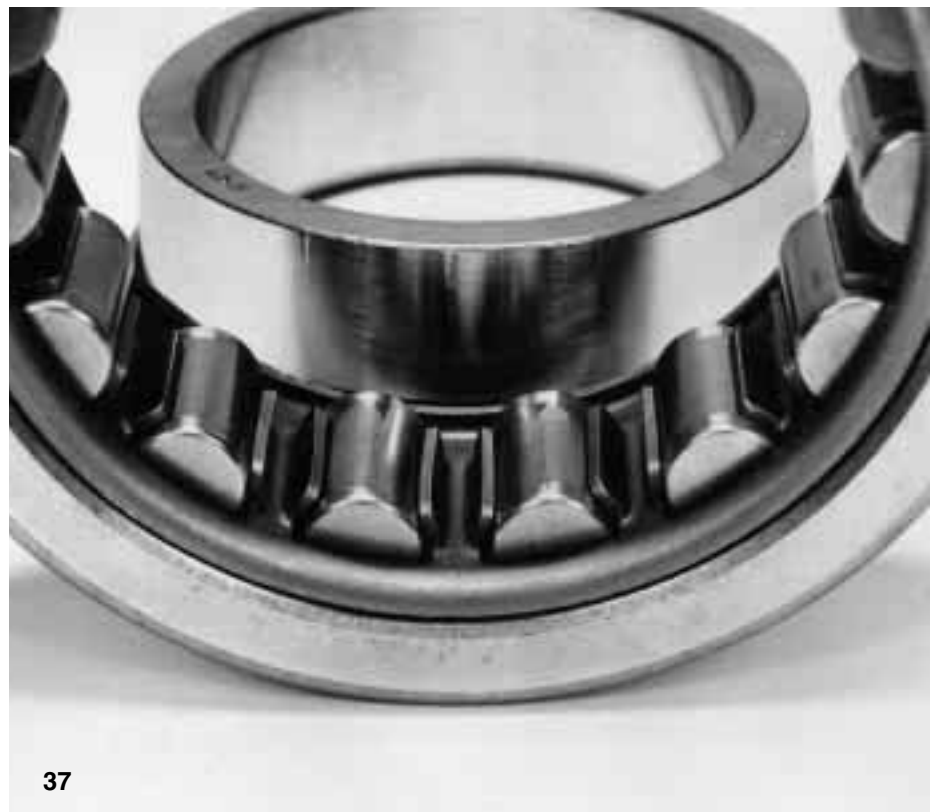
Fig 37 A cylindrical roller bearing with smear streaks in the inner ring raceway and on the rollers. The smearing has been caused by the roller assembly being entered askew without being rotated

Rotate the bearing when it is being adjusted. Apply the mounting force against the ring with the tightest fit; never allow the force to pass through the rolling elements.

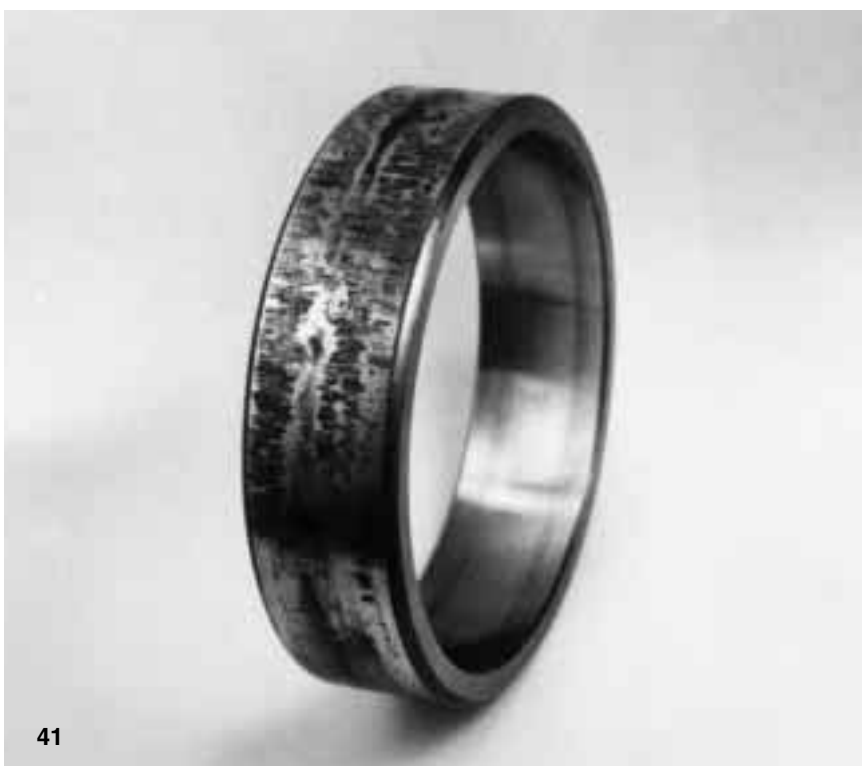
Fig 40 Smeared face of a cylindrical roller bearing inner ring

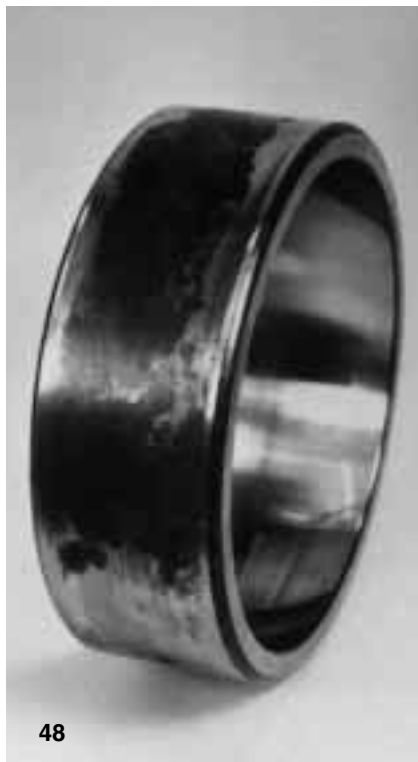
Fig 48 Fretting corrosion on the outer ring of a spherical roller bearing

Adjust seatings.

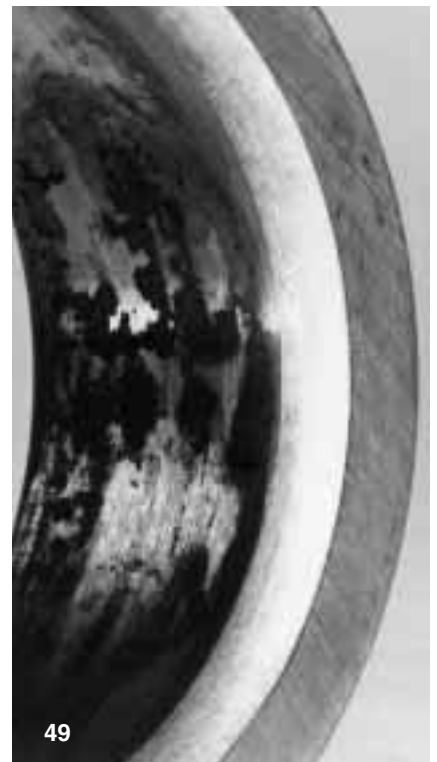
Fig 49 Extensive fretting corrosion in the bore of a self-aligning ball bearing

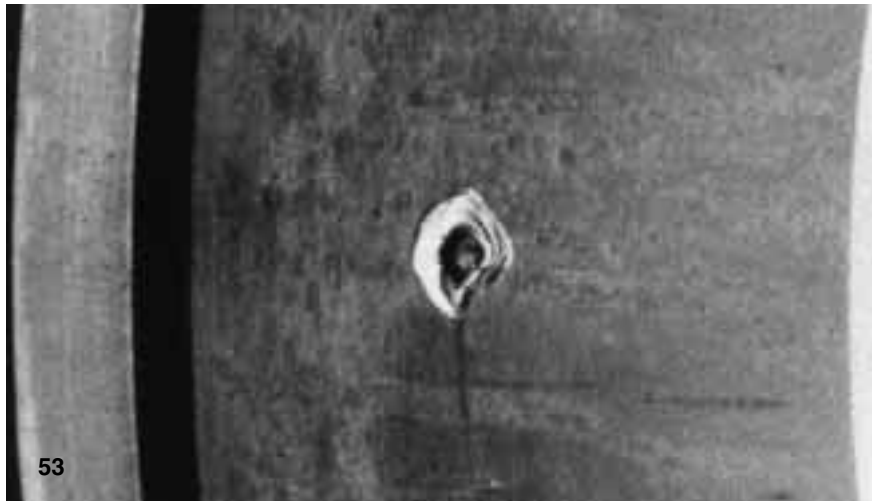
Fig 54 Roller of a railway axlebox bearing damaged by electric current (same bearing as in fig 53)

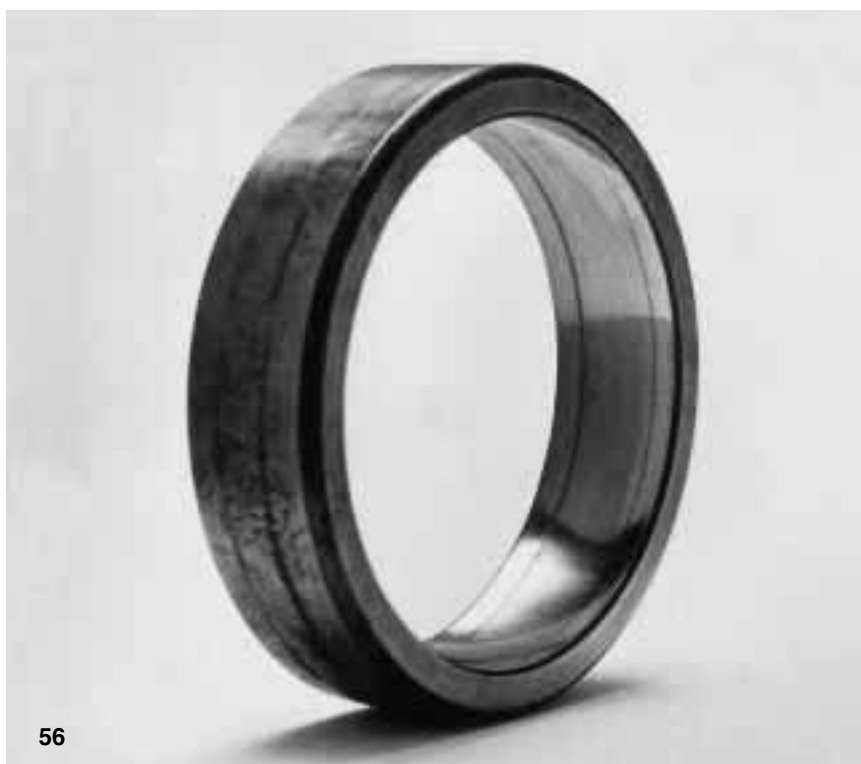
Fig 56 Outer ring of a self-aligning ball bearing that has been driven too far up its tapered seating. The bearing had only performed a few revolutions when the damage was detected. Flaking would soon have occurred if the bearing had been put into service

Appearance	Cause	Action
Heavily marked path pattern in raceways of both rings.	Preloading on account of fits being too tight.	Alter the fits or select bearing with larger internal clearance.
Flaking usually in the most heavily loaded zone.	Excessive drive-up on a tapered seating.	Do not drive the bearing so far up its tapered seating. Follow carefully the instructions given by SKF.
	Single row angular contact ball bearings or taper roller bearings adjusted to give excessive preload.	Re-adjust the bearings to obtain lighter preload.
	Temperature differential between inner and outer rings too great.	Select bearing with larger internal clearance.

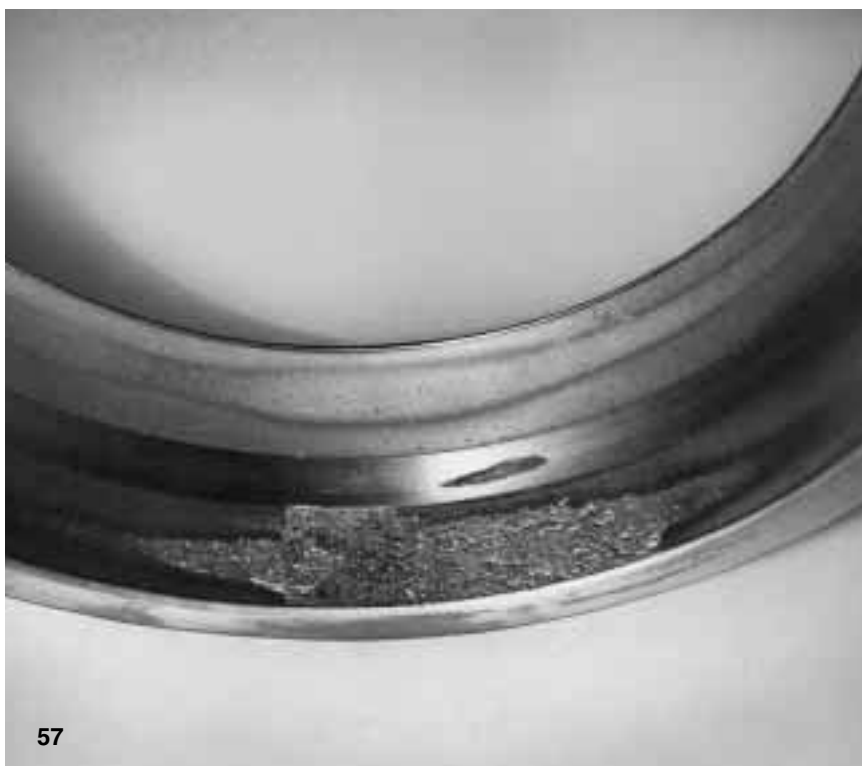
Fig 57 Flaking in the outer ring outer ring of spherical roller bearing that has been mounted in a housing with oval bore

Adjust the base.

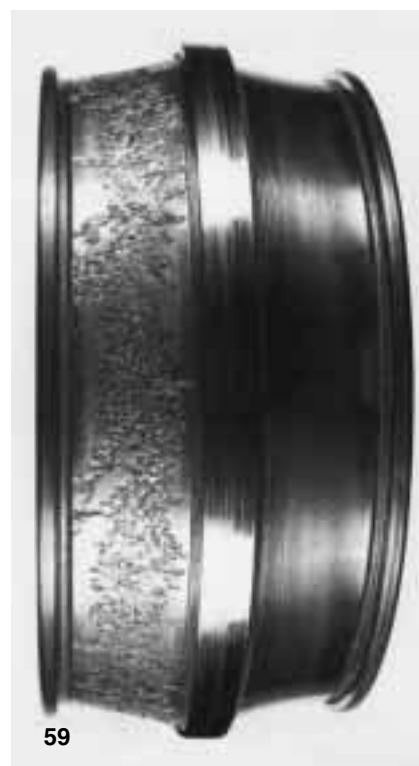
Fig 59 Flaked inner ring of a spherical roller bearing. The extent of the flaking around one entire raceway indicates that the axial load has been very heavy in relation to the radial load

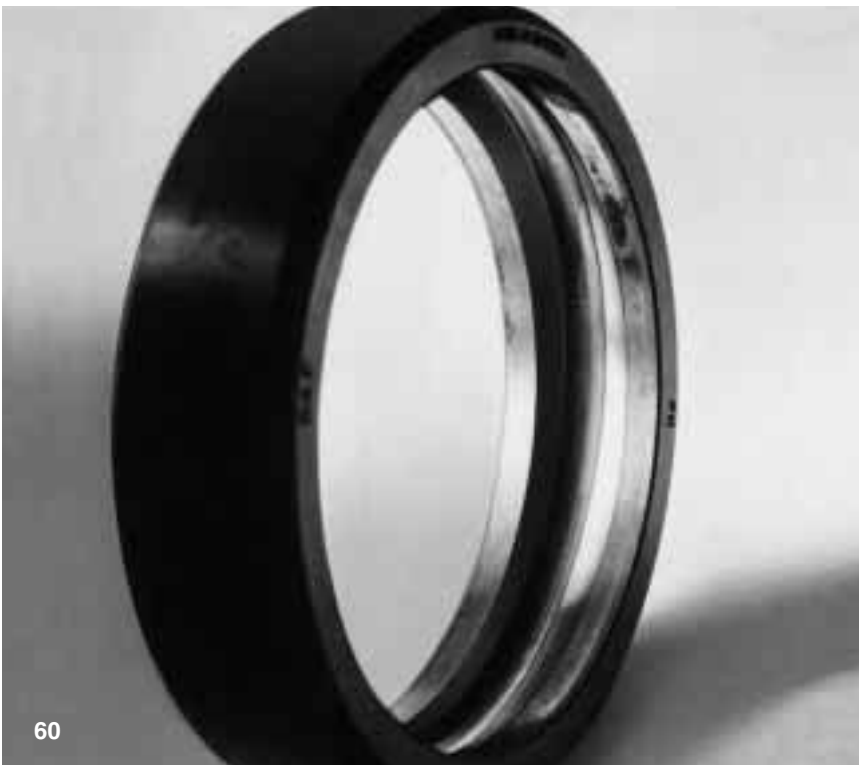
Fig 60 Deep groove ball bearing outer ring that has been out of alignment with the shaft. The ball path has an oval configuration on account of the misalignment. The result is the same as with oval compression, see page 31

Rectify the seatings.
Use mounting sleeve with parallel faces.

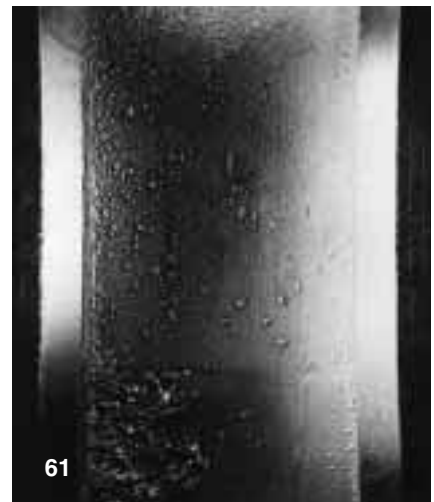
Fig 61 Cylindrical roller bearing inner ring with flaking at one side of the raceway, as a result of overloading due to misalignment

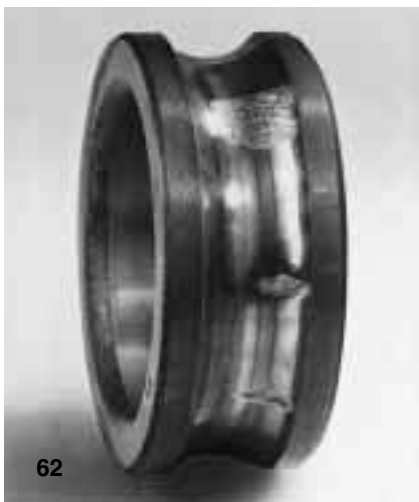
Fig 62 Various stages of flaking in the inner ring of a deep groove ball bearing. The ring has been mounted with interference fit on the shaft and blows have been directed against the outer ring, causing the mounting force to pass through the balls, which have produced the indentations

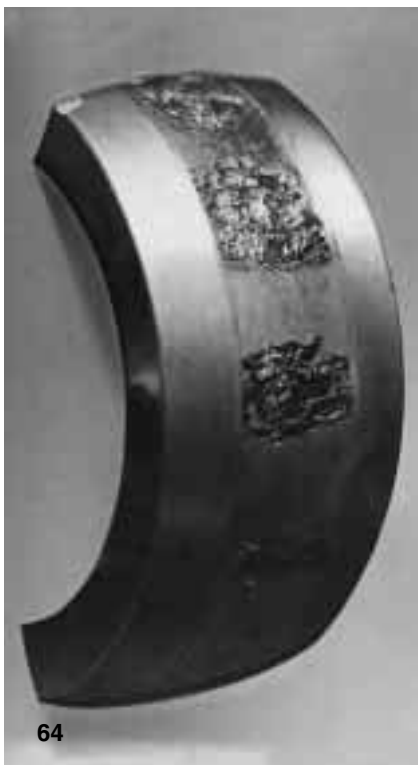
Fig 64 Inner ring of a cylindrical roller bearing with extensive flaking caused by smearing of the kind depicted in fig 65

Transverse smearing resulting from faulty mounting practice, see page 19.

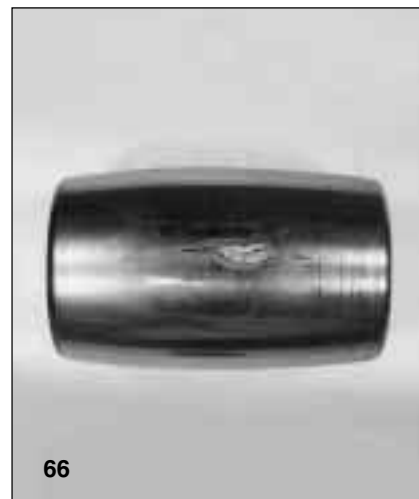
Fig 66 Flaking originating from deep seated rust on the roller of a spherical roller bearing

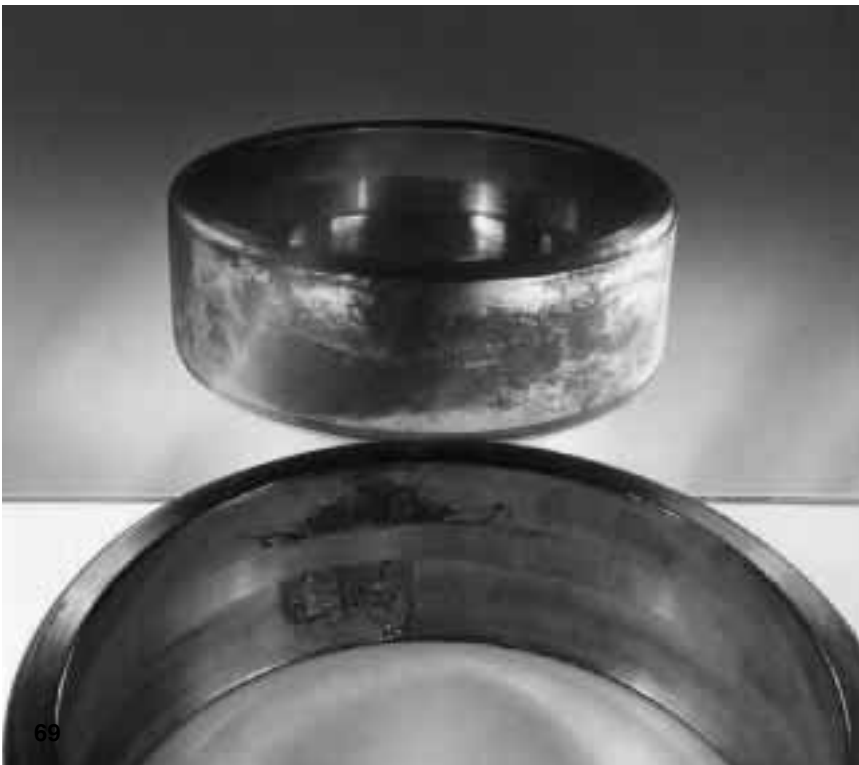
Fig 69 Flaking in the raceways of the outer ring of a spherical roller bearing. Corresponding area of advanced fretting corrosion on the outside surface (for this photograph the ring has been placed in front of a mirror). Development of the corrosion has been accompanied by an increase in volume that has led to deformation of the bearing ring and localised overloading. The results have been premature fatigue and flaking

Fretting corrosion, see page 25.

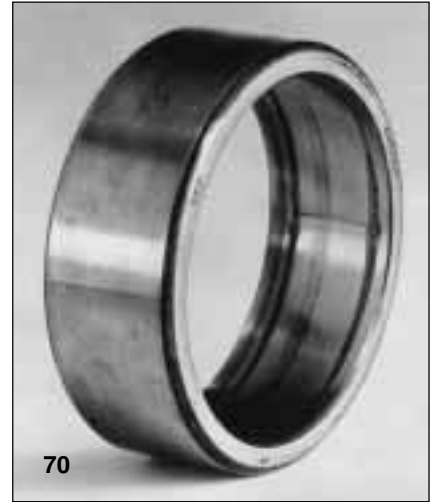
Fig 70 The outer ring of a self-aligning ball bearing with flaking caused by craters that have formed in conjunction with the passage of electric current. It is evident that the flaking has originated at the craters, from where it has spread out in both directions. Detached fragments of flaked material have in turn caused indentations and further flaking

Electric current damage, see page 26.

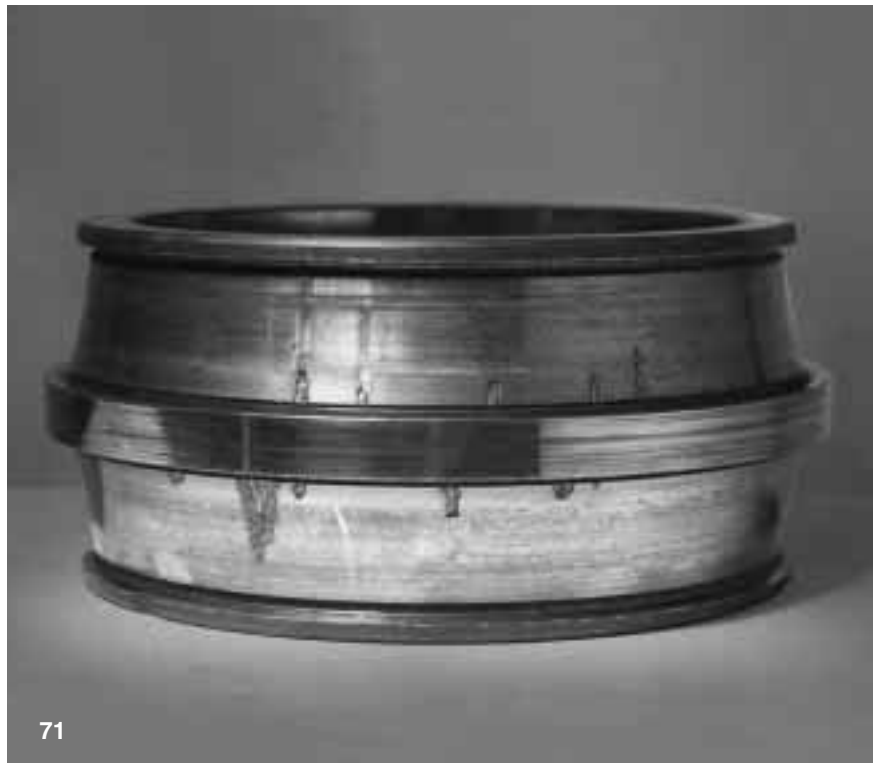
Fig 71 Flaking in both raceways of the inner ring of a spherical roller bearing. The flaking has originated from the vibration markings

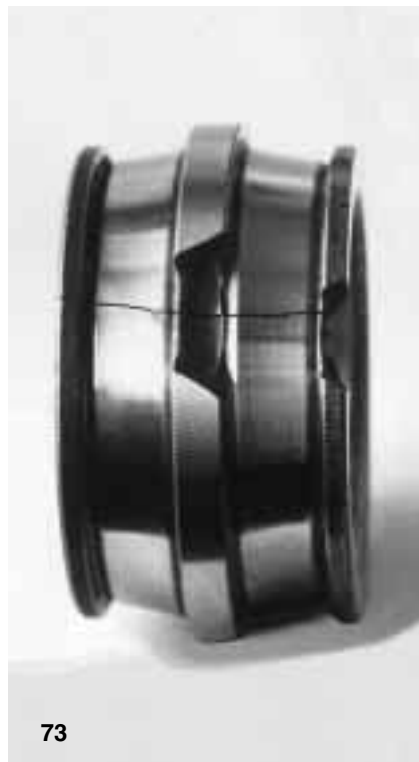
Fig 73 Cracked inner ring of a spherical roller bearing. One roller has been removed to allow the raceway of the left-hand of the photograph to be examined. The roller has then been hammered back in place, causing part of the centre flange to break away. The impacts have been transmitted via a roller in the other row and part of the outer flange has broken off too. At the same time the ring has cracked right through

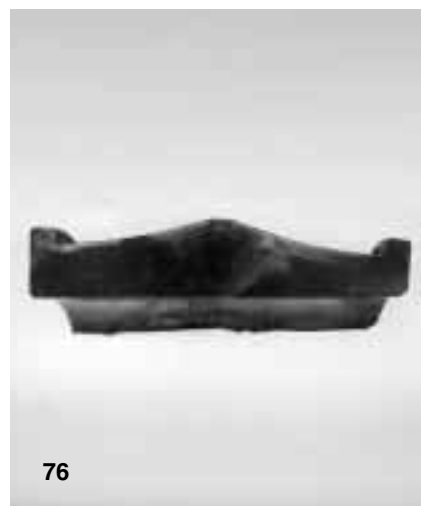
Fig 76 Fractured surface of the inner ring in fig 75

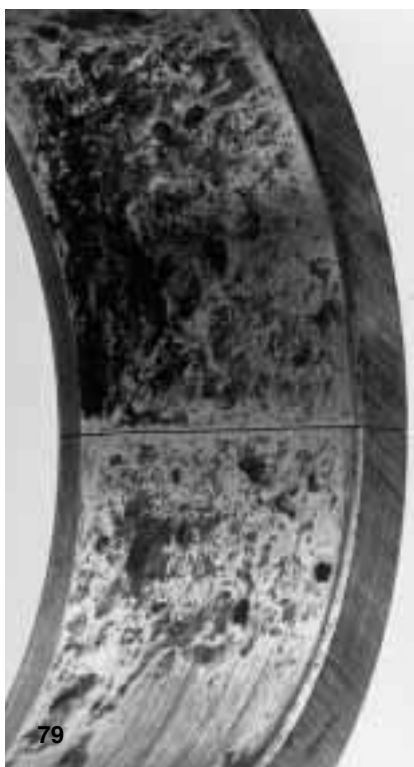
Fig 79 Spherical roller bearing inner ring with fretting corrosion and a transverse crack right through the ring. The fretting corrosion has caused the cracking
