# Bearing failures and their causes

## Bearing failures and their causes

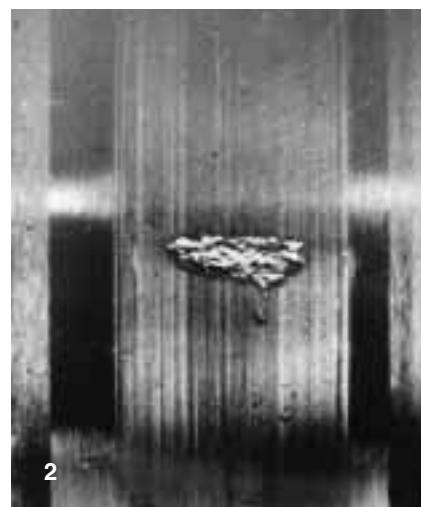
**Figs 1–4** Progressive stages of flaking

magnitude of the load. Fatigue is the result of shear stresses cyclically appearing immediately below the load carrying surface. After a time these stresses cause cracks which gradually extend up to the surface. As the rolling elements pass over the cracks fragments of material break away and this is known as flaking or spalling. The flaking progressively increases in extent (figs 1 to 4) and eventually makes the bearing unserviceable.

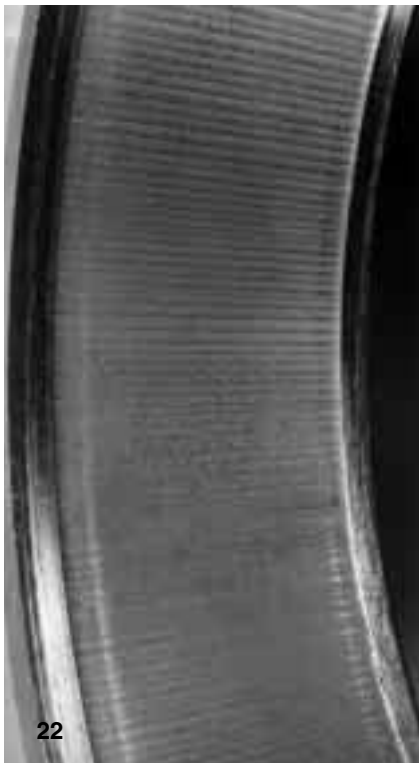
**Fig 22** Outer ring of taper roller bearing damaged by vibration during operation

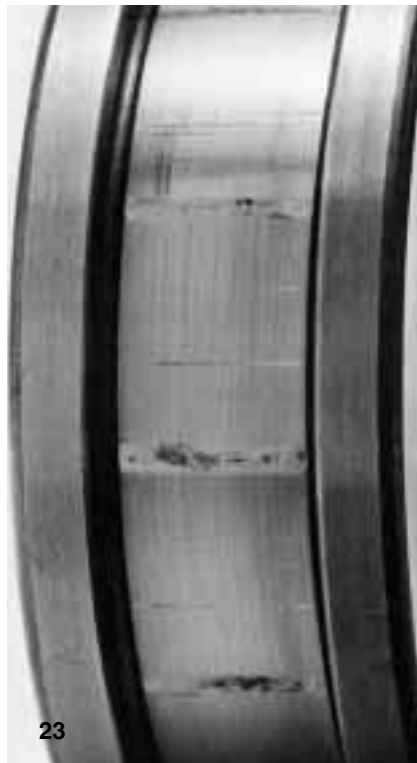
**Fig 23** Vibration damage to the ring of cylinder roller bearing. The damage has arisen while the bearing was not running. It is evident, from the fainter fluting discernible between the pronounced depressions with corrosion at the bottom, that the ring has changed position for short periods

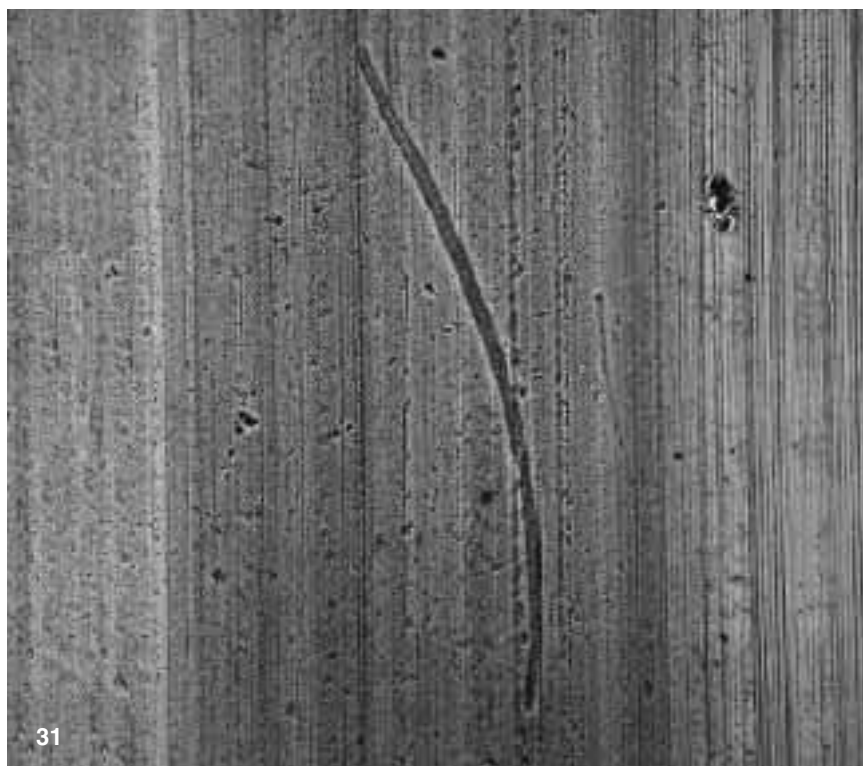
**Fig 31** Indentations, caused by dirt, in one of the raceways of a roller bearing – 50 × magnification

Cleanliness to be observed during the mounting operation.  
Uncontaminated lubricant.  
Improved seals.

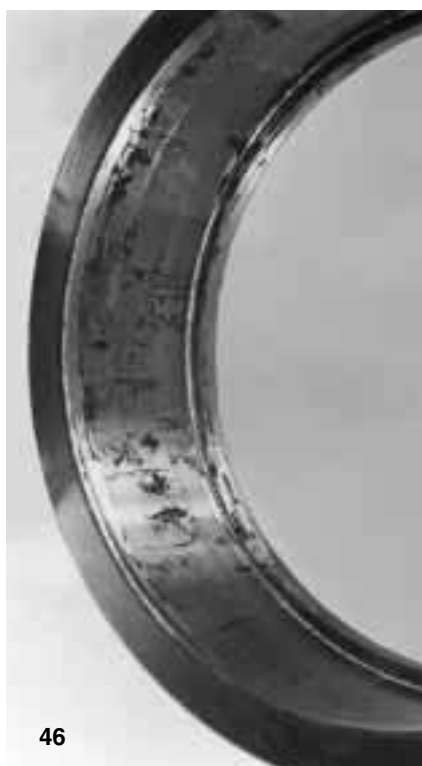
**Fig 46** Deep seated rust in the outer ring of a cylindrical roller bearing

Improve sealing.  
Use lubricant with better rust-inhibiting properties.

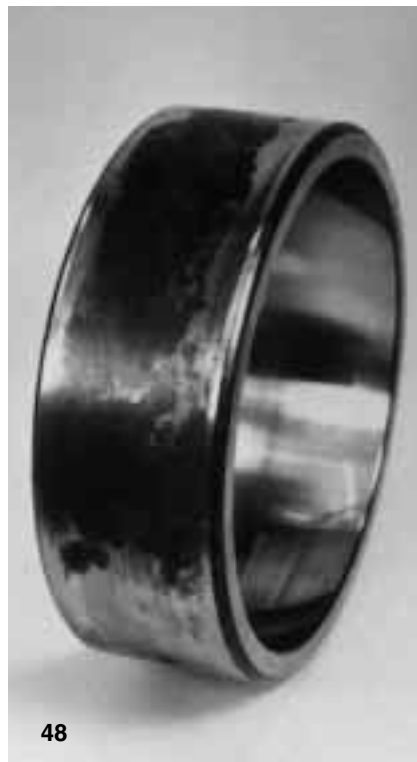
**Fig 48** Fretting corrosion on the outer ring of a spherical roller bearing

Adjust seatings.

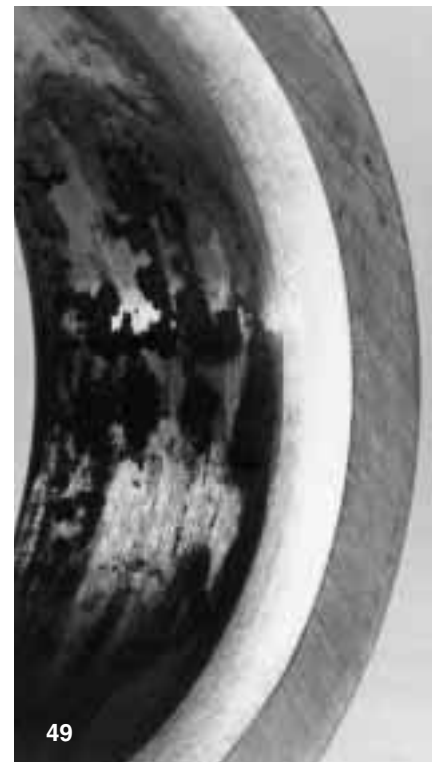
**Fig 49** Extensive fretting corrosion in the bore of a self-aligning ball bearing

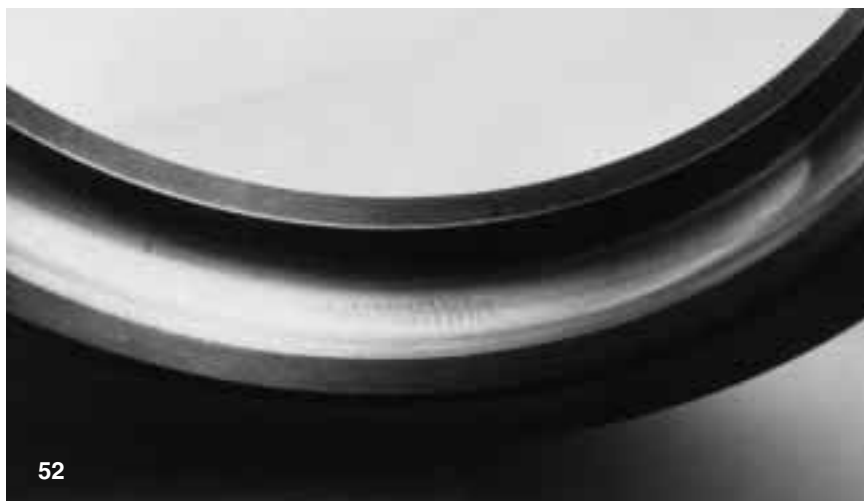
**Fig 52** Deep groove ball bearing with electric current damage in zigzag pattern. It is assumed that burns of this configuration arise when the momentary passage of high amperage current is accompanied by axial vibration

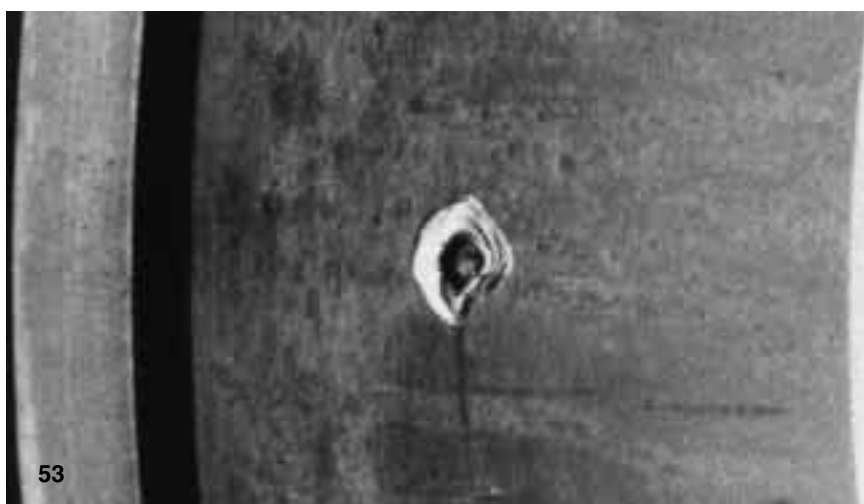
**Fig 53** A railway axlebox bearing damaged by the passage of high amperage current while the bearing was not running

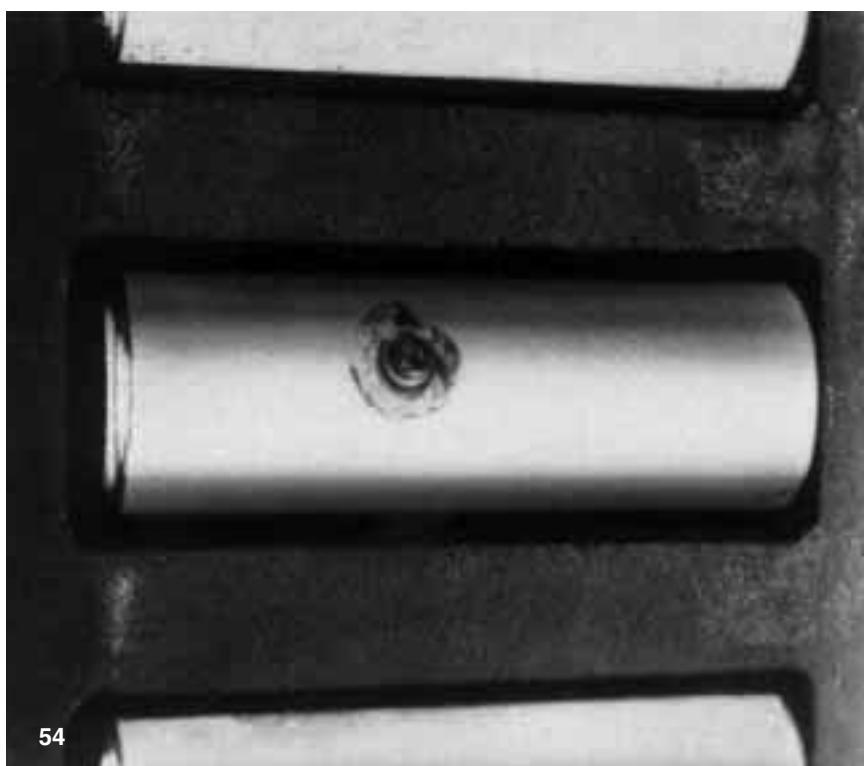
**Fig 54** Roller of a railway axlebox bearing damaged by electric current (same bearing as in fig 53)

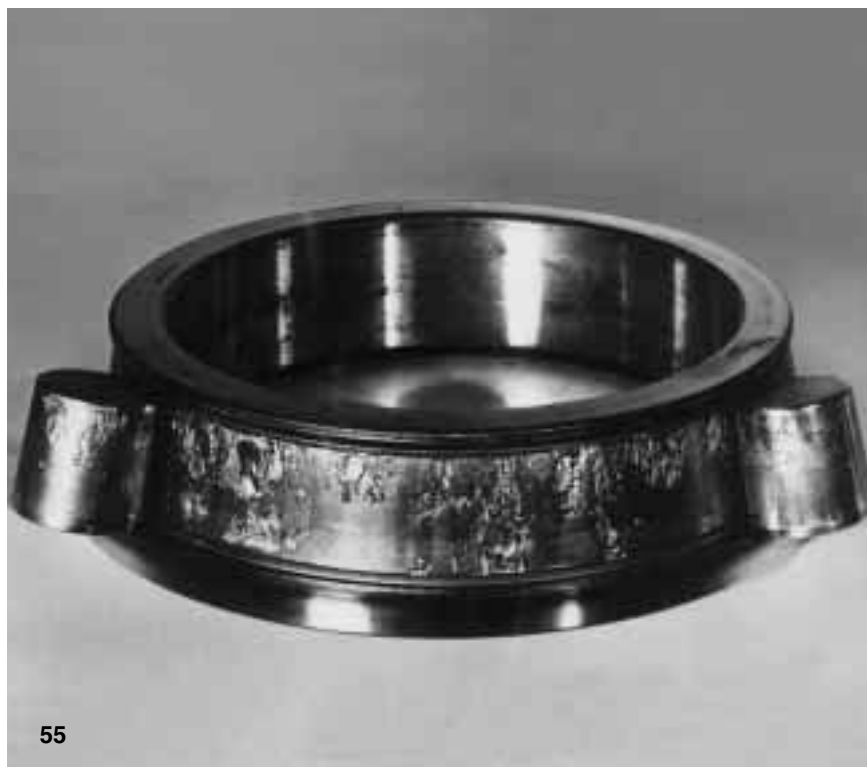
**Fig 55** Flaked cone and rollers of taper roller bearing. Heavy loading and inadequate lubrication are the causes of this damage

The causes of premature flaking may be heavier external loading than had been anticipated, preloading on account of incorrect fits or excessive drive-up on a tapered seating, oval distortion owing to shaft or housing seating out-of-roundness, axial compression, for instance as a result of thermal expansion. Flaking may also be caused by other types of damage, such as indentations, deep seated rust, electric current damage or smearing.

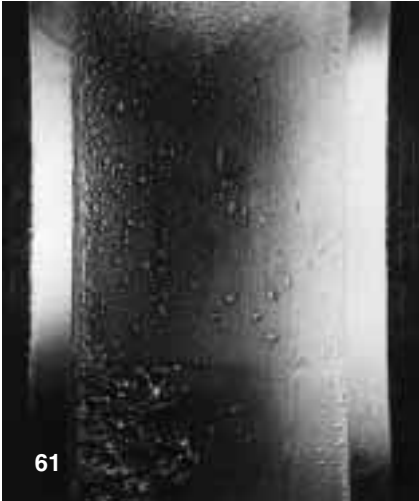
**Fig 61** Cylindrical roller bearing inner ring with flaking at one side of the raceway, as a result of overloading due to misalignment

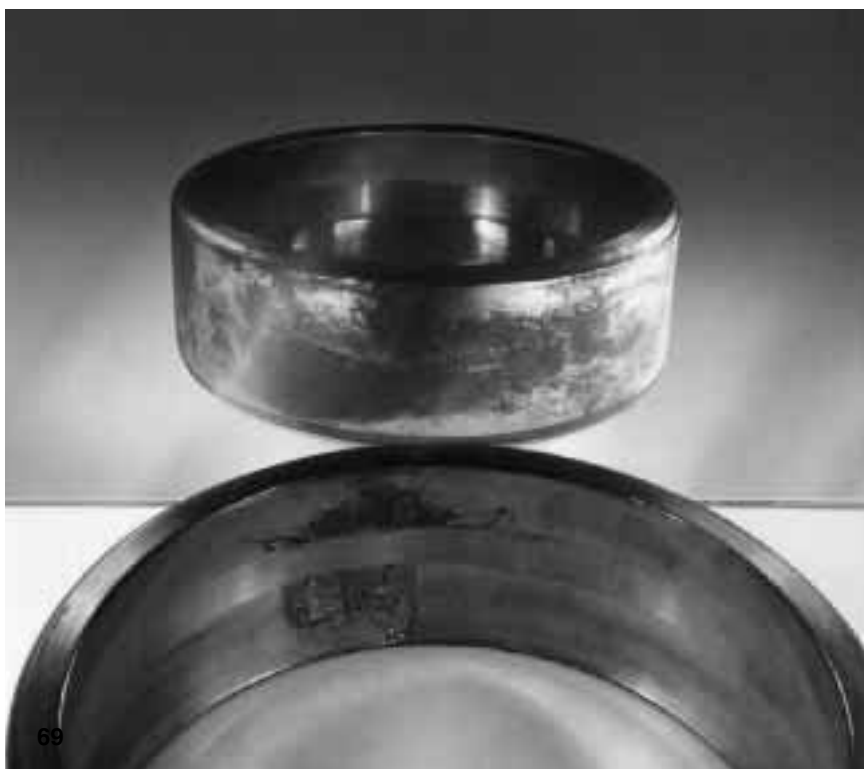
**Fig 69** Flaking in the raceways of the outer ring of a spherical roller bearing. Corresponding area of advanced fretting corrosion on the outside surface (for this photograph the ring has been placed in front of a mirror). Development of the corrosion has been accompanied by an increase in volume that has led to deformation of the bearing ring and localised overloading. The results have been premature fatigue and flaking

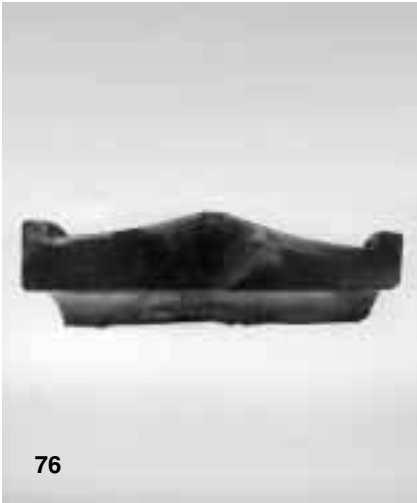
**Fig 76** Fractured surface of the inner ring in fig 75
