Calibration Report

Date: July 1, 2019	Project: Moosehorn
HiGrade Project #: 2019-DPI-001	Project Location: Alaska
Prepared by: Jonas Boehnke	Client:
Email: jonas@highgrade.tech	Email:
Phone: 1 604 3678221	Phone:

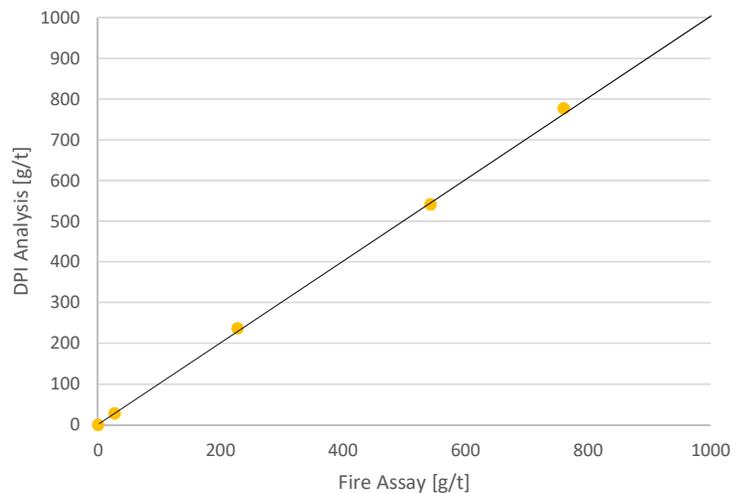
Reconciliation of Assay methods

The optical DPI analysis correlates well with the industry standard fire assay. The deviation between the two methods is -0.4% to 3.9%. Five subsamples of table concentrate (approx 1g each) were analyzed with the non-destructive DPI tool, then blended with 24 g of clean silica sand and submitted for fire assays to MSALabs. Blending with silica sand homogenizes the sample and ensures that the maximum permissible fire assay grade (1000 g/t) is not exceeded. The sample contained no interfering minerals or metals, such as pyrite.

Sample #	DPI [g/t]	Deviation [%]	Fire Assay [g/t]
1	0	0.0%	0
2	28	3.7%	27
3	237	3.9%	228
4	777	2.2%	760
5	541	-0.4%	543
