Thermal weak spots in your building envelope design can have U-values several times higher than the rest of the envelope. Consequently, they can contribute significantly to conductive heat flow even if they make up a small area. Improving those weak spots thus can substantially improve performance.

Two design iterations for a building envelope renovation on a 4 storey mixed use building are depicted in the plots below.

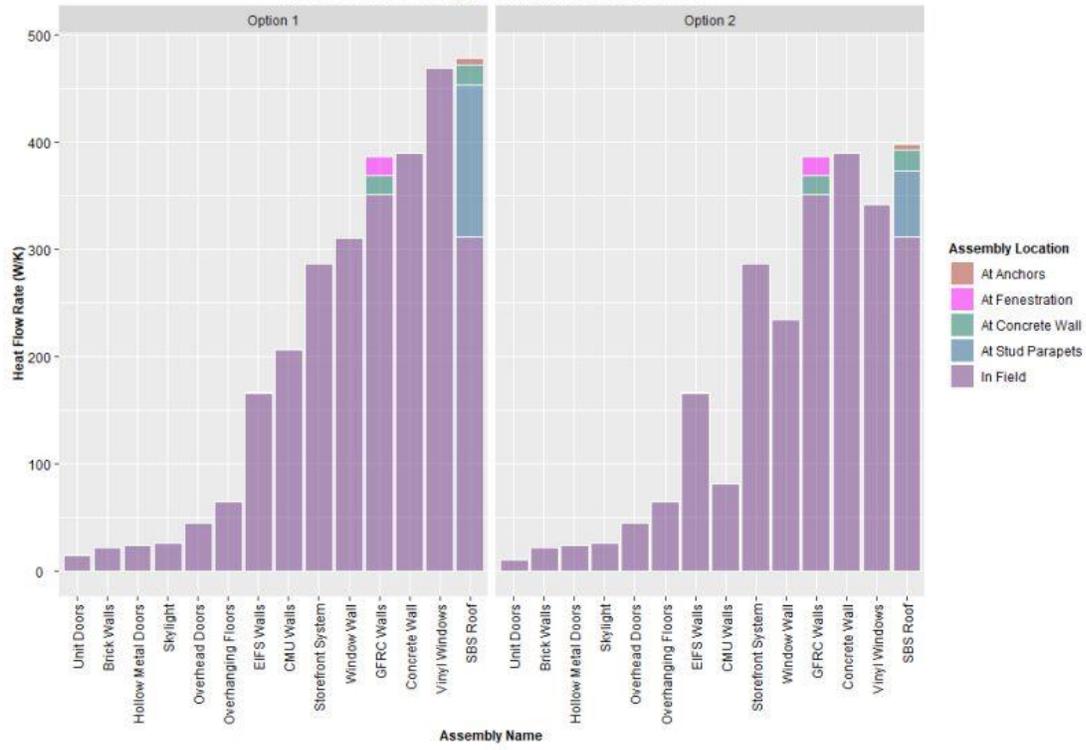
Total Heat Flow Rate By Assembly Name And Location

The bars show the total conductive heat flow rate through each assembly type. The different colours in each bar indicate where the heat flow is occurring: the field of the assembly or at thermal anomalies in those assemblies.

The weak spots in the first design include whole assemblies that have high U-values, as well as thermal anomalies in well insulated assemblies.

Thermally weak assemblies include the CMU walls and fenestration. Within the roofs, excess heat flow occurs at the parapets.

These weak spots make up 17% of the above grade envelope area, but contribute 50% to total conductive heat flow.

Insulation was added to the CMU walls, thermal breaks were added to the parapets, and the glazing was improved everywhere except the storefronts, which are not being replaced. This resulted in a 15% reduction in total conductive heat flow rate.
