Re: Drainage relating to lands subdivided by Strata Plan LMS3080 (the "**Strata Lands**") affecting the Eagle Mountain Middle School (the "**School**") Development Site (Lot 2 Plan BCP5107 and Lots 4 and 5 Plan LMP40733, all of Section 16 Township 39 New Westminster District) (the "**School Site**") owned by The Board of Education of School District No. 43 (Coquitlam)

**Re: Surface Water Runoff/Seepage Sampling Results
Heritage Middle School
Anmore, BC
File No. 10988**

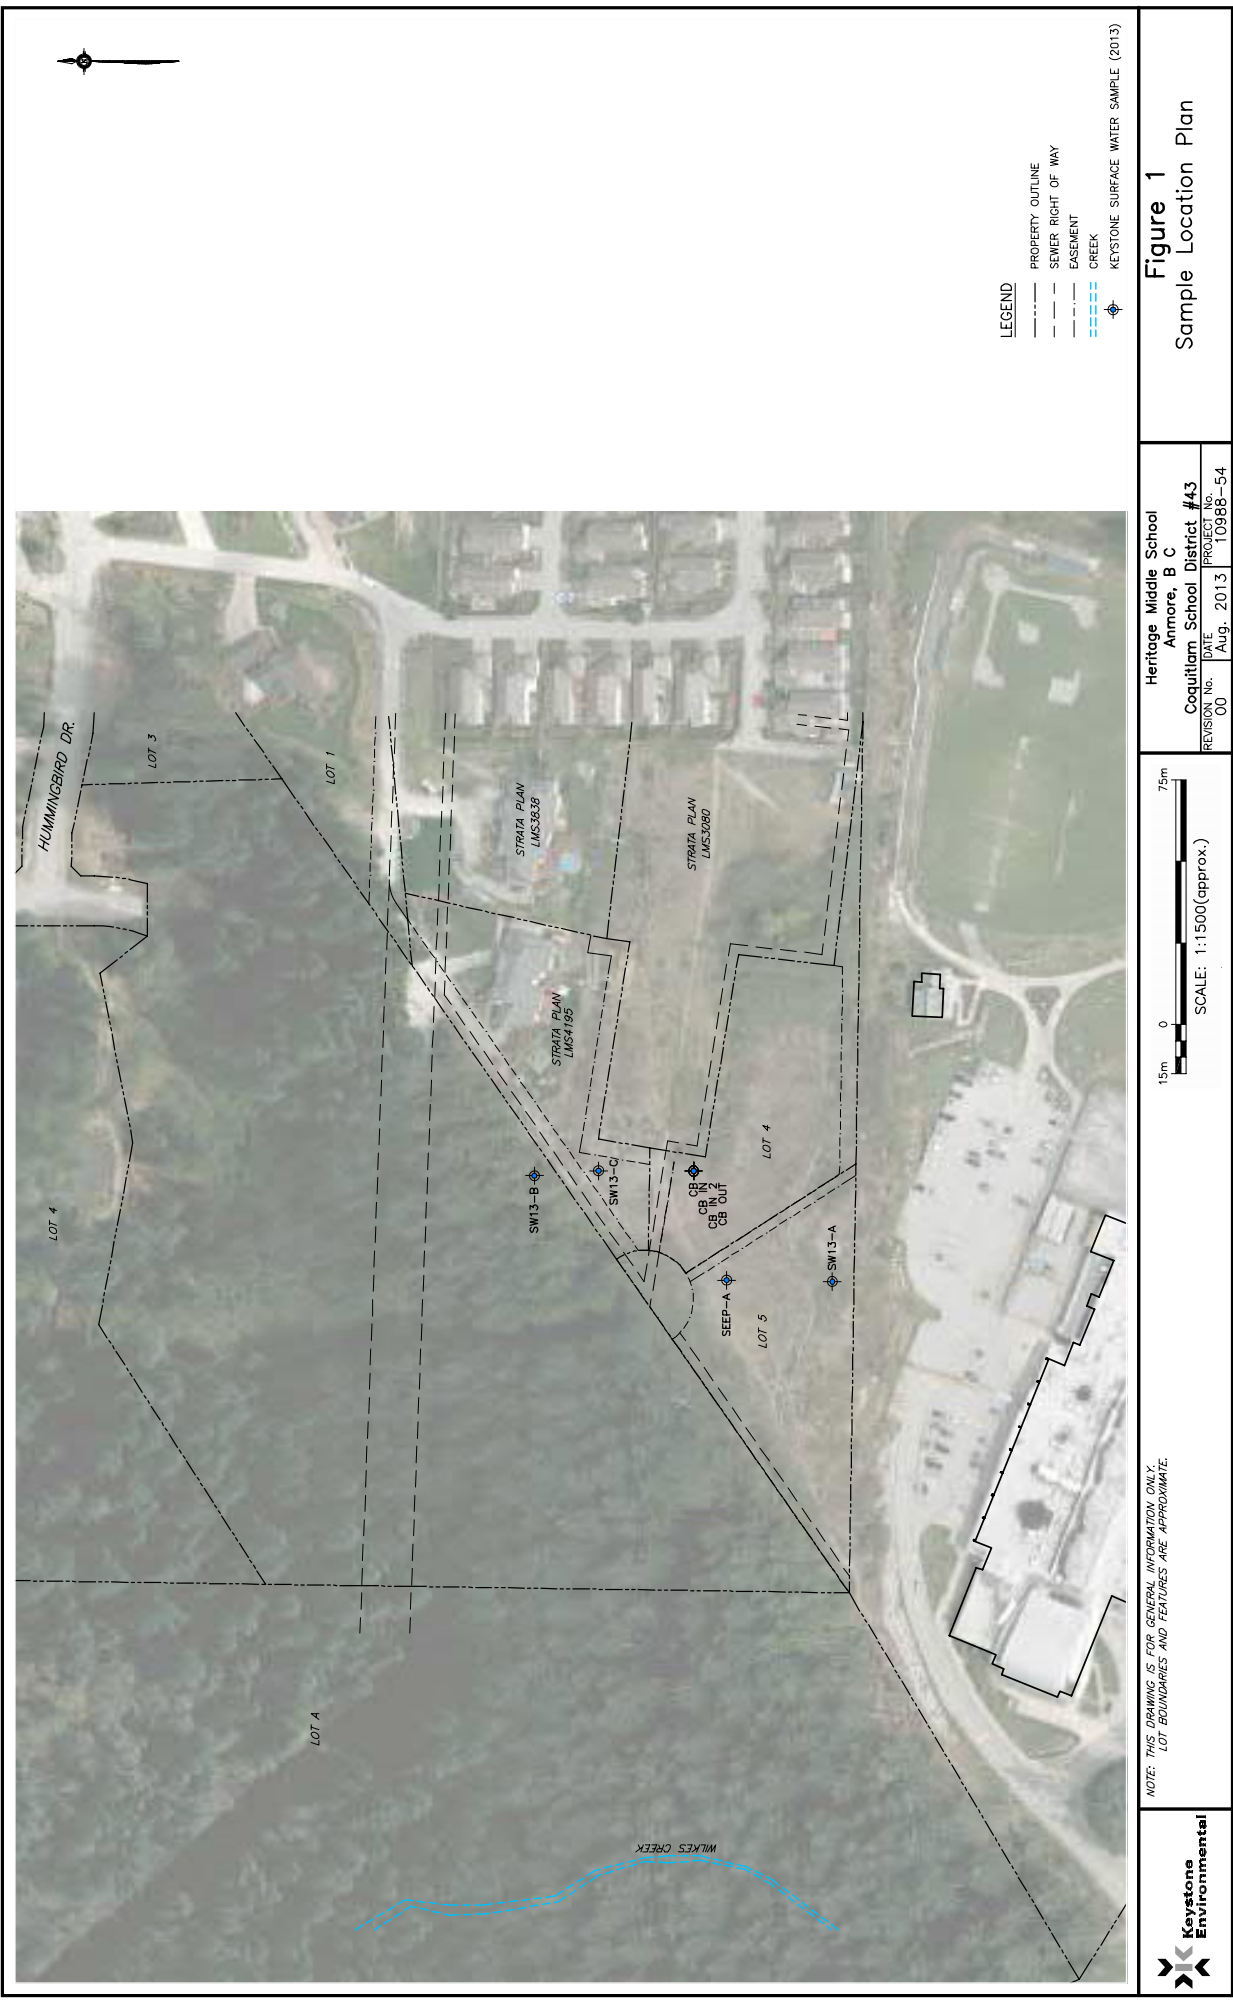
FIGURE 1 – SAMPLE LOCATION PLAN

- SW13-A: surface water and seep collected from the base of a slope at the southern edge of the Site (March 26, 2013)
- CB IN 2: a storm drain pipe directed into the catch basin on the eastern edge of the Site from the southeast (April 29, 2013)

- CB IN: a storm drain pipe directed into the catch basin on the eastern edge of the Site from the northeast (April 29, 2013)
- CB OUT: water from the catch basin on the eastern edge of the Site (April 29, 2013)

- SW13-B: surface water collected south of the Site access road approximately 20 m northwest and up-gradient of the catch basin on the eastern edge of the Site (May 15, 2013)

- SEEP-A: groundwater seep collected from the excavation wall near the centre of the Site (May 15, 2013)
- SW13-C: surface water collected south of the Site access road approximately 10 m northwest and up-gradient of the catch basin on the eastern edge of the Site (May 15, 2013)

- CB: a second sample from the catch basin on the eastern edge of the Site. The water level was above both pipe inlet sample points (CB IN and CB IN 2) on this date (June 25, 2013).

It is recommended, based on bacteria values and future on-Site land use, that the Village of Anmore and Anmore Estates be made aware of the human health concerns, and implement measures to prevent the septic field discharge migrating on-Site prior to the Site school being operational and/or Site grounds accessible to the public. If this request does not receive an immediate response, it is recommended that the BC Ministry of Health be contacted to alert them of the potential public health threat.
