ARKEMA CHEMICAL CROSBY, TX - 2017 ACCIDENT INVESTIGATION

Organic Peroxide Decomposition, Release, and Fire at Arkema Crosby Following Hurricane Harvey Flooding

Crosby, Texas

Exposures to Emergency Responders, Community Evacuation, and Property Damage

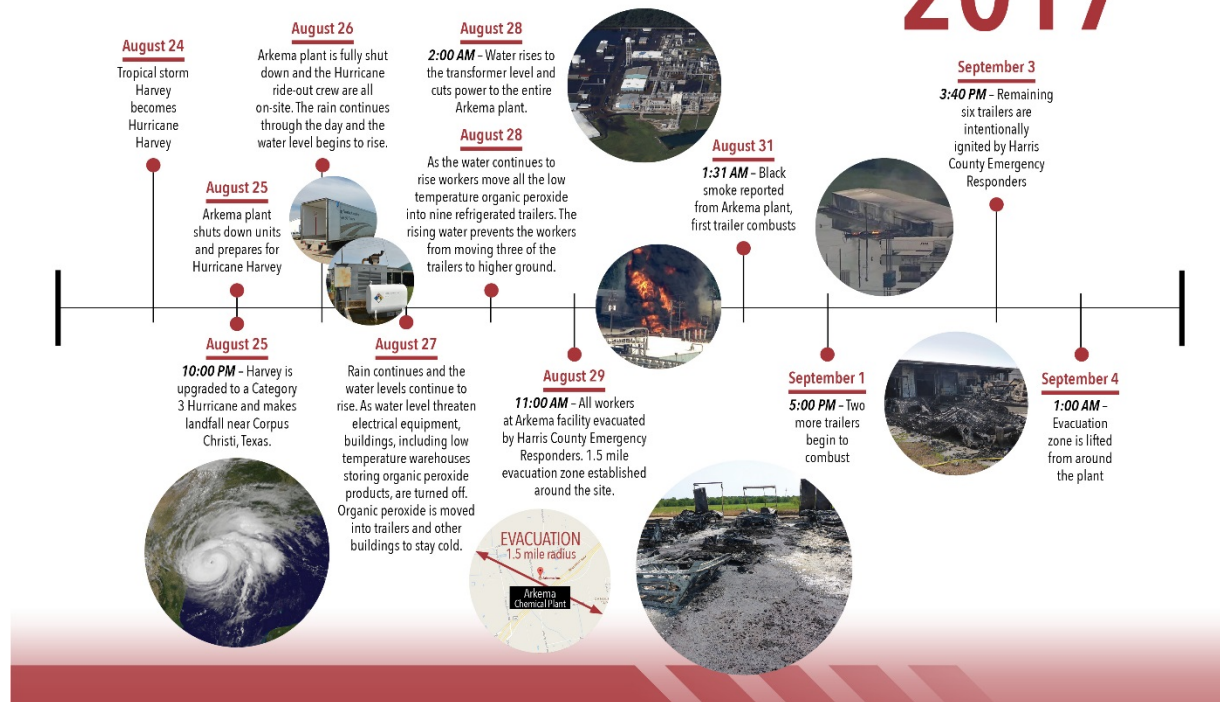
Figure 1. Overview Timeline for the Incident Events and Activities at the Arkema Crosby Facility.

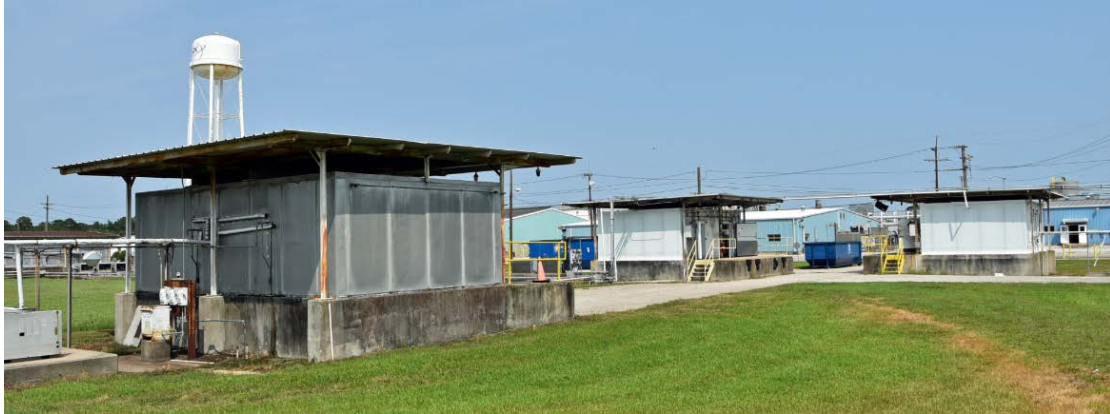
Figure 3. Crosby Low Temperature Warehouses. Three of the seven Low Temperature Warehouses at the Arkema Crosby facility are shown in this photograph. (Source: CSB Photo)

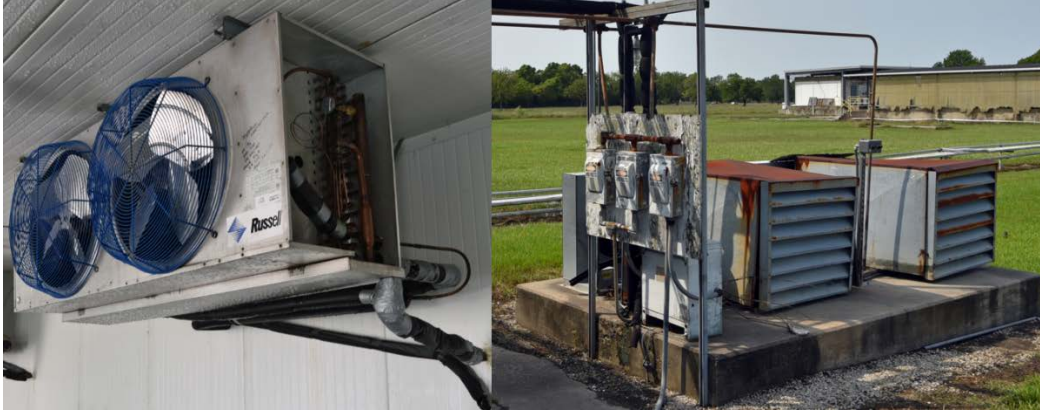
Figure 4. Typical Refrigeration Equipment Used to Keep the Low Temperature Warehouses Cold at the Arkema Crosby Facility. The photo on the left shows refrigeration evaporator equipment used to remove heat from the inside of a Low Temperature Warehouse. The photo on the right shows refrigeration condensing equipment, that removes heat from the refrigerant and also shows electrical equipment for the refrigeration system and other electrically powered equipment for the building, such as lighting.^a (Source: CSB Photo)

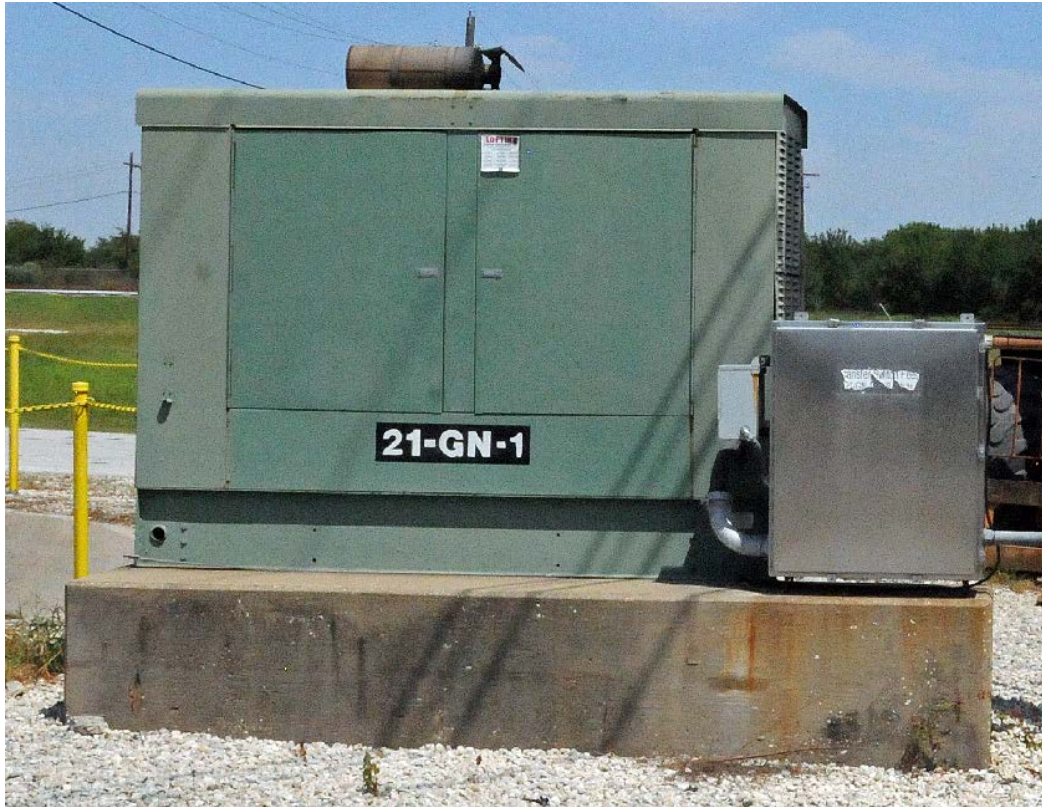
Figure 5. One of Seven Emergency Generators at the Arkema Crosby Facility. Generator 21-GN-1 is one of the two generators providing emergency electrical power to Arkema's seven Low Temperature Warehouses. The bottom of the generator (top of the concrete foundation) is about two feet above the ground. (Source: CSB Photo)

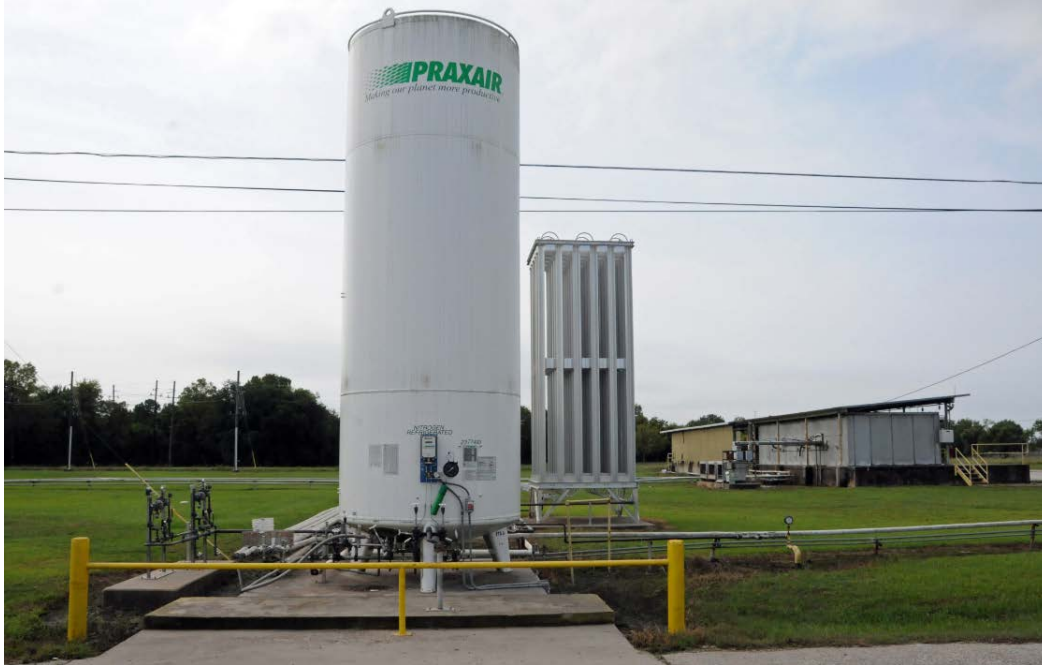
Figure 6. Liquid Nitrogen Tank at the Arkema Crosby Facility. Among other uses, this tank holds up to 40,000 pounds of liquid nitrogen that can be injected into each of the organic peroxide Low Temperature Warehouses to provide a backup refrigeration source. (Source: CSB Photo)

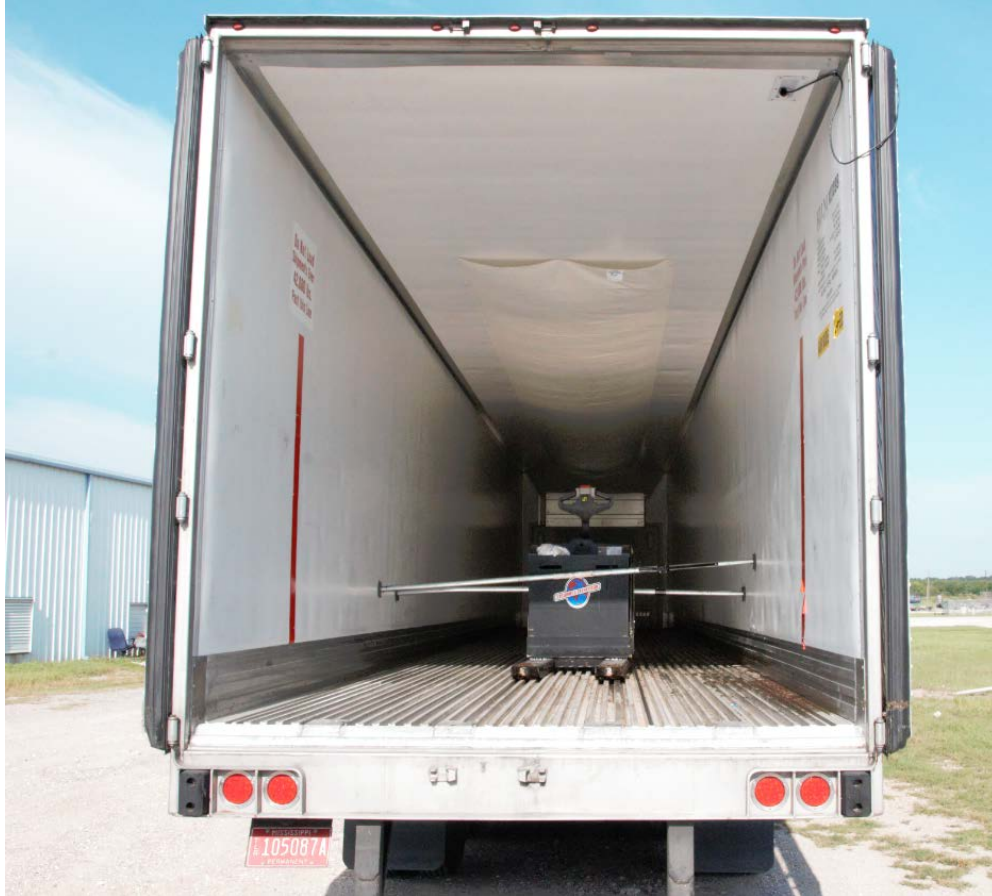
Figure 7. Refrigerated Truck Trailer. Arkema used about a dozen refrigerated truck trailers like this one used to ship organic peroxide products to customers and to provide a temporary storage location if the refrigeration at one or more of the Low Temperature Warehouses could not be maintained. (Source: CSB Photo)

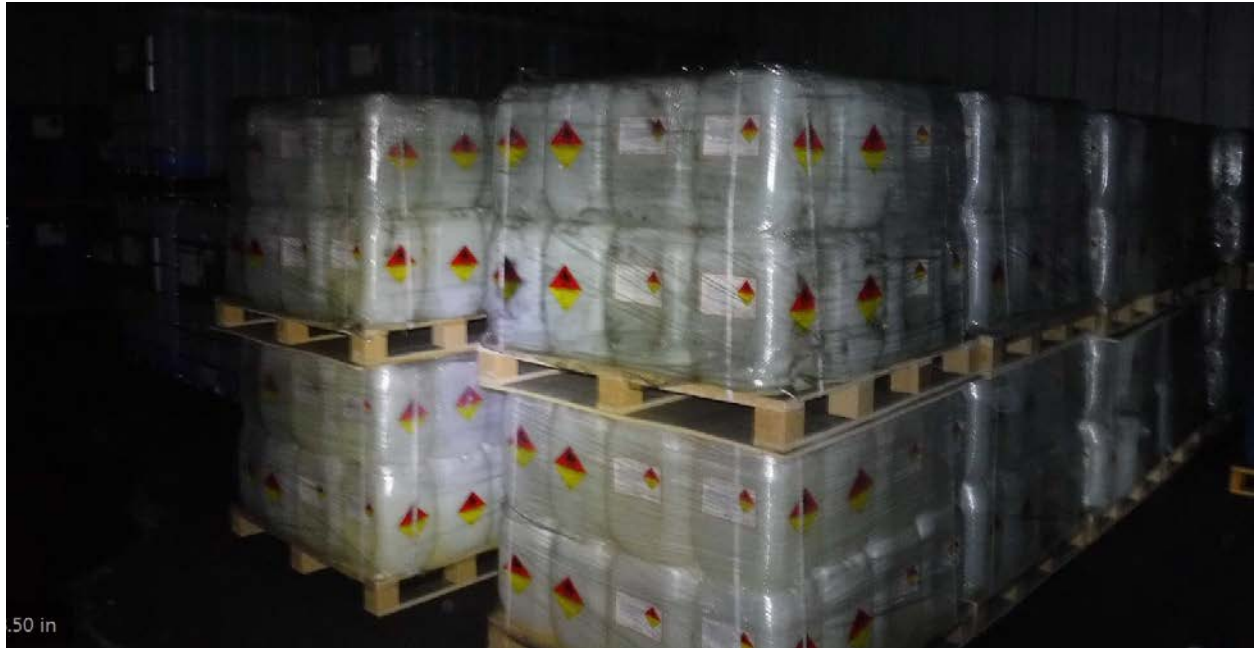
Figure 8. Stacked Organic Peroxide Totes. This example shows shrink-wrapped five-gallon containers on pallets. (Source: Arkema Photo)

56. Organic peroxide products that require low-temperature storage are generally packaged in either one or five-gallon plastic containers, or totes. Customers frequently use small quantities of organic peroxides so such totes are convenient for customers. These organic peroxide totes are stacked onto pallets and shrink-wrapped, enabling workers to move the products more easily around the facility and providing stability during shipping (Figure 8).

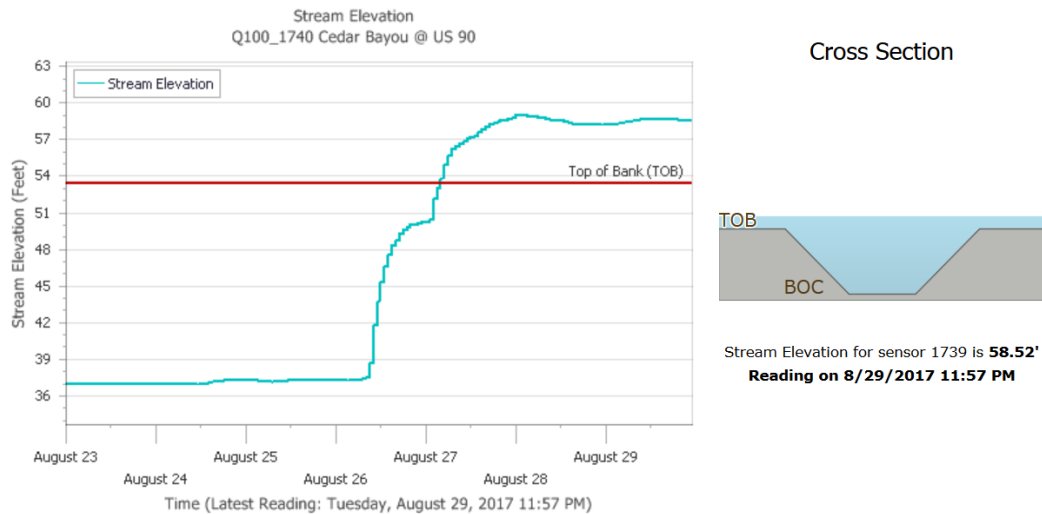
Figure 14. Gauge Station 1740 Graphic Showing Cedar Bayou Stream Elevation During Hurricane Harvey. The water level steadily rose for most of the day on Saturday, August 26, 2017 [29].^{a, b}

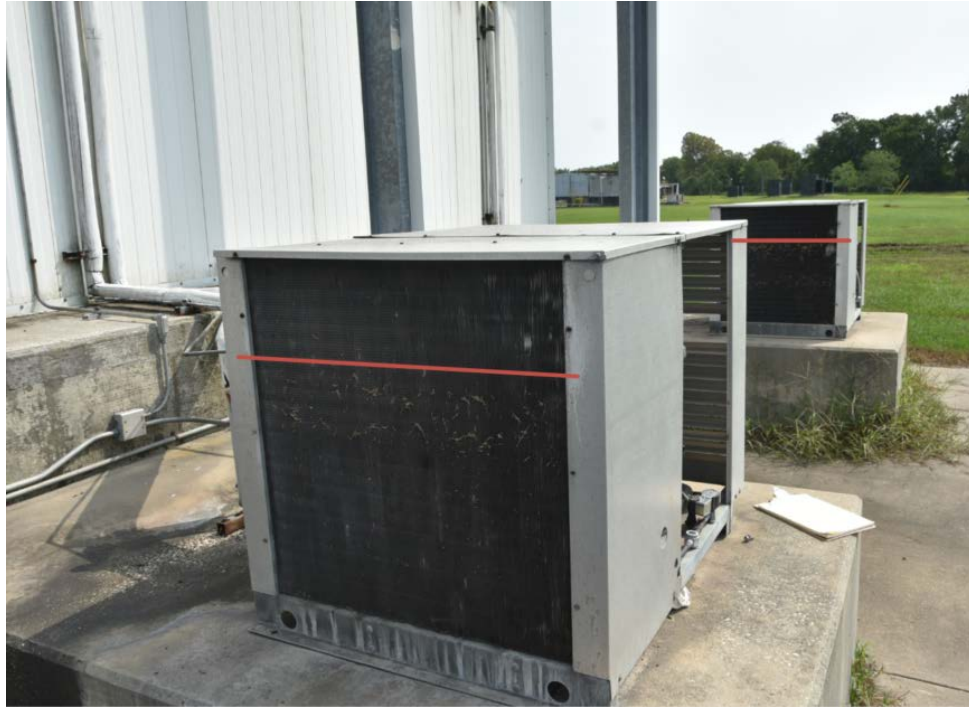
Figure 17. Air Conditioning Units Behind One of the Low Temperature Warehouses. The final floodwater level is approximated by the red lines on the air conditioning equipment at the Arkema Crosby facility. (Source: CSB Photo)

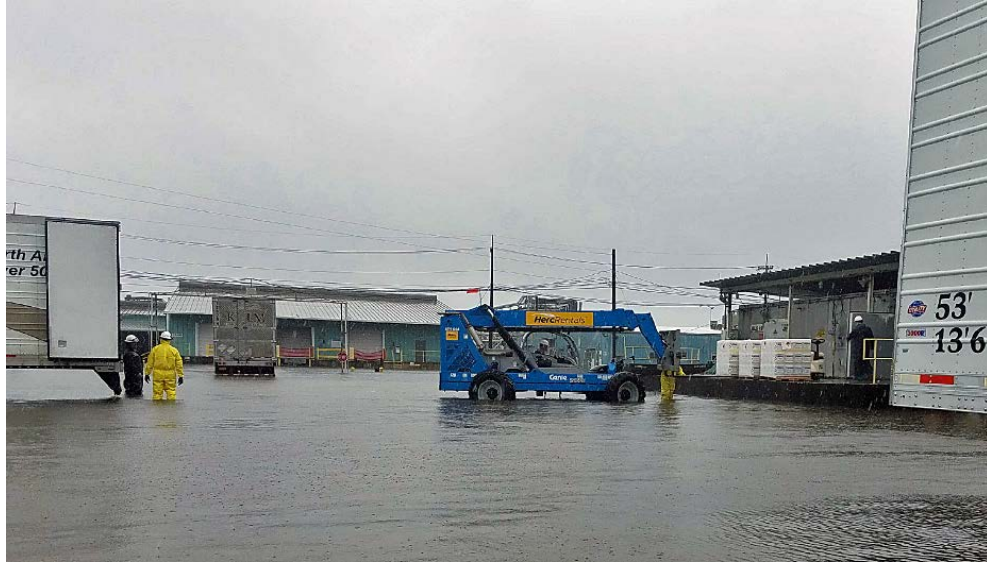
Figure 18. Forklift Used by the Ride-out Crew. Ride-out crew members used the forklift shown in this image to move organic peroxide pallets from the storage buildings after they turned off power to the buildings because of the rising floodwater. (Source: Arkema Photo)

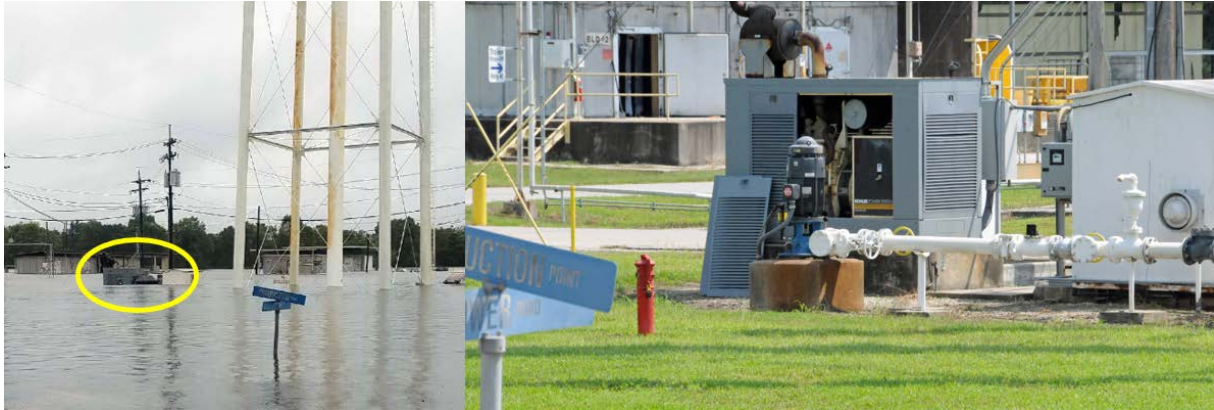
Figure 19. One of the Emergency Generators Providing Backup Electricity to the Low Temperature Warehouses. The photo on the left shows floodwater covering the bottom half of the generator (yellow oval) on Tuesday August 29, 2017. The post-incident photo on the right shows the same generator. (Source: Arkema Photo (left) Modified by CSB, CSB Photo (right))

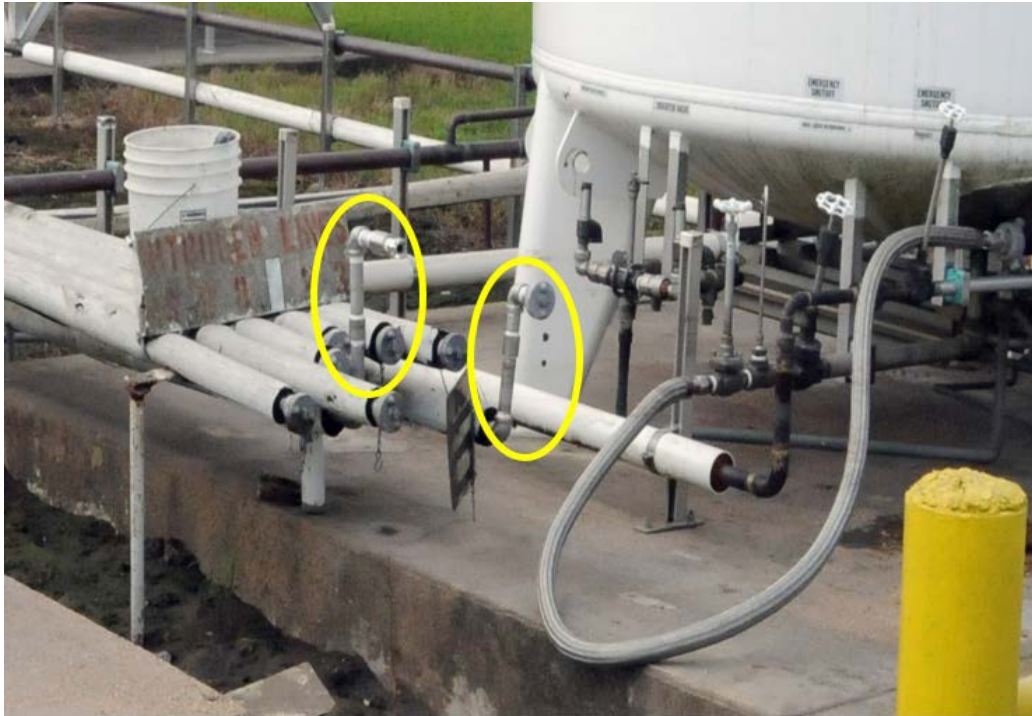
Figure 20. Liquid Nitrogen Piping Extensions. A supervisor modified the liquid nitrogen piping, extending it to ensure that the connection point would be above the floodwater if the ride-out crew needed to inject liquid nitrogen into one of the Low Temperature Warehouses that still contained organic peroxide products. These elevated (extended) connections, however, were not high enough; the rising floodwater eventually submerged them. (Source: CSB Photo)

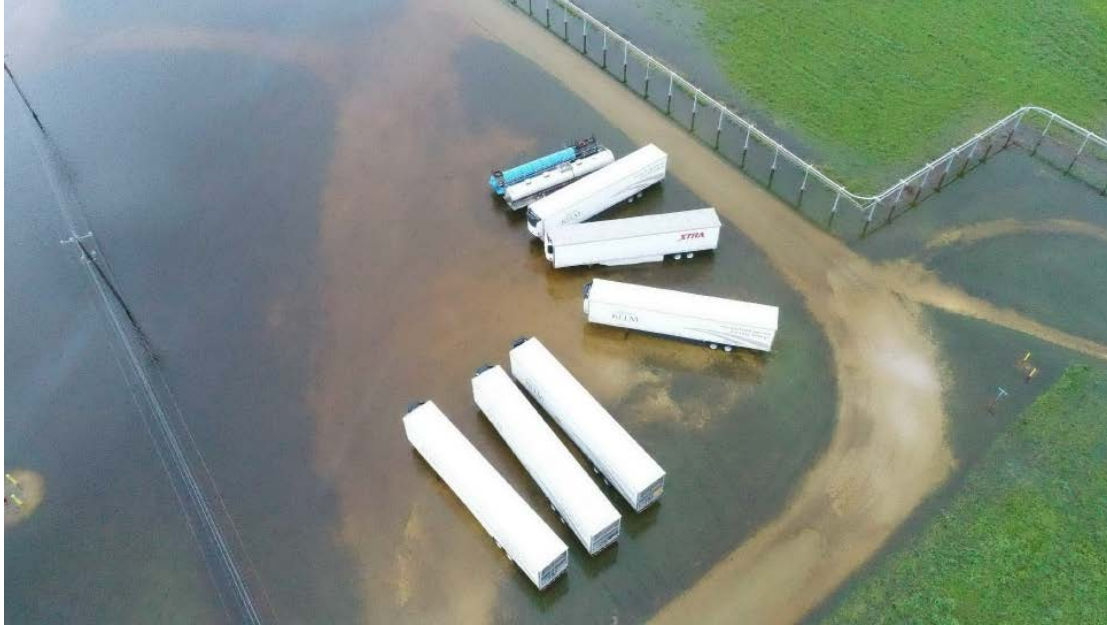
Figure 21. Refrigerated Trailers in the Laydown Area. Six refrigerated trailers loaded with organic peroxide products are shown at the Arkema Crosby facility. Two empty tanker trailers are also shown at the top of the photo. (Source: Photo provided by Arkema)

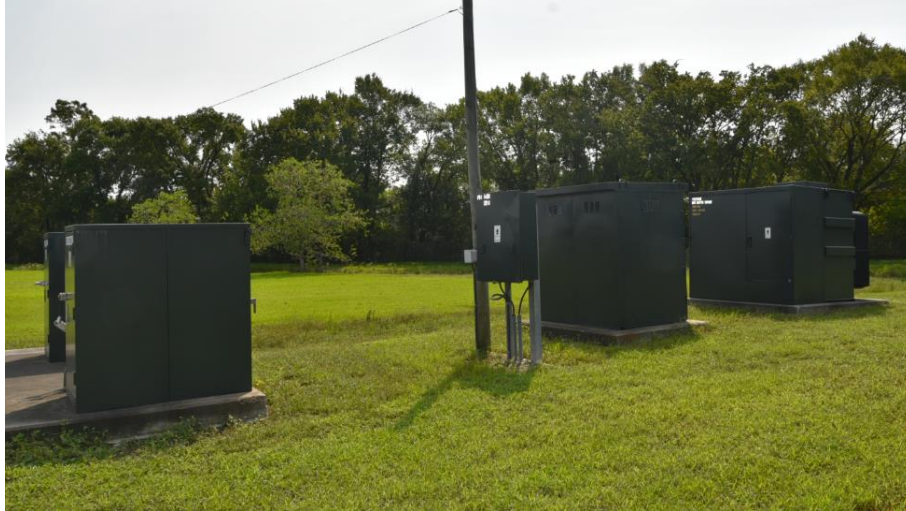
Figure 24. CenterPoint Transformers at the Arkema Crosby Facility. These are the main CenterPoint power transformers onsite at the Arkema Crosby facility. (Source: CSB Photo)

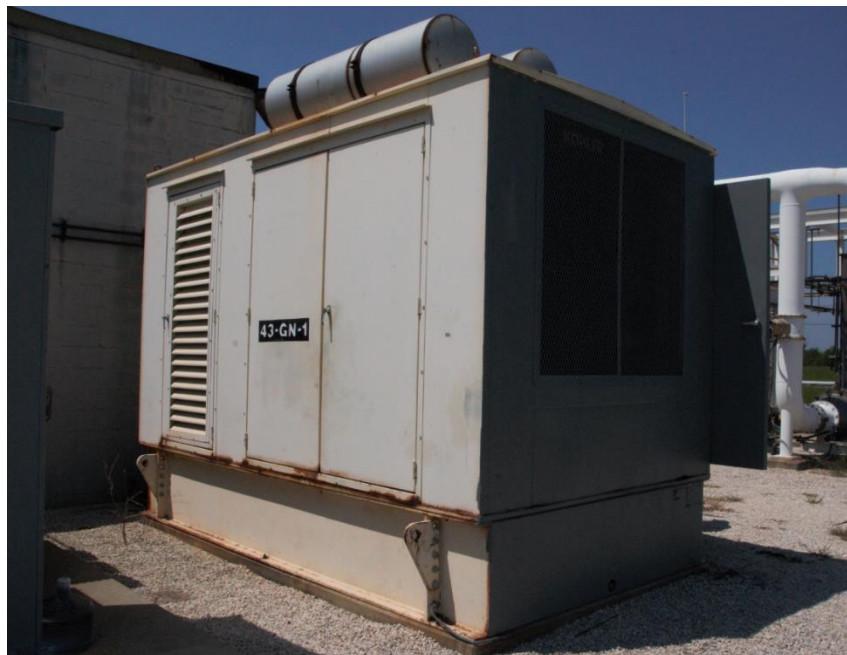
Figure 25. Emergency Generator. This is one of the emergency generators that automatically turned on when the power failed at the Arkema Crosby facility. (Source: CSB Photo)

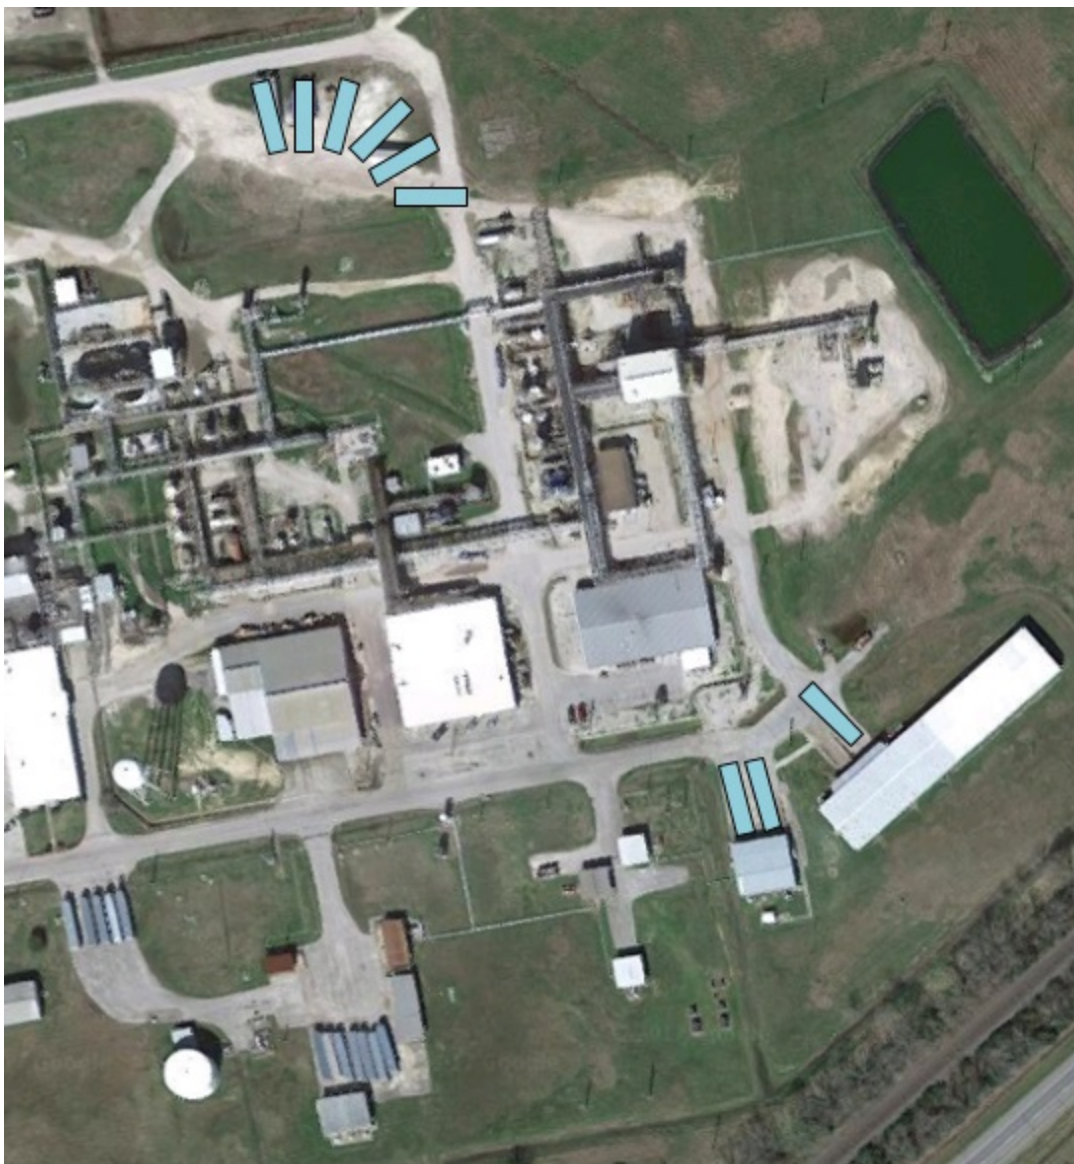
Figure 27. Location of the Nine Refrigerated Trailers Containing Organic Peroxide Products.
(Source: Google Earth Image Modified by CSB)

99. By the end of Monday, workers had moved 11 different organic peroxide products—which required low-temperature storage, were held in about 10,500 individual containers, and totaled more than 350,000 pounds—into 9 refrigerated trailers. Figure 27 and Figure 28 show the final location of the nine refrigerated trailers. The three refrigerated trailers near the south end of the facility, which held more than 4,000 containers, were still sitting in floodwater, and the ride-out crew members were concerned that these trailers would not be able to continue operating and refrigerating the organic peroxide products they held.

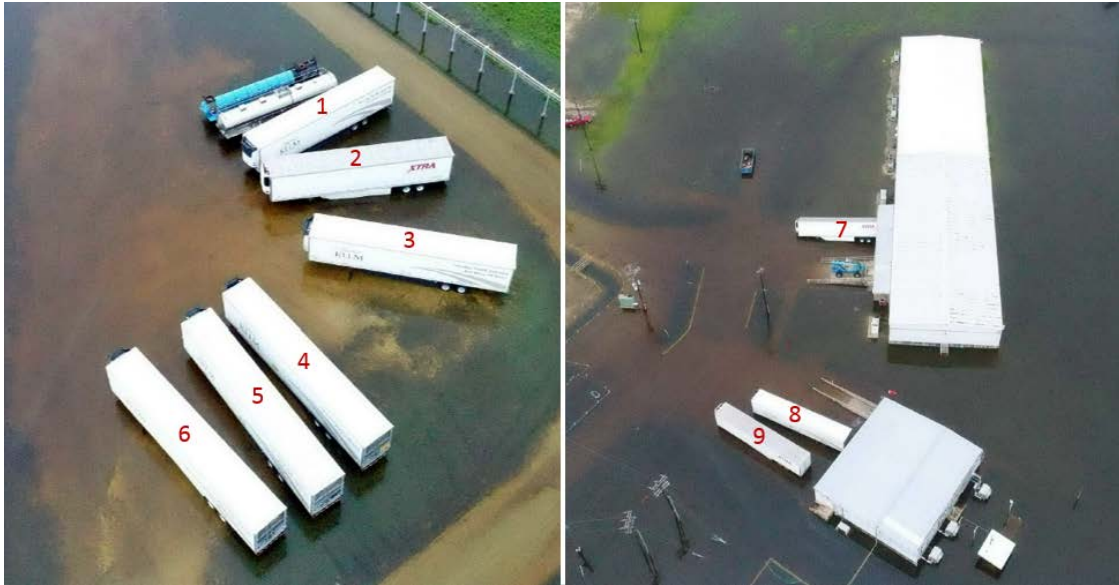
Figure 28. Photo Identifying the Nine Refrigerated Trailers of Organic Peroxide Products. (Source: Photos Provided by Arkema and Modified by CSB)

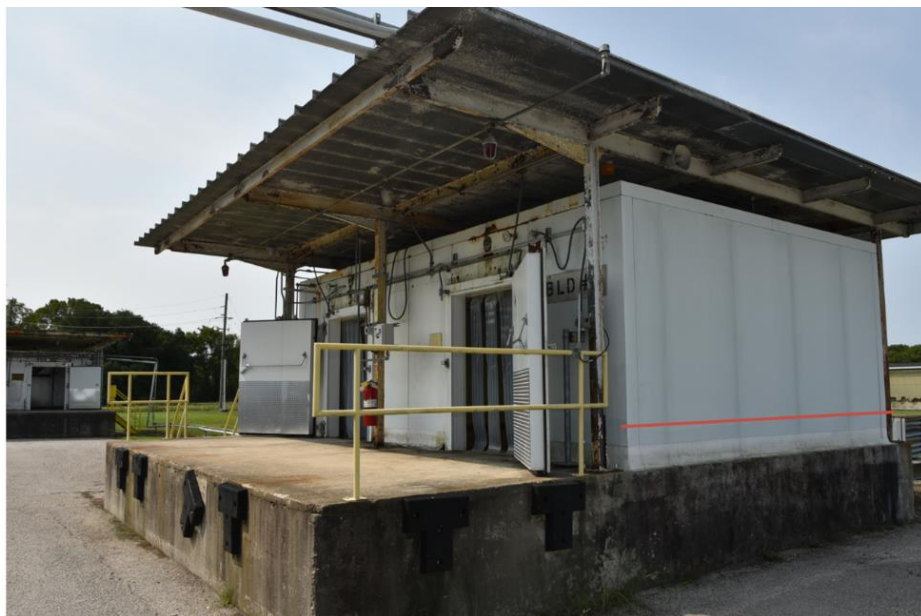
Figure 29. Low Temperature Warehouse at the Crosby facility. The red line shows the high-water mark, just over five feet above the ground. (Source: CSB Photo)

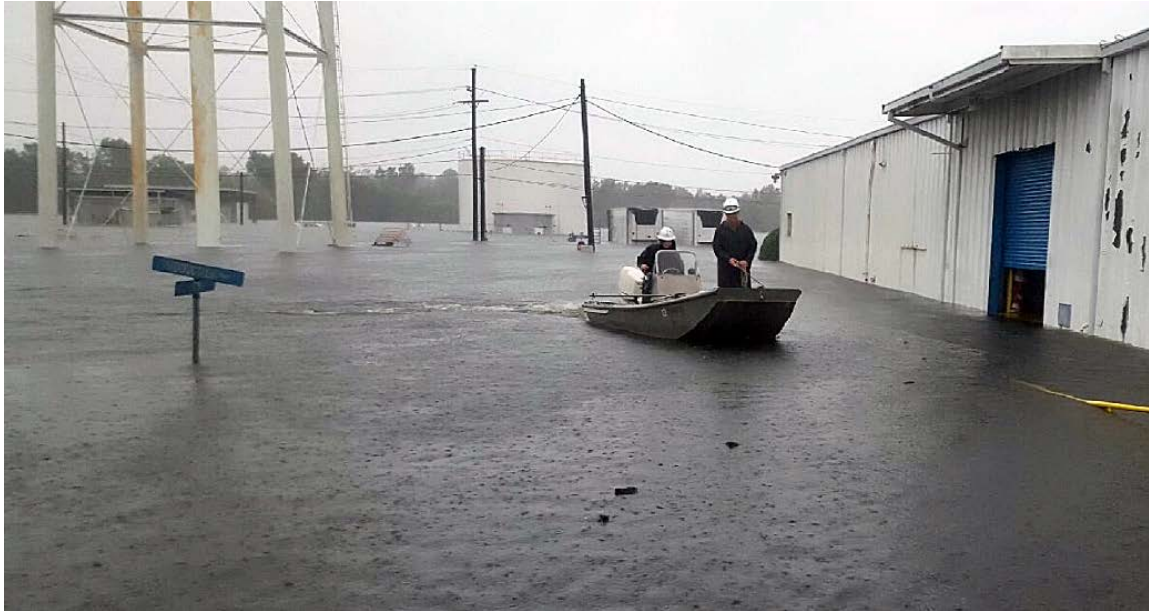
Figure 30. Boat Used by Ride-out Crew to Move Around the Arkema Crosby Facility. This photo shows two members of the ride-out crew in the 16-foot boat used to travel around the site during the flood. (Source: Arkema Photo)

101. By Monday evening, the most practical and safest way to move around the facility was by boat (Figure 30). Two boats were onsite. The first was a smaller boat, which was onsite as part of the Arkema site's Hurricane Preparedness Plan. As the floodwater heights increased, a relative brought a ride-out crew member's larger 16-foot boat to the site.

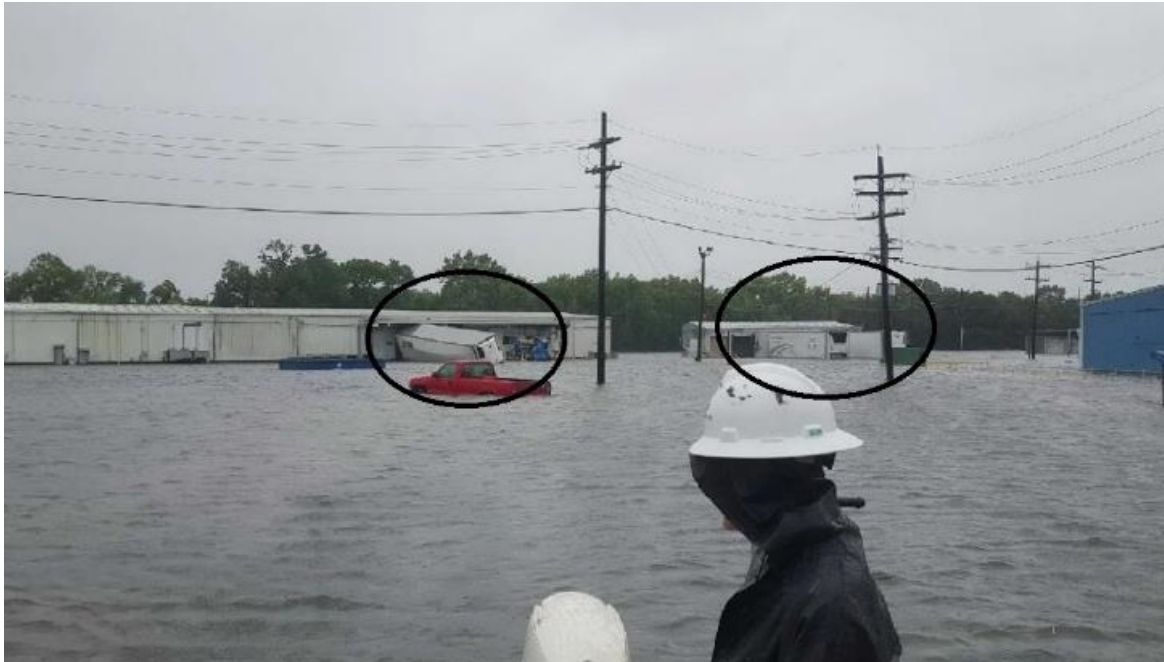
Figure 31. Condition of the Crosby Facility on the Morning of Tuesday, August 29, 2017. The ride-out crew sent this photograph to the corporate crisis team showing the trailer on the left had tilted. (Source: Arkema Photo Modified by CSB)

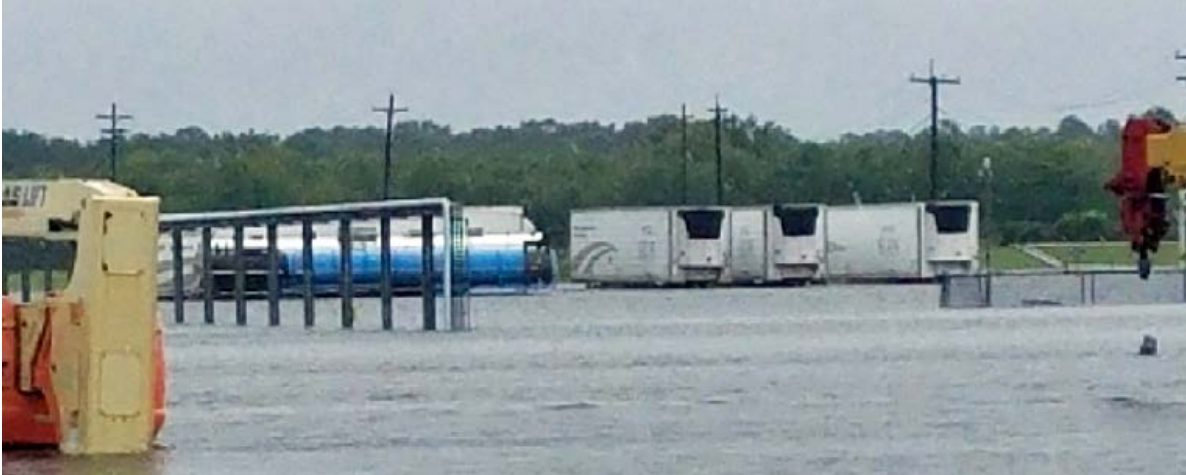
Figure 32. Refrigerated Organic Peroxide Trailers Located on High Ground. The refrigerated trailers containing organic peroxide products and resting on high ground are pictured here, located on the north side of the Arkema Crosby facility during high floodwater conditions on Tuesday August 29, 2017. All six trailers at this location were incinerated during a controlled burn on September 3, 2017. (Source: Arkema Photo)

105. During the morning, the ride-out crew motored around the site by boat one last time to understand the condition of the facility to provide an update to the Arkema corporate crisis team and the emergency responders. Around midday, Harris County emergency responders evacuated the ride-out crew members by boat and transported them to a nearby fire station.
106. Figure 31 shows three of the trailers that the ride-out crew members could not move to the higher ground in the laydown area. The cooling systems of all three refrigerated trailers shown in Figure 31 likely failed due to the high floodwater level. At that time, the six trailers at the laydown area were still operating and cooling their organic peroxide products (Figure 32).

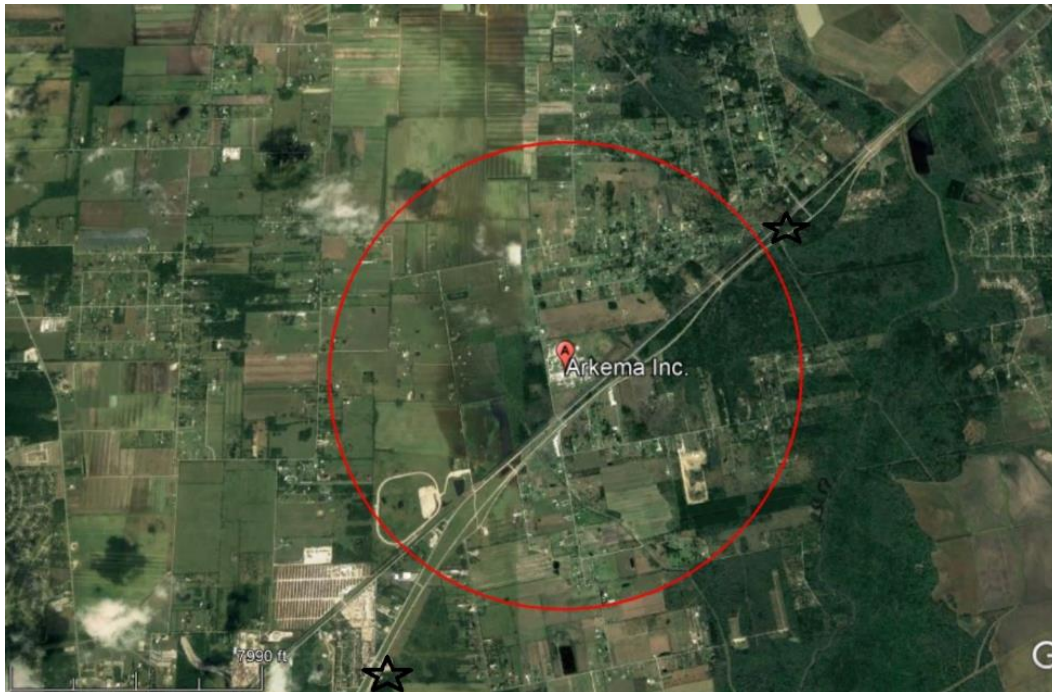
Figure 33. Extended Evacuation Zone. The 1.5-mile extended evacuation area around the Arkema Crosby facility is displayed within the red circle. (Source: Google Earth Image Modified by CSB)

110. Emergency responders handling the Arkema Crosby incident established a 1.5-mile evacuation zone around the Arkema Crosby facility (Figure 33). Emergency response agencies—including FEMA, the Environmental Protection Agency (EPA), and the Harris County Fire Department—performed analysis and modeling that assumed the combustion of the refrigerated trailers. The analysis evaluated a release from the sulfur dioxide storage tank, a release from the isobutylene storage tank, and ash fallout from the burning refrigerated trailers. Based on soot and particulate matter resulting from the refrigerated trailer combustion, a one-mile evacuation zone would be sufficient. To be conservative, provide greater safety for the surrounding residents, and efficiently allocate resources, emergency response officials extended the evacuation zone 1.5 miles. As part of this decision process, the Arkema corporate crisis team was consulted, and the crisis team agreed that 1.5 miles was sufficient given the likely scenario of organic peroxide products combusting. As a result, emergency responders initiated evacuations of residents within the evacuation zone. About 205 residents were evacuated from their homes during this process.

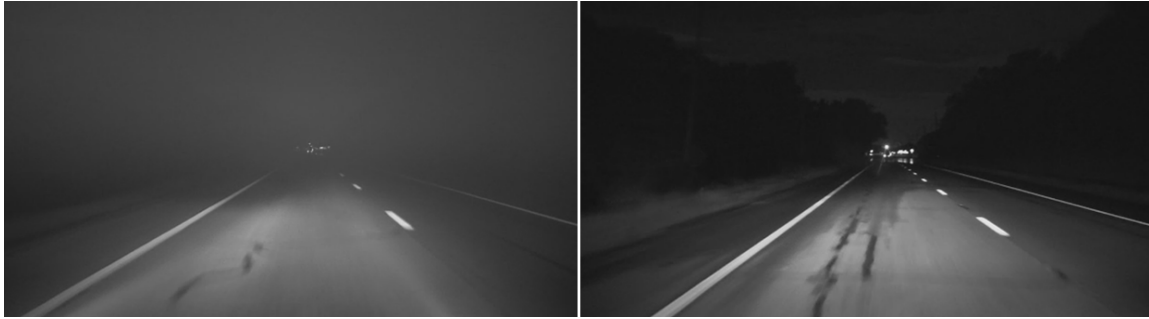
Figure 36. Police Vehicle Dash Cam Image of White Smoke. The left dash cam image shows the view of the white smoke cloud adjacent^a to the Arkema Crosby facility at about 11:52 pm on August 30, 2017. The image on the right provides a baseline of how the scene appeared on the dash cam outside of the white smoke. (Source: Harris County, Texas)

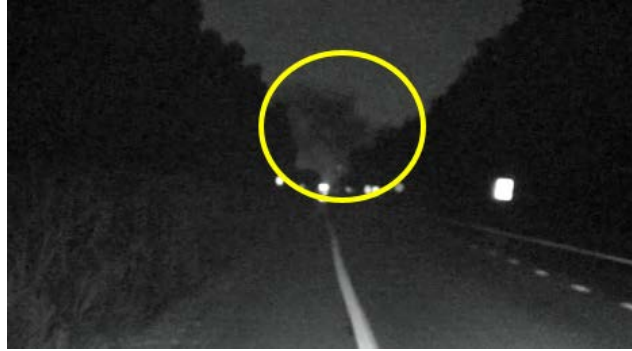
Figure 38. Police Vehicle Dash Cam Image of Black Smoke. The yellow circle shows the black smoke emanating from the Arkema Crosby facility at about 1:30 am on August 31, 2017. When this image was recorded, the police vehicle was parked on Highway 90 near Shady Lane, about 2.5 miles northeast of the Arkema Crosby facility. (Source: Harris County, Texas Modified by CSB)

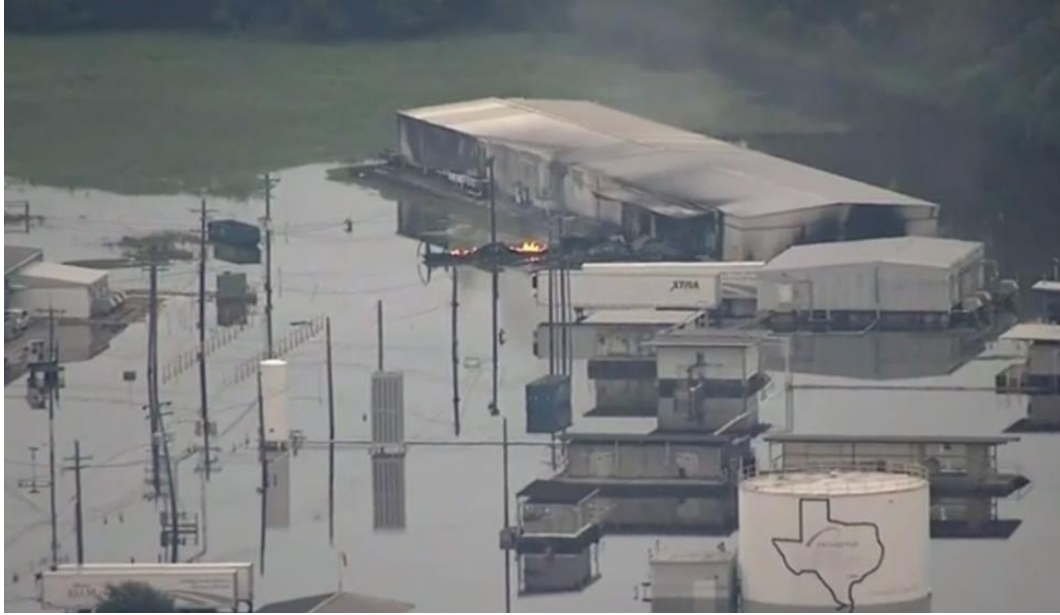
Figure 39. First Refrigerated Trailer to Burn at the Arkema Crosby Facility. The first refrigerated trailer to burn is shown smoldering outside of Building 21 [37].

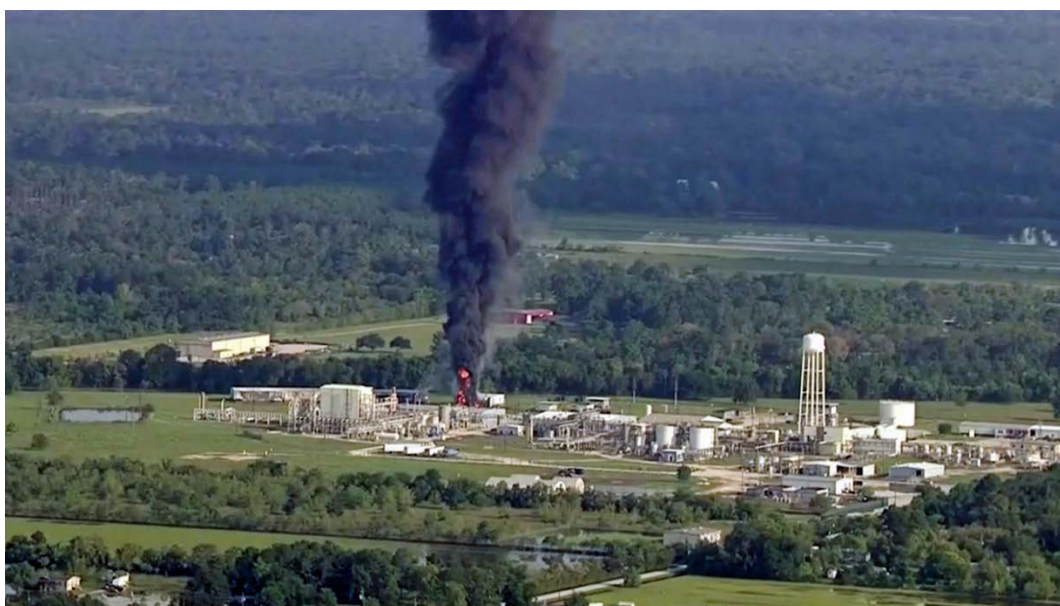
Figure 40. The Second and Third Refrigerated Trailers Burning. Fire and smoke are visible from two refrigerated trailers burning at the Arkema Crosby facility on September 1, 2017 [40].

130. Around 5:00 pm, two more refrigerated trailers ignited and burned. At that point, the three refrigerated trailers that could not be moved to high ground because of the floodwater on Monday had all burned, leaving the six refrigerated trailers with organic peroxide cargo in the laydown area still uncombusted. Figure 40 shows the smoke plume from the two burning trailers and Figure 41 is an image of the remains of the two refrigerated trailers after they combusted.

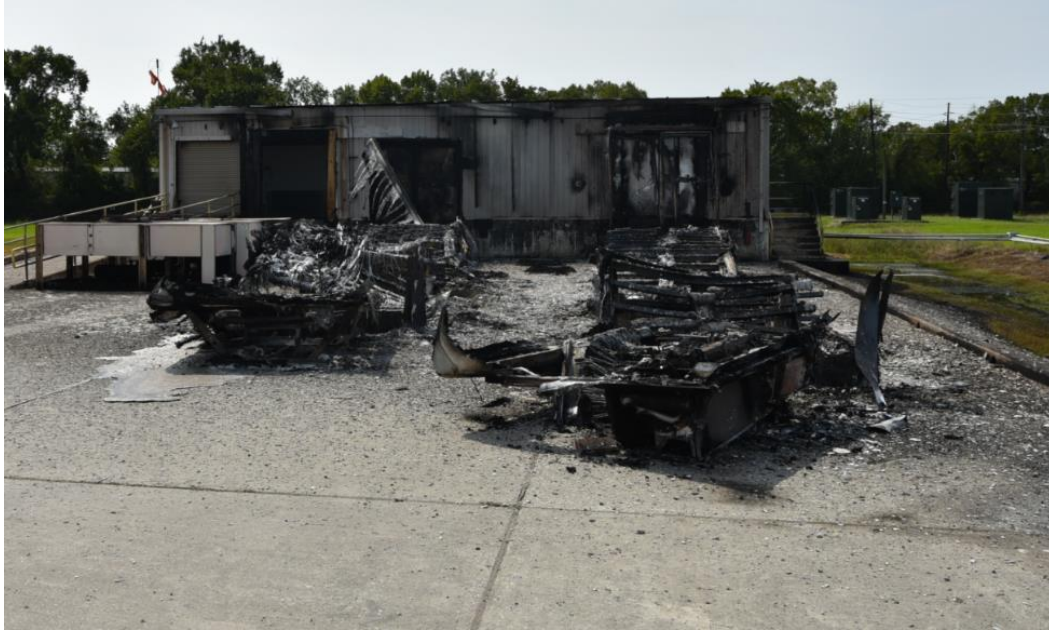
Figure 41. Remains of the Second Fire that Consumed Two Trailers Storing Organic Peroxide Products. The second fire consumed two refrigerated trailers storing organic peroxide products; the remains of those trailers are shown in this image. (Source: CSB Photo)

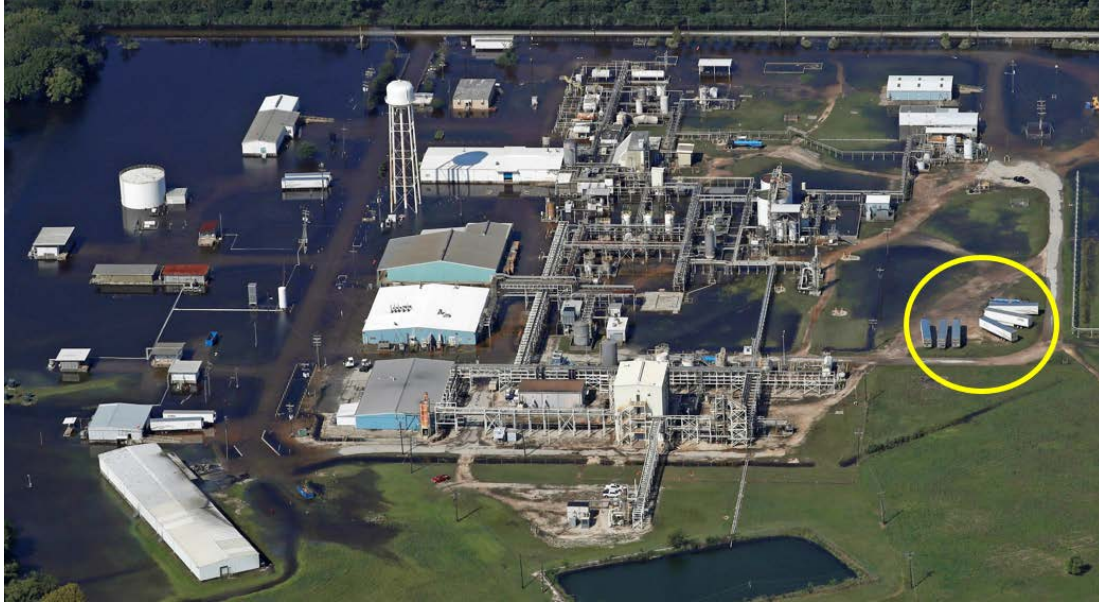
Figure 42. Photo Showing the Location of the Last Six Refrigerated Organic Peroxide Trailers [41].
(Photo Modified by CSB)

131. On Saturday, September 2, 2017, only six refrigerated organic peroxide trailers remained (Figure 42). These six remaining refrigerated trailers were also more likely to have working refrigeration units, so it was uncertain how long they would last until decomposition and combustion occurred.

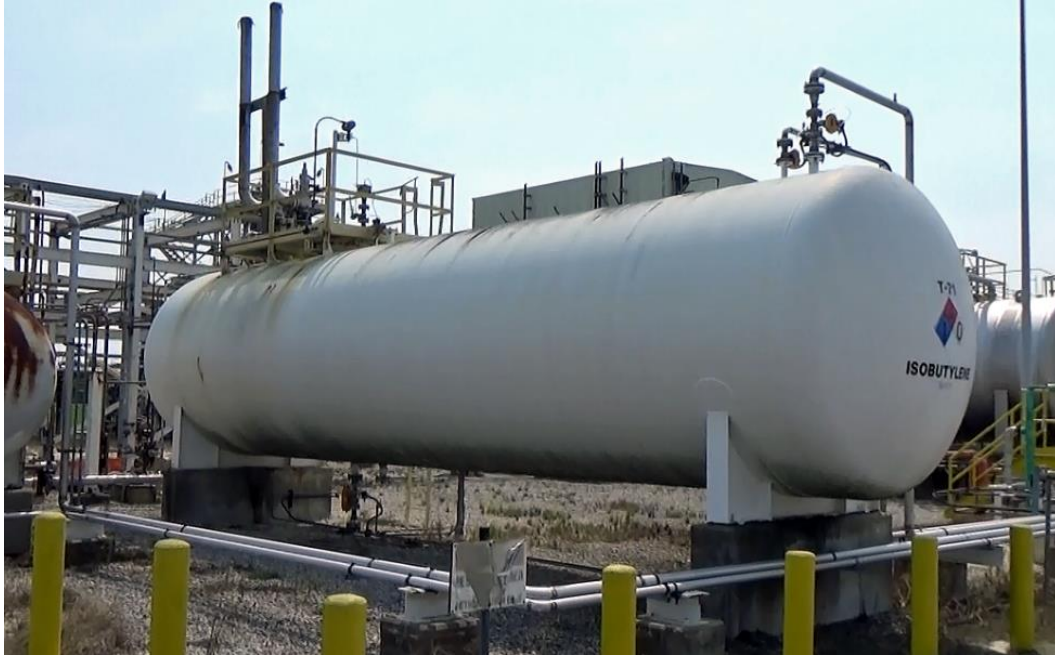
Figure 43. Isobutylene Storage Tank at the Arkema Crosby Facility. The isobutylene tank posed a concern because the controlled burn of the six refrigerated trailers in the laydown area would occur within about 40 yards of this storage tank. (Source: CSB Photo)

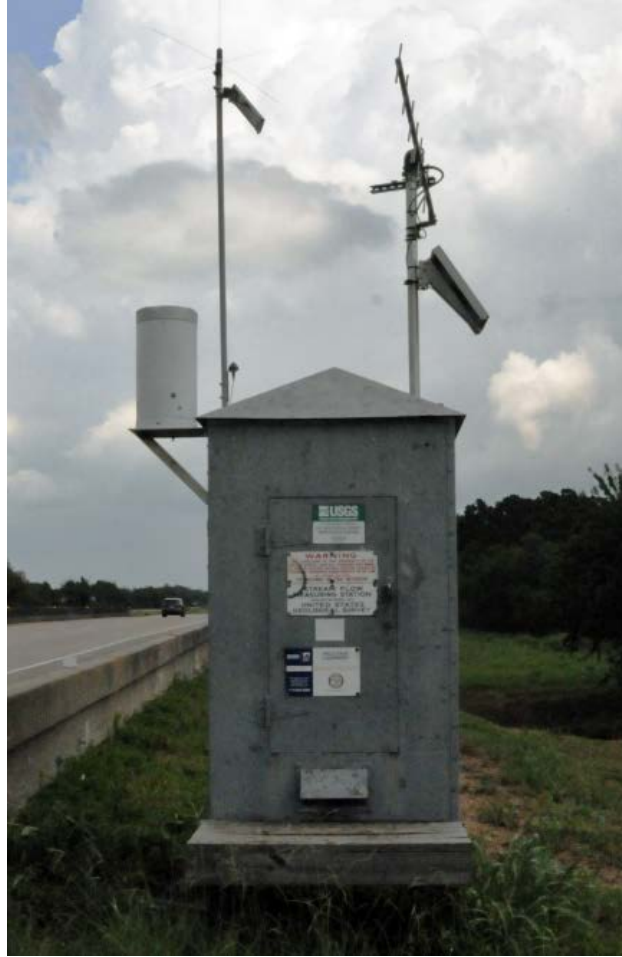
Figure 47. Gauge Station 1740. This gauge station uses a bubbler system to measure the Cedar Bayou water elevation at Highway 90, about three miles northeast of the Arkema Crosby facility.^a (Source: CSB Photo)
