ARKEMA CHEMICAL CROSBY, TX - 2017 ACCIDENT INVESTIGATION

Organic Peroxide Decomposition, Release, and Fire at Arkema Crosby Following Hurricane Harvey Flooding

Crosby, Texas

Exposures to Emergency Responders, Community Evacuation, and Property Damage

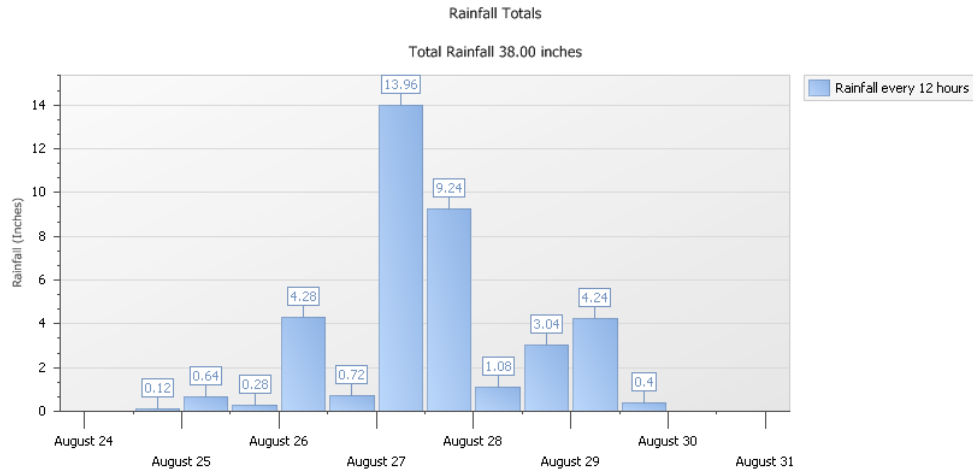
Figure 49. Rainfall Totals During Hurricane Harvey. Cedar Bayou gauge station 1740 measured rainfall totals during Hurricane Harvey [29]. The maximum 12-hour rainfall of nearly 14 inches occurred during the morning of August 27, 2017 [29].

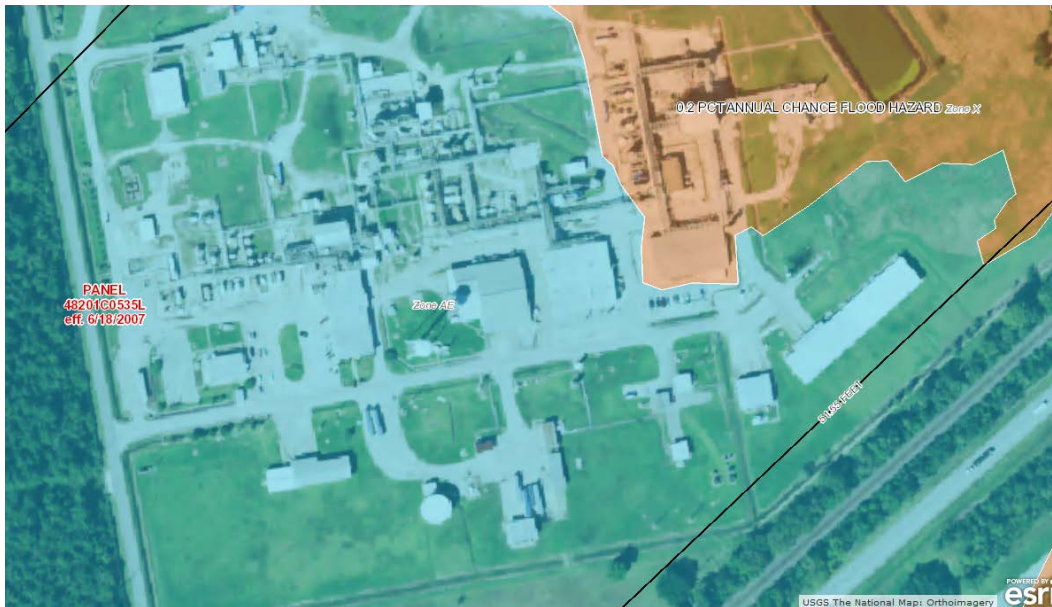
Figure 52. Southern Part of the Arkema Crosby Facility in the 100-Year Floodplain. This digital image shows that the southern part of the facility, where Arkema's electric utility equipment and refrigerated organic peroxide product storage facilities are located, sits in the 100-year floodplain. The blue portion of the map is Zone AE – the 100-year floodplain [58].^a

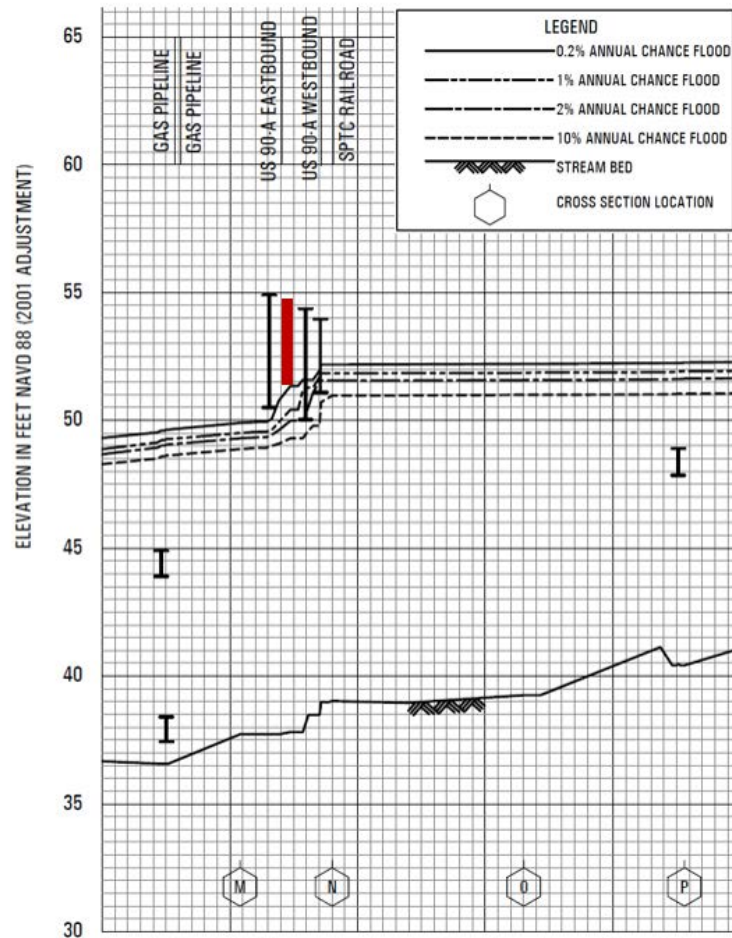
Figure 53. Excerpt from the Adlong Ditch Flood Profile. This excerpt from the Adlong Ditch flood profile shows the estimated water elevation for various flood chance scenarios adjacent to the Arkema Crosby facility [60, p. 35]. The red rectangle was placed by the CSB to show that the approximate floodwater height from Hurricane Harvey was more than two feet above the 500-year flood elevation. Exceeding the 500-year flood elevation by more than two feet is significant because the flood elevation difference between the 100-year and 500-year events is less than one foot. (Graphic Modified by CSB)

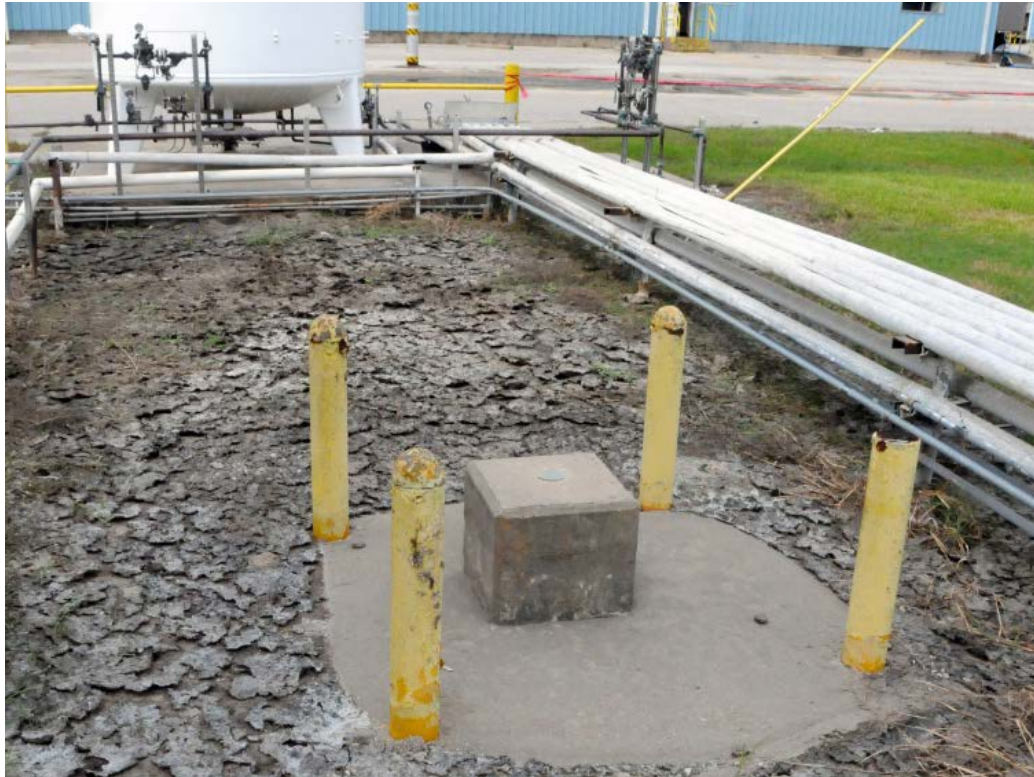
Figure 55. Elevation Survey Marker Near the Liquid Nitrogen Storage Tank. The metal plate on top of the concrete block shows that the elevation is 51.5 feet, about six inches lower than the base flood elevation. During Hurricane Harvey, floodwater exceeded the height of the survey marker by more than three feet. (Source: CSB Photo)

160. Figure 55 shows one of several elevation survey markers at the Arkema Crosby facility. The base flood elevation is six inches above the elevation of this survey marker.

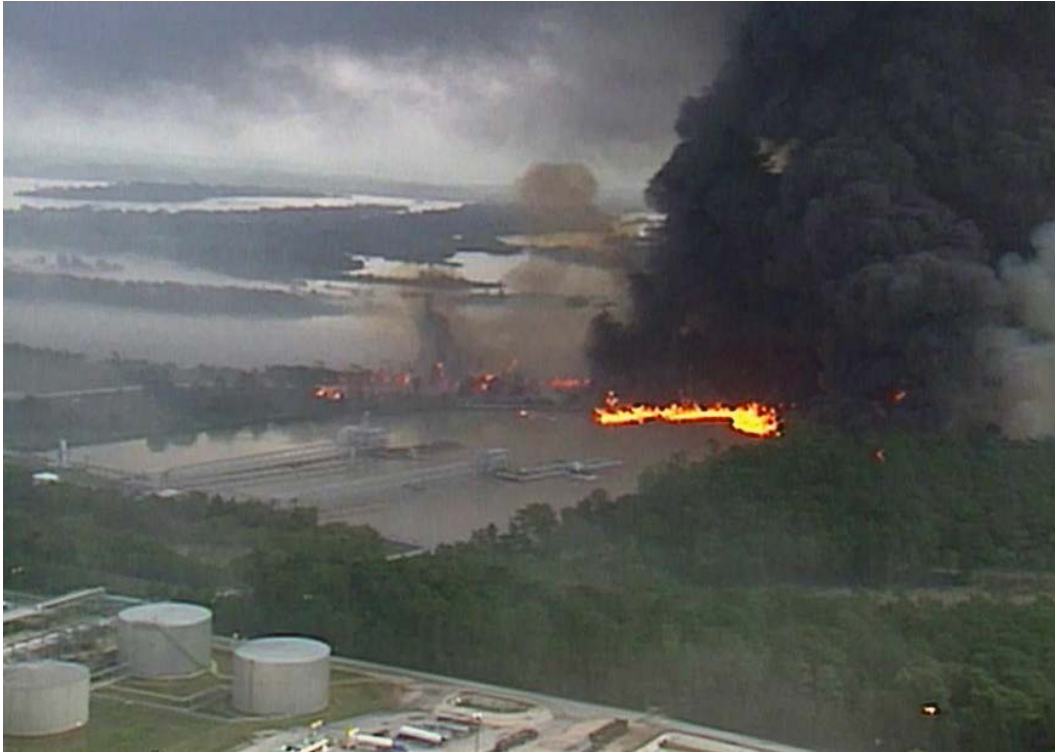
Figure 57. San Jacinto River Fire, 1994. This local news photo shows the San Jacinto River fire in October 1994 after pipeline ruptures resulted in the release of petroleum products [99].

276. In October 1994, atmospheric moisture from Hurricane Rosa contributed to major flooding of the San Jacinto River watershed near Houston, Texas [96] and [97]. The San Jacinto watershed is a few miles to the west of the Arkema Crosby facility and is adjacent to the Cedar Bayou watershed where the Arkema facility sits [97]. The flooding resulted in ruptures in eight pipelines and damage to 29 others [98, p. v]. More than 35,000 barrels of petroleum and petroleum products were released into the river [98, p. v]. The ignition of hydrocarbons released into the river resulted in burn and inhalation injuries for 547 people [98, p. v].^a (Figure 57).

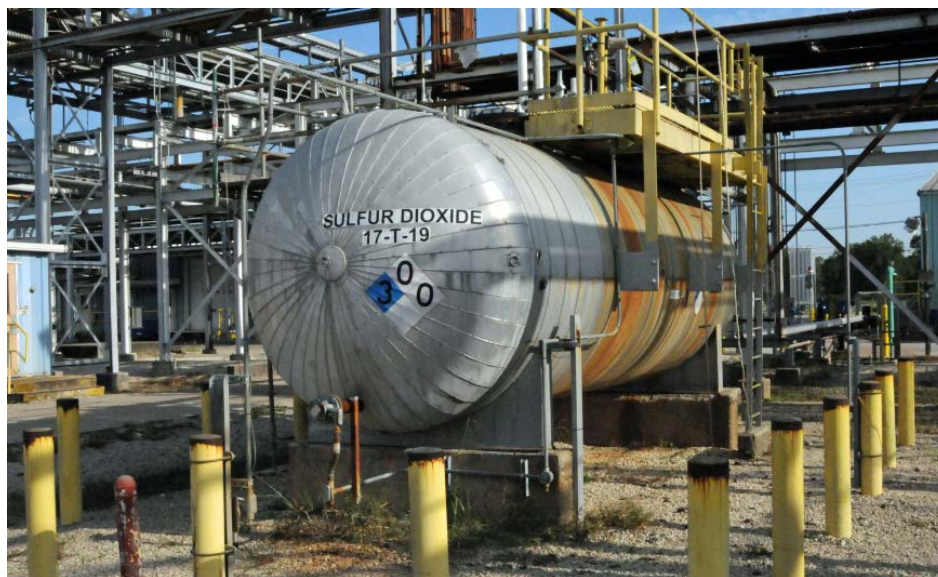
Figure 58. Crosby Sulfur Dioxide Storage Tank. The sulfur dioxide storage tank at the Arkema Crosby facility was roughly 300 feet from the isobutylene tank and 400 feet from the nearest refrigerated trailer storing organic peroxide products during the incident. (Source: CSB Photo)

286. The Arkema Crosby sulfur dioxide storage tank (Figure 58) was located more than 300 feet from the isobutylene storage tank and about 400 feet from the nearest refrigerated trailer storing organic peroxide products. Despite the unlikely nature of a release, emergency response officials modeled a sulfur dioxide release of 16,000 pounds per hour, based on a scenario where a pressure-relief device on the tank opened and remained stuck in the open position. It should be noted that no sulfur dioxide was released during the incident.

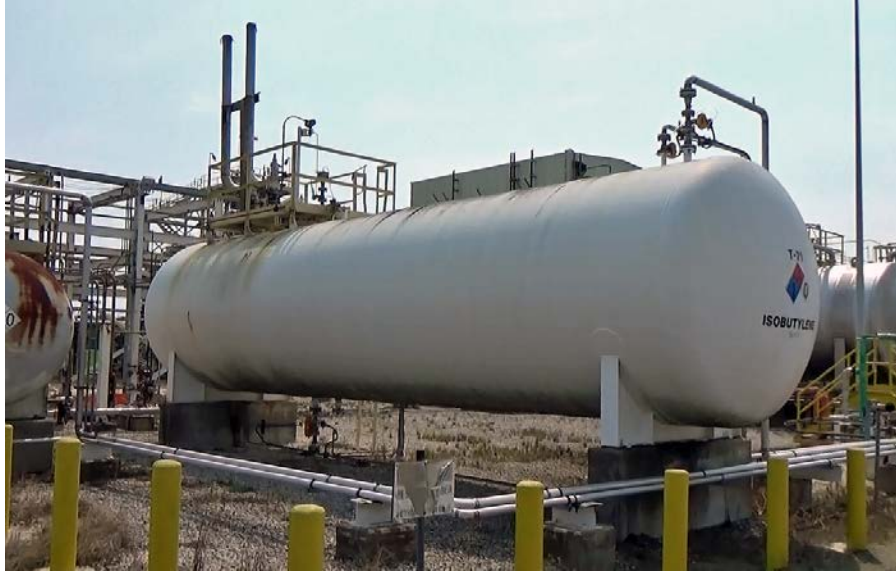
Figure 59. Arkema Crosby Isobutylene Storage Tank. The isobutylene storage tank at the Arkema Crosby facility was located more than 100 feet from the nearest refrigerated trailer containing organic peroxide products. (Source: CSB Photo)

290. The Arkema isobutylene storage tank (Figure 59) was more than 100 feet from the nearest refrigerated trailer of organic peroxide products. To evaluate the potential isobutylene hazard, emergency response officials modeled an explosion of the isobutylene storage tank. The modeling results showed that the predicted blast pressure effects were concentrated within the Arkema Crosby facility.
