# DUPONT CHEMICAL LA PORTE, TX- 2014 ACCIDENT INVESTIGATION

## Investigation Report

Published: June 2019

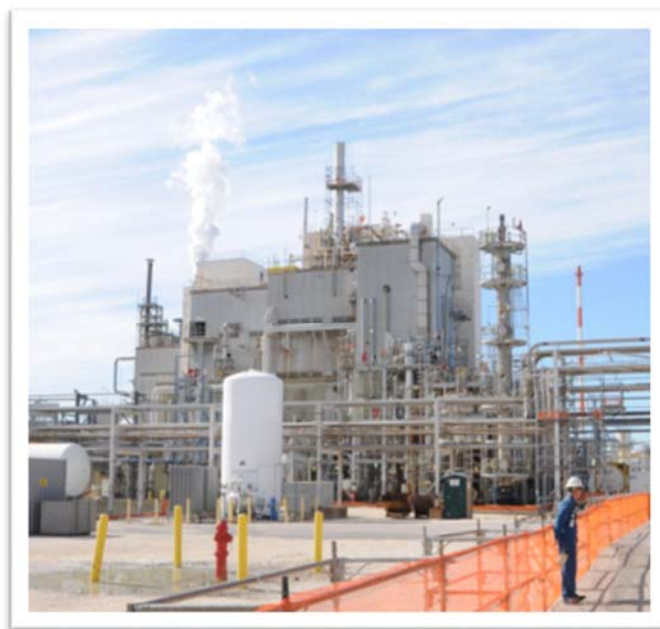
**Figure 1.** The Lannate<sup>®</sup> Manufacturing Building. The methyl mercaptan release occurred in the manufacturing building. Source: CSB.

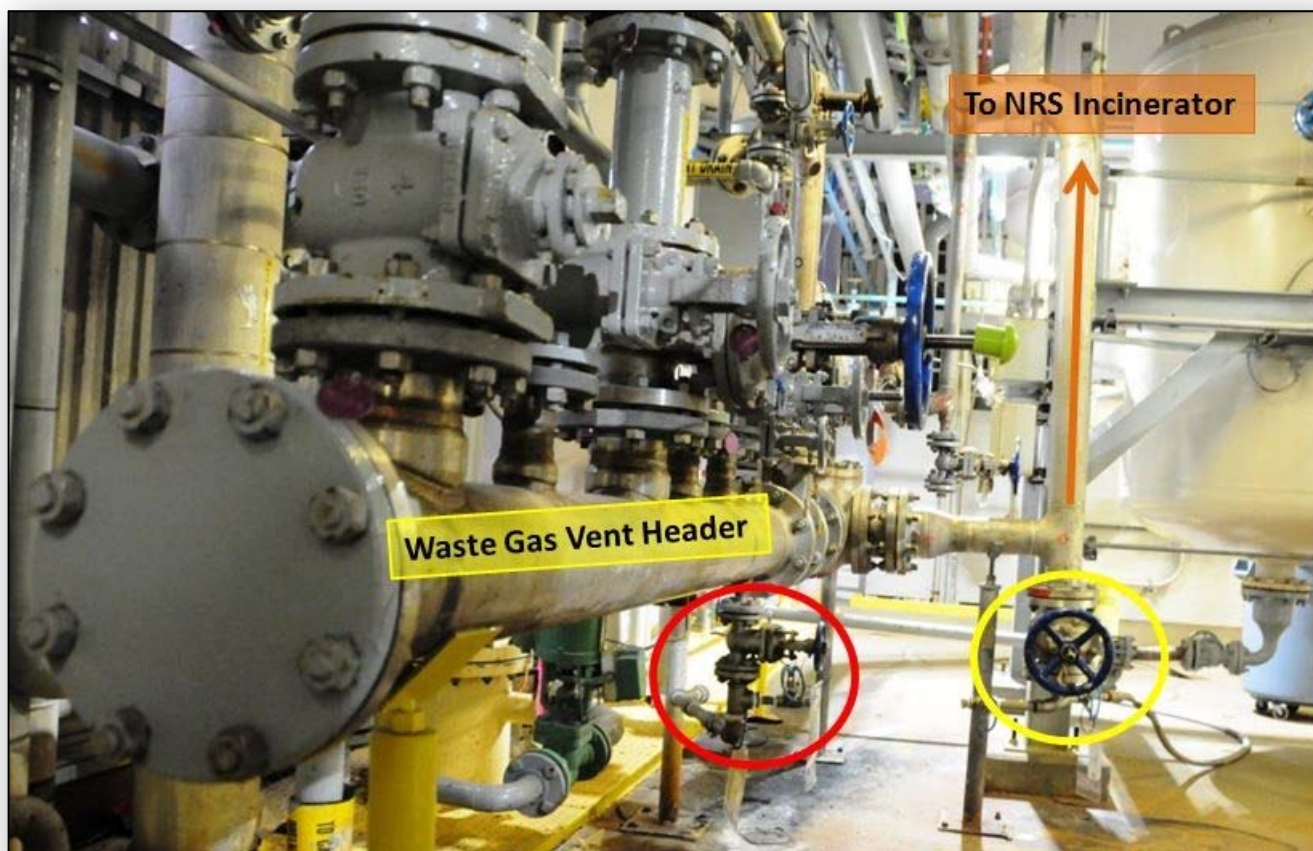
**Figure 2.** Waste Gas Vent Header Piping on the Third Floor of the Manufacturing Building. This portion, where several waste gas sources come together, is referred to as the *waste gas vent header*. Waste gas from this portion of the vent header traveled up to reach the NRS incinerator, a piping configuration that created a low spot where liquid accumulated. To remove the liquid during waste gas vent header piping high-pressure events, operators were instructed to open valves (yellow circle) and drain the system through a hose routed to a floor drain located near a safety shower. The floor drain is connected an open trench-type sump on the first floor. At the time of the incident, a second set of drain valves (red circle) were also opened directly to the floor inside the manufacturing building. Source: CSB.

When the hydrate formed, lacking safeguards to control the potential safety hazards associated with dissociating (breaking up) the hydrate (such as using heat tracing to prevent the hydrate from forming a solid inside the piping or developing a procedure to dissociate the hydrate safely), DuPont workers went into troubleshooting mode (Section 6.3). Ineffective hazard management while troubleshooting the plugged methyl mercaptan feed piping formed yet another link in the chain and allowed liquid methyl mercaptan to flow into the waste gas vent header piping toward the NRS incinerator—a location where it was never intended to go (Section 6.4.1 and [Interim Recommendations](#)) [1, pp. 25-26]. As discussed earlier, DuPont La Porte did not fully resolve liquid accumulation in the waste gas vent header by the NRS incinerator. Consequently, DuPont La Porte workers dealt with the common problem of liquid accumulation in the waste gas vent header on a routine basis by draining the liquid (line breaking) without an engineered solution or without ensuring the use of safety procedures or personal protective equipment (Section 6.4.3 and [Interim Recommendations](#)) [1, pp. 18, 28]. However, when the liquid drain valves were opened on November 15, 2014, flammable and highly toxic methyl mercaptan flowed onto the floor and filled the manufacturing building with toxic vapor.

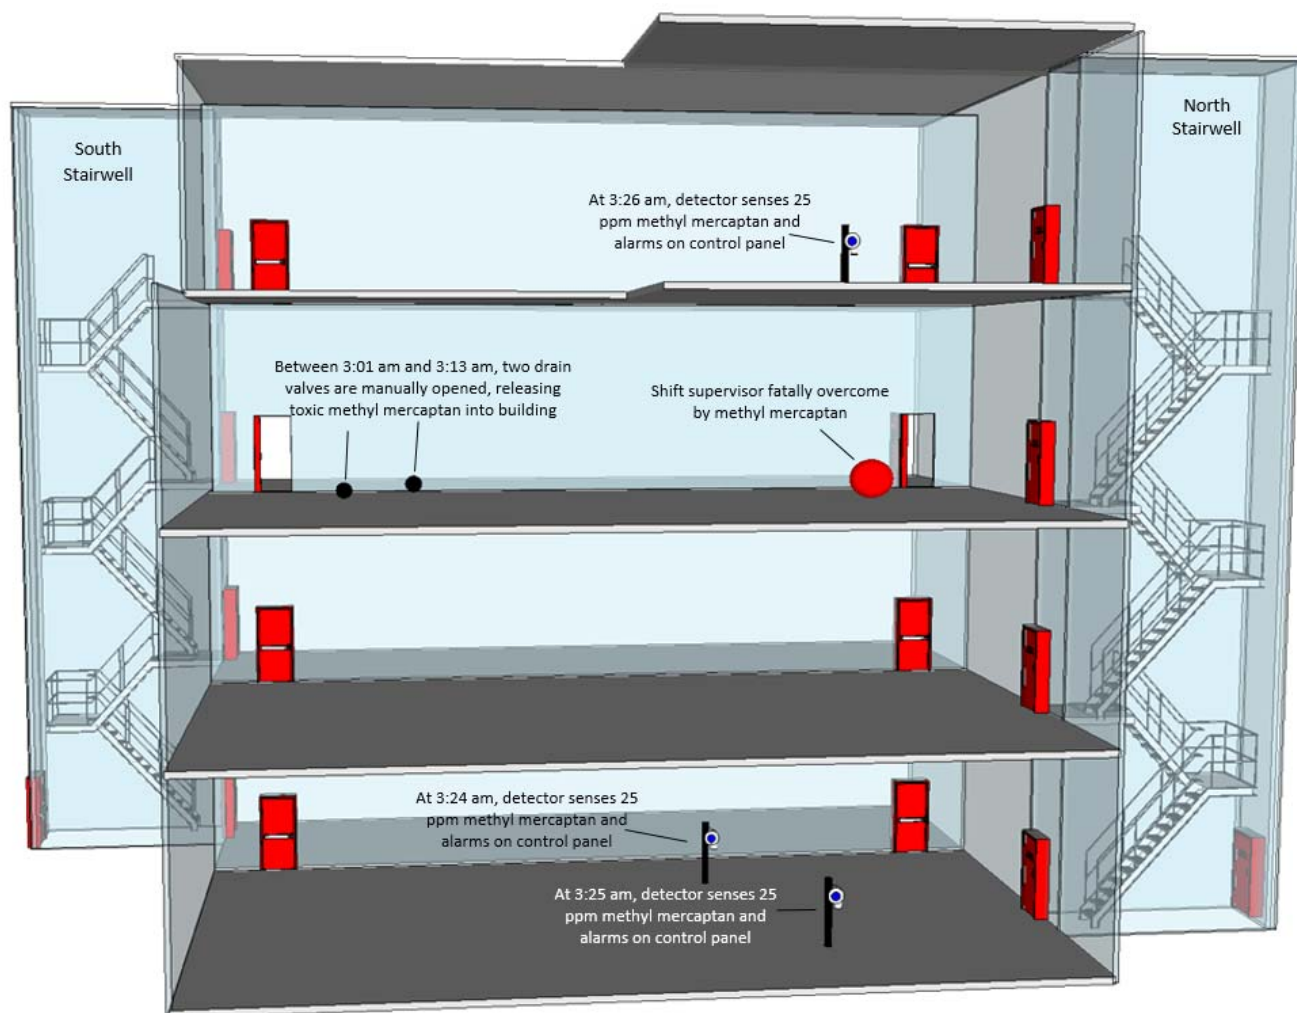
**Figure 3.** Depiction Showing Where Drain Valves Were Opened. These drain valves released toxic methyl mercaptan into the manufacturing building. Methyl mercaptan detectors on the first and fourth floors detected high concentrations of methyl mercaptan shortly after the release began. This depiction is a simplified graphic of the manufacturing building (see Section 4.5) and does not show the location of Operator 1. Source: CSB.

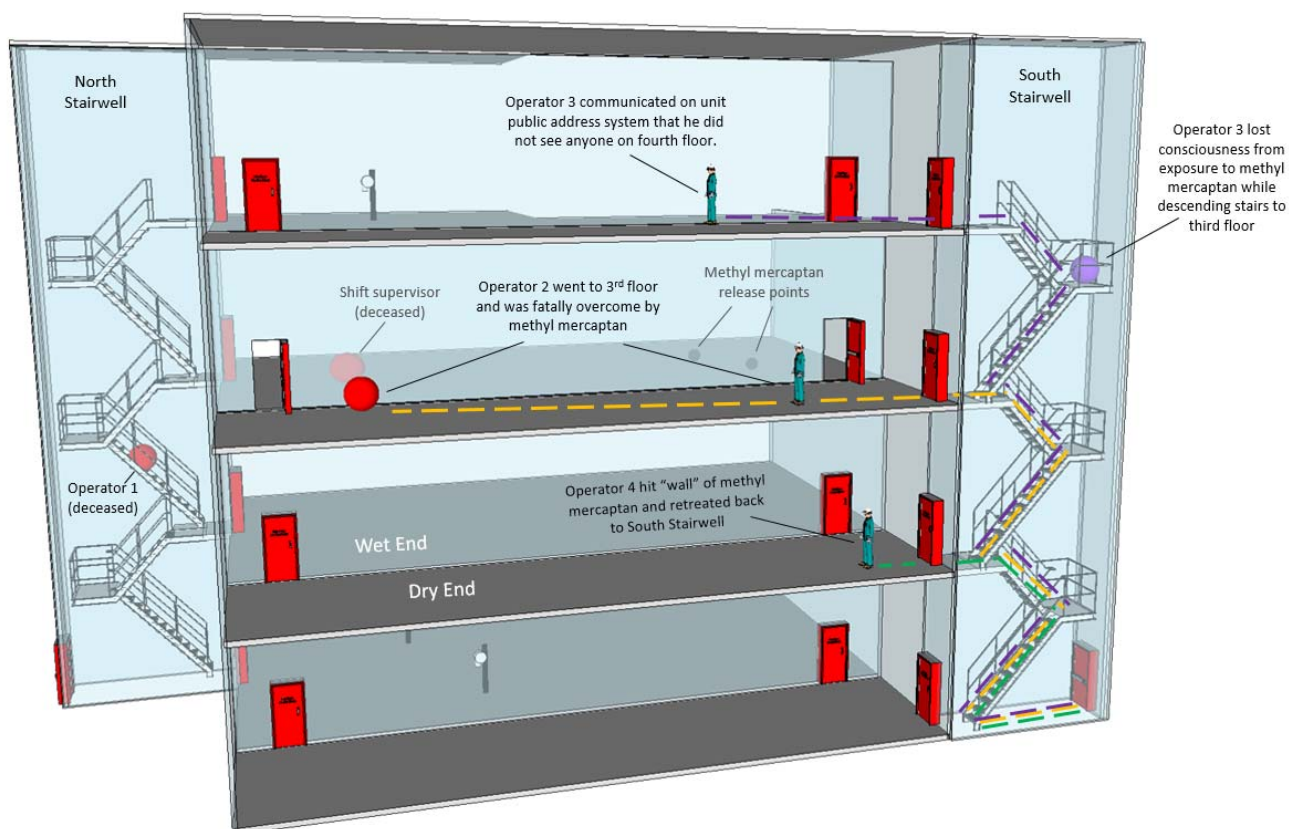
**Figure 4.** Depiction of Paths Taken by Operator 2, Operator 3, and Operator 4 When They Responded to Operator 1's Distress Call. Locations of the deceased Shift Supervisor and Operator 1 are also shown. Operator 2 was killed by methyl mercaptan exposure, and Operator 3 and Operator 4 were exposed to high concentrations of methyl mercaptan. This figure shows the opposite side of the manufacturing building from the view in Figure 3. Source: CSB.

Operator 2, Operator 3, and Operator 4 each entered the south stairway and took different a route inside the manufacturing building to try to find Operator 1 (Figure 4). Operator 2 went to the third floor, where he was fatally overcome by methyl mercaptan [1, p. 29]. Operator 4 went to the second floor. He walked about 10 feet and hit what he later described as a "wall" of methyl mercaptan, but he managed to retreat to the stairwell [1, p. 29]. Operator 3 went to the fourth floor but did not find anyone. He then announced on the Lannate<sup>®</sup> Unit's public-address system that he did not see anyone on the fourth floor. The Board Operator responded that the Shift Supervisor and Operator 1 may be on the third floor [1, p. 29]. Operator 3 then began to feel light-headed. He made his way to the stairwell and lost consciousness while descending from the fourth floor [1, p. 29].

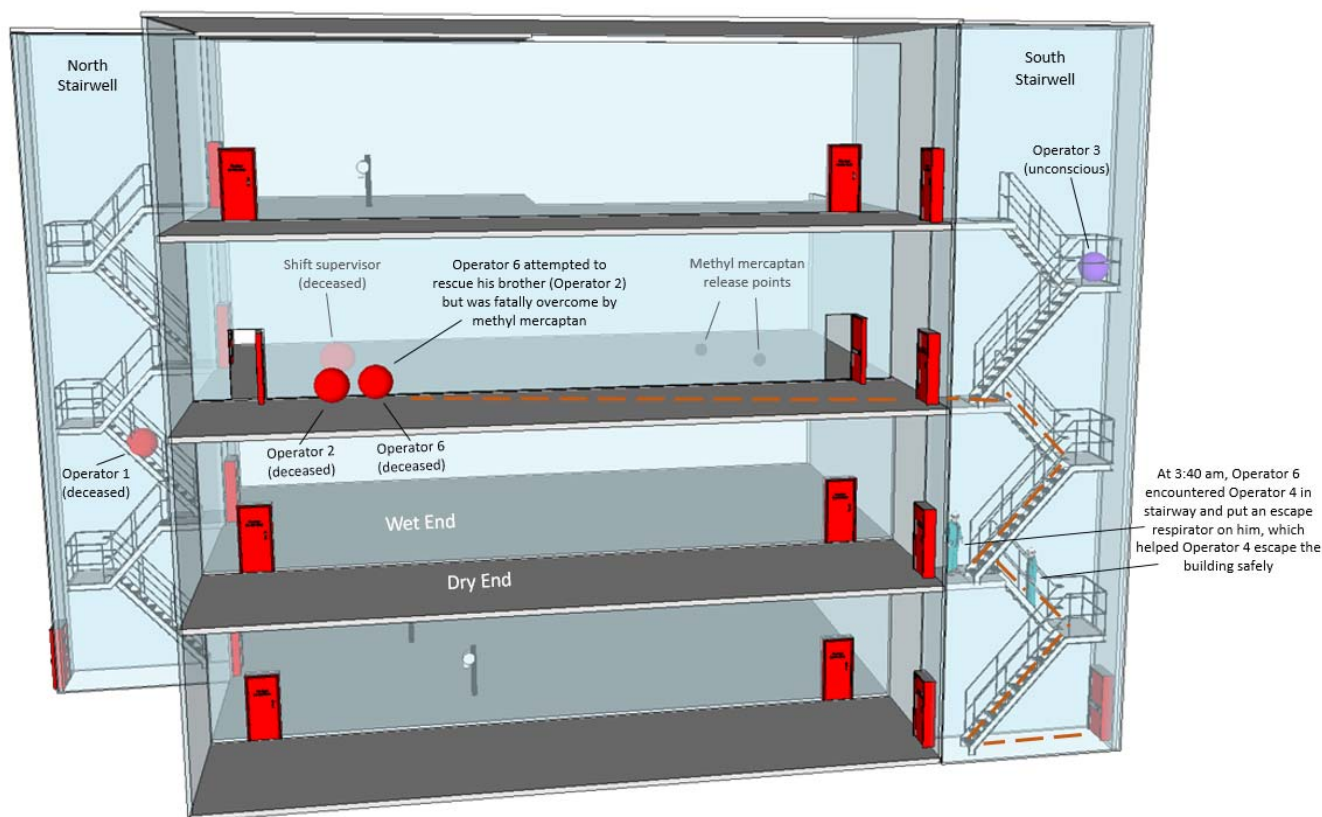
**Figure 5.** Depiction of the Path Taken by Operator 6 Inside the Manufacturing Building. Operator 6 helped Operator 4 escape by providing him with a respirator. Operator 6 was fatally overcome by methyl mercaptan when trying to rescue his brother, Operator 2, on the third floor. Source: CSB.

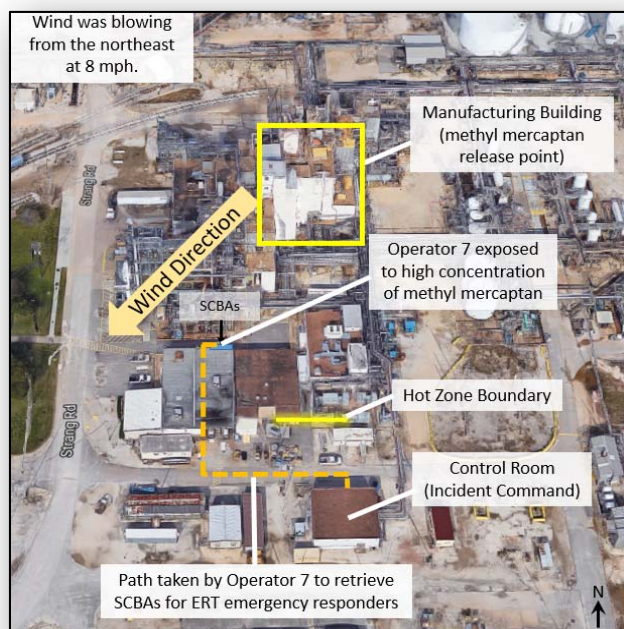
**Figure 6.** Depiction of Path Taken by Operator 7 to Retrieve SCBAs for ERT When the Mini Pumper Truck Would Not Start. The hot zone was not controlled adequately to ensure that personnel did not enter a hazardous area. Source: Google Earth, with annotations by CSB.

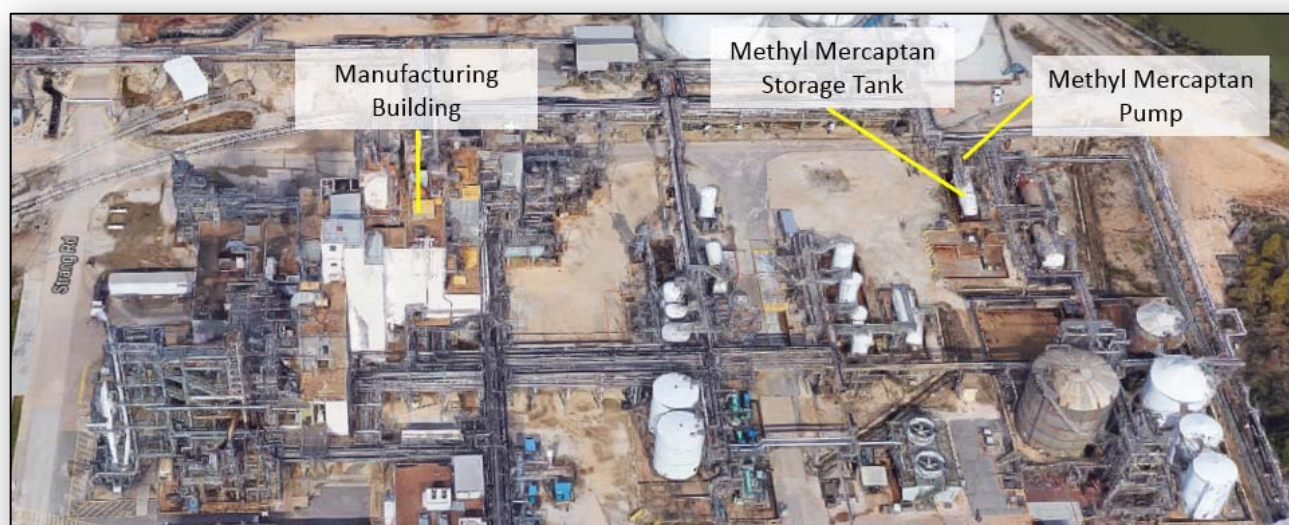
**Figure 7.** Location of Methyl Mercaptan Pump. The pump was turned off nearly three hours after the release began. Source: Google Earth, with annotations by CSB.

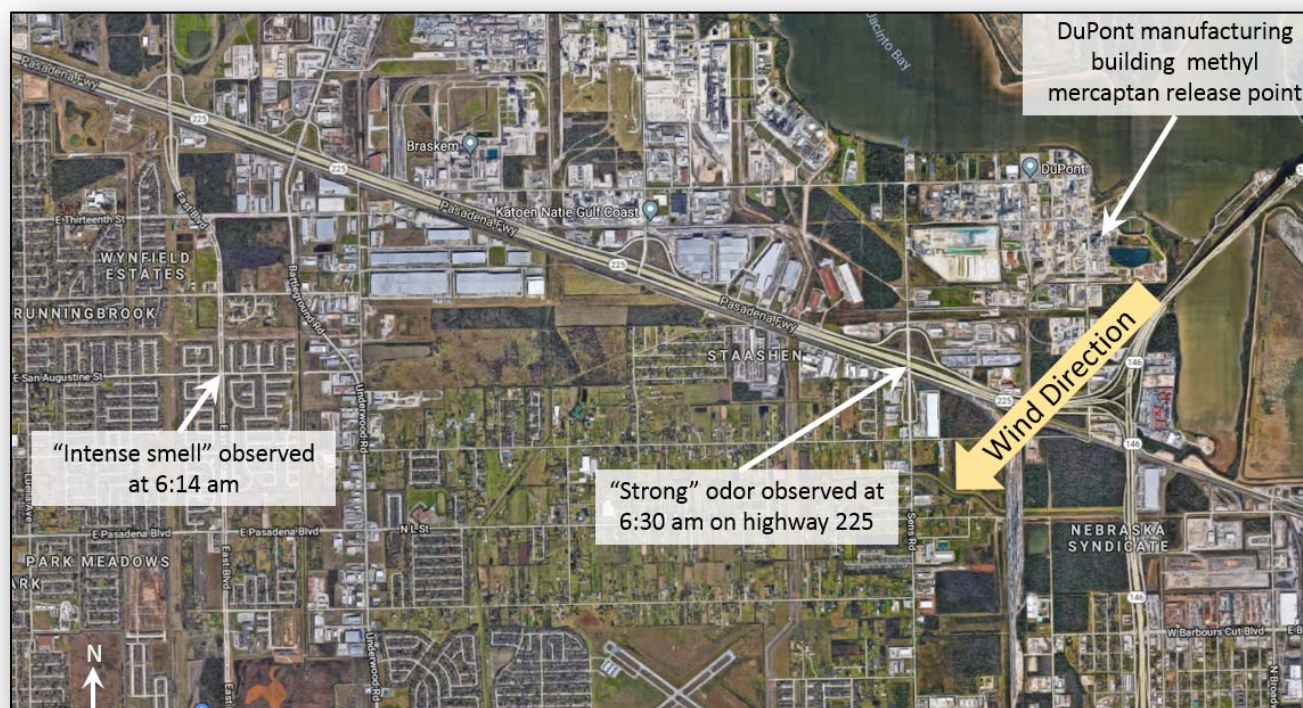
**Figure 8.** Locations Where a Sheriff's Sergeant Reported Strong Methyl Mercaptan Odor During the Incident. Source: Google Earth, with annotations by CSB.

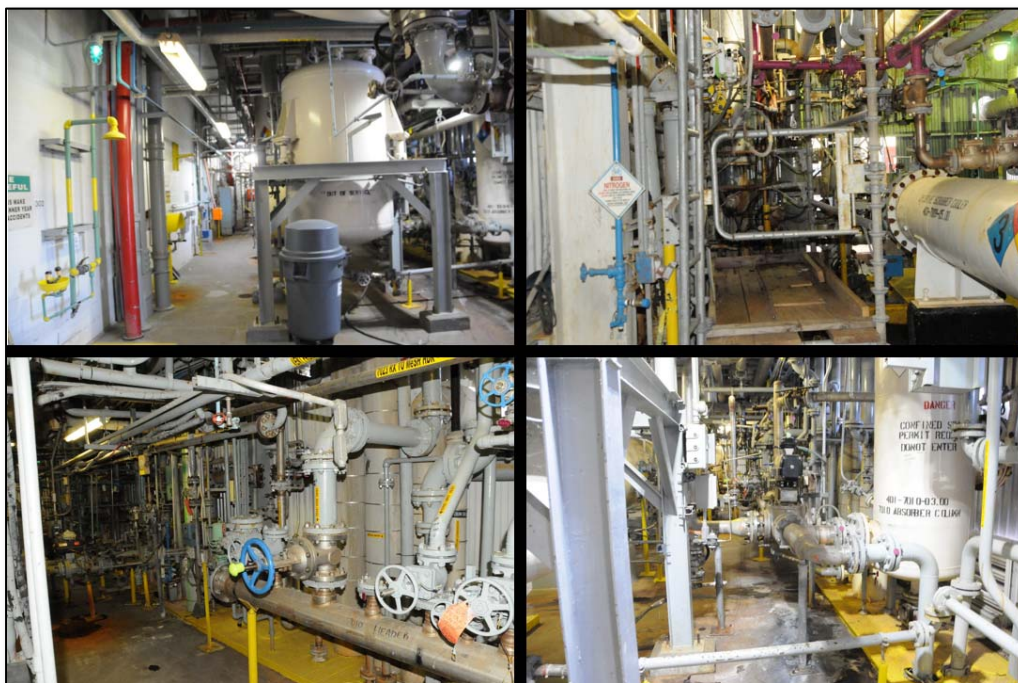
**Figure 11.** Photos of the Interior of the Lannate® Manufacturing Building. Source: CSB.

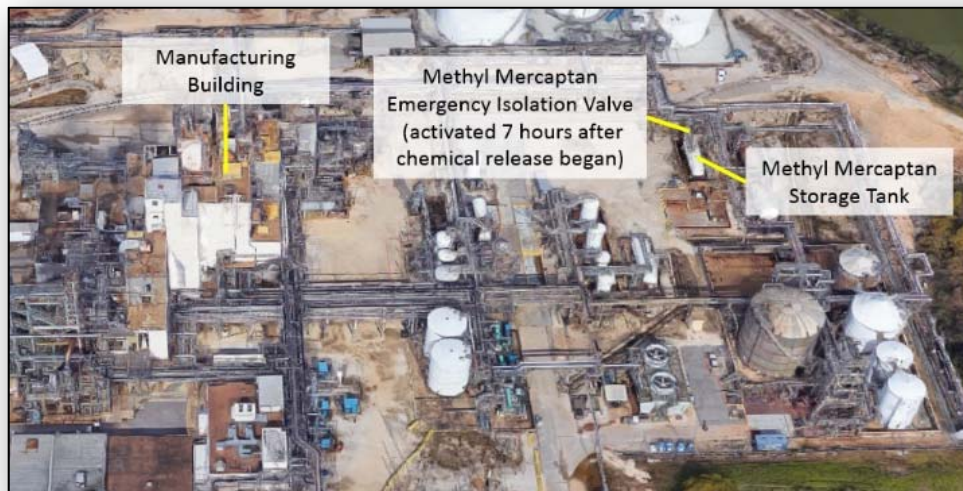
**Figure 13.** Location of Methyl Mercaptan Emergency Isolation Valve Relative to Manufacturing Building Where Leak Occurred. The emergency isolation valve was not activated until seven hours after the release began. Source: Google Earth, with annotations by CSB.

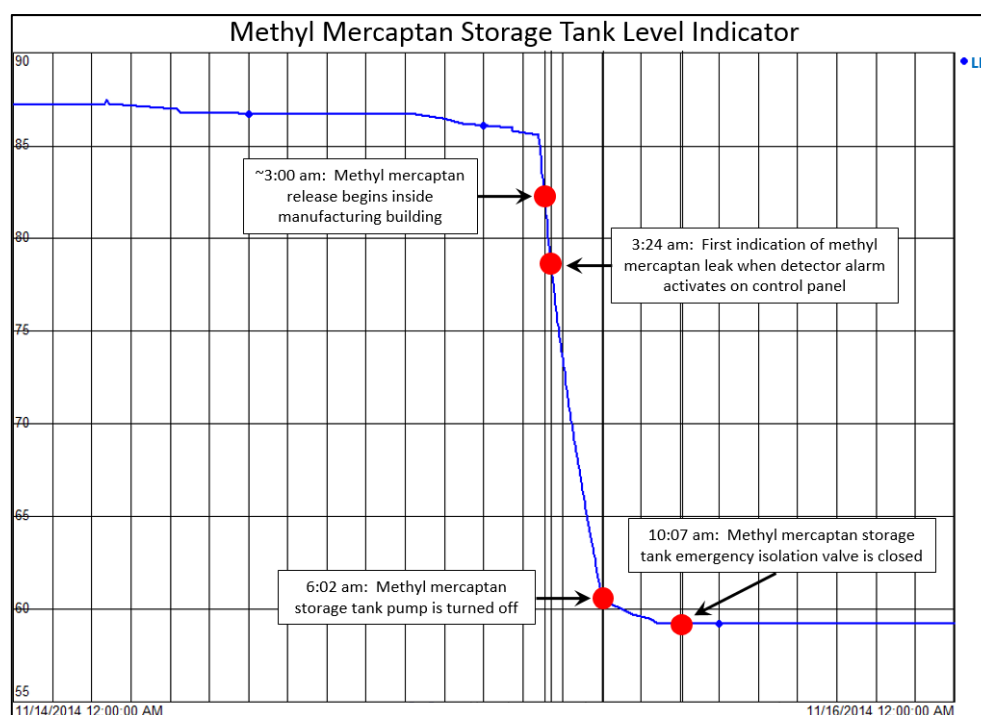
**Figure 14.** Process Data from November 15, 2014. Data shows that methyl mercaptan was abnormally flowing from the methyl mercaptan storage tank. No one analyzed these data during the first hours of the incident. Source: CSB graph based on DuPont data.

1. Personnel did not recognize the need to close the methyl mercaptan storage tank isolation valve when they determined that methyl mercaptan was the chemical being released inside the manufacturing building.
2. No one evaluated process data to determine what was causing the release until hours into the response efforts. Had personnel looked at the process data earlier during the release, it should have been clear that methyl mercaptan was flowing from the methyl mercaptan storage tank, requiring closure of the emergency isolation valve (Figure 14).

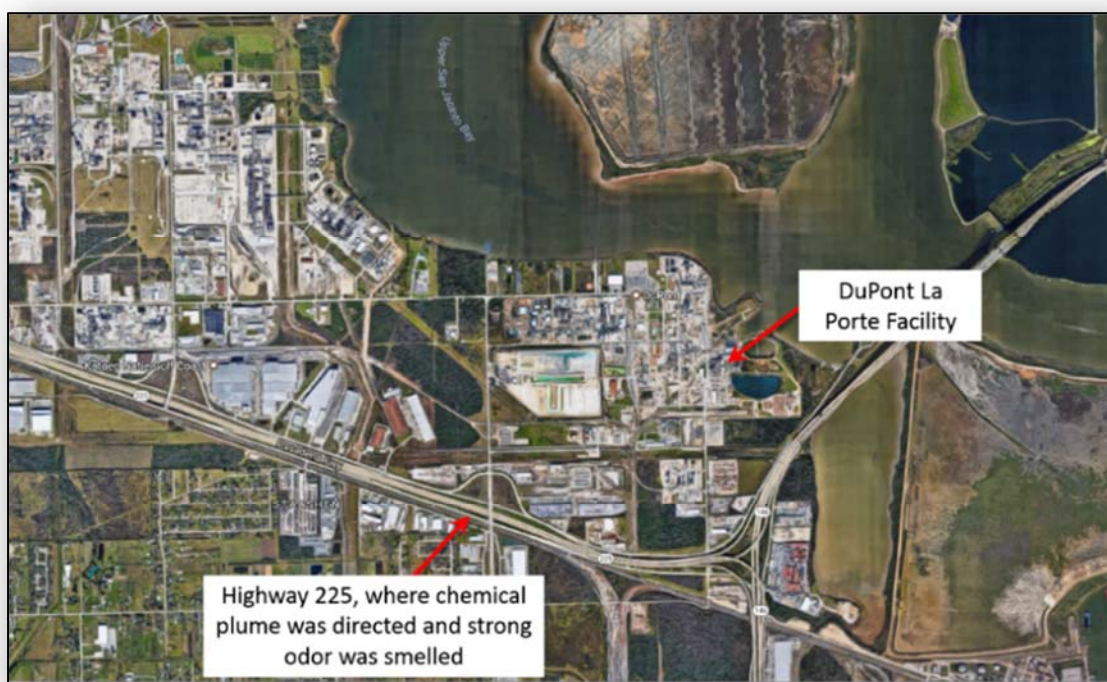
**Figure 16.** Overhead Image of DuPont La Porte Facility. A plume of methyl mercaptan left the DuPont property in a southeasterly direction toward a major highway and residential area. Source: Google Earth, with annotations by CSB.

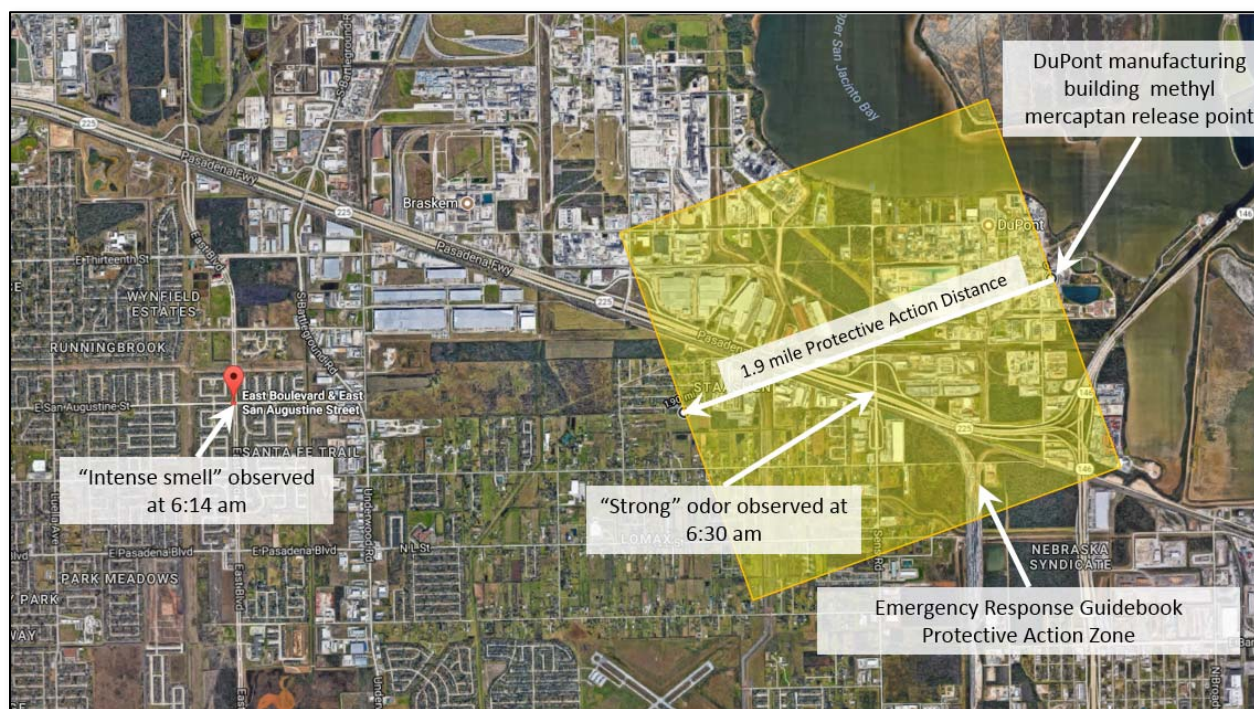
**Figure 17.** Overhead Image of DuPont La Porte Facility with Recommended Downwind Protection Zone (Shown in Yellow) Based on the 2016 *Emergency Response Guidebook* [12, p. 297]. Downwind sections of Highway 225 and residential areas were within the area recommended for public protection from a methyl mercaptan chemical leak. Source: Google Earth, with annotations by CSB.

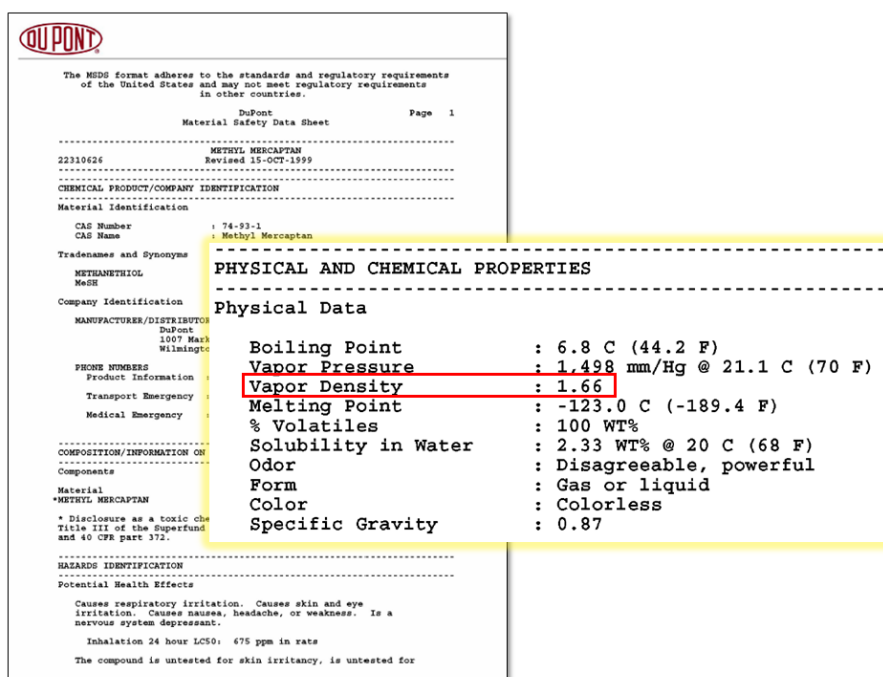
DuPont  
Material Safety Data Sheet Page 1

Methyl mercaptan, however, is heavier than air<sup>a</sup> and will tend to stay near ground level. DuPont's technical standard for methyl mercaptan states that methyl mercaptan "gas is colorless and heavier than air, so that it can spread at ground level." Also, DuPont's safety data sheet (SDS)<sup>b</sup> for methyl mercaptan specifies its vapor density, showing that methyl mercaptan is heavier than air (Figure 18). The CSB could not determine why the emergency response representative communicating this information believed that methyl mercaptan was lighter than air.

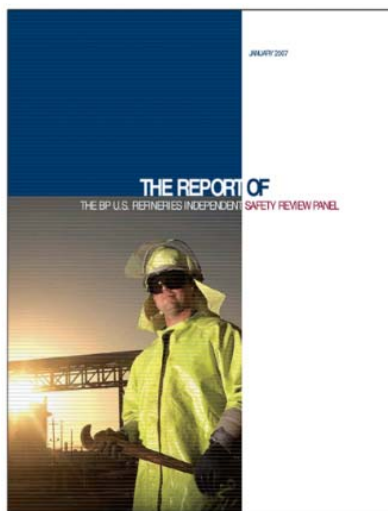
**Figure 20.** Excerpt from the Baker Panel Report. The Baker Panel found that BP emphasized personal (worker) safety performance and did not adequately focus on process safety. Similarly, 12 years after this accident, DuPont La Porte's safety culture assessments at its site focused solely on personal safety performance. Source: Baker Panel Report [58].

The Baker Panel concluded that BP "mistakenly interpreted improving personal [worker] injury rates as an indication of acceptable process safety performance" (Figure 20) [58, p. xii]. The panel also noted, "the presence of an effective personal safety management system does not ensure the presence of an effective process safety management system ... [and] BP's [worker] injury rates were not predictive of process safety performance at BP's five U.S. refineries" [58, p. 21].

<sup>b</sup> The Baker Panel found that BP “mistakenly interpreted improving personal injury rates as an indication of acceptable process safety performance” (see Figure 20).

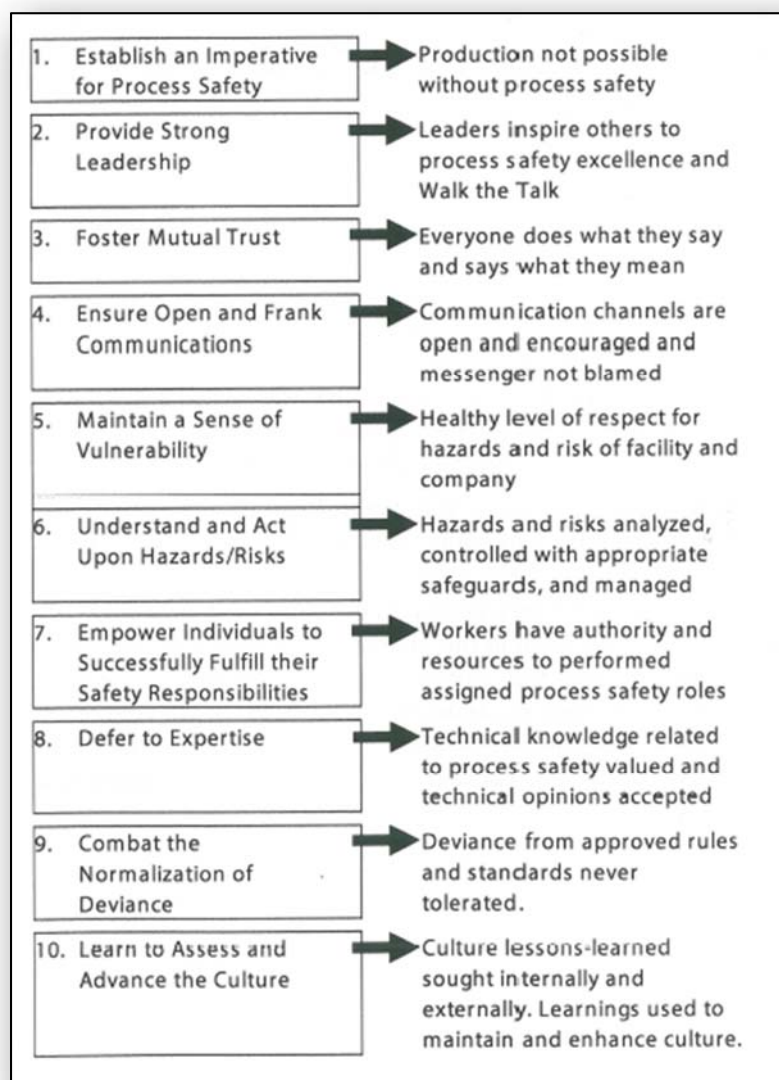
**Figure 21.** Excerpt from “Overview of Core Principles of Process Safety Culture,” in CCPS, *Essential Practices for Creating, Strengthening, and Sustaining Process Safety Culture* [56, p. 24]. Source: CCPS.

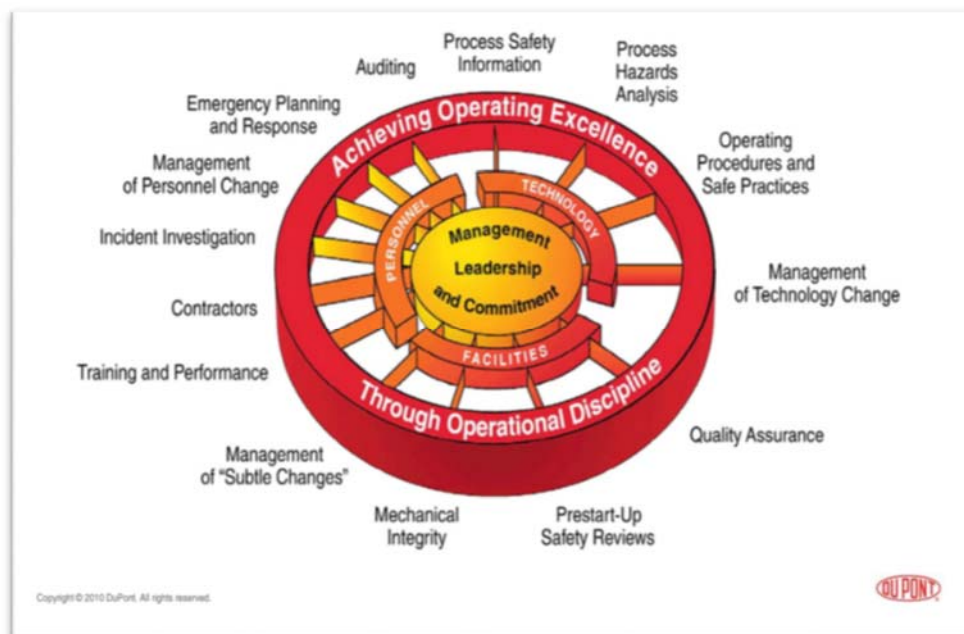
**Figure 22.** DuPont's Process Safety Management and Risk Model [54, p. 2]. Source: DuPont Sustainable Solutions.

DuPont created the Process Safety Management and Risk Model (also called the PSM Wheel) to represent visually how the last three steps (management leadership and commitment, implementing a comprehensive process safety management program, and operational discipline) should interact with each other, using a wheel to show that DuPont's process safety management system integrates management leadership and commitment with operational discipline (Figure 22) [54, p. 2].

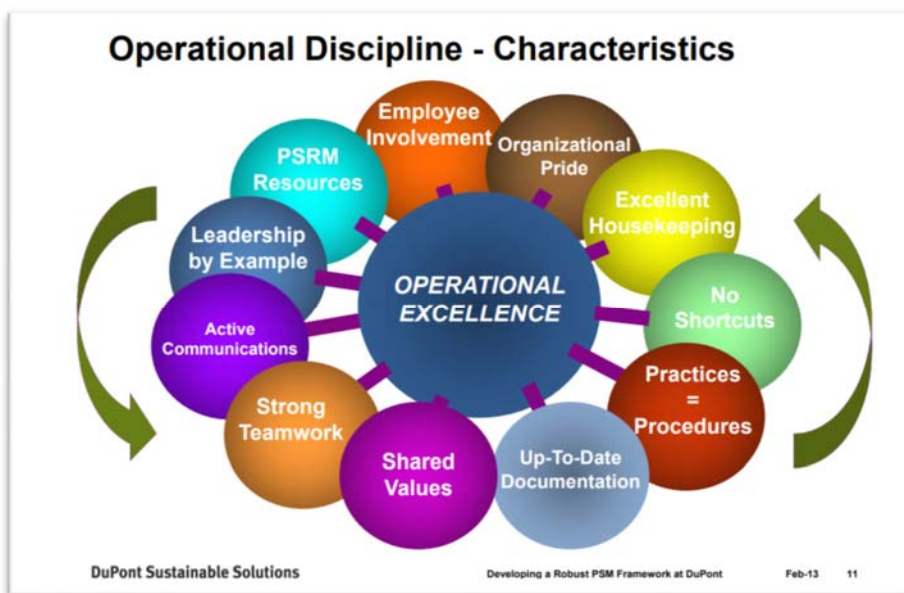
**Figure 23.** Excerpt from DuPont Presentation Titled “Developing a Robust PSM Framework at DuPont.” This slide illustrates DuPont’s perception of the characteristics of an effective operational discipline program that translates to operational excellence [118, p. 11]. Source: DuPont Sustainable Solutions.

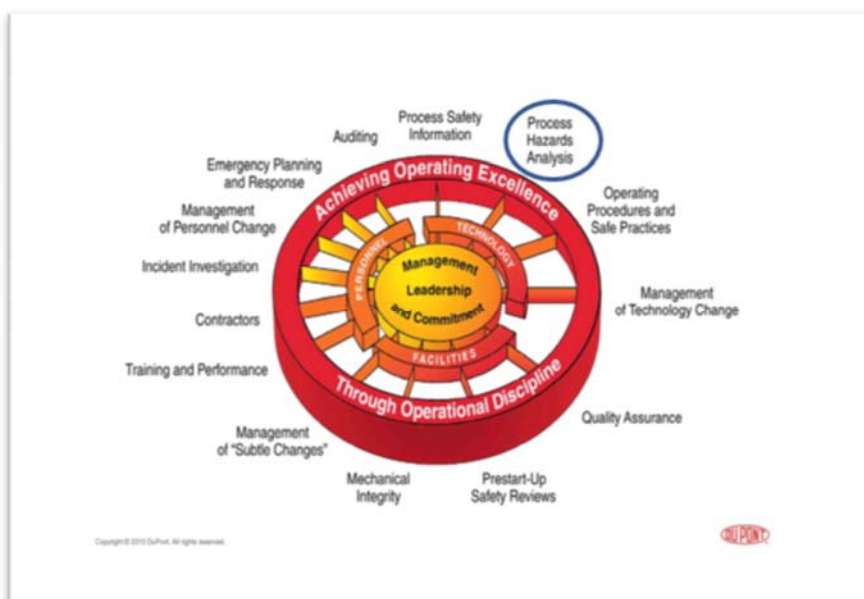
**Figure 24.** Where PHA is Located on DuPont's Process Safety Management and Risk Model (PSM Wheel) [54, p. 2]. Source: DuPont, with annotations by CSB.

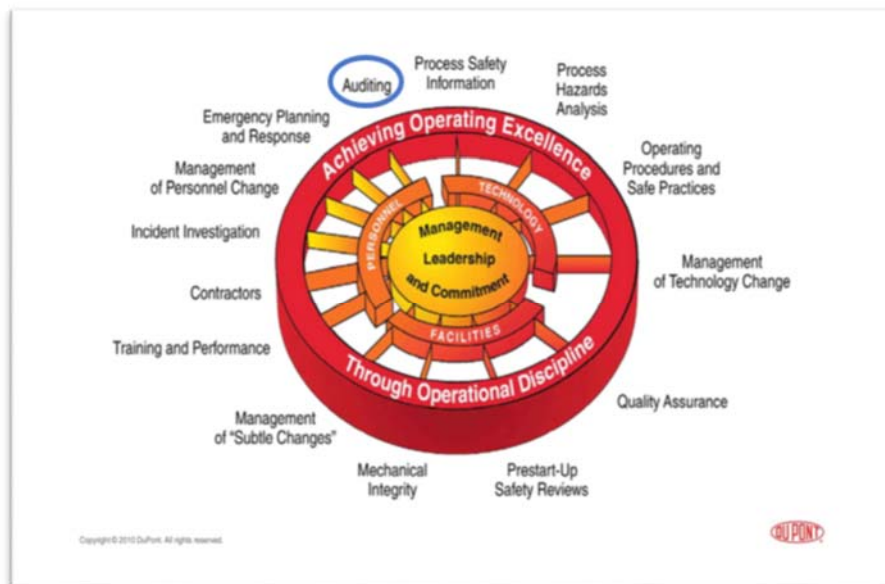
**Figure 26.** Where Auditing is Located on DuPont's PSM Wheel [54, p. 2]. Source: DuPont, with annotations by CSB.

According to OSHA's *Process Safety Management Guidelines for Compliance*, taking corrective actions is one of the most important parts of an audit and includes identifying deficiencies, planning, following up, and documenting needed corrections [19]. Audits, PHAs, incident investigations, and emergency response drills are among the various PSM program elements that can generate corrective action items. At times, the corrective action program at DuPont La Porte did not appropriately correct gaps identified by site PSM audits (Figure 26).

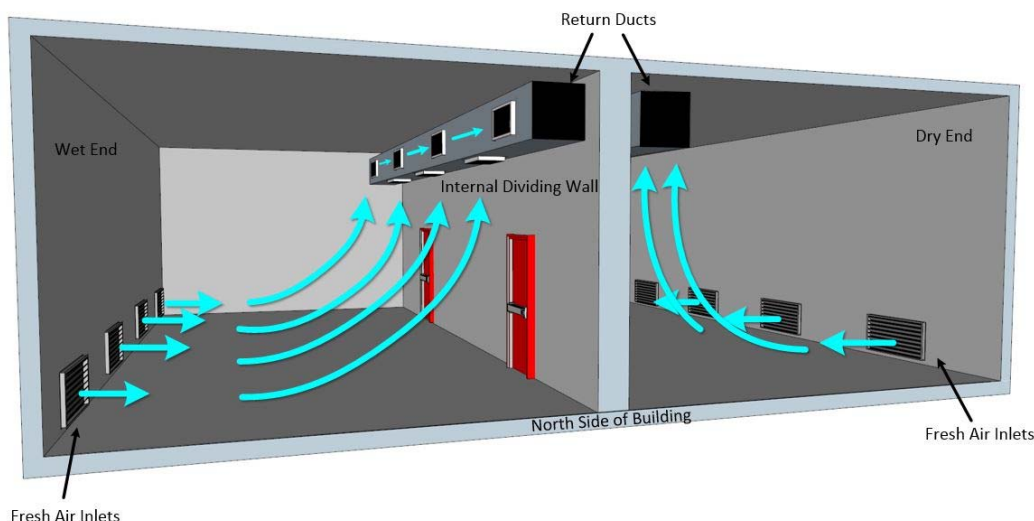
**Figure 27.** Simplified Graphical Representation of a Typical Floor of the Manufacturing Building. It shows how fresh air was pulled in from the outside walls, swept across the floor, and entered the exhaust return air ducts on each side. Source: CSB.

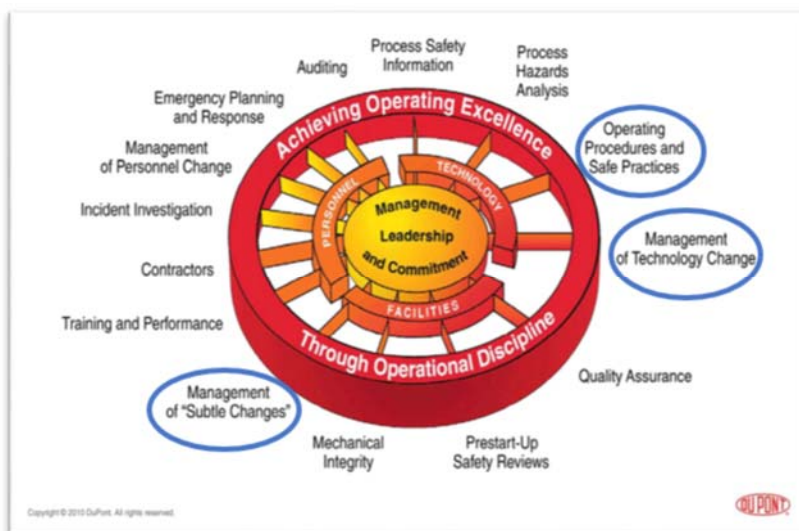
**Figure 28.** Where troubleshooting Could Fall on DuPont's PSM Wheel [54, p. 2]. Source: DuPont, with annotations by CSB.

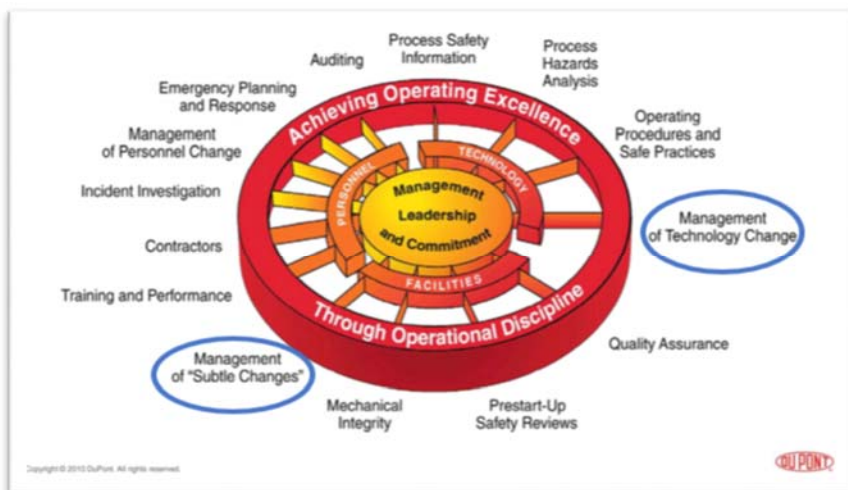
**Figure 29.** Where MOC is Located on DuPont’s PSM Wheel [54, p. 2]. Source: DuPont, with annotations by CSB.

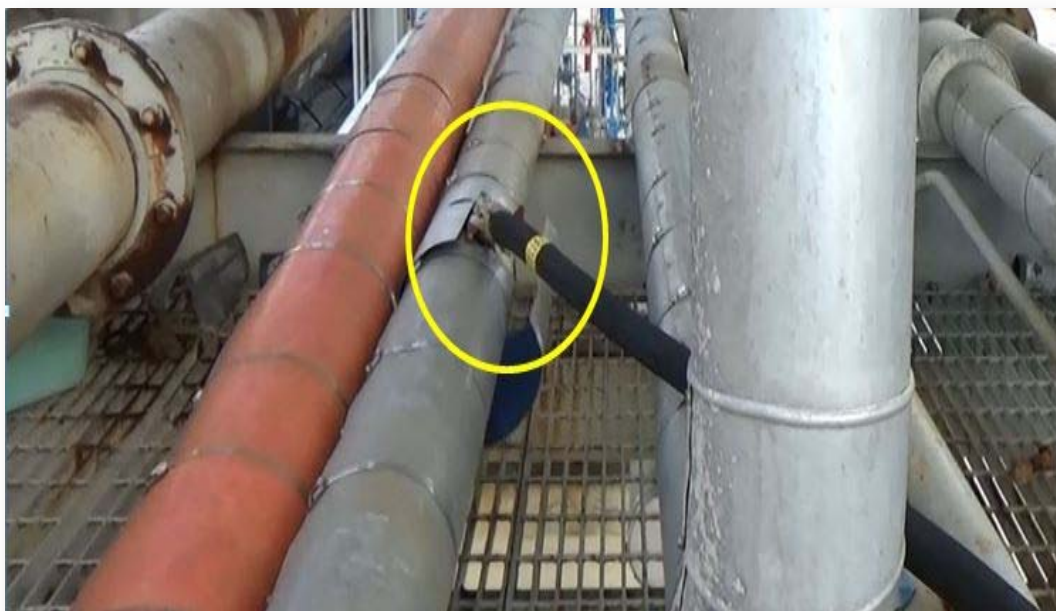
**Figure 30.** Hot Water Hose Positioned on the Liquid Methyl Mercaptan Feed Piping. Hot water flowed between the piping and the insulation to heat the piping and dissociate the solid hydrate that had formed after water inadvertently entered the methyl mercaptan storage tank. Source: CSB.

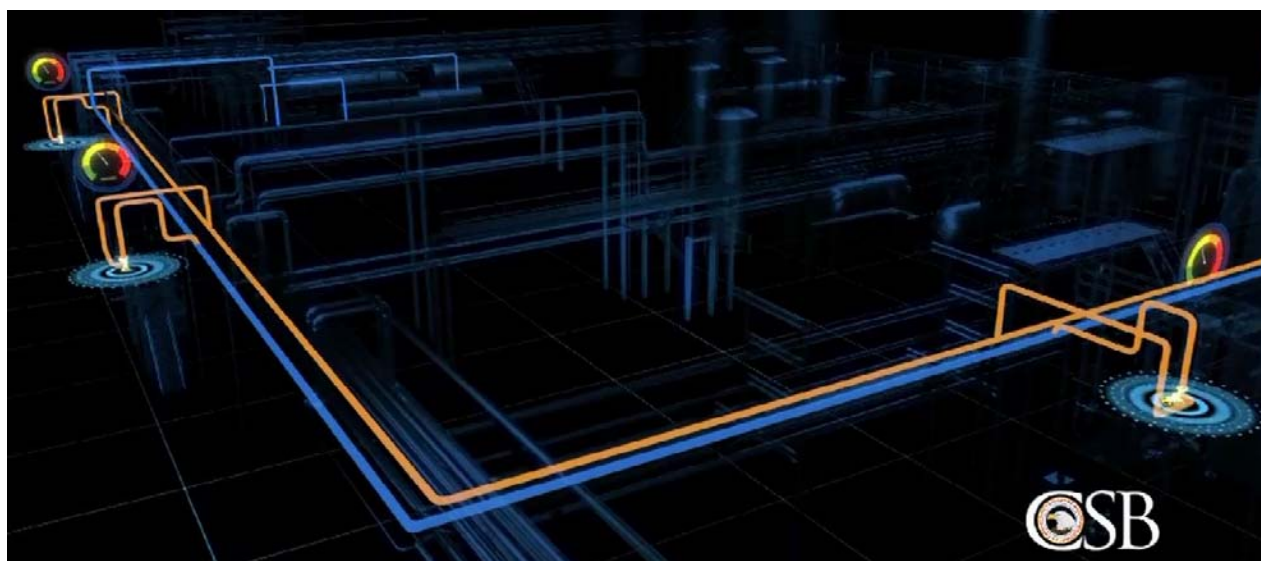
**Figure 31.** Excerpt from CSB Animation. It depicts the three locations where valves connected the methyl mercaptan feed piping (blue) to the waste gas vent header piping (orange). Workers used the pressure gauges shown at these locations to monitor the progress of clearing the hydrate blockage inside the methyl mercaptan feed piping. Source: CSB.

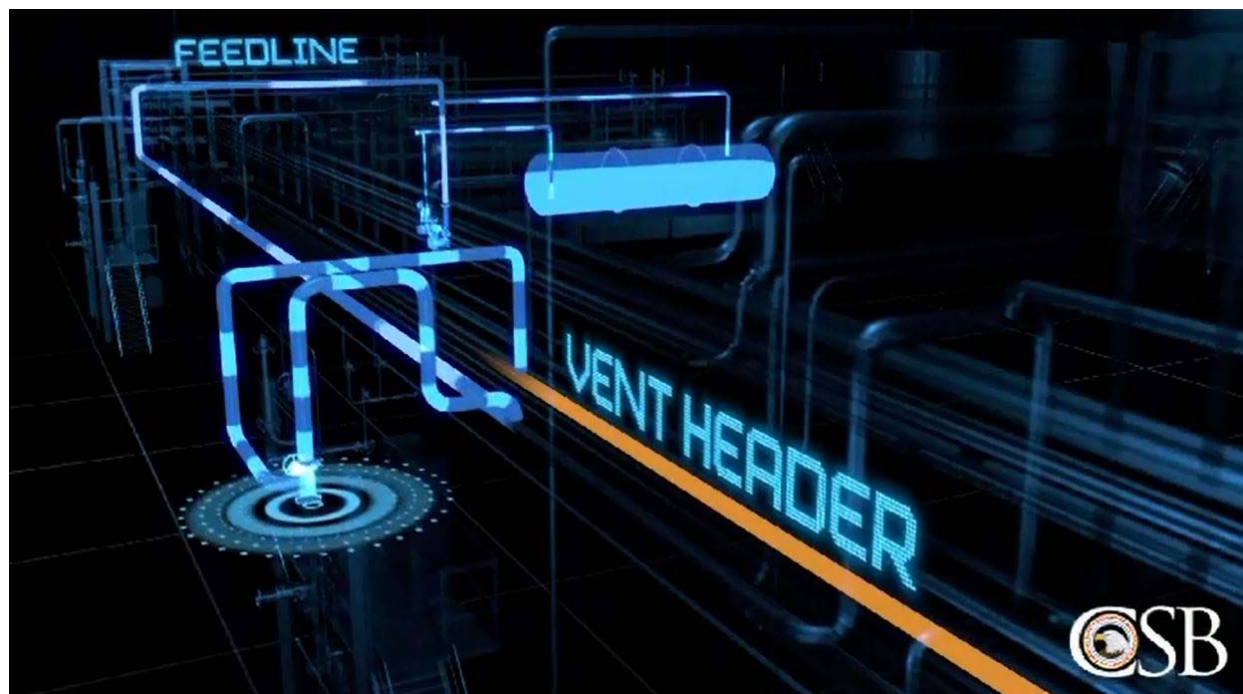
**Figure 32.** Excerpt from CSB Animation. It depicts the piping arrangement that allowed liquid methyl mercaptan from the feed line (blue) to flow into the waste gas vent header piping (orange). Source: CSB.

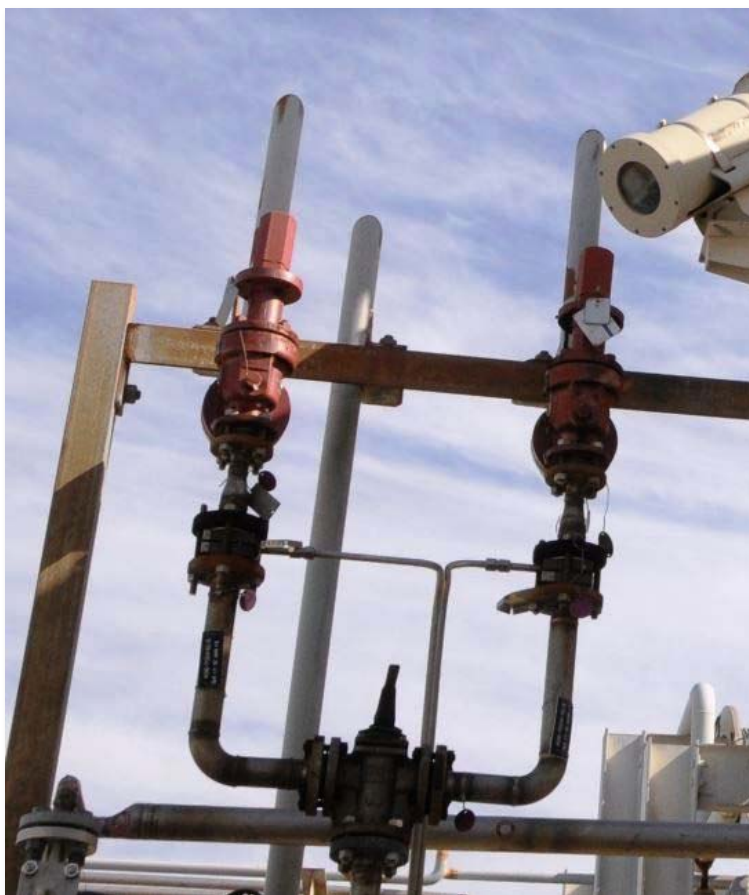
**Figure 33.** Nitrogen Relief Valves at One of the Two Methyl Mercaptan Railcar Unloading Stations. DuPont PHAs and relief valve design documents never considered the possibility of lining up the methyl mercaptan storage tank pumps to these relief valves—as they were at the time of the incident. As a result, liquid methyl mercaptan was discharged from a system designed for nitrogen vapor. Source: CSB.

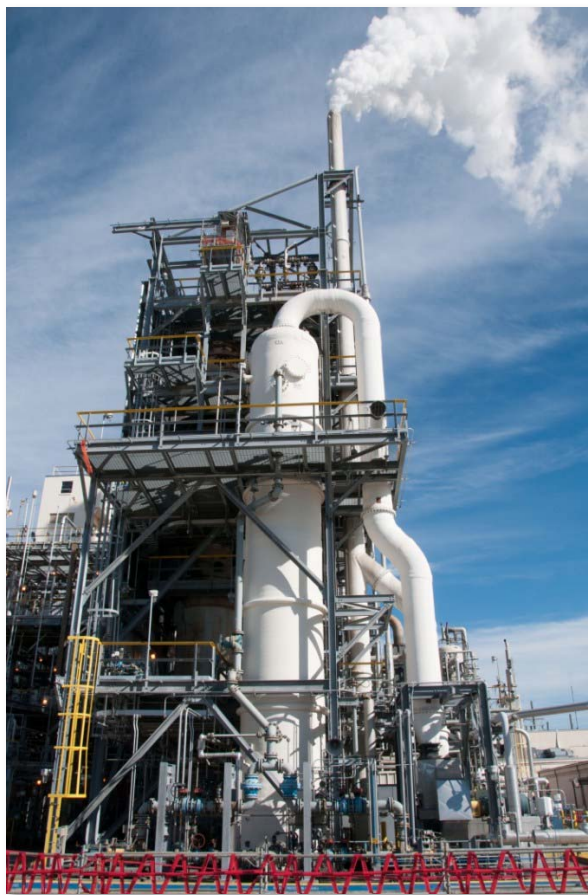
**Figure 34.** NRS Incinerator. NRS was installed in 2011 to reduce emissions and allow increased production at the DuPont La Porte facility. Source: CSB.
