# DUPONT CHEMICAL LA PORTE, TX- 2014 ACCIDENT INVESTIGATION

## Investigation Report

Published: June 2019

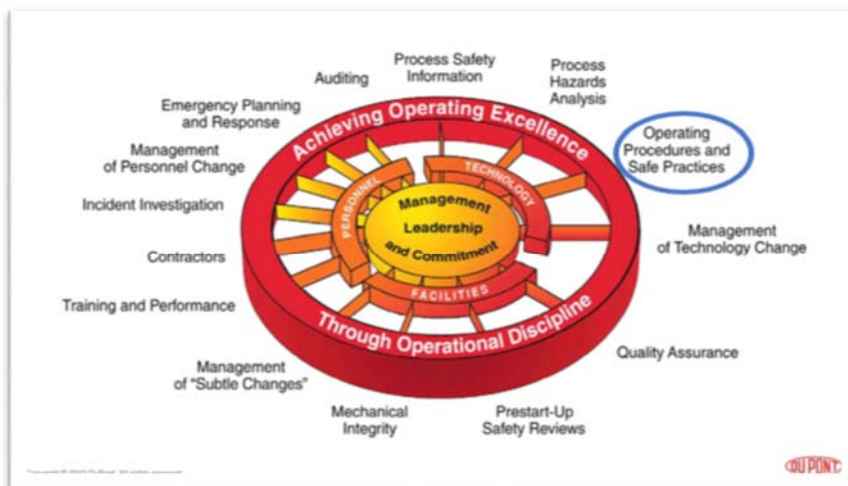
**Figure 35.** Where Safe Work Practices Are Located on DuPont’s PSM Wheel [54, p. 2]. Source: DuPont, with annotations by CSB.

pipng (i.e., line breaking).<sup>a</sup> According to *Guidelines for Risk Based Process Safety*, from CCPS, safe work practices help control hazards and manage risks involved with nonroutine activities [52, p. 286]. Managing risks associated with nonroutine processes requires robust systems, thorough training and awareness, sound culture, and diligence [52, p. 293]. CCPS further suggests developing an integrated system for safe work practices, including safe work procedures, permits, checklists, and other written standards [52, pp. 291-92] (Figure 35).

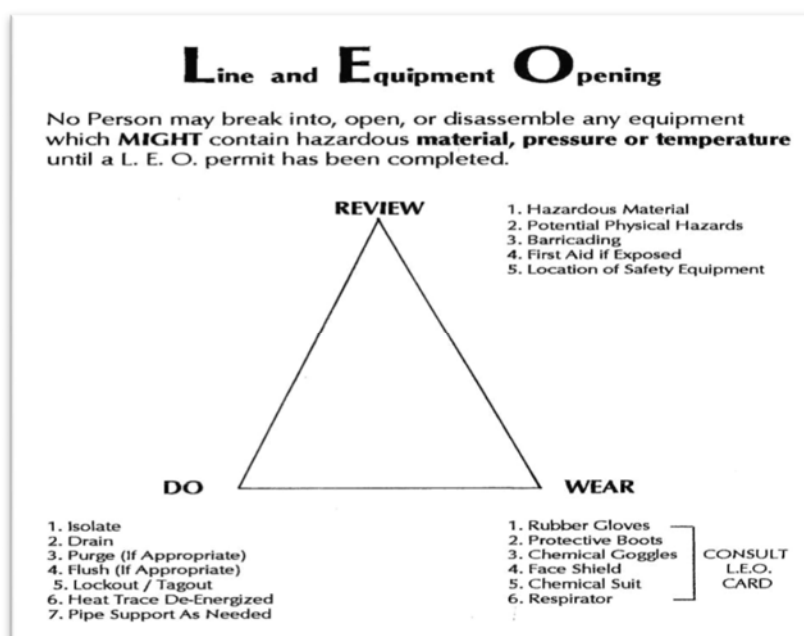
**Figure 36.** Triangle Approach to Line and Equipment Opening Permits. This slide is from a training document about OSHA operating procedures, safe work practices, and training [73, p. 27]. Source: OSHA website.

Any time a valve is opened to the atmosphere, the mechanical integrity of the system is compromised. Under PSM, employers must develop and implement safe work practices to control hazards during line breaking [18].<sup>b</sup> Figure 36 shows an approach to line and equipment opening (breaking) from a document that was produced under OSHA's grant program.

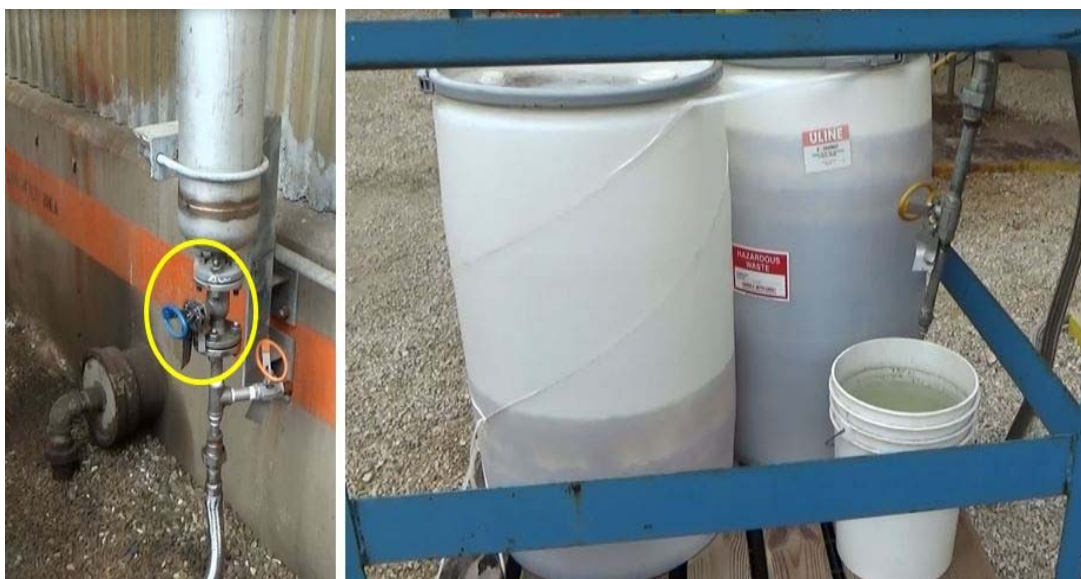
**Figure 37.** Photo Showing Another Line Break. Operators drained liquid accumulation in another vent header without using line-breaking procedures. Source: CSB.

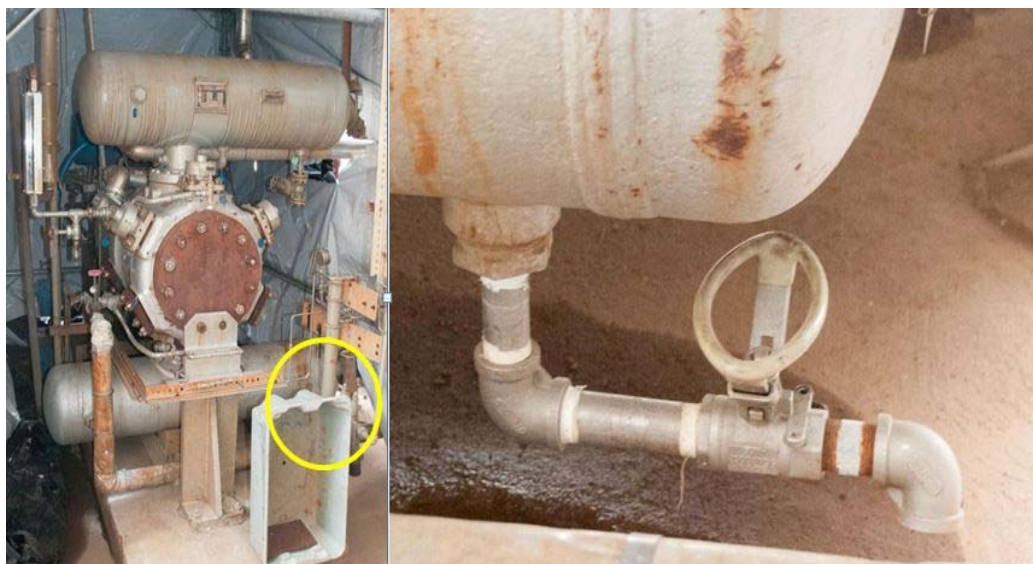
**Figure 38.** Methylene Chloride<sup>a</sup> Compressor. Photo shows where operators routinely drained liquid accumulation from a methylene chloride compressor without using line-breaking procedures. Source: CSB.

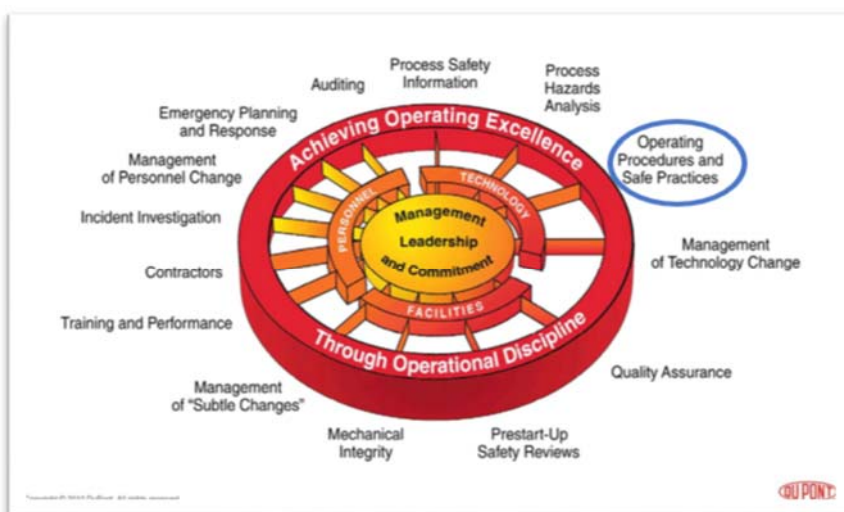
**Figure 39.** Where Shift Communication Falls on DuPont's PSM Wheel [54, p. 2].  
Source: DuPont, with annotations by CSB.

Companies should develop procedures and practices for effective communication among their personnel (Figure 39). Effective communication depends on reliable and complete information that is transmitted and received in a timely manner. Understanding the information is imperative for safe operations.

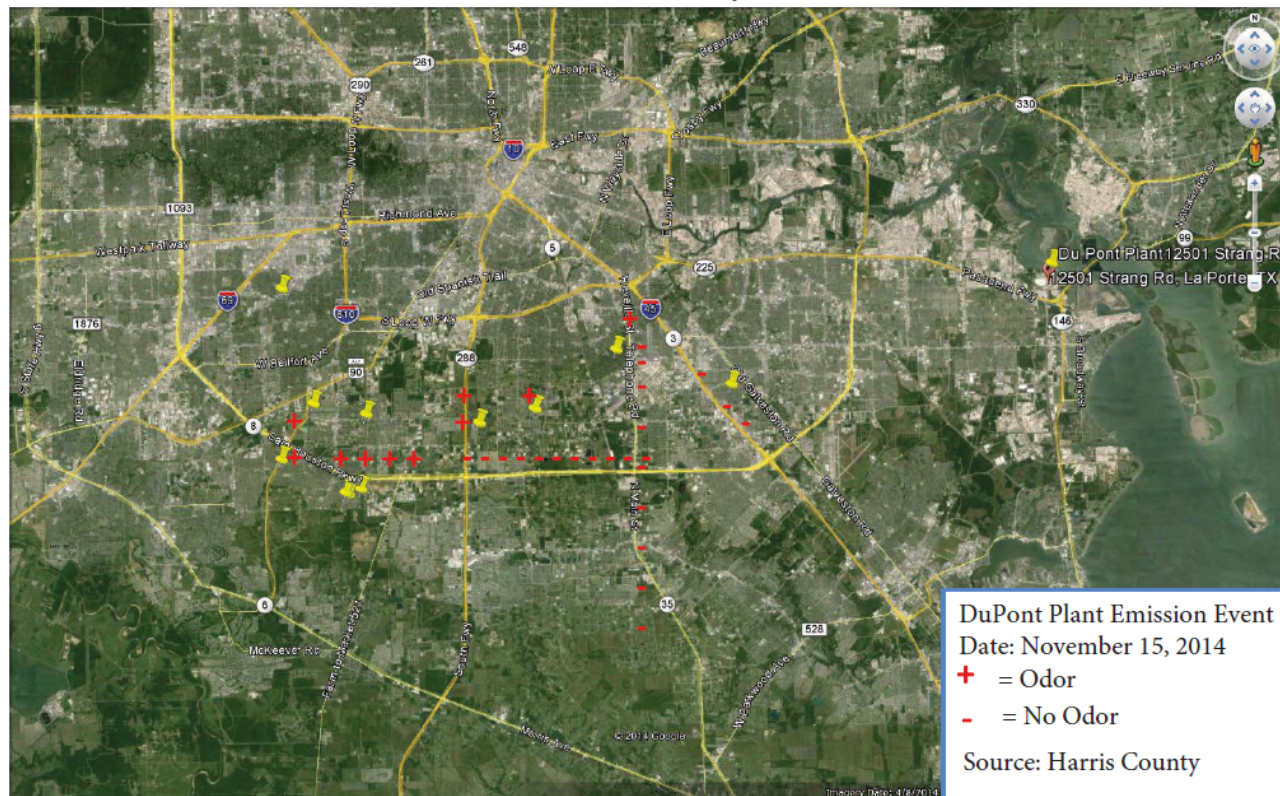
**Figure 40.** Map of the Odor Complaints (Yellow Pins) from the November 15, 2014 Incident. Source: Harris County, Texas.

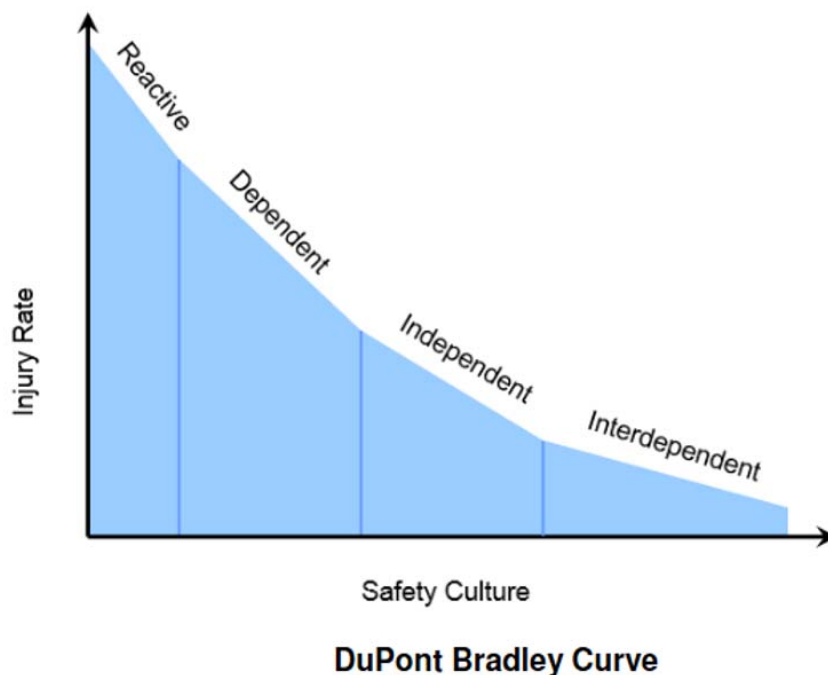
**Figure 41.** The DuPont Bradley Curve. The Bradley Curve correlates improved safety culture with reduced OSHA recordable injury rates. For more information, see [Bradley Curve](#). Source: DuPont.

Verlon Bradley, then manager of the DuPont plant in Beaumont, Texas, along with the Discovery Team, created a model named the Bradley Curve (Figure 41). The Bradley Curve aimed to illustrate the strength of an organization's safety culture and its relationship to the number of worker (OSHA recordable) injuries [77]. DuPont began using the Bradley Curve model internally, and in 1995, DuPont's consulting service, DuPont Sustainable Solutions, began applying the Bradley Curve model to improve safety performance at other companies in various industries [78].

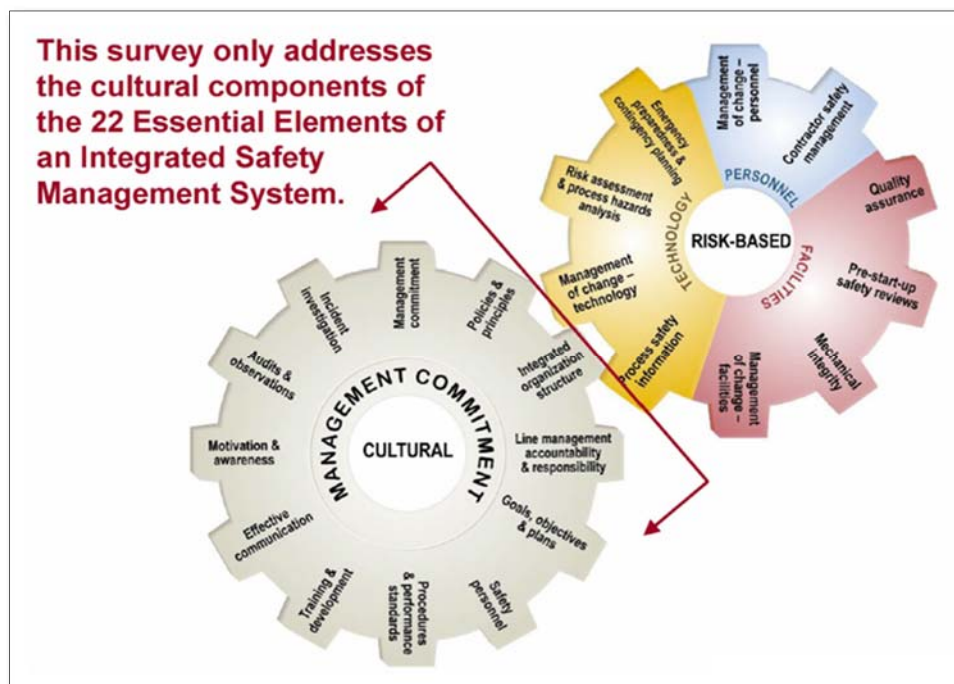
**Figure 42.** To DuPont, Each Wheel Represents Different Aspects of Safety. The wheel on the left (Cultural) represents the only aspects of safety that DuPont’s Safety Perception Surveys cover. The wheel on the right (Risk-Based) represents aspects of safety typically associated with process safety. Source: DuPont.

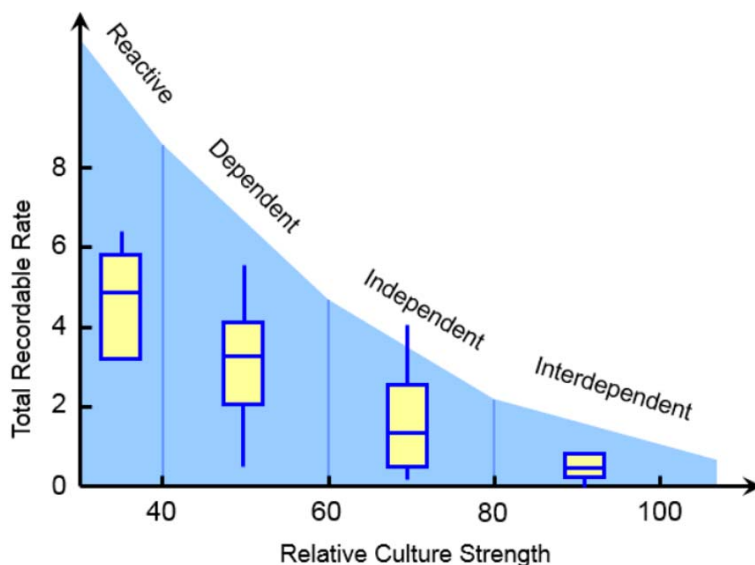
**DuPont Bradley Curve with RCS**

**Figure 43.** DuPont Bradley Curve with Plotted RCS results from 169,000 Safety Perception Surveys. The yellow bars show the range of the middle 50 percent of the data in each category, and the horizontal blue line in each box indicates the median. DuPont found that a higher RCS correlated with a lower worker injury rate (OSHA total recordable injury rate). Source: DuPont.

Beginning in 2007, DuPont began calculating a “Relative Culture Strength” (RCS) score based on responses to the Safety Perception Surveys.<sup>a</sup> DuPont found that higher RCS correlated with a lower OSHA total recordable injury rate.<sup>b</sup> The correlation also fit the Bradley Curve (Figure 43) [59, p. 7]. Because of this correlation, DuPont often uses the OSHA total recordable injury rate “as [its] measure of safety performance” [59, p. 2]. Additionally, DuPont uses the RCS in combination with the Bradley Curve (Figure 43) to determine what stage of safety culture a facility has achieved. The curve represents the progress of a facility’s culture strength. The

higher the score, the further along the facility is on the curve, with the highest level designated “World Class.”<sup>a</sup> DuPont classified facilities with a calculated RCS value of 80 or greater as having a “World Class” safety culture. Results from a 2012 Safety Perception Survey conducted at the La Porte site, the last safety culture survey conducted at the site before the incident, classified its perception of safety performance as “World Class.” This safety classification, however, relied on the DuPont La Porte site’s employees’ perception of personal (worker) safety performance only, because the Safety Perception Survey used at DuPont La Porte did not include process safety considerations.
