PCA MILL DERIDDER, LA - 2017 ACCIDENT INVESTIGATION

Report Number: 2017-03-I-LA April 2018 The **U.S. Chemical Safety and Hazard Investigation Board** (CSB) is an independent Federal agency whose mission is to *drive chemical safety change through independent investigations to protect people and the environment.*

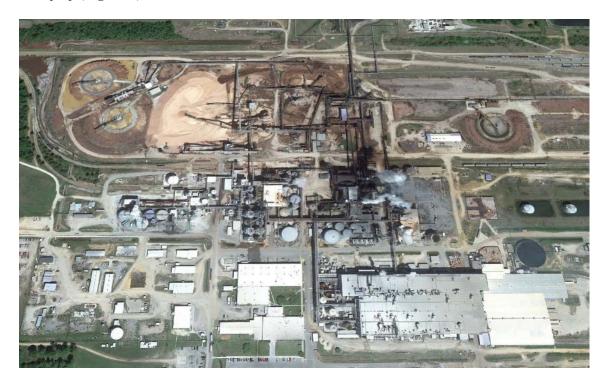
Figure 2. Overhead Photograph of the PCA DeRidder Mill. The larger complex at the bottom right of the photograph is primarily the paper mill area. Photograph: Google Earth.

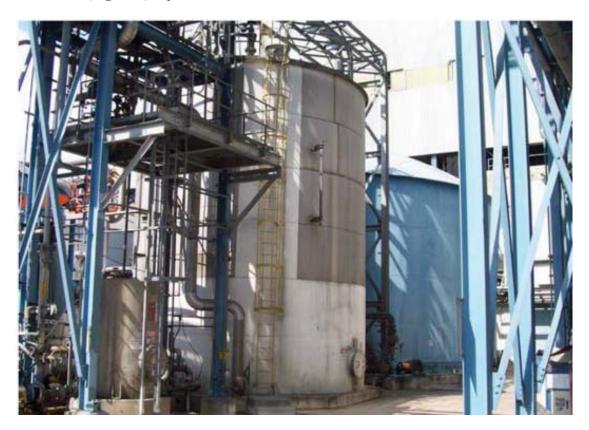
Figure 7. Pre-Incident Photograph of the DeRidder Mill Foul Condensate Tank. Welding work was being conducted above the tank on the pipe rack at the time of the incident. Photograph: PCA.

1. At approximately 11:05 am central daylight time (CDT) on February 8, 2017, a tank containing foul condensate (**Figure 7**) exploded at the PCA DeRidder mill in DeRidder, Louisiana.

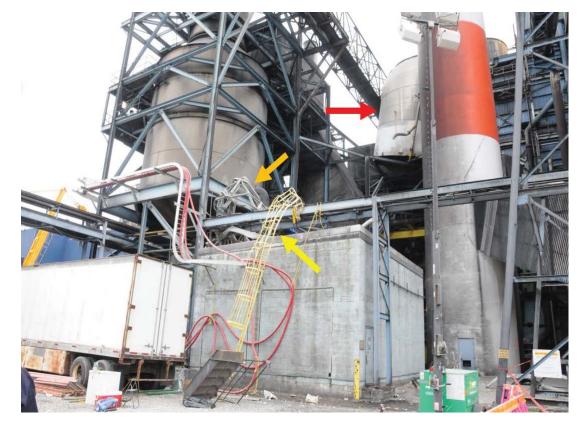
Figure 9. Post-Incident Photograph Showing the Location of the Foul Condensate Tank and Associated Structures. The foul condensate tank is indicated by the red arrow. The ladder previously attached to the tank is indicated by the yellow arrow. The pipe rack, which had previously been located above the tank, is indicated by the orange arrow. Photograph: CSB.

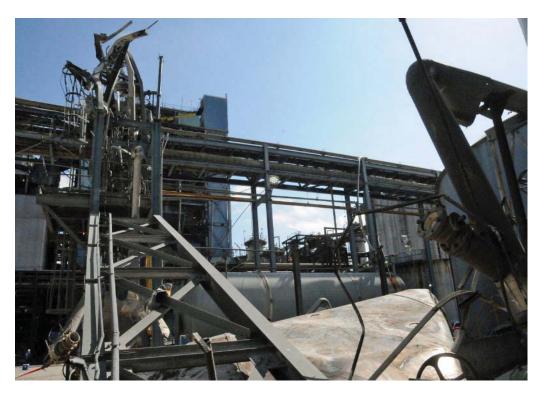
Figure 10. Photograph Showing Explosion Damage at the PCA DeRidder Mill in DeRidder, Louisiana. The bottom right corner of the photograph shows the foul condensate tank's base upside-down. The explosion separated the tank from its base. Photograph: CSB.

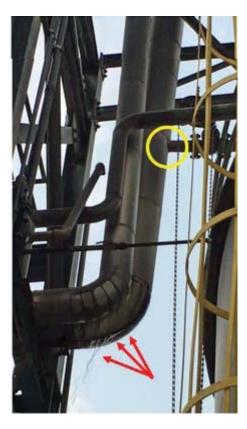
Figure 12. Pre-Incident Photograph of the Water Leak. The water piping (yellow circle) had cracked at the connection point between the eight-inch vertical water piping and the three-inch horizontal piping entering the foul condensate tank. Water was leaking from the crack (red arrows). Photograph: PCA.

- There were no known risks among mill personnel of leaving liquid in the tank.
- The company did not have plans to work directly on the tank during the outage.
- There were resource limitations as mill staff had numerous other tasks to complete during the annual outage.
- 8. During the outage, there was no planned or actual work directly on the foul condensate tank. However, work was planned on water piping located above the foul condensate tank. Months earlier, that piping shifted off its supports and cracked at the intersection of an eight-inch line and a three-inch line that was connected to the foul condensate tank (**Figure 11**), resulting in a significant leak that was visible in a pre-incident video taken by a mill employee who planned the repair work (**Figure 12**).

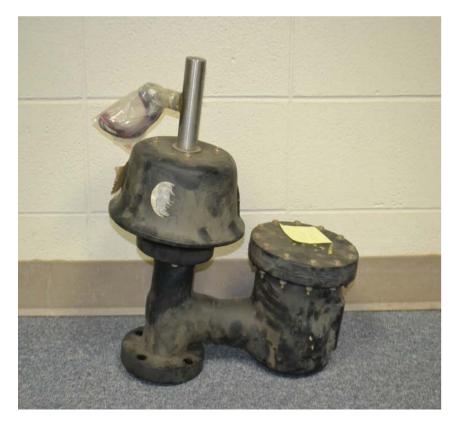
Figure 15. Photograph of a Spare Pressure Vacuum Breaker for the CNCG System at the DeRidder Mill. If the foul condensate tank experiences high-pressure (six-inches of water), the left-hand portion of the pressure vacuum breaker opens and releases vapor to the atmosphere. If the tank experiences low-pressure (minus six-inches of water), the portion of the pressure vacuum breaker extending to the right will open and pull air into the tank.^b Photograph: CSB.

1. A combination of physical evidence, interviews, and process data suggests that pressure swings during normal operation pulled air into the foul condensate tank. Air most likely entered through the tank's pressure vacuum breaker (**Figure 15**), as designed, to relieve the low-pressure condition it was experiencing during swings in the foul condensate tank level. The internal pressure dropped below the minus (-) six-inches of water set pressure of the vacuum breaker. Additional air entered the foul condensate tank during the course of the mill's annual outage. Because the tank had been isolated and was cooling from its operating temperature of 185 °F, some of the vapor condensed.^a The ingress of air and the ambient cooling of the liquid brought the tank's atmosphere below the UEL, creating an explosive atmosphere.

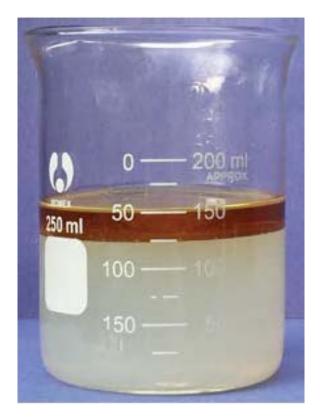
Figure 16. Photograph of Immiscible Oil Layer on Top of Water. This photograph shows how oil forms an immiscible liquid layer on top of water similar to how a turpentine layer might appear inside the foul condensate tank. Photograph: CSB.

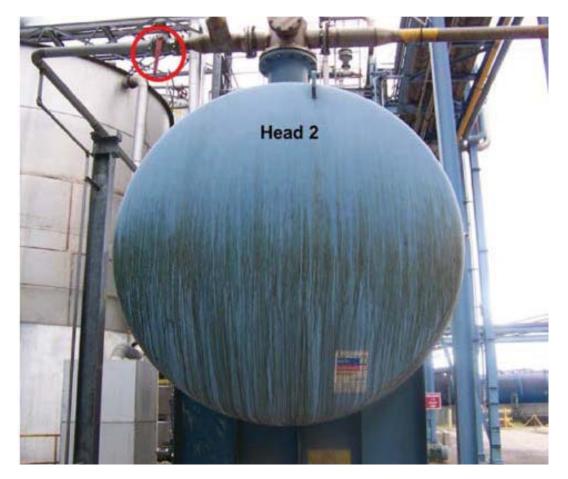
Figure 21. Closed Valve on the Piping from the Foul Condensate Weir to the Turpentine Recovery System. This photograph from the mill's 2010 inspection file shows that the valve is in the closed position. Post-incident, this valve also was found in the closed position. The CSB learned that the PCA DeRidder mill had not used the foul condensate tank's weir system to remove turpentine. Photograph: PCA.

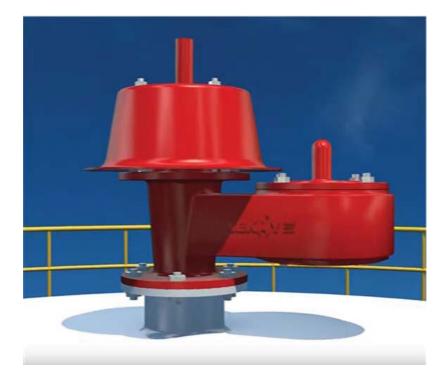
Figure 23. Image of a Pressure Vacuum Breaker. If the vessel experiences an over pressure event, the top portion of the pressure vacuum breaker releases to the atmosphere. If the vessel experiences an under pressure event, the portion of the pressure vacuum breaker extending to the right will pull air into the vessel. Photograph: Finekay [12].

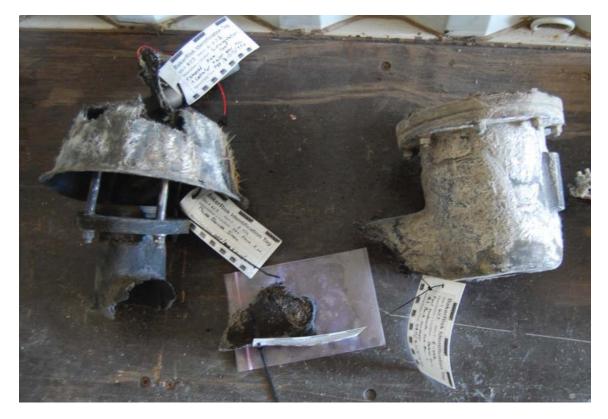
Figure 24. Post-Incident Pressure Vacuum Breaker. The foul condensate tank's pressure vacuum breaker is shown post-incident. Photograph: PCA.

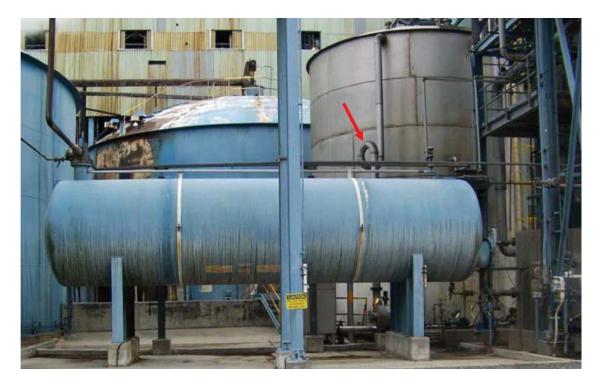
Figure 29. Pre-Incident Photograph Showing Overflow Seal Leg. This pre-incident photograph shows the overflow seal leg on the foul condensate tank (red arrow). Photograph: PCA.

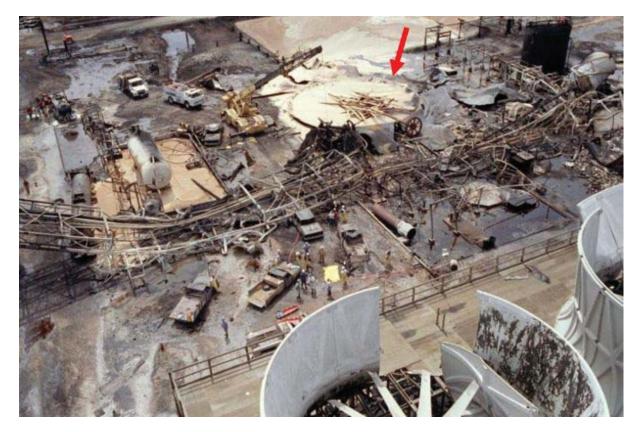
Figure 36. Post-Incident Photograph of the July 1990 Explosion at the ARCO Chemical Facility in Channelview, Texas. The location of the wastewater storage tank is indicated by the red arrow. Photograph credit: [41].

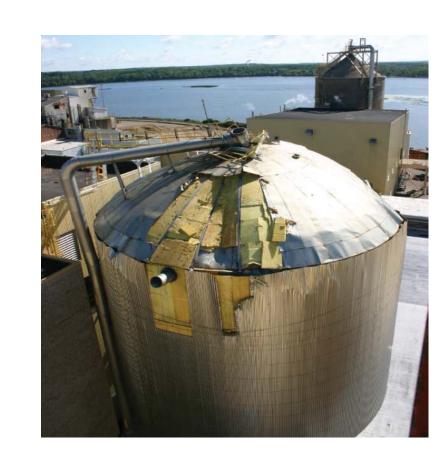
Figure 39. Post-Incident Photograph at the PCA Tomahawk Mill. This photograph shows the postincident storage tank at the PCA Tomahawk mill in 2008. Photograph: CSB.

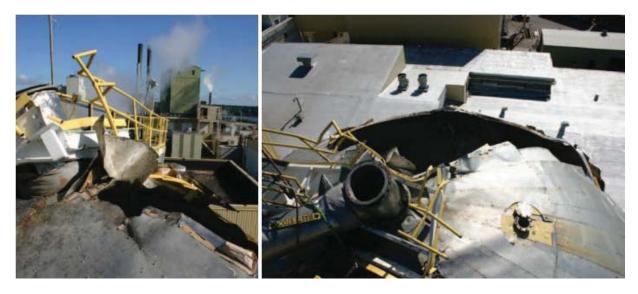
Figure 40. Post-Incident Photographs from the PCA Tomahawk Mill. These photographs show views of the top of the storage tank involved in the 2008 explosion at the PCA Tomahawk mill. Photograph: CSB.

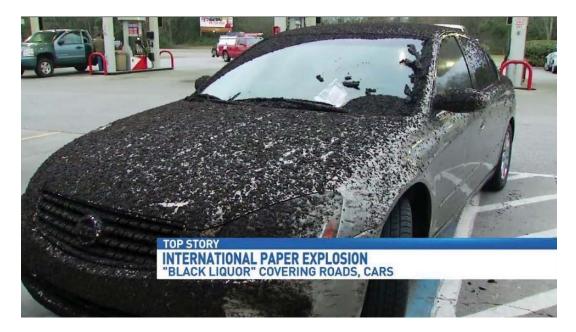
Figure 42. Post-Incident Photograph of Debris on a Car. This photograph shows a car covered with process chemicals that were released when a digester at the Pensacola mill exploded on January 22, 2017. Photograph: WEAR Television [51].

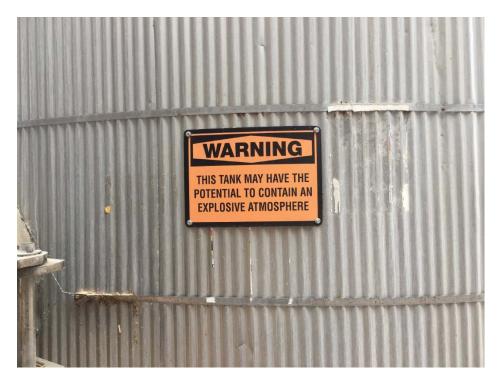
Figure 44. Post-Incident Warning Label. This warning label is intended to inform personnel of the potential hazards associated with a flammable atmosphere inside a vessel. Photograph: PCA.

2. As discussed above, PCA has posted labels on any vessel in the mill that may contain a flammable atmosphere. Examples of these labels can be seen in **Figure 44** and **Figure 45**.

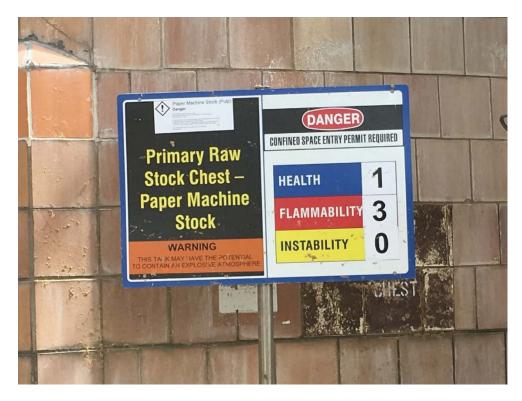
Figure 45. Post-Incident Danger Label. This label is intended to warn mill personnel of the hazards associated with a potential flammable atmosphere inside a vessel. Photograph: PCA.
