# INVESTIGATION OF HYBRID COMPOSITE BRIDGE BEAMS

<b>Main Category:</b>	Civil Engineering
<b>Sub Category:</b>	Structural Engineering
<b>Course #:</b>	STR-121
<b>Course Content:</b>	103 pgs
<b>PDH/CE Hours:</b>	5

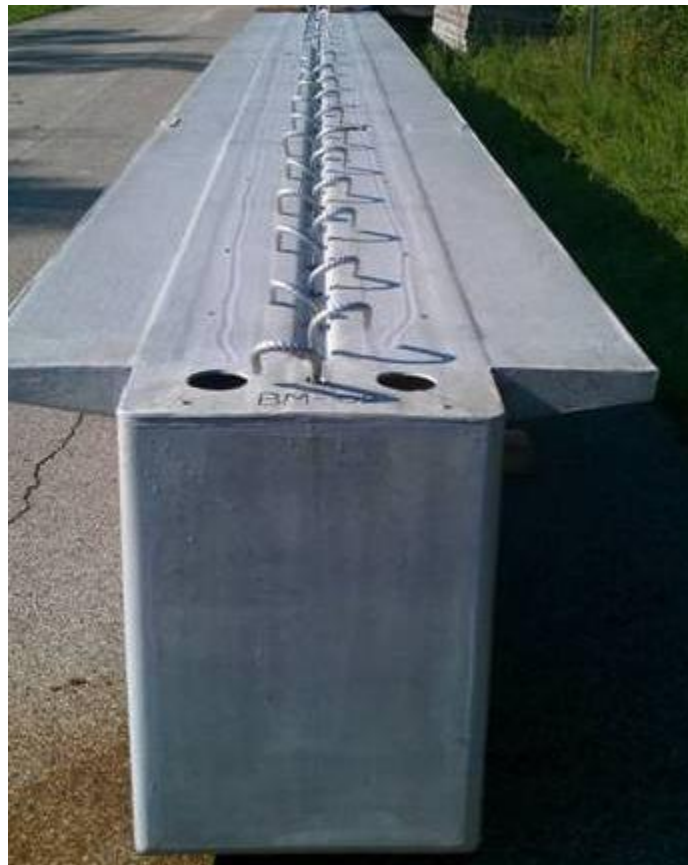
Figure 3. Ports for injecting SCC.

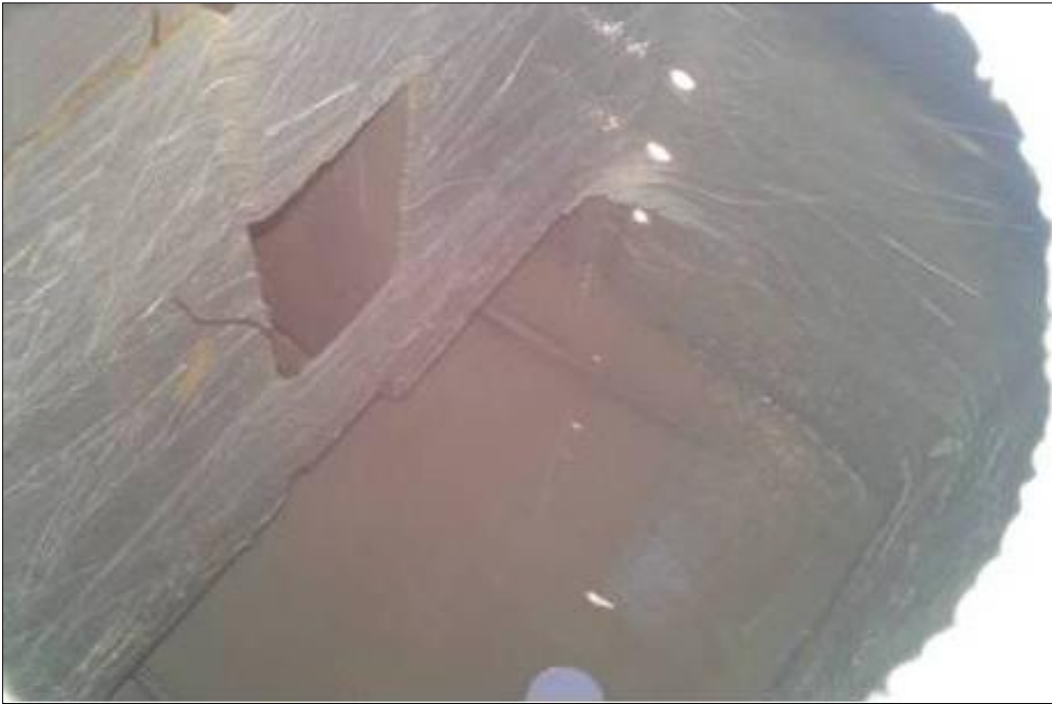
Figure 4. Interior view of a concrete-filled HCB.

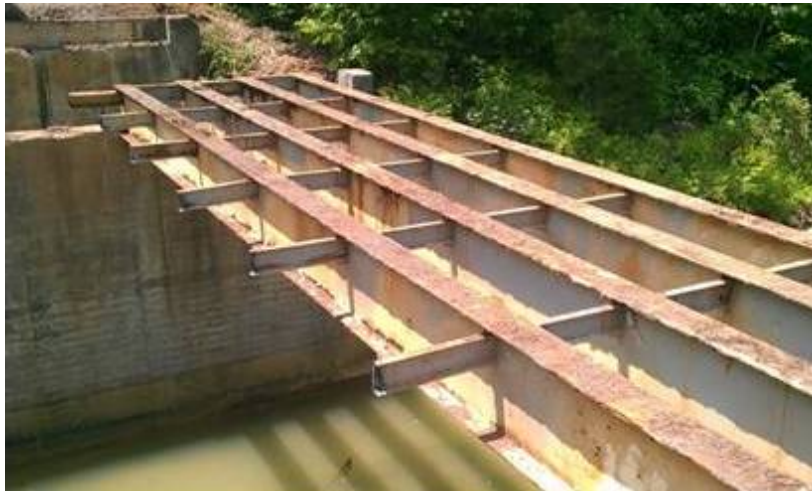
Figure 6. Corroded support beam structure visible during demolition.

The existing 82-foot long Bridge No. 4 was demolished to remove the existing road deck and support beams for the two spans. Demolition was done by the Fort Knox DPW and its support contractor, All Cities Enterprises of Fort Knox, Kentucky. The abutments and pier were not removed, but they were rehabilitated by forming and pouring new concrete landings for the new support beams. The condition of the support beam structures, as visible during demolition, is shown in Figure 6 and Figure 7.

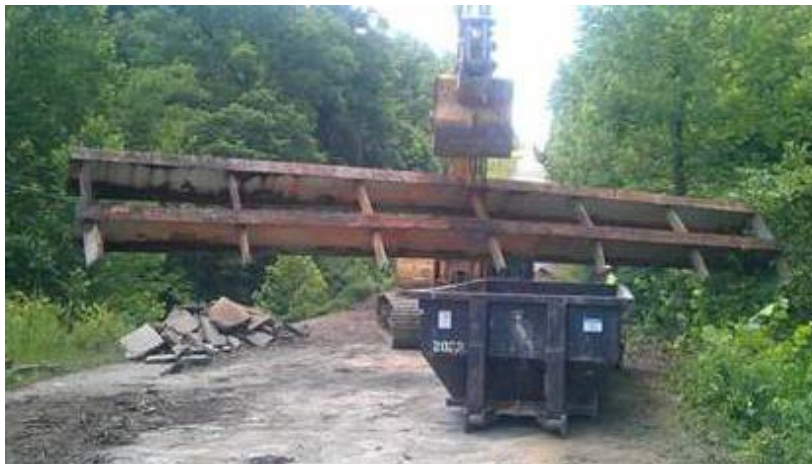
Figure 7. Lifting degraded steel beam structure during demolition.

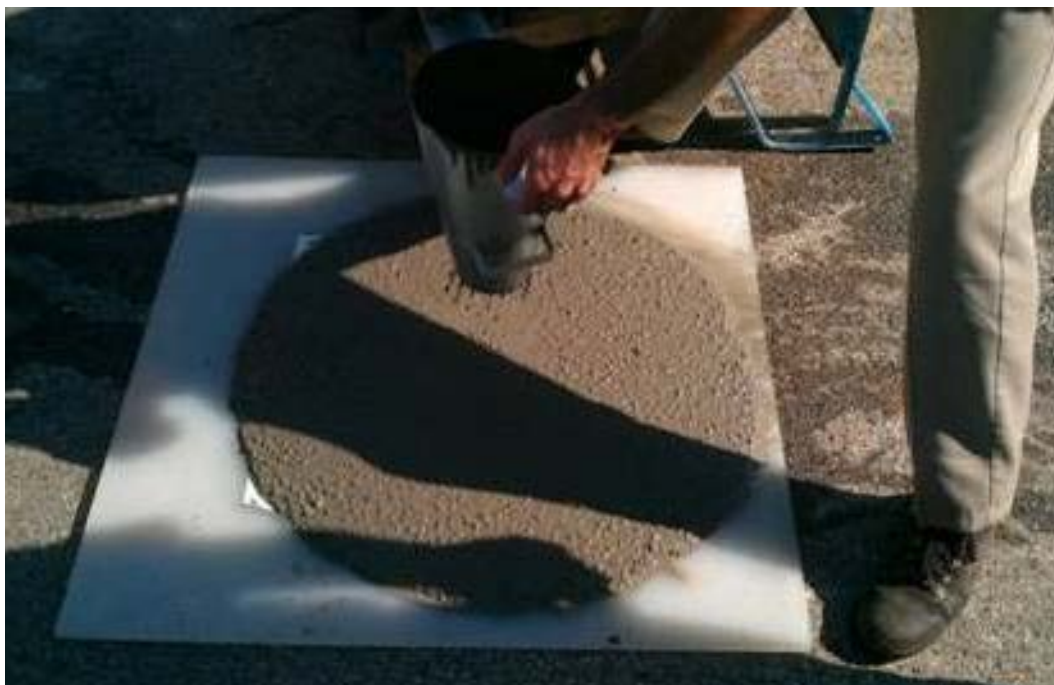
Figure 9. Slump test of SCC.

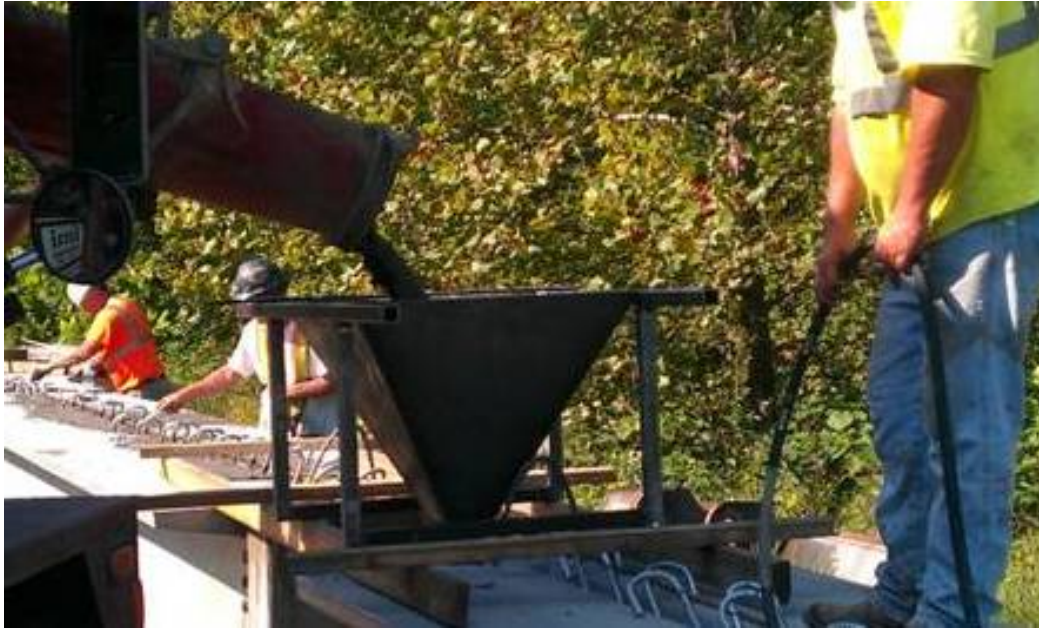
Figure 10. Casting the internal compression reinforcement arch.

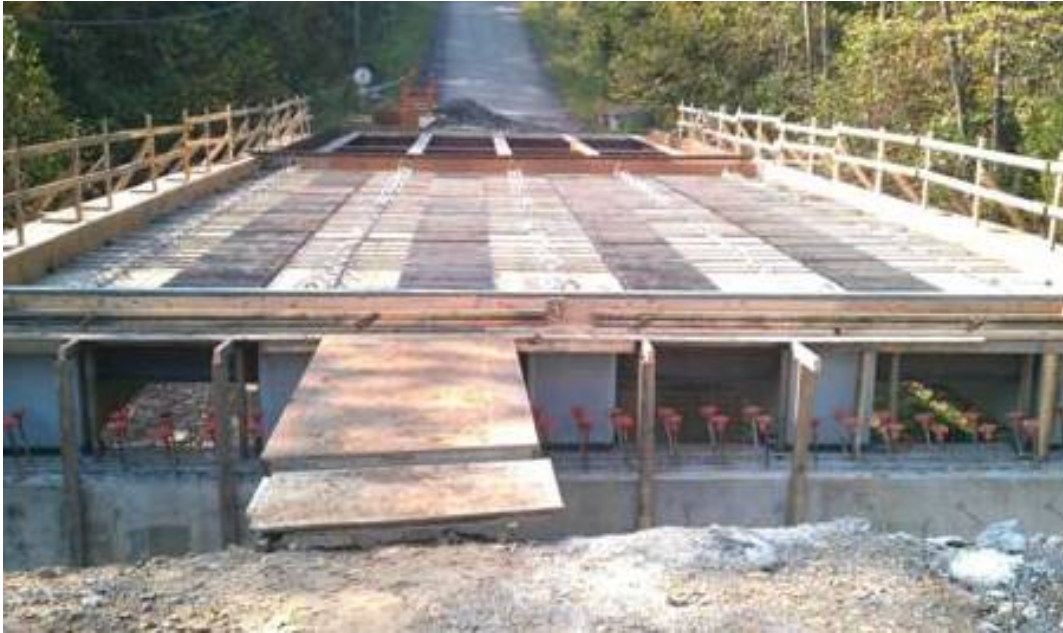
Figure 14. Forming bridge deck and installing rebar.

with two rows of rebar installed in a 4-inch grid pattern and a 3-inch separation between rows (Figure 14 and Figure 15). The top row maintained a 1.75-inch clearance from the surface of the deck. Sensors were placed in the bridge deck to measure site corrosivity (see sections 3.1.1). The completed bridge span is shown in Figure 16. When completed, the bridge was load-tested to assess the structural integrity and then retested after 1 year (see 3.1.2). Details of these tests are in another report, ERDC/CERL CR-16-5 (Commander and Carpenter 2016).

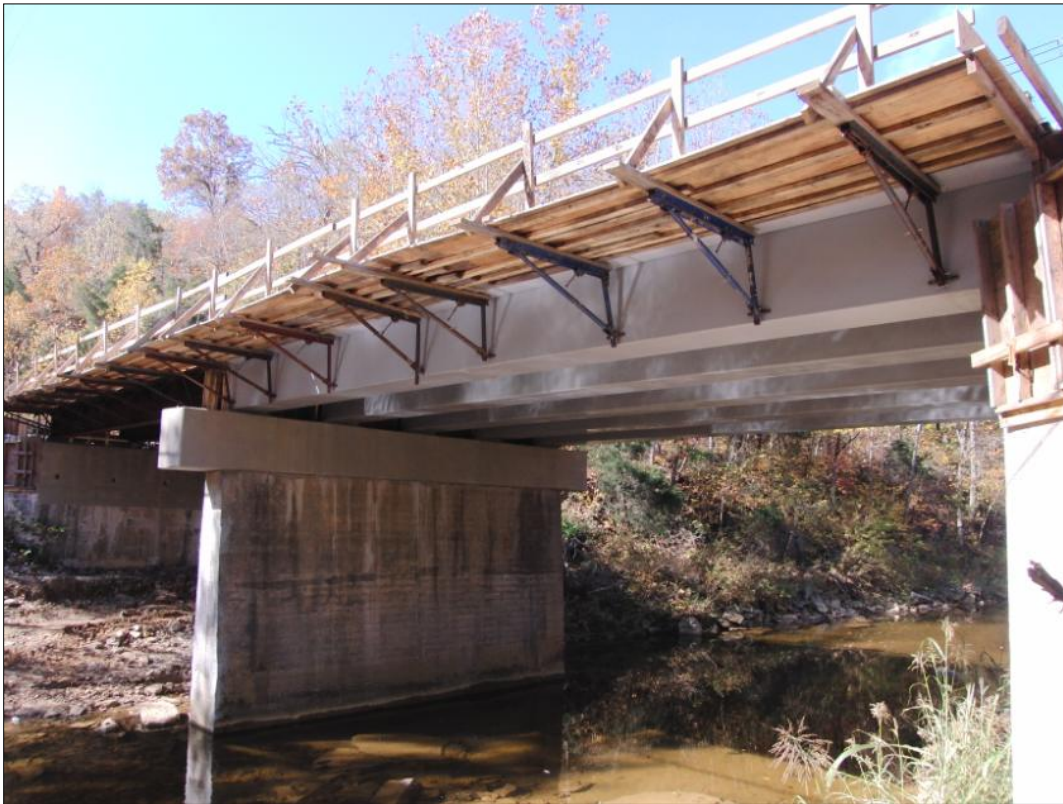
Figure 15. Bridge deck construction in progress.

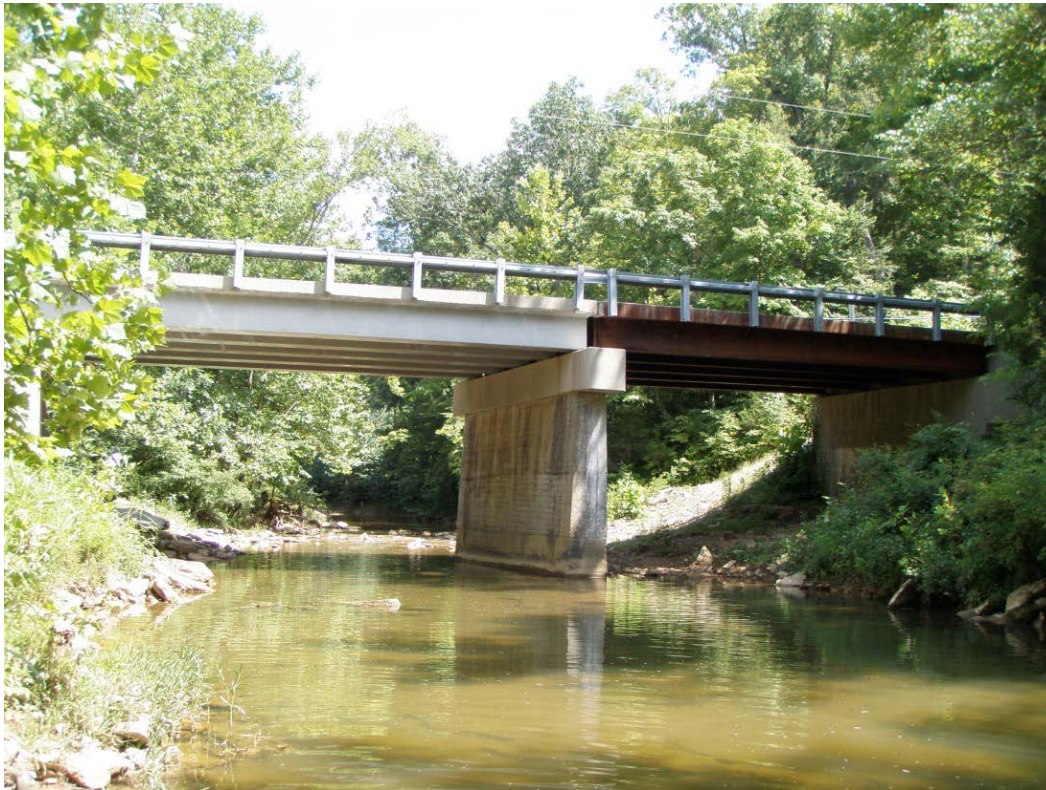
Figure 16. Completed bridge No. 4 with HCBs (left) and Gridform deck on Cor Ten® weathering steel beams (right).<sup>1</sup>

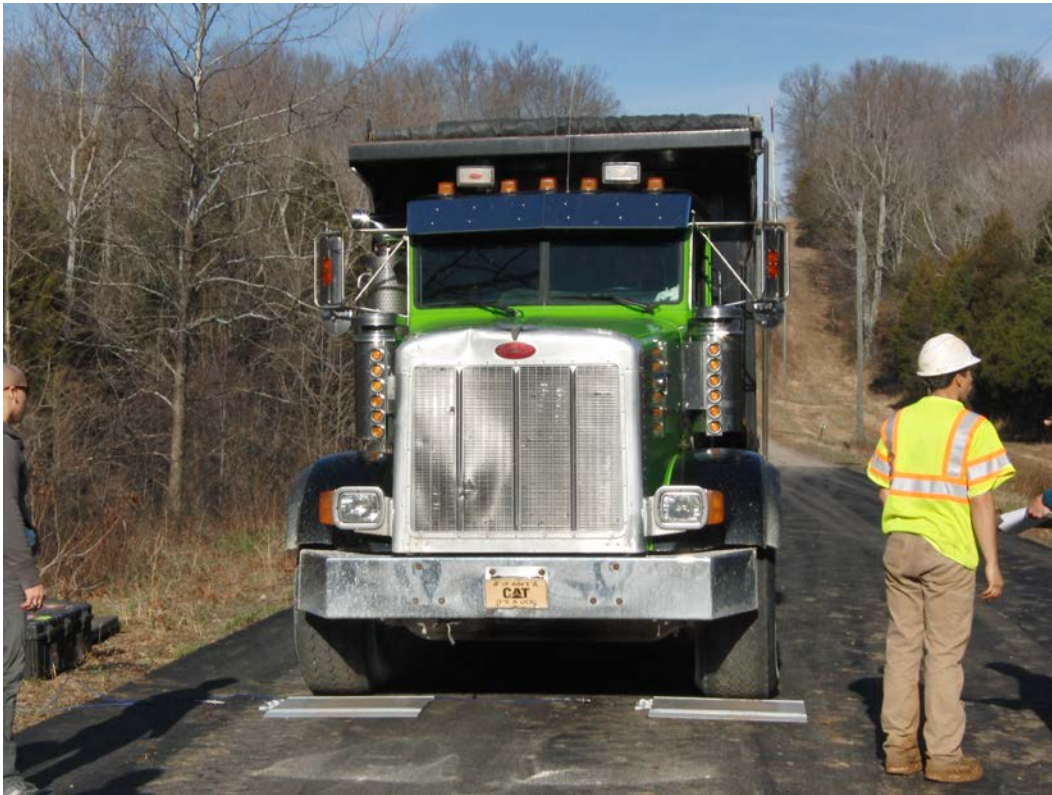
Figure 17. Weighing a truck to be used for load testing.

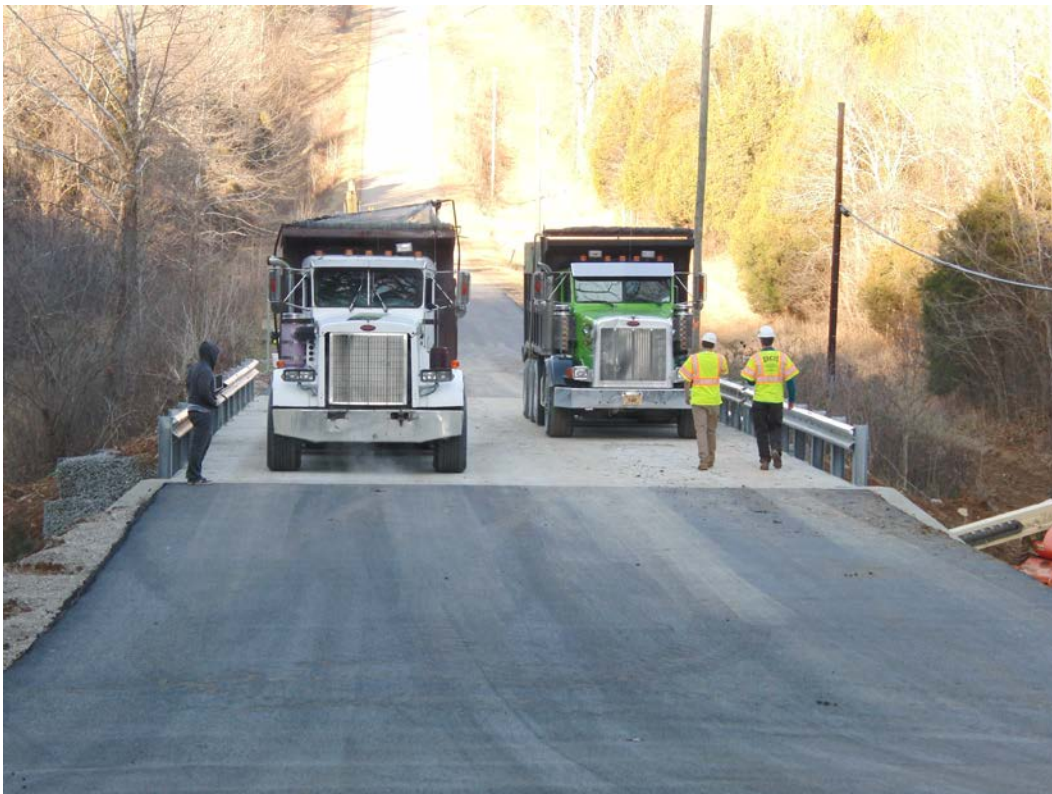
Figure 18. Two-lane load testing.

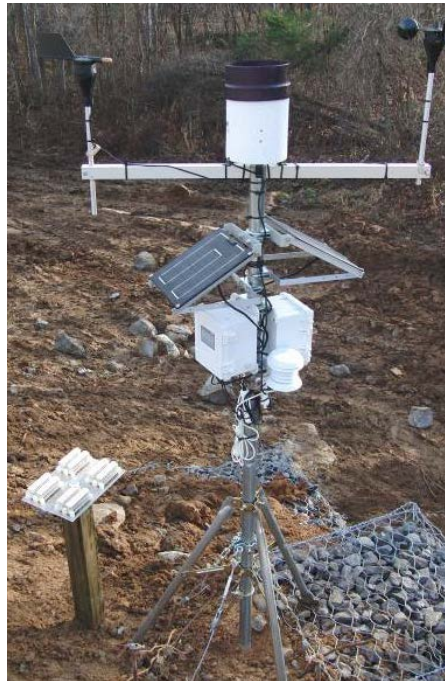
A weather station was installed to measure and record environmental characteristics throughout the exposure period as shown in Figure B1. The station measured temperature, relative humidity, wind speed and direction, and rainfall. The weather station was powered by a solar panel and a rechargeable battery. A data logger was used to store the measurements which were recorded every 12 hours by the rain gage and every 15 minutes for the remaining sensors. Data was downloaded manually during each quarterly inspection through the use of a laptop computer. The data logger has a storage capacity to continue storing data at 15-minute intervals for approximately 2.5 years. Upon reaching full capacity, the data logger will truncate the oldest data point to create room for new, incoming data.

Figure B1. Weather station.

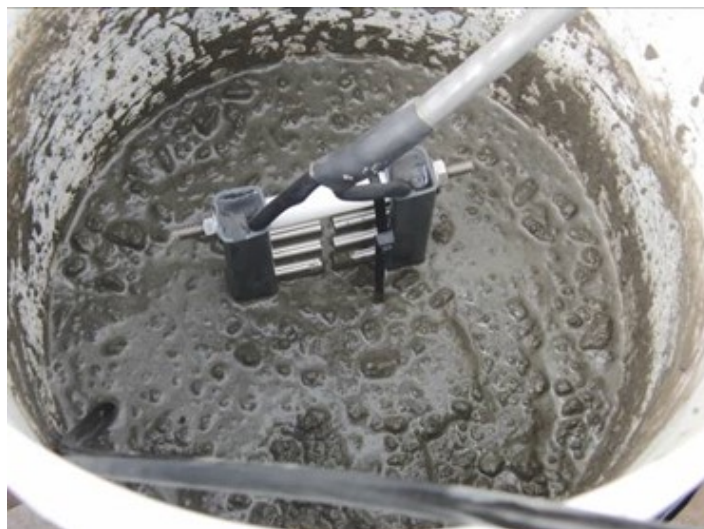
A concrete coupon was formed in a 5-gallon bucket to provide a method to simulate chloride penetration. The bucket was filled approximately half-way with a concrete mix including one cup of sodium chloride. A corrosion ladder was situated in the form such that the chloride enriched concrete covered the first two set of electrodes of the chloride sensor. A corrater was also submerged in the concrete. The concrete was provided 24 hours to cure before filling the rest of the form with standard concrete. Figure B2 shows the chloride-enriched concrete covering the corrater and half of the chloride ladder sensor. Figure B3 shows the cured concrete coupon. Measurements were collected during the quarterly inspections.

Figure B2. Coupon preparation.

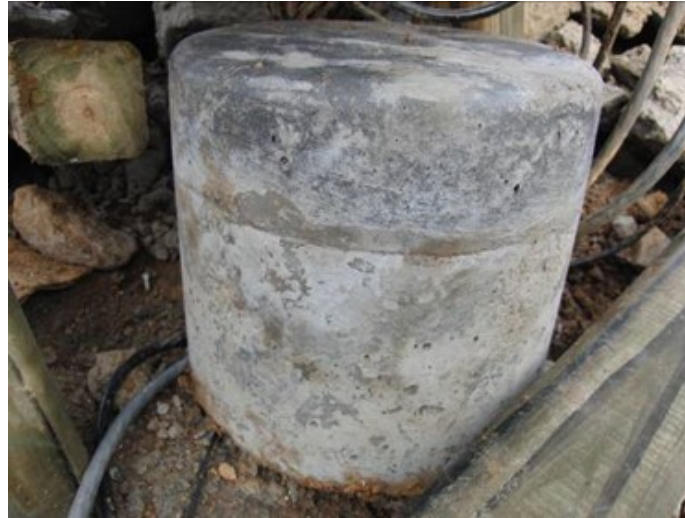
Figure B3. Finished coupon.

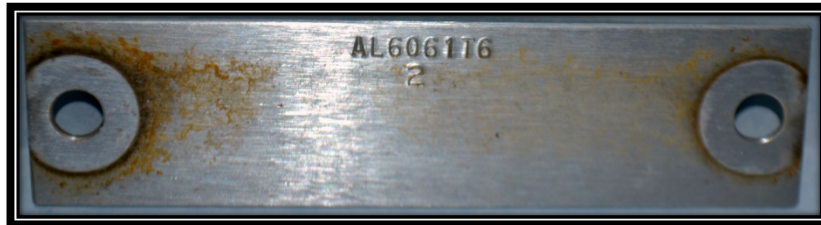
**Figure 1:** AL6061 T6 Sample prior to Corrosion Removal

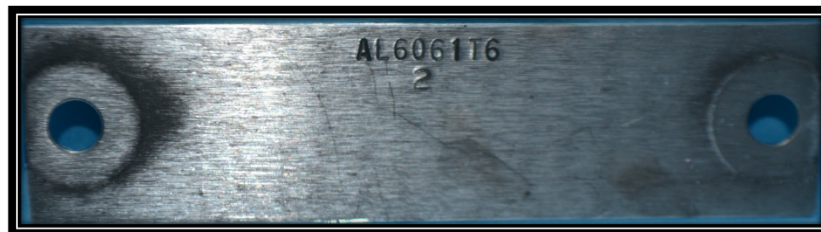
**Figure 2:** AL6061 T6 after Corrosion Removal

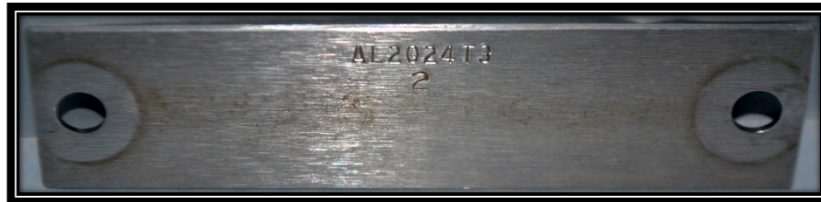
**Figure 3:** AL2024 T3 Sample prior to Corrosion Removal

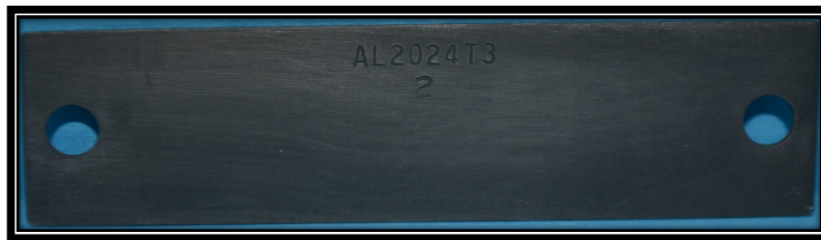
**Figure 4:** AL2024 T3 after Corrosion Removal

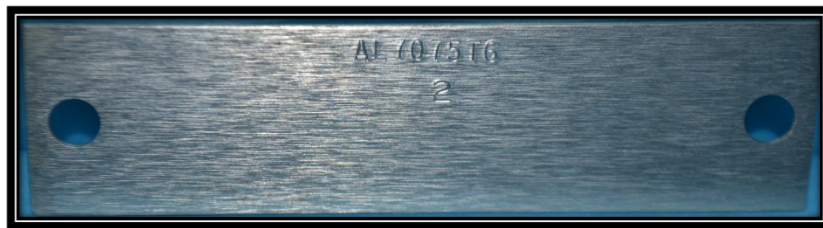
**Figure 6:** AL7075 T6 after Corrosion Removal

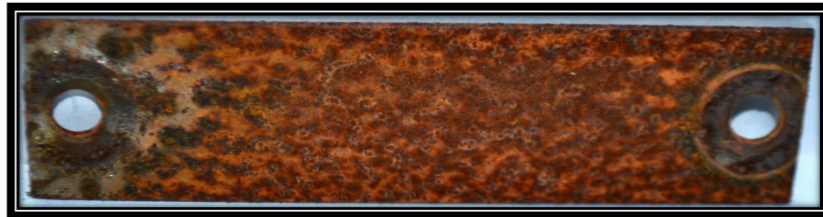
Figure 7: C1010 Sample prior to Corrosion Removal

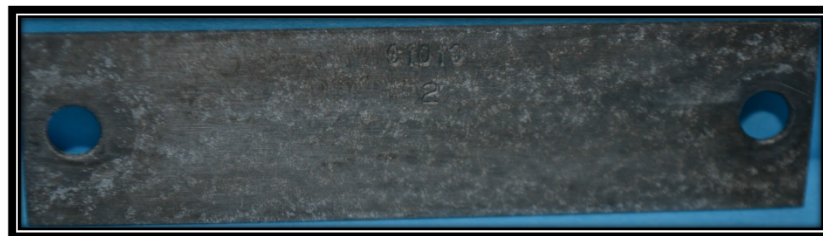
Figure 8: C1010 after Corrosion Removal

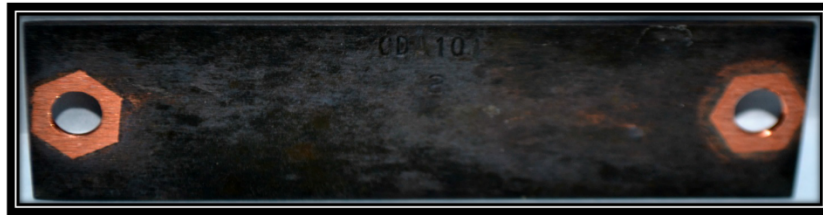
**Figure 9:** CDA101 Sample prior to Corrosion Removal

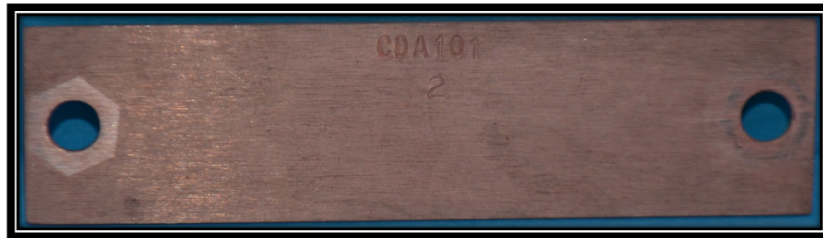
**Figure 10:** CDA101 after Corrosion Removal

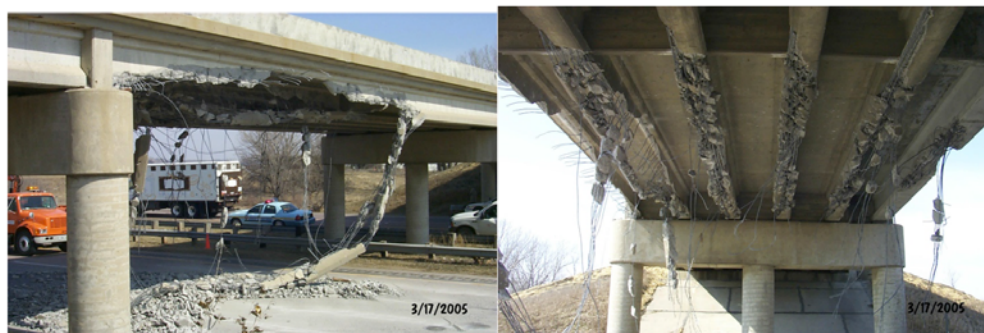
Another issue that comes up quite frequently has to do with the resulting damage that might occur in the event that an HCB bridge is impacted transversely from an over-height vehicle passing under the bridge. Like the issue of fire resistance, this is an issue that is not directly addressed in the AASHTO design codes, but is a legitimate concern. In one study back in 1980, it was documented that about 120 prestressed concrete girder bridges are damaged in the United States each year by impact from over height vehicles (Shanafelt and Horn). Figure 3.1 demonstrates an extreme example of this type of impact. In all likelihood, there are probably even more girders damaged that are not reported. Further, it is likely that an equal or greater number of steel bridges are also impacted each year. Given this frequency of impact, the probability of an HCB bridge being impacted by an over-sized vehicle almost becomes inevitable once a significant number of these bridges have been deployed. The questions that arise are; what kind of damage will be sustained by the HCB for similar impact loads, will an impact load result in collapse of the bridge and how will the HCB damage from an impact be repaired.

Figure 3.1 Photos Showing Prestressed Beam Bridge Impacted by Over-Height Vehicle
