CLIENT: Obsidian Homes

PROJECT: Land adjacent to Brynheulog St Clears

DRAWING TITLE: Tree Location and Arboricultural Impact Assessment

DRAWING NO: ARW1116:01

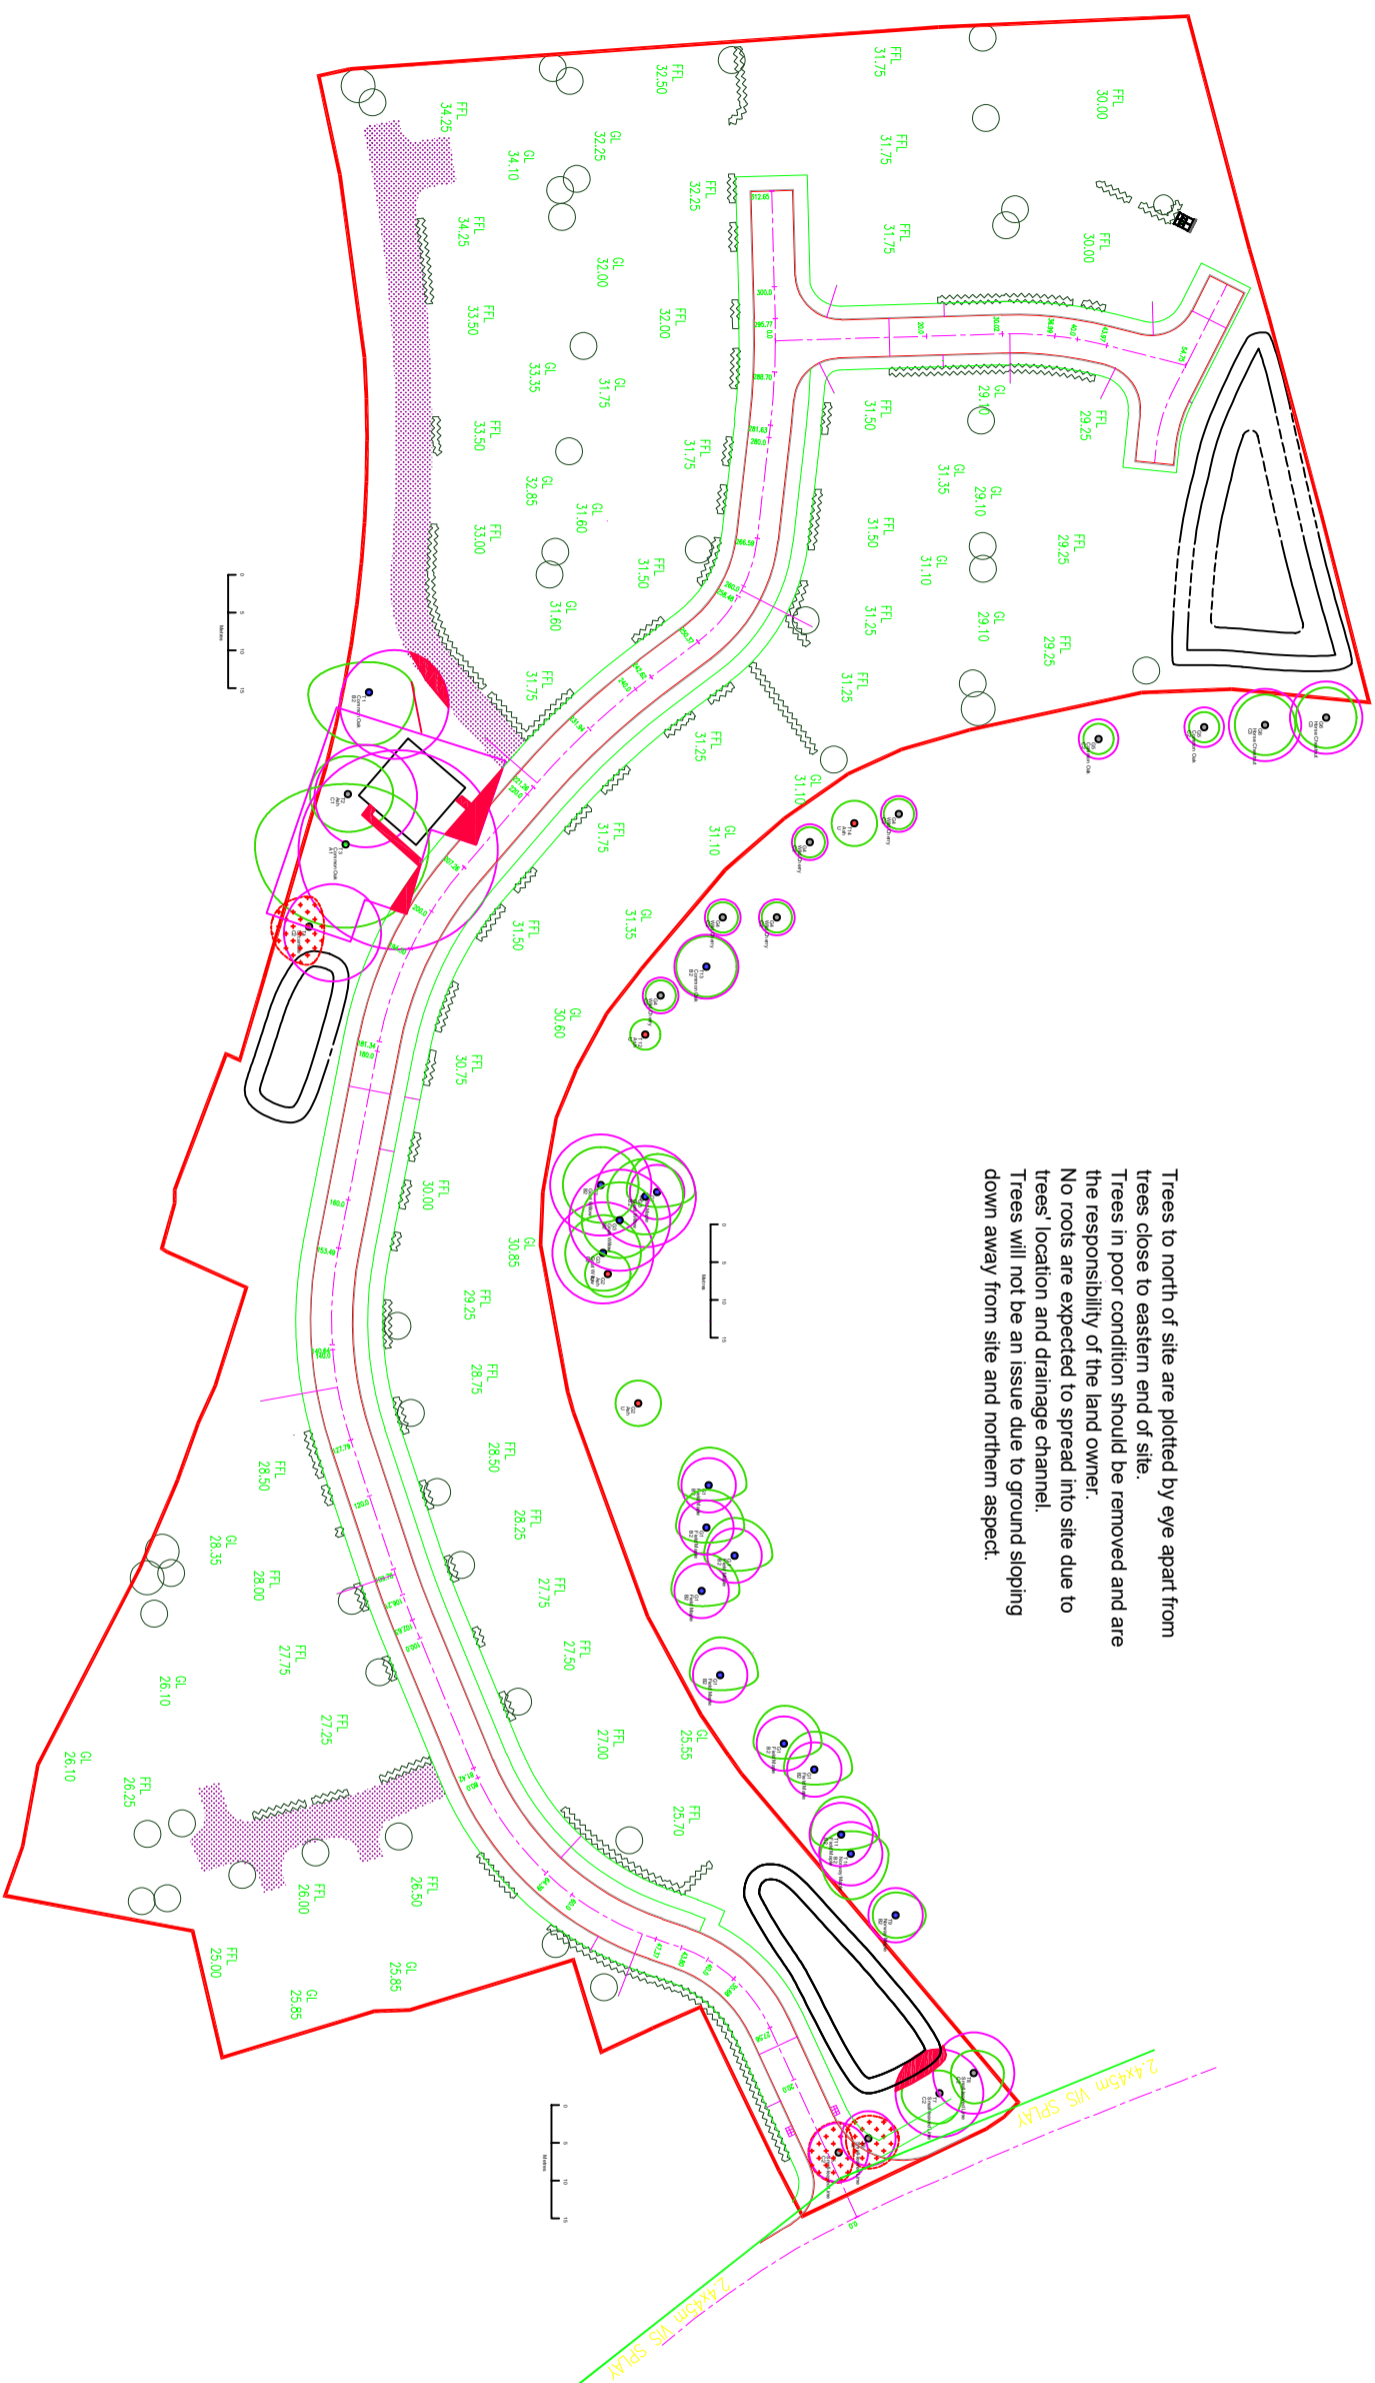
Trees to north of site are plotted by eye apart from trees close to eastern end of site.  
 Trees in poor condition should be removed and are the responsibility of the land owner.  
 No roots are expected to spread into site due to trees' location and drainage channel.  
 Trees will not be an issue due to ground sloping down away from site and northern aspect.

Only roads and attenuation basins close to trees, houses removed for clarity.
