# A GENTLEMAN'S GUIDE TO SMITHS ELECTRONIC TACHOMETERS

## A gentleman's guide to Smiths electronic tachometers

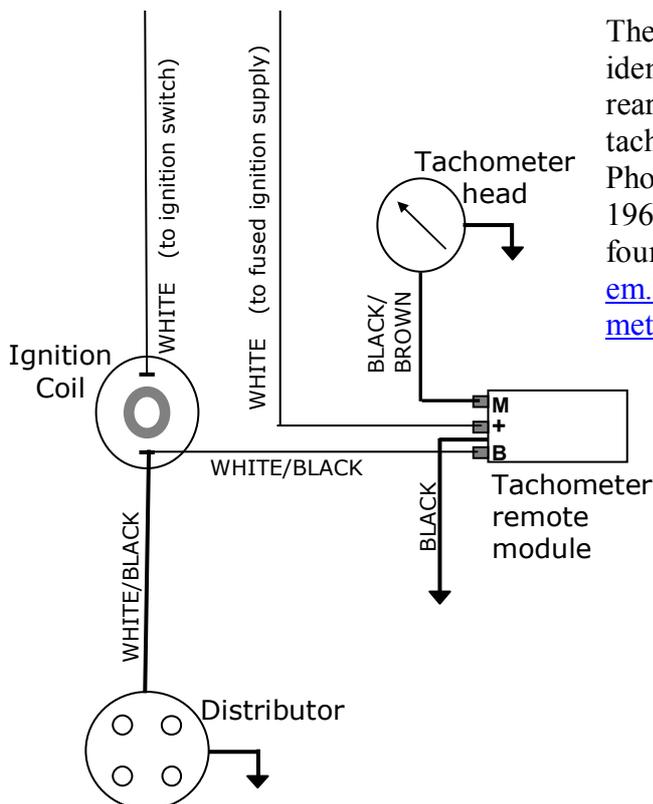
"GEN-0.5" TACHOMETER WIRING AS PROVIDED IN VOLVO SERVICE MANUAL. THIS APPLIES ONLY TO THIS INSTRUMENT!

The tachometer head of these instruments can be identified by the presence of two blade connectors on the rear of the case as the only electrical connections to the tachometer.

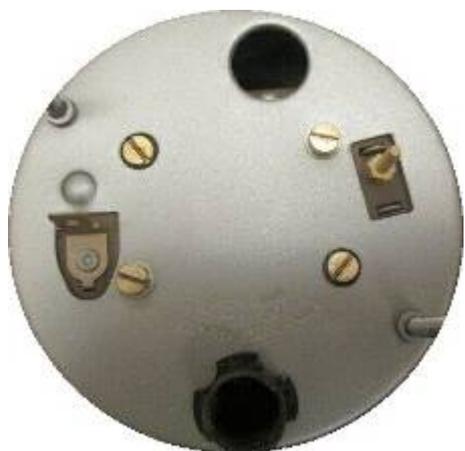
### RVI Gen-1 OEM tachometer:

This is the Gen-1 OEM tachometer which has one of the power supply connections electrically connected to the metal case. In many cases the "red-line" will be marked on the dial but not always. Similarly, polarity will be generally be marked on the dial as shown but this also may not always be the case.

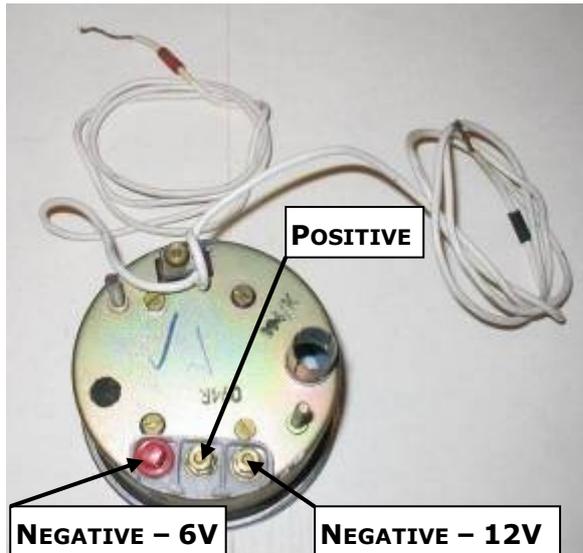
## RVI Gen-1 accessory tachometer:

Picture at left is the Gen-1 accessory type tachometer. The main difference here is that there is no electrical connection between the internal circuitry and the instrument case. Two or three terminals for power supply connection are provided as can be seen in the lower part of the picture. This particular example has two connection terminals, the third terminal being covered by a red plastic cap. The centre terminal is the positive connection. The right-hand terminal, as shown in the picture, is the negative 12V connection and where provided (uncapped), on early production units, the left-hand terminal is the negative 6V connection. The early impulse pickup assembly is shown in detail below.

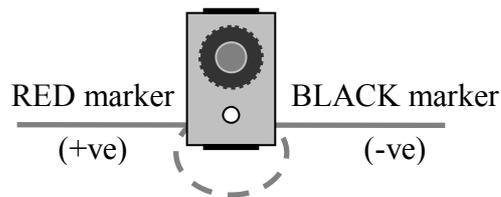
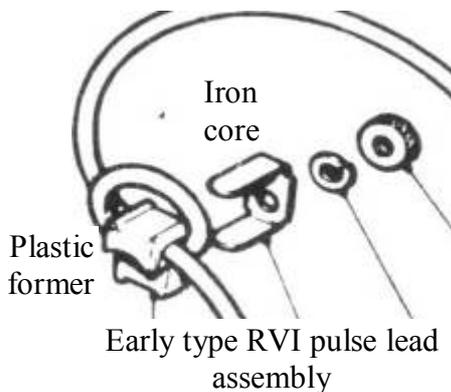
The figures below show the wiring for the pulse lead block attaching to the back of Gen-1 instruments. Accessory type instruments had coloured markers at the end of the long pulse leads when new but these markers were almost always cut off once the tachometer was fitted to a vehicle. Since the sense (or polarity) of these connections is critical to the operation of the tachometer, the sketch below is provided to assist in getting it right first time.

View of assembly as mounted, from rear of tachometer. Dashed line is the loop present on factory/OEM instruments but may be removed for use with higher current (>4 Amps) ignition coils.

A most important piece of the pulse lead assembly of the early RVI tachometer is the "Iron core". Without it, the tachometer will not work! One could easily be made if required. This "little bit of tin" completes the magnetic circuit that allows the tachometer to sense pulses. ***It is a fairly simple matter to make a new iron core. See Appendix C to this document for details.***

The plastic former shown in the diagram holds the pulse lead in place to prevent the wire chafing against the case and shorting out. A replacement could be fabricated from a piece of polyethylene (from an old plastic chopping board for example).

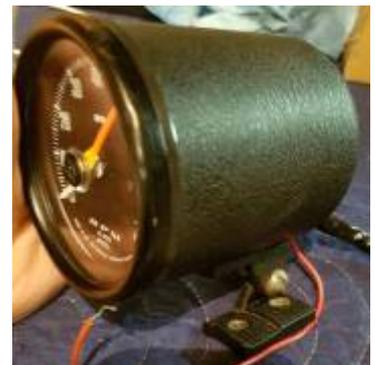
Accessory tachometers are 3 inch diameter instruments. (There may have been a 2 inch type.) Smiths also produced an optional aluminium pod and mount to house these. A special mounting bracket was a part of the pod kit which allowed the instrument to be secured with a single screw at the rear of the pod. These were commonly used when fitting tachometers to Minis. Similar pods were used in some Volvo vehicles. Photo at right shows an accessory tachometer fitted to a pod.

Suitable mounting pods such as this are advertised on the internet and may be available locally in some areas. (Photo supplied by Mark Olson.)

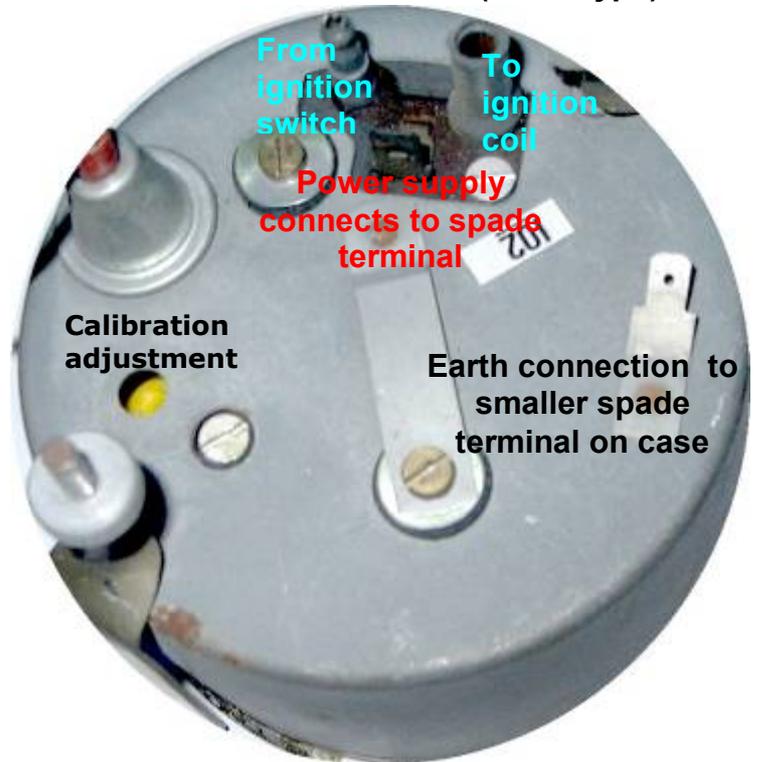
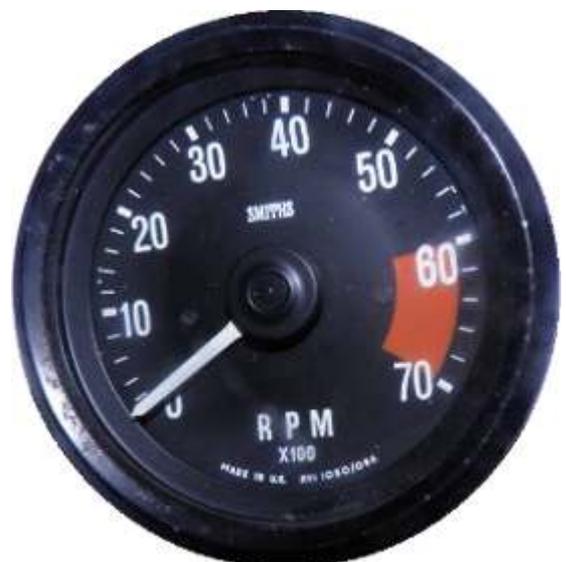
### Pulse connectors (bullet type)

One instrument found fitted with the alternate board is an RVI 1050/06A (right) which was fitted to Rover 2000, and possibly supplied in other marques. Note the presence of a marked "red-line" area which identifies this as an OEM instrument. It may have been fitted to early production, positive earth, models. This is a 3 inch diameter instrument with a spun-on bezel but no polarity marked on the dial (for this particular negative earth instrument). One of the power supply terminals to this unit is connected to the case. One would hope that any positive earth instrument of this type would be marked "POSITIVE EARTH" on the dial. Changing polarity involves opening the case which may require a new bezel. Check tachometer polarity if unsure (refer "Checking an electronic tachometer" later in this document). Note that pulse loop connections, as described above, will be "reversed" for positive earth vehicles!

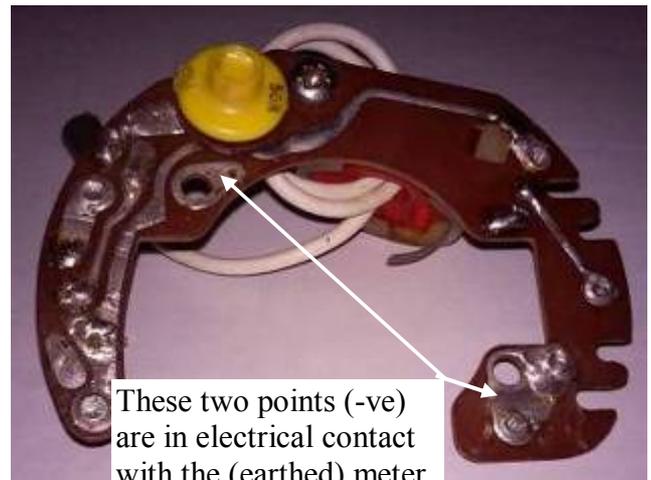
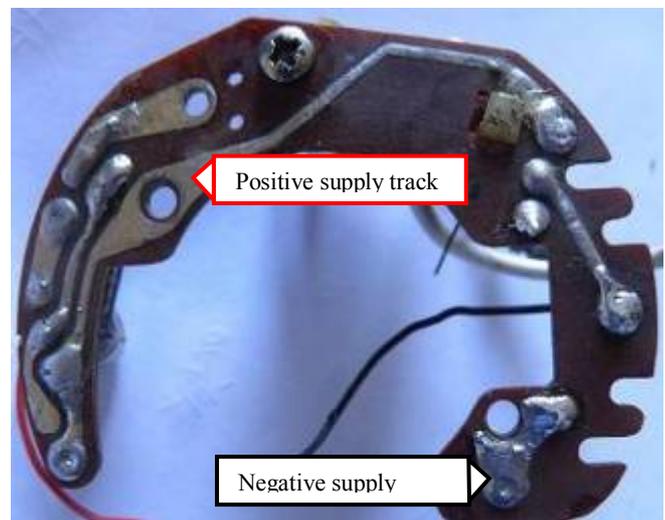
Should you have removed a Gen-2 movement from its case, the pictures on the right show the difference between the two boards used in these instruments.

The "usual" blocking oscillator, gen-2 tachometer circuit board is shown in the top picture, which shows most common circuit board for these instruments. Circuit board tracks make electrical contact with the body of the meter and hence the chassis of the vehicle. The upper left hand track is not generally used but provides a negative supply connection for a caseless instrument. Hence these instruments are always negative earth as isolation cannot be readily or reliably achieved due to the copper tracks extending to the edge of the mounting screw holes.

The lower picture shows a circuit board from another gen-2 instrument, presumably earlier, with a slightly different track layout. It will be noted that the circuit board tracks, for both positive and negative rails, are set back from the mounting holes to prevent connection with the mounting screws. One supply track must be insulated from the meter frame by way of an insulating washer. If this board is mounted without an insulating spacer then a dead short exists between the power supply terminal and the earth via the meter frame. This particular board can thus be configured for positive or negative earth vehicles though this would have been a production, rather than a user, option.

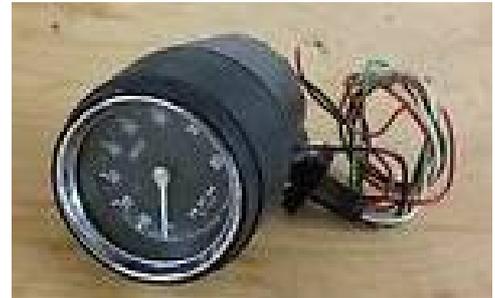
Pulse leads are white and, when new, are marked with short red and black sleeves near the end of the wires.

The red marked wire should connect (for a negative earthed vehicle) to the ignition supply.

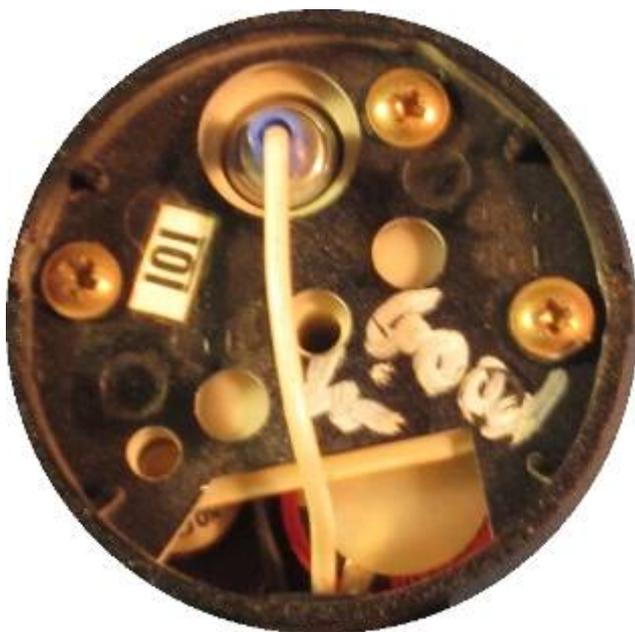
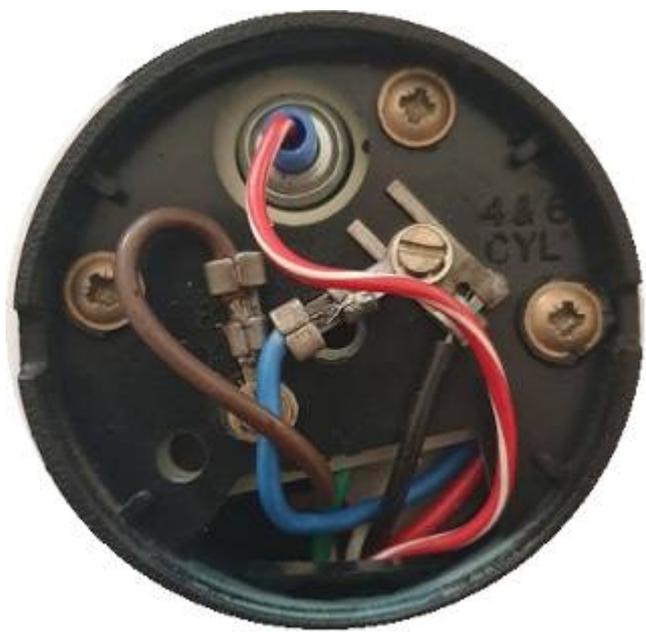
The following pictures show, at left, the rear view of an OEM tachometer, with the cover removed, without a voltage select option. The right-hand picture shows the same view of an accessory instrument and the voltage select terminals. Blue wire is the -12V connection as can be seen here, the brown wire the -6V connection. The black wire is the lead to the vehicle's negative supply. Changing voltage simply involves transferring the black wire to the terminal corresponding to the required voltage.

(Left-hand photo supplied by Mark Olson)

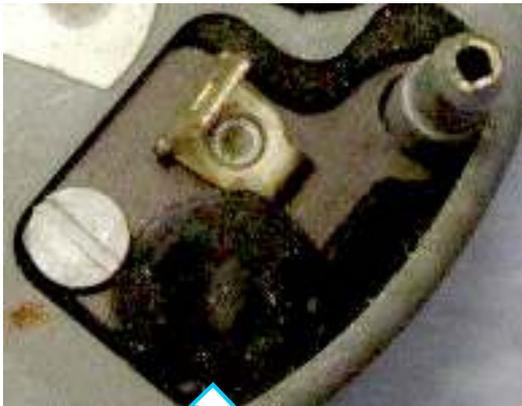
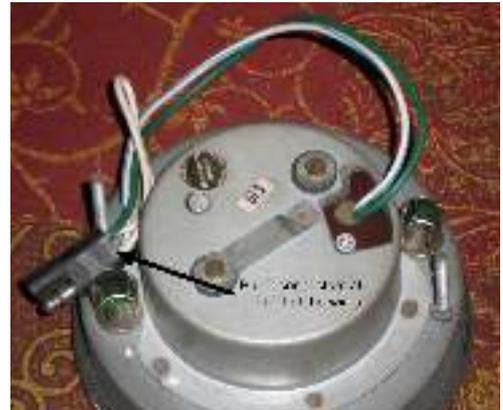
The early model RVC tachometer, with meter mounting holes in a rectangular pattern, is known to have been fitted to MG and Jaguar vehicles in the early 1970s. The "MGB-style" (left) looks almost identical to the Gen-2 RVI model except that the dial is marked "RVCxxxx" and the female pulse lead bullet connector is replaced with a rubber plug. OEM instruments retained the bullet style connector for the pulse lead in most cases. Jaguar vehicles used this same model tachometer with the pulse and supply leads brought out to a 4-pin connector with a white wire looped between two of the pins (below right).

Rubber plug here in lieu of female bullet connector on the RVI tachometer.

*Jaguar tachometer photo courtesy of Mark Olson, Accutach.*

Note that Jaguar's wiring to this connector in this manner allowed an RVC tachometer to be fitted in lieu of an (earlier) RVI type with no wiring changes. Smart.

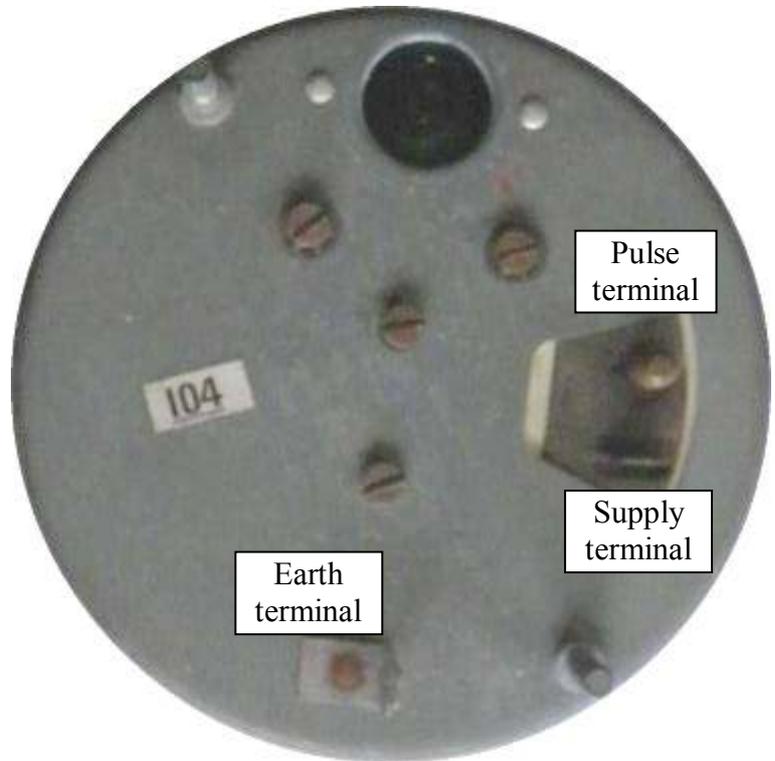
Connections in a late model RVC OEM device consist of a blade connector for power supply, a spade connector spot-welded to the case for negative or earth connection and a single “bullet” type connector for the pulse lead as shown at right. The “Y” mounting screw layout of the Gen-4 instrument is plain to see here.

There were also caseless versions of the Gen-4 instruments manufactured. Gen-4 caseless instruments (e.g. RVC6419/00) were fitted to Triumph TR7/TR8 cars and possibly in other marques.

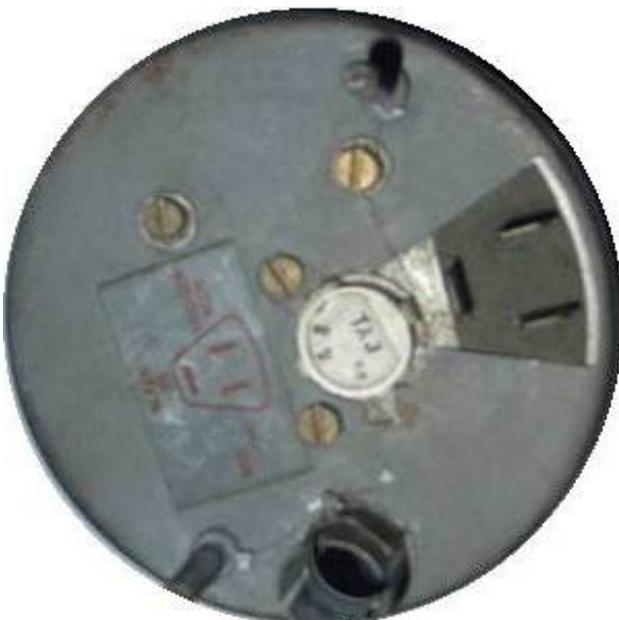
Pictures below show the rear of the “accessory” type Gen-4 tachometer. As with earlier accessory instruments, the electronics inside are electrically isolated from the case.

Note the white selector switch next to the terminals. This selector switch is only found on Gen-4 instruments, Gen-3 RVC tachometers used a switch accessed through a hole in the rear of the case.

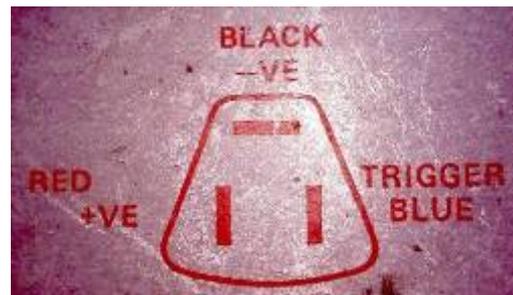
The lower picture is a close-up of the label setting out the connections for all these instruments.

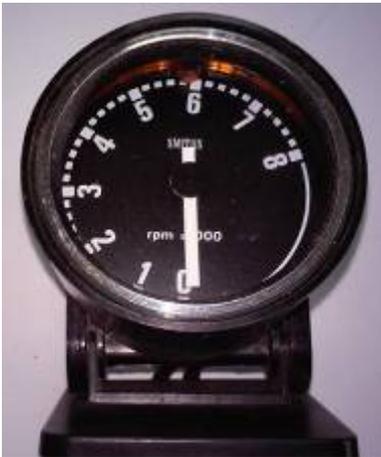
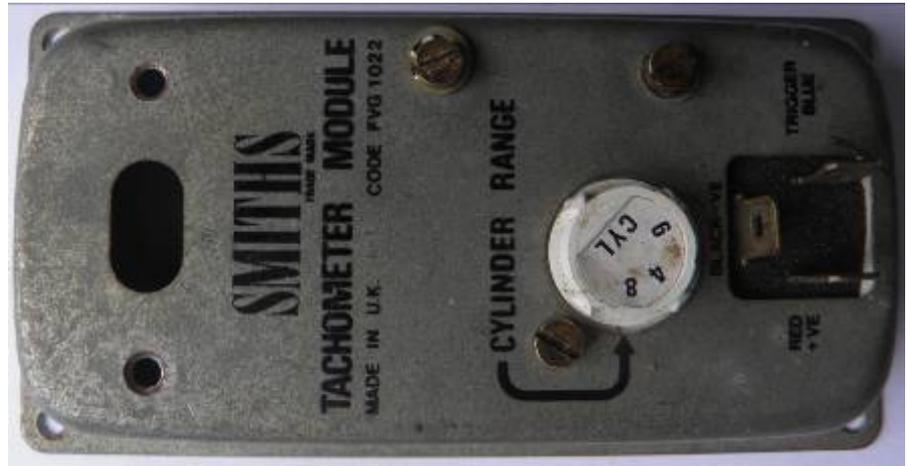
The picture below left shows the RVC range's answer to the RVI 5000 series instruments. This comprises a small indicator head designed to be mounted on a dashboard with sticky pads fitted to the base. Four wires (2 for meter, 2 for lighting) lead from the underside of the indicator head through a hole cut in the dashboard. All the electronics are housed in a rectangular metal case which is intended to be hidden behind the dashboard. Power and pulse connections are made at the electronics unit and are the same as those shown for the Gen-4 accessory tachometer above.

The pictures below show this instrument. A two-pin socket for connection to the indicator pod meter is provided and located where the hole is above "Smiths" in this picture.

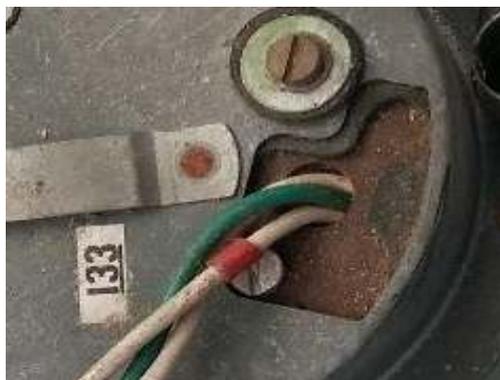
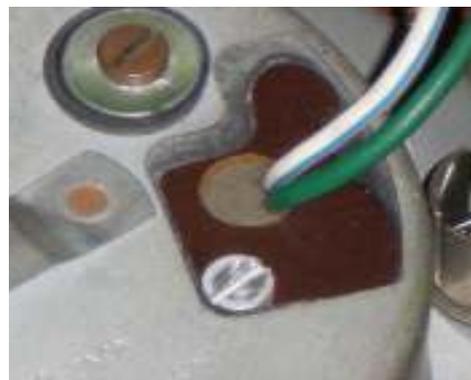
If testing Jaguar tachometers, make sure you identify the correct type, which is printed on the dial but may not be legible. The left-hand tachometer in the picture is a Jaguar gen-2 RVI tachometer (two white leads from inside case), the one on the right a gen-3 RVC (single white/blue lead from inside case). Use tests below appropriate for type.

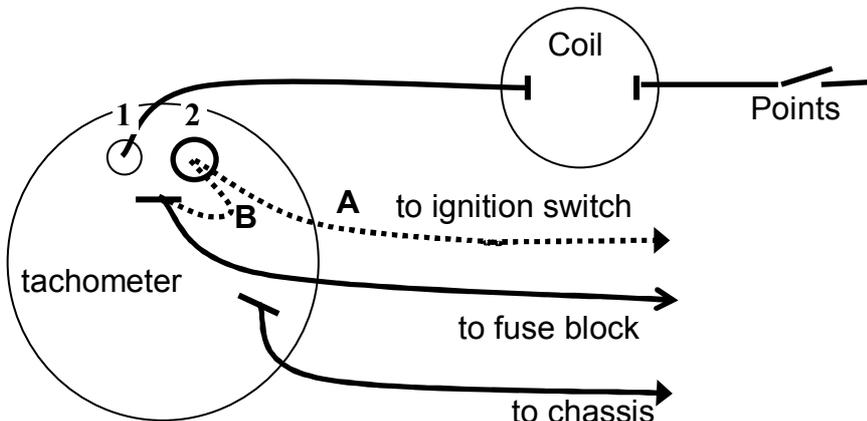
The diagram below shows how to connect the Gen-2 RVI OEM instrument. Illustrations in Appendix A show the earlier type.

While it is possible to place a jumper as shown at "B", the connection "A" represents "best practice" with the power to the instrument from a fused supply.

This should have the tachometer displaying rpm with the engine running. If not, check first for smoke (supply polarity wrong) then for 12 volts between the case and the spade terminal. If this is OK then swap connections to terminals 1 and 2. If the tachometer is still not working then it needs repair.

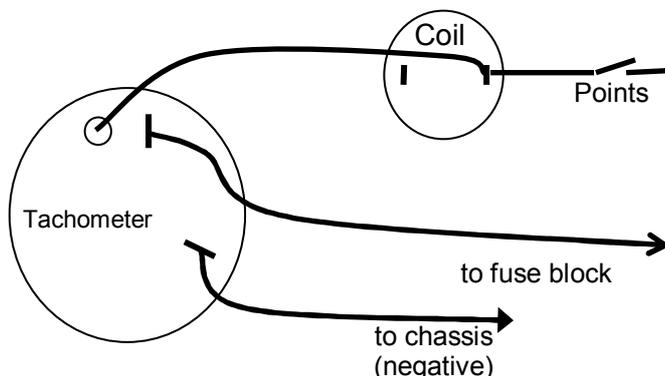
The sketch below shows how all OEM RVC tachometers are connected. The accessory tachometer is wired similarly though the terminals style differ – refer Appendix A.

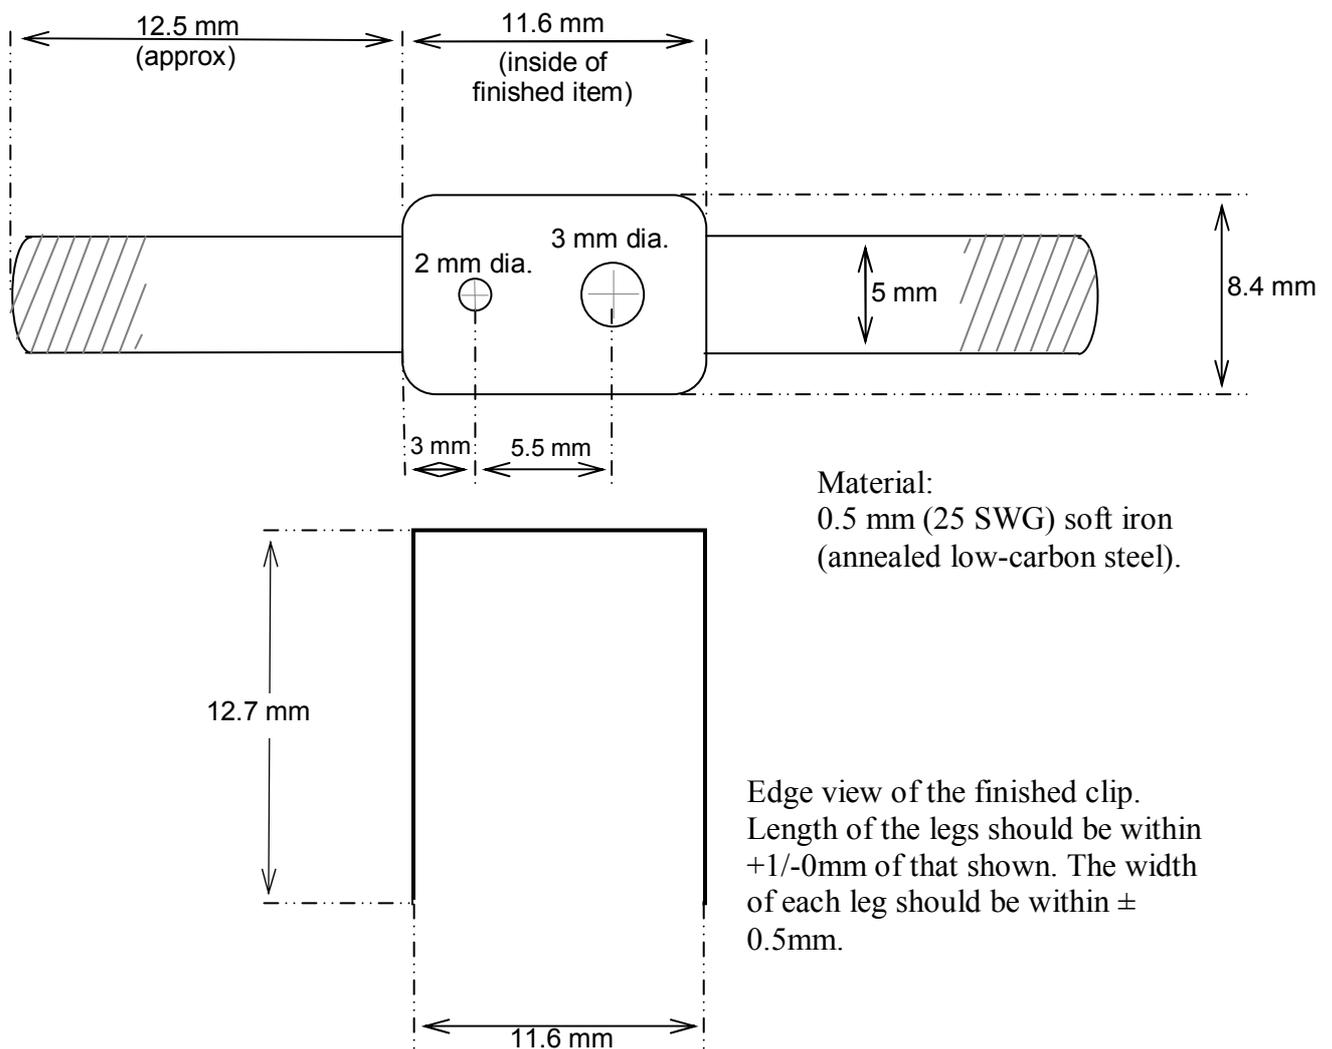
The sketch below is a pattern the iron core, or clip, of the Gen-1 tachometer. One can readily be made if required. Dimensions have been obtained from a Smiths item in good condition.

A strip of metal 5mm wide could be used for the whole thing but I would suggest in this case a brass washer is placed beneath the securing nut.

Make sure that any ragged edges and burrs on the completed core have been removed.

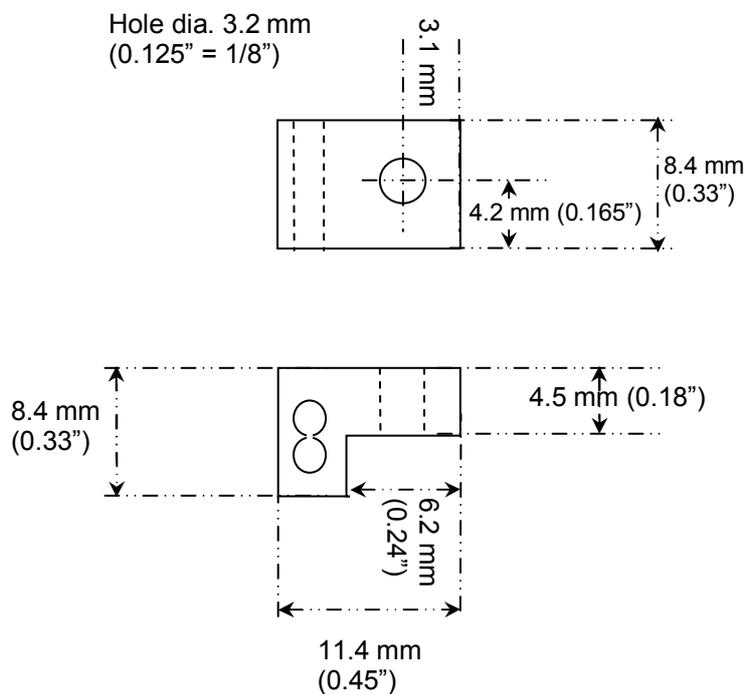
The block (below) is not critical in most dimensions and can be made from any insulating material. Possibly the most available would be polyethylene from an old cutting board.

The sole purpose of this block is to prevent chafing, and eventual shorting, of the pulse loop wires against any metal components. The original item has raised guides to locate the clip. These have not been shown here. If it was desired to more accurately mimic the original then increase the width between the legs of the clip by 1 mm and cut a 5 mm chase, 0.5 mm deep, on each side of the block to locate the steel clip.

The most critical dimensions are the overall width that fits inside the clip (previous page), the overall height (needs to be close). The chase cut to clear the nut supporting the internal core/coil assembly must be sufficient to clear the nut (approx 4 mm). If not providing guides for the clip legs, a small dab of silicone sealant between the block and the clip would prevent movement.

Siamesed holes for the pulse loop wires are shown as for the original pattern and are 3.2 mm (1/8") diameter. The holes can be separated slightly if needed and the pulse loop wires should be a firm fit through them.
