CINCINNATI PUBLIC RADIO

RE-THINKING  
A NEW HOME

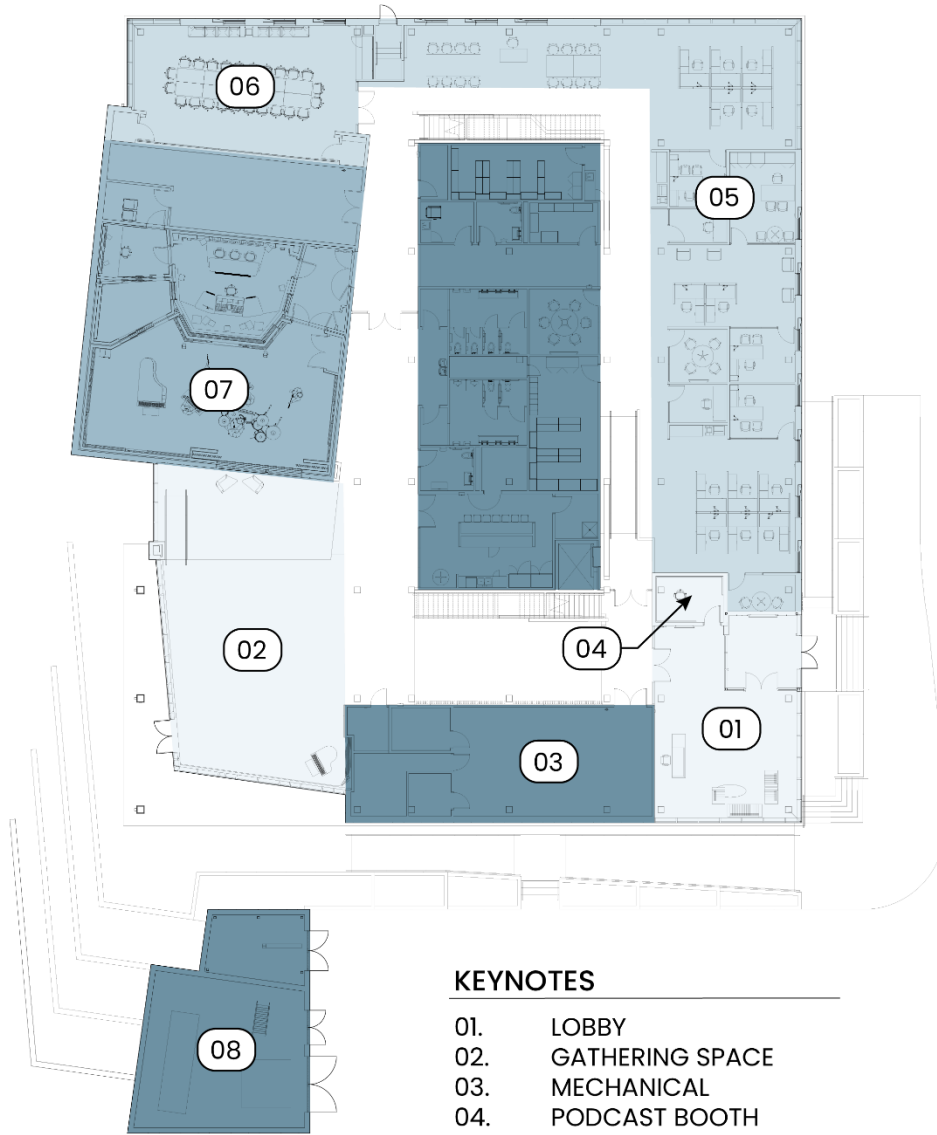
## LEVEL 1

### KEYNOTES

- 01. LOBBY
- 02. GATHERING SPACE
- 03. MECHANICAL
- 04. PODCAST BOOTH
- 05. OFFICES
- 06. BOARDROOM
- 07. PERFORMANCE STUDIO
- 08. GENERATOR & TRASH
- 09. BALCONY

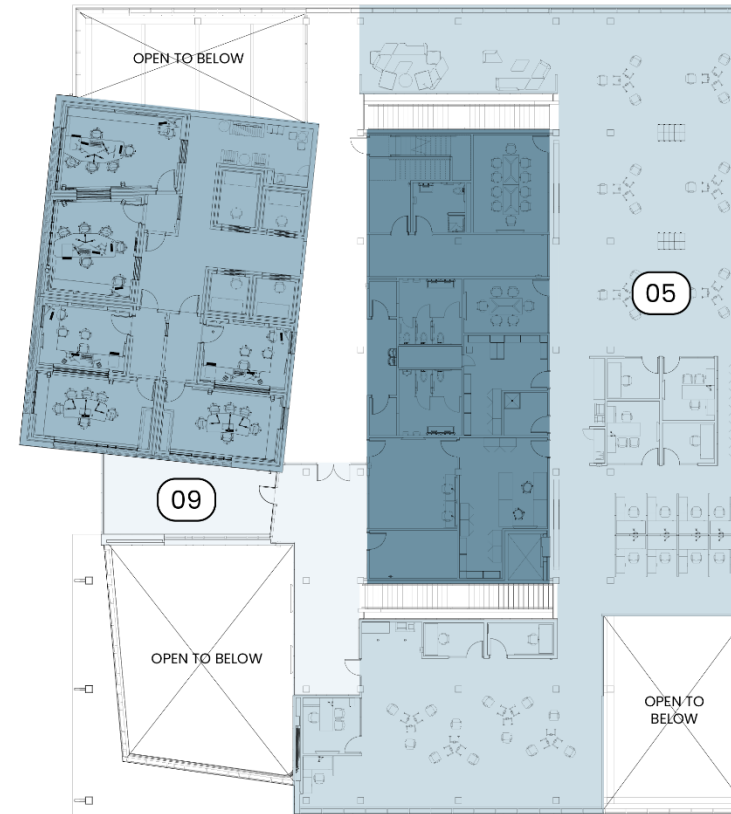
## LEVEL 2

- UTILITY / ENCLOSED
- STUDIO SPACE
- BUSINESS
- PUBLIC SPACE

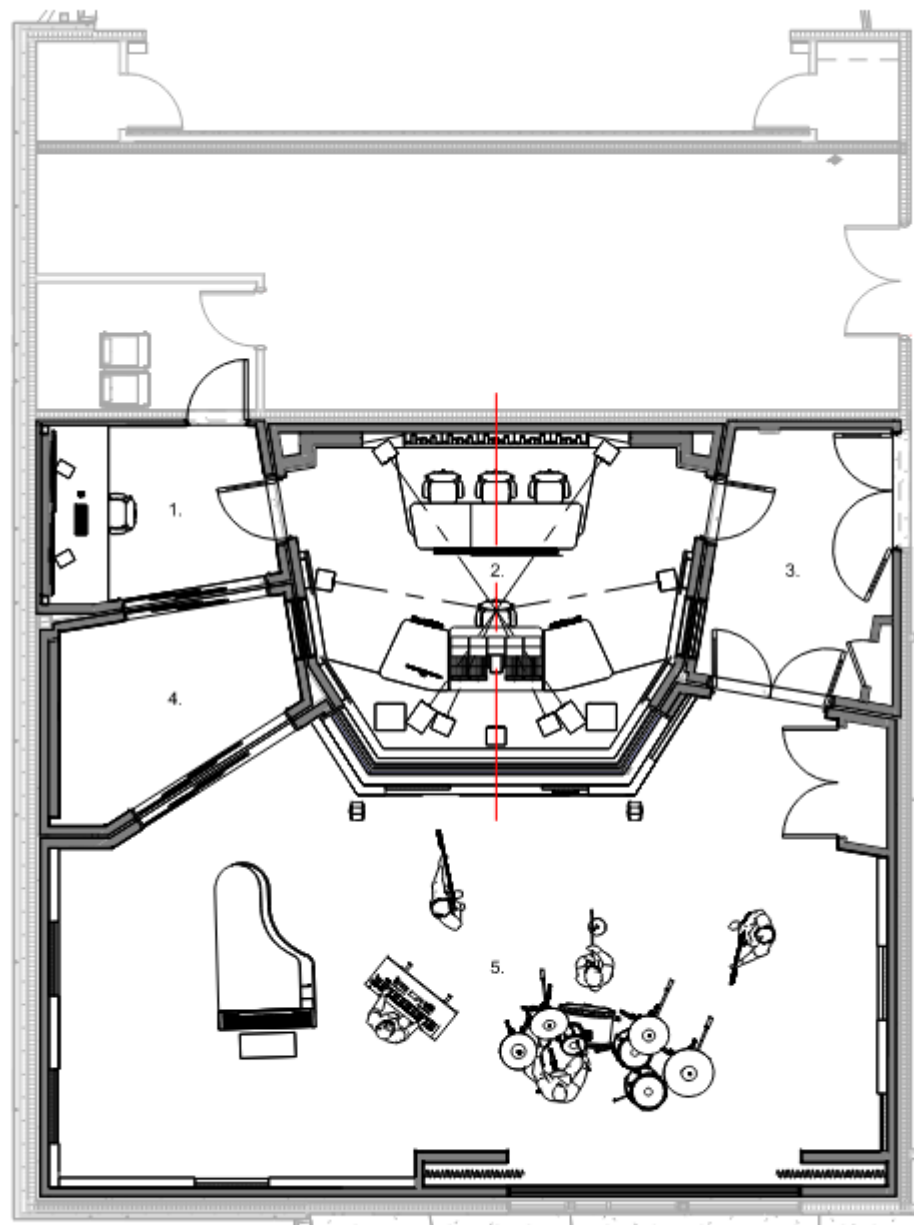
**Studio A**

- 1. VCR
- 2. Control Room A
- 3. Sound Lock
- 4. Isolation Booth
- 5. Live Room A

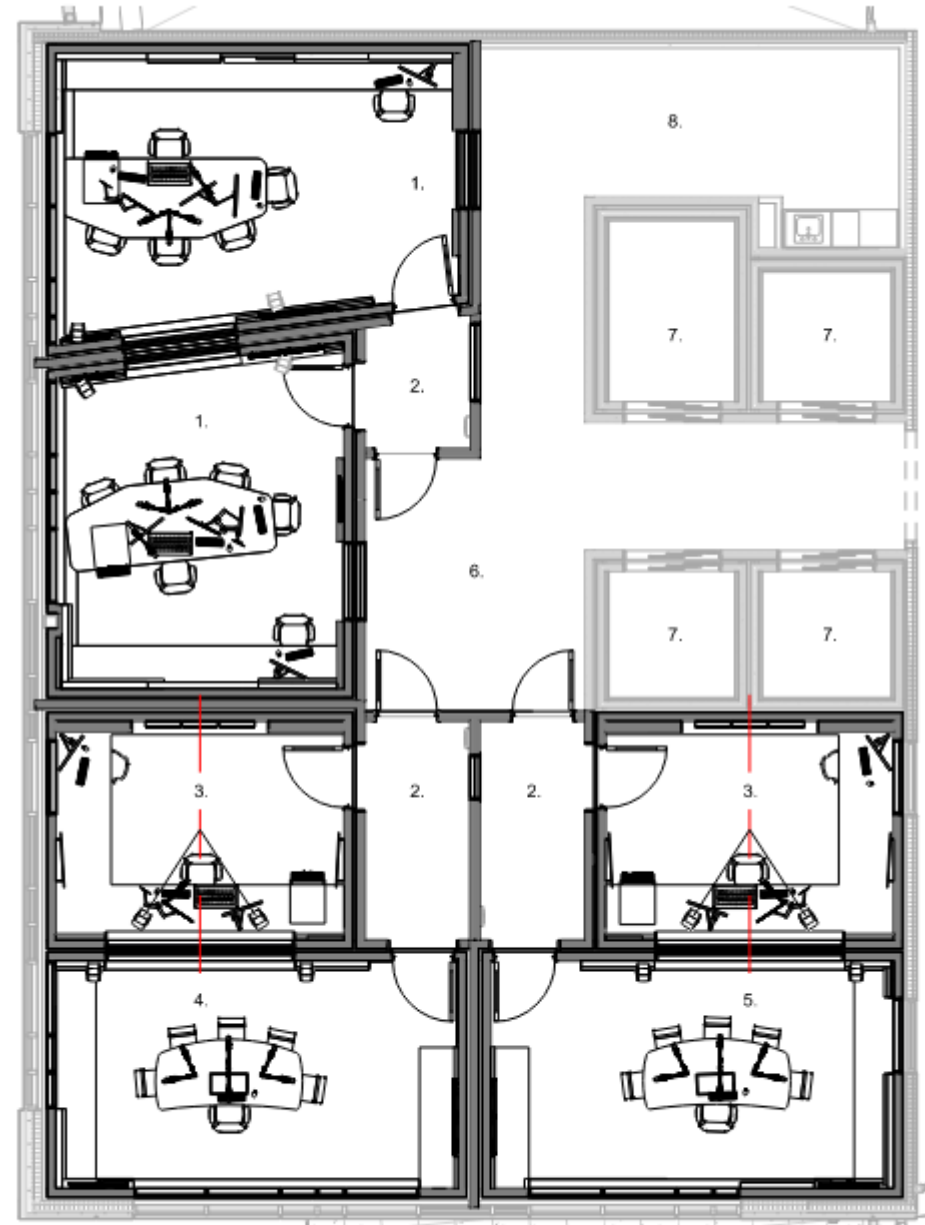
**On-Air & Interview Studios**

- 1. On-Air Studio
- 2. Sound Lock
- 3. Interview Control Room
- 4. Art & Culture Studio
- 5. News & Information Studio
- 6. Suite Lobby
- 7. Edit Pod
- 8. Green Room

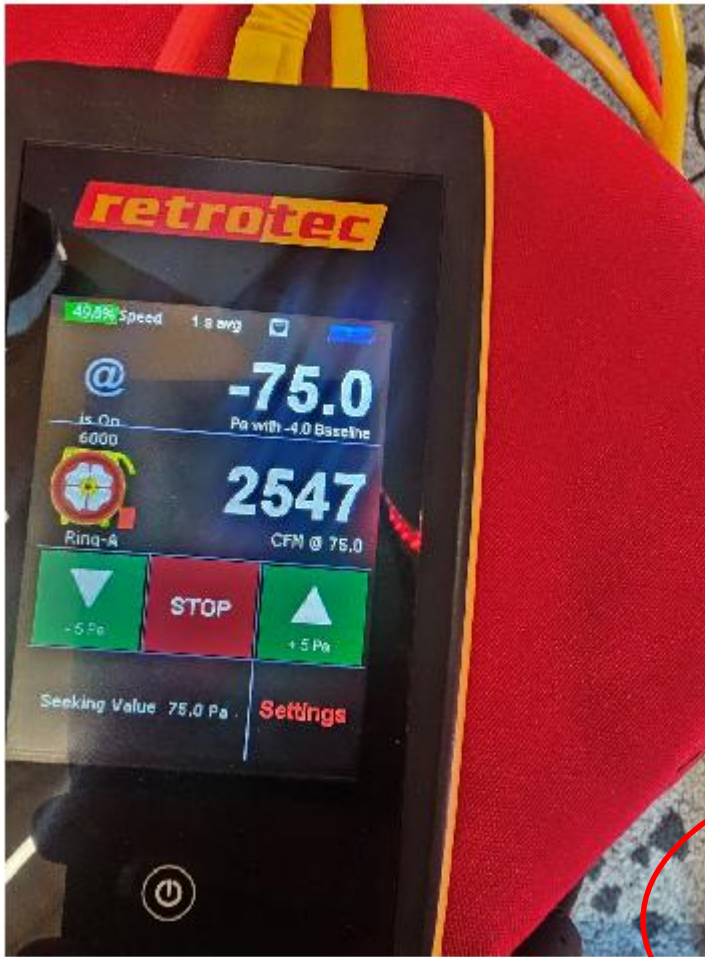
Project Location Norwood, OH  
Date: 12/19/2024  
Test By: IHH  
Witness: MD  
Door Set Up Man Door @ North  
Elevation  
Ambient Conditions 39F/81%RH  
OverCast  
Wind Calm  
Average Pressure Baseline (Pa) -4.233  
Envelope Area: 54,971  
Induced Pressure Target -50, -75Pa  
Allowable Leakage (CFM) Per SF 0.2  
Allowable Leakage @ Pressure 10,994

| Pass | Pass | Specified .2 CFM/SF @ 75 Pa |

| Average Leakage @ Pressure 50 Pa | 2,087 |
| Average Leakage per SF @ Pressure 50 Pa | 0.038 |
| Average Leakage @ Pressure 75 Pa | 2,693 |
| Average Leakage per SF @ Pressure 75 Pa | 0.049 |
