TIMKEN

BEARING DAMAGE ANALYSIS REFERENCE GUIDE

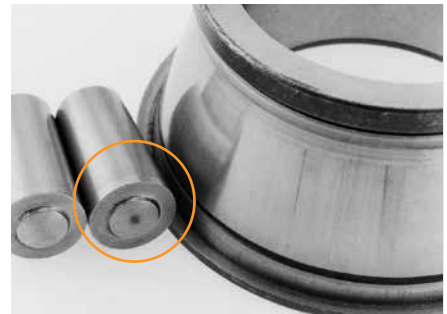
Fine particle contamination caused abrasive wear on this tapered roller bearing.

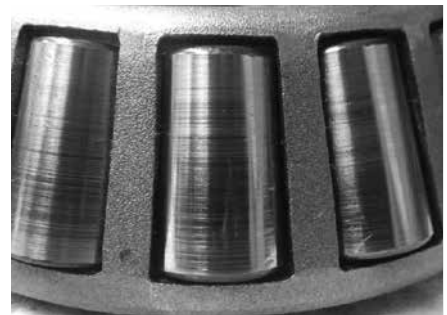
Circumferential grooving.

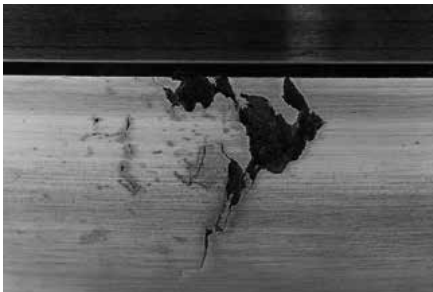
A tapered roller bearing inner ring with spalling from debris contamination bruises.

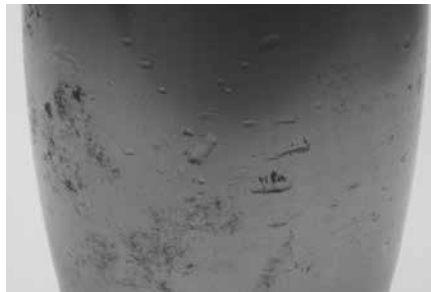
Hard particles caused contamination bruising on this spherical roller bearing.

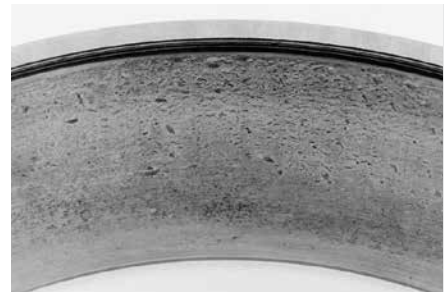
Debris from other fatigued parts, inadequate sealing or poor maintenance caused bruising on this tapered roller bearing race.

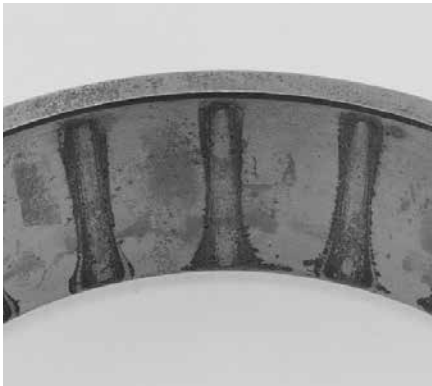
This outer ring has heavy corrosion on the race. This type of corrosion may only be a surface stain without pitting. If the staining can be cleaned with a fine emery cloth or crocus cloth, the bearing may be reused. If there are pits that cannot be cleaned with light polishing, the bearing should either be discarded or, if practical, refurbished.

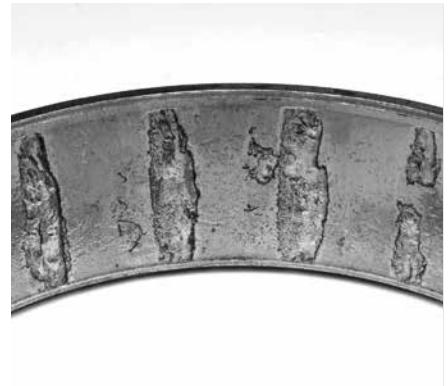
Advanced spalling initiated at water etch marks on the outer ring race makes this bearing unsuitable for further service.

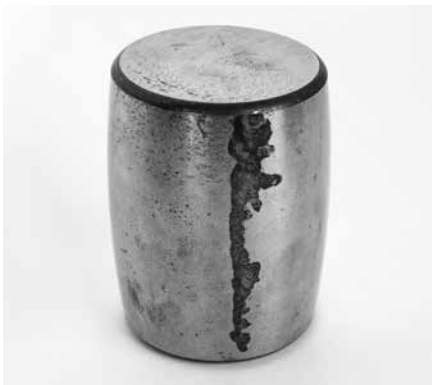
Advanced etching.

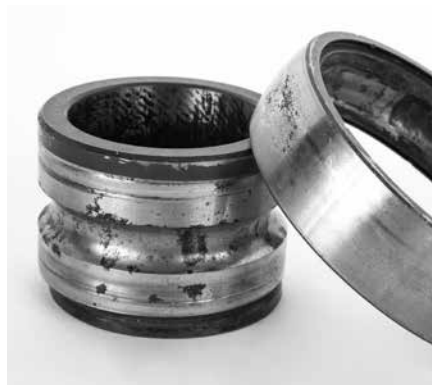
Advanced corrosion and etching.

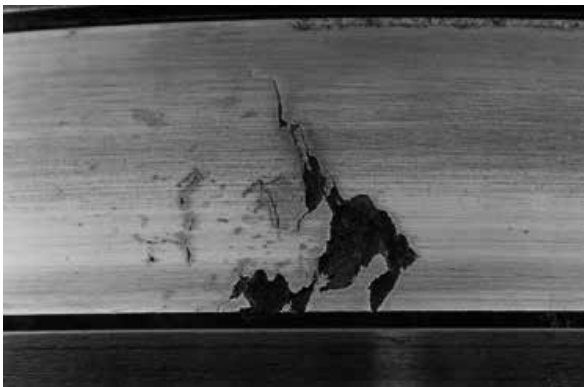
PSO spalling caused by debris or raised metal exceeding the lubricant film thickness on this tapered roller bearing inner ring.

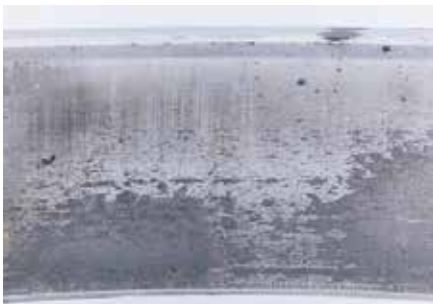
Level 2 – Micro-spalling or peeling results from thin lubricant film due to high loads/low speed or elevated temperatures.

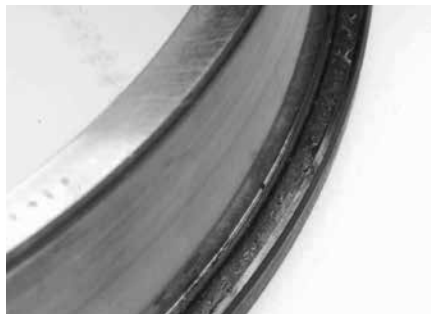
Level 2 – Advanced rib scoring is due to inadequate lubricant film.

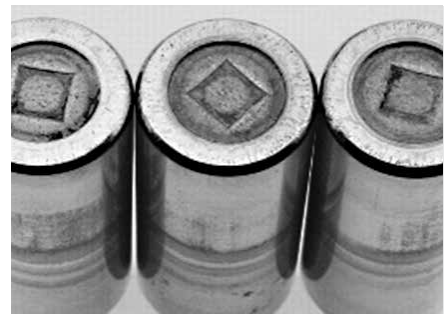
Scoring damage on roller end.

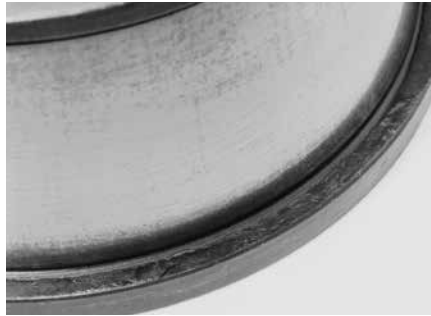
Rib and roller end heat damage.

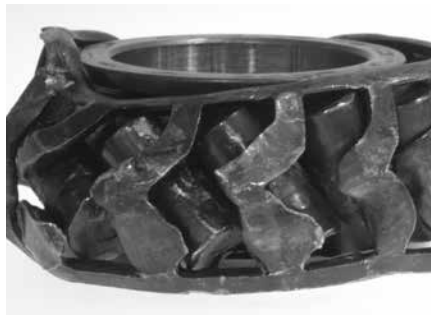
Cage damage from bearing lockup.

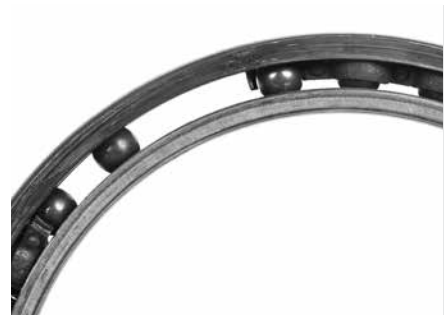
Cage damage from bearing lockup.

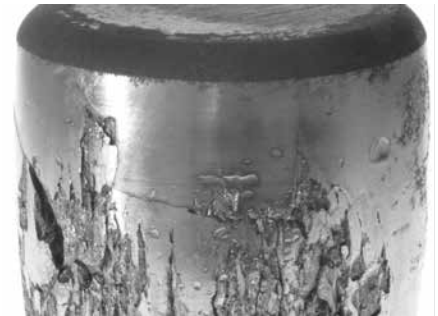
Heavy spalling and fracturing from high loads on this spherical roller bearing.

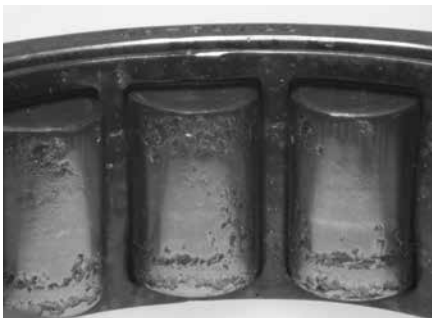
High loads resulted in fatigue spalling on this cylindrical roller bearing.

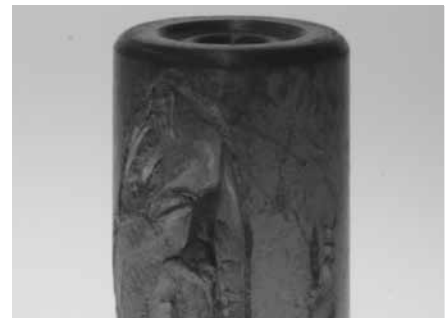
Overloading on this cylindrical roller bearing caused roller surfaces to fracture.

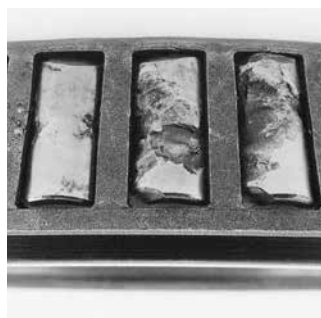
A heavily overloaded tapered roller bearing resulted in premature, severe fatigue spalling on the rollers. The load was so heavy that large pieces of metal broke off the rollers.

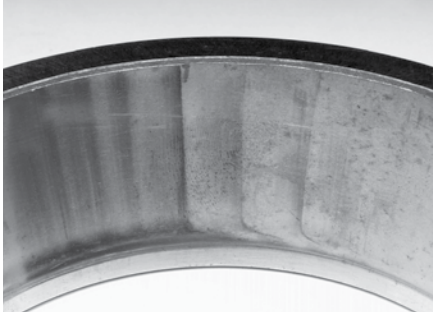
Scalloping marks in the outer ring are common with excessive endplay. This occurs when unloaded rollers enter the small load zone and are suddenly exposed to heavy loads.

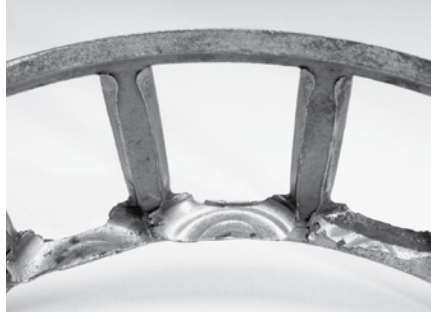
Cage pocket damage results from excessive roller movement.

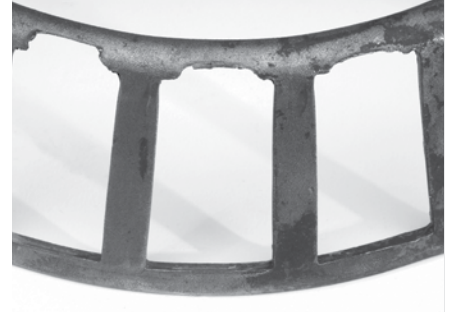
Heavy wear in the small end of the cage pockets is typical of excessive endplay.

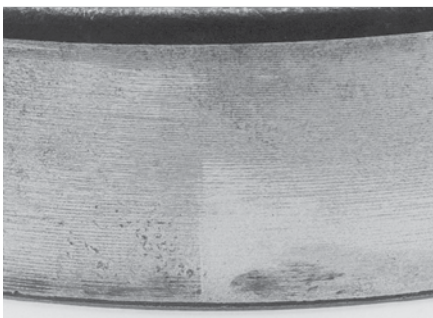
The marks visible on the outside diameter of this outer ring are caused by a high spot on the housing. The outer ring race was found spalled at the location that corresponds to the outer ring mark from heavy contact with the housing high spot.

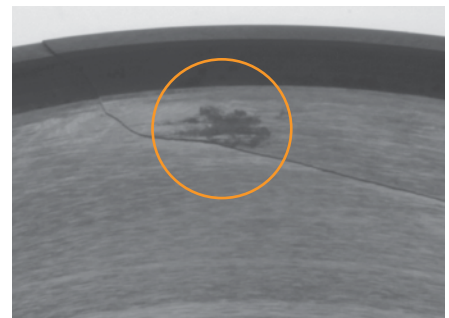
This ball bearing inner ring fracture resulted from installation on top of a metal contaminant or raised metal nick.

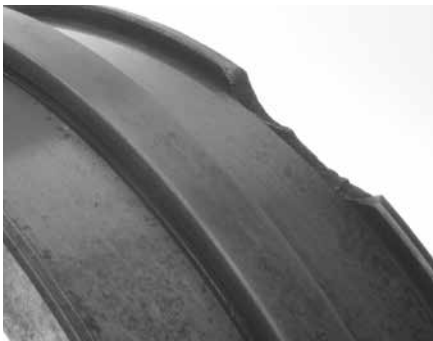
This spherical roller bearing inner race depicts a fractured small rib caused by the use of improper installation tools.

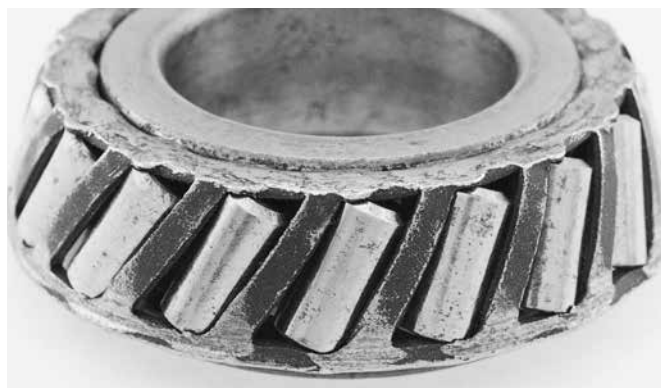
Binding and skewing of these tapered rollers was due to compression of cage ring during installation or interference during service.

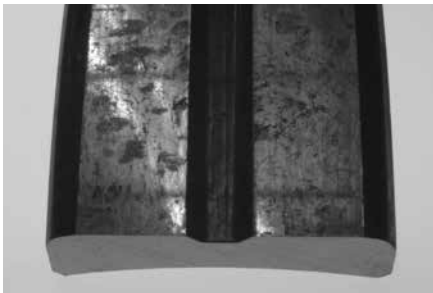
A worn-out housing caused this bearing to lose fit and fret (move) during service. As a result, metal tearing and wear occurred on this spherical outer ring.

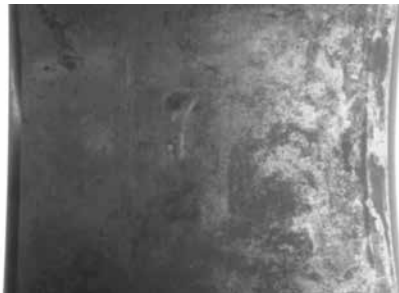
Classic fretting corrosion from poor fitting practice is depicted here. Relative movement under load between the bearing and its seat caused this worn and corroded condition.

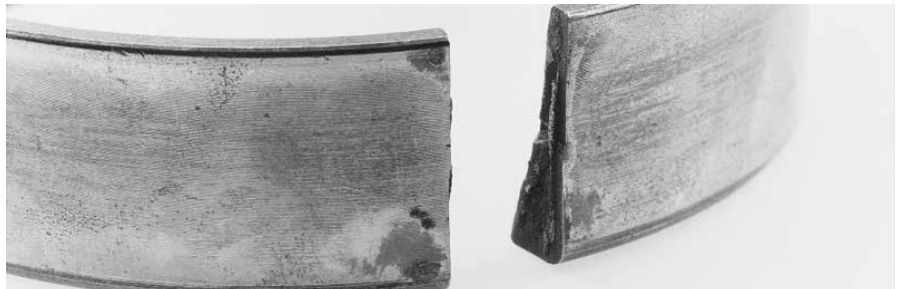
Cracked outer ring in a wheel hub. The outer ring turns and wears the outer ring seat so the fit becomes more loose. Then the outer ring starts to stretch or roll out. Wear and stretching continues to the point where the metal reaches its breaking point and the outer ring cracks open.

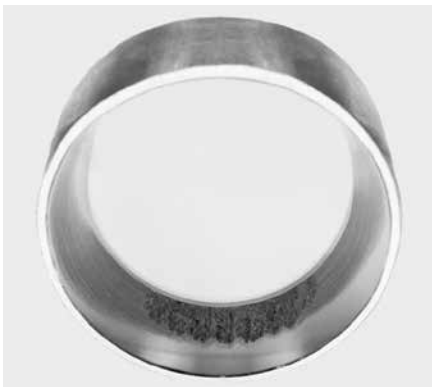
Deflection, inaccurate machining or wear of bearing seats caused an irregular roller path on this tapered roller bearing outer ring.

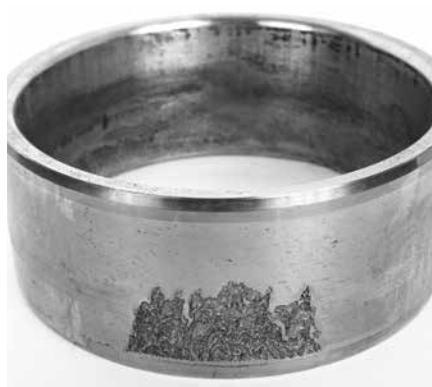
Heavy loads causing shaft deflection can lead to GSC spalling in this cylindrical roller bearing inner ring.

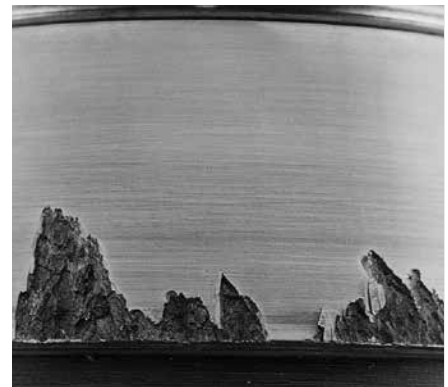
Geometric Stress Concentration (GSC) spalling.

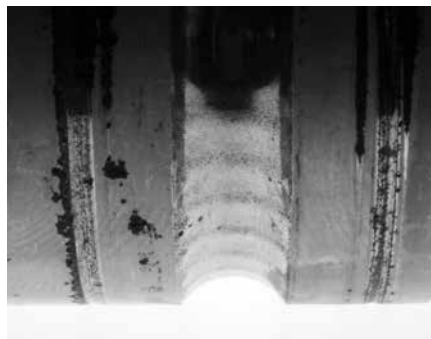
Note shock loading caused brinell damage on this ball bearing inner ring.

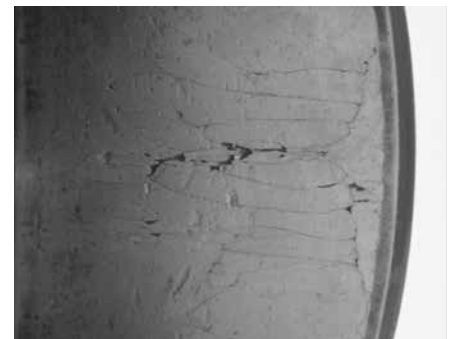
This cylindrical roller bearing inner ring was crushed by an application failure during service.

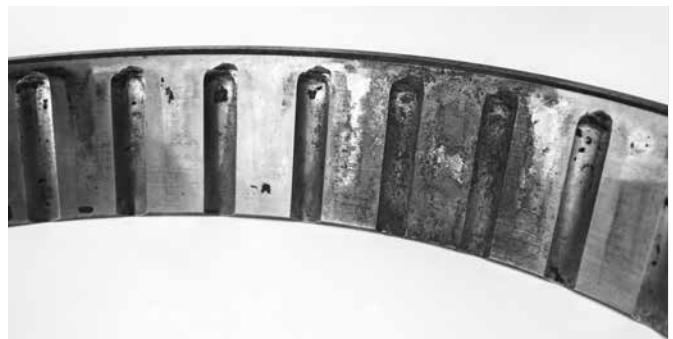
Heavy false brinell on outer race.

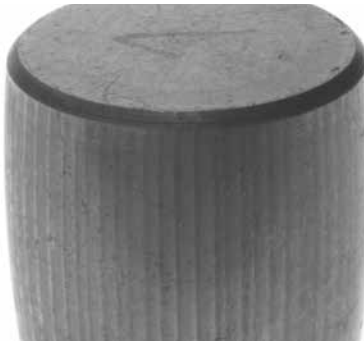
Welding on a machine, while the bearings were rotating, caused electric arc fluting on this spherical roller bearing.

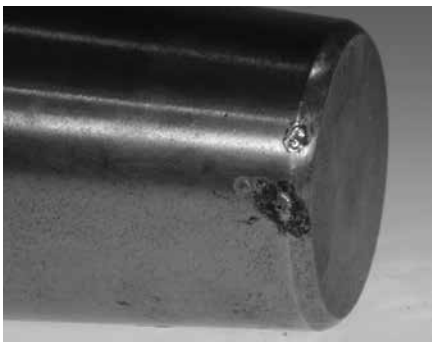
Roller with electric arc burns.

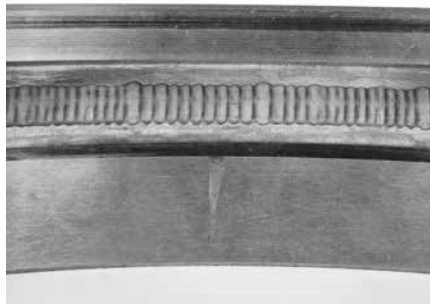
Burns from electric current.
