MAINTAINING ASSET INTEGRITY IN THE OIL AND GAS INDUSTRY – UPSTREAM

Belzona Protective Coatings and Engineering Composites

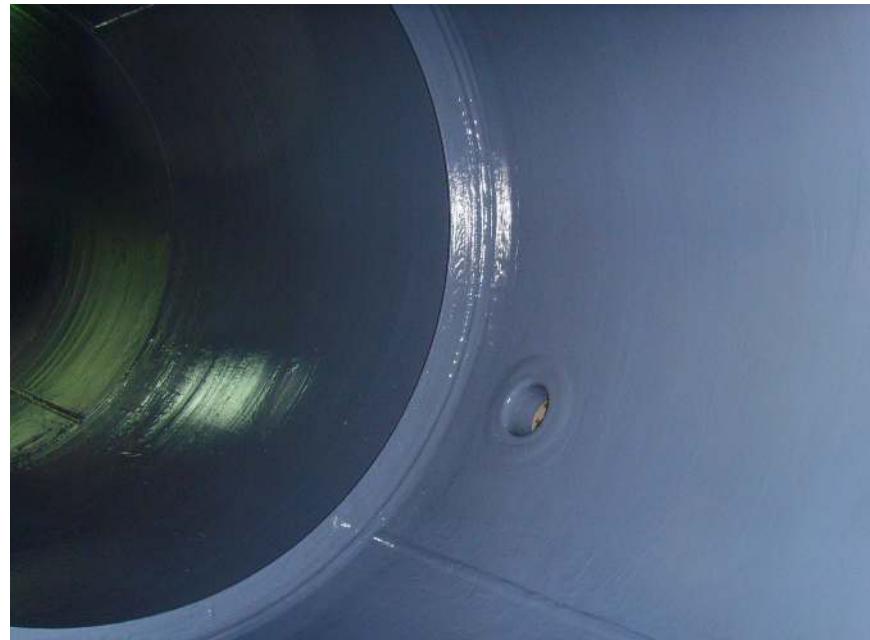
Belzona lining applied to a newly fabricated separator

Our linings can be spray or hand applied and, once cured in service, form a barrier between the substrate and corrosive media, enabling the operator to implement a corrosion management plan. As well as resisting erosion-corrosion, Belzona linings are designed to withstand vast pressure and temperature fluctuations, including steam-out and explosive decompression.

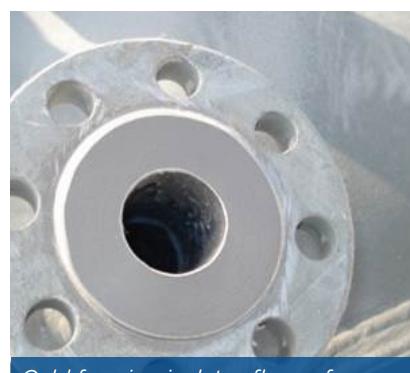
Cold forming isolates flange faces from corrosive media

Crevice and galvanic corrosion can be prevented or repaired with a unique Belzona composite forming technology. Prefabricated formers are used to shape the specified Belzona material that bonds strongly to the flange face. The sealing face is then effectively isolated from corrosive media whilst maintaining its shape and profile.

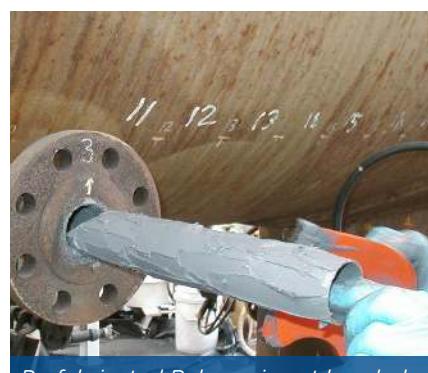
Prefabricated Belzona insert bonded into small bore nozzle

Narrow nozzles no longer need to be considered "the Achilles' heel" of process vessels. Tailor made Belzona inserts can be bonded into the nozzle using a fluid grade material, eliminating the risk of pinholes or holidays. Excellent chemical and erosion resistance ensures long-term protection of the nozzle, thus extending maintenance-free periods.

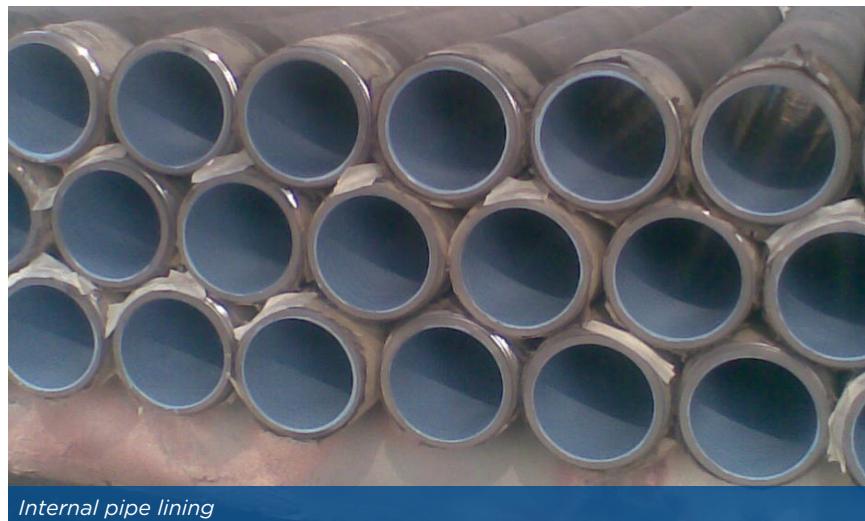
Internal pipe lining

Sprayable erosion-corrosion protective linings allow for the material to be spin spray applied in situ at wet film thickness up to 1250 microns without sagging, effectively covering girth welds and joints in a single coat. The thermoplastic filler blend is formulated to achieve excellent impact and sliding abrasion resistance, a high degree of toughness and chemical resistance.

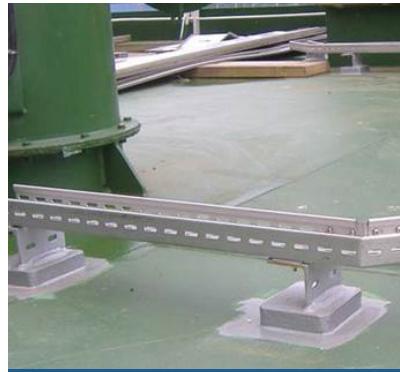
Cable tray bonded on FPSO

Cold bonding deck equipment eliminates the need for hot work and facilitates rapid installation. With tensile shear adhesion of up to 2,960 psi (20.4MPa), pull off adhesion of up to 3,240 psi (22.3MPa) and flexural strength of up to 14,300 psi (98.6MPa) deck equipment, framework and supports can be bonded permanently and safely. Belzona cold bonding is equally effective at a fabrication stage, during turnarounds or whilst the platform is in operation. Belzona cold bonding materials are also recommended to fill gaps arising in tack welded elements, such as pipe saddles supports.

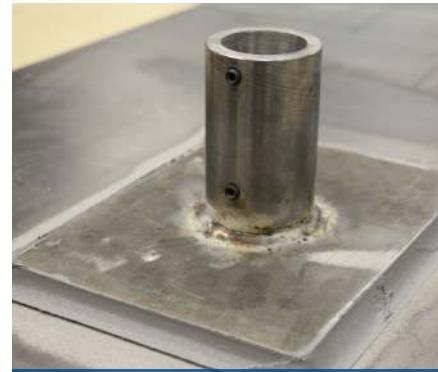
Handrail bonding

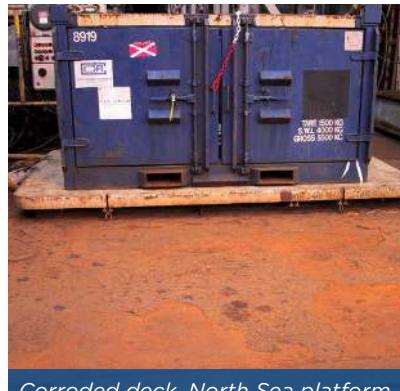
Corroded deck, North Sea platform

Corroded equipment and structures can be repaired in situ with Belzona's pioneering injection bonding technology. This technique has been successfully utilised for deck renovation and other structural integrity repairs. Over a decade of successful applications, which are still in service today, attest to this method's effectiveness and have prompted engineering houses to specify injection bonding for greenfield applications.

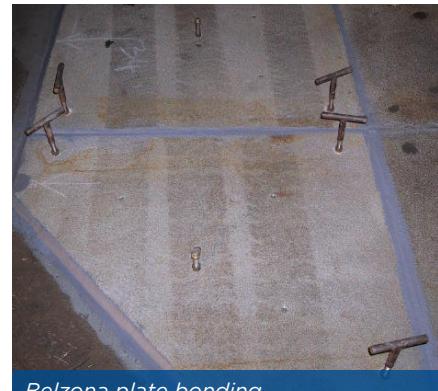
Belzona plate bonding

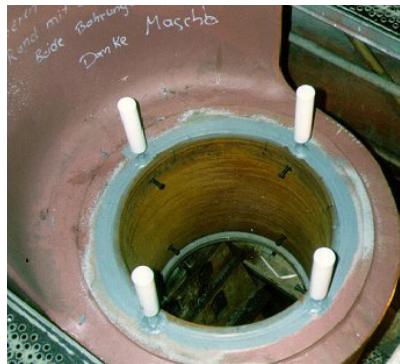
Rudder bearing bonding - top view

Bearing bonding is carried out by injecting the Belzona material between the bearing and the housing. The Belzona shim takes up any ovality or housing wear, thus creating a durable barrier with 100% surface contact, electrically isolating the bearing. This method has been applied to multiple situations including riser bearings and bushes amongst others.

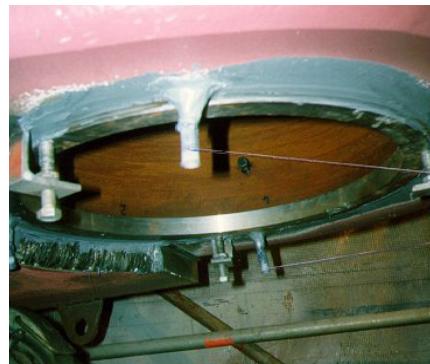
Rudder bearing bonding - bottom view

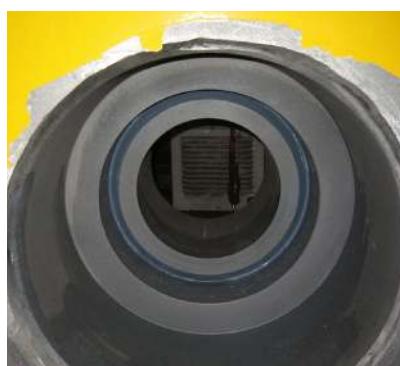
Bush installation, North Sea

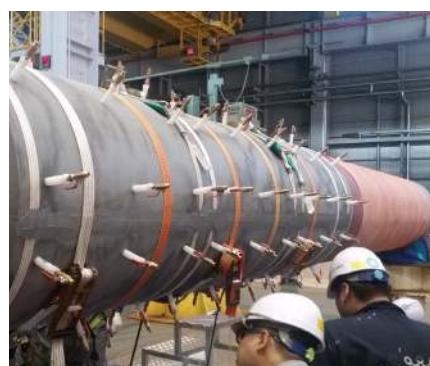
Riser bearing bonding

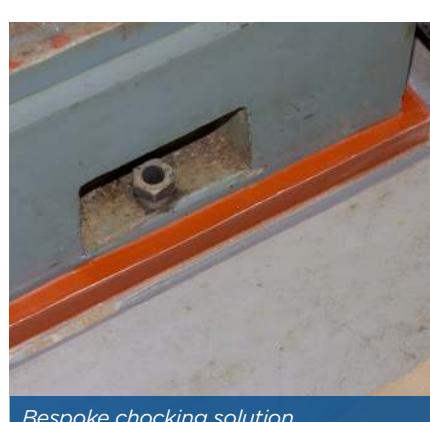
Bespoke chocking solution

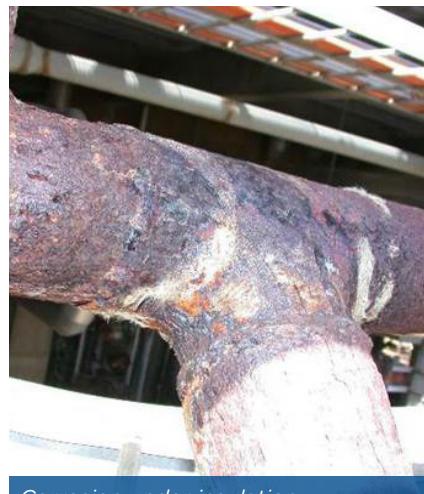
Corrosion under insulation

Corrosion under insulation occurs at an accelerated rate and can remain undetected for some time. Taking affected parts of the pipework out of service for repairs or replacement can in turn lead to high costs and lengthy downtime. To address this problem, in the late 1990s, Belzona formulated heat activated composites and coatings that facilitate on-line repairs. These materials adhere exceptionally well to hot contaminated surfaces and penetrate deep into the substrate eliminating the need for an angular blast profile prior to application.

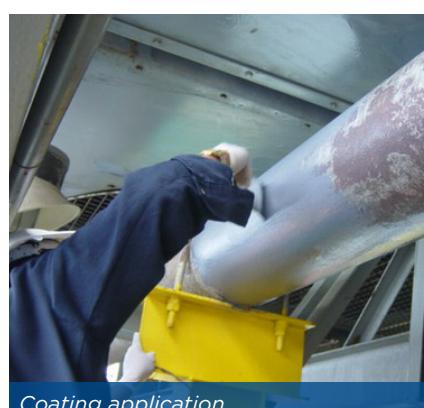
Coating application

Simple manual surface preparation and on-line brush application have inspired the use of Belzona heat activated materials to combat CUI globally, from the Gulf of Mexico to the North Sea. Typical applications in the range of -10°C to 150°C (50°F – 302°F) will resist salt spray and commonly found inorganic acids and alkalis at concentrations up to 20%.

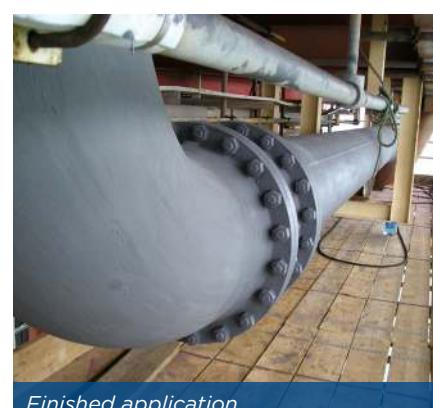
Finished application

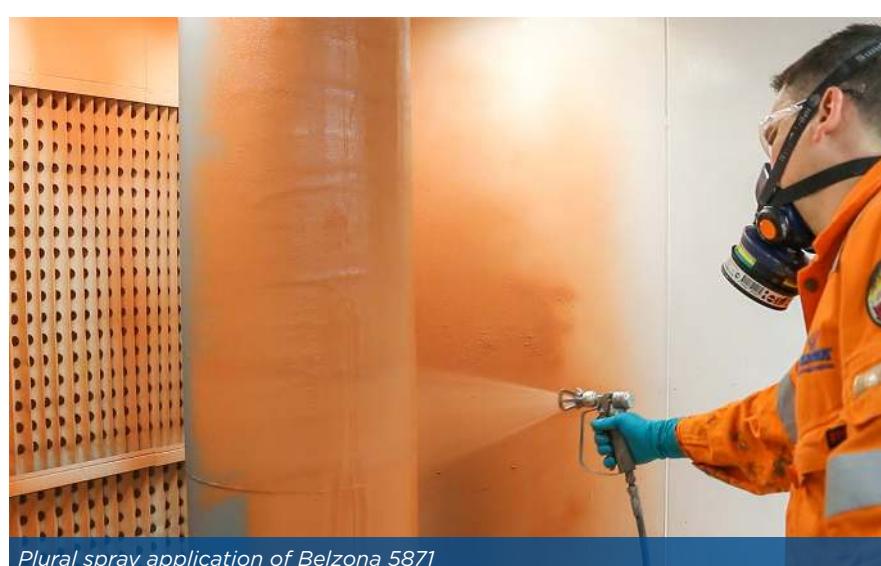
Plural spray application of Belzona 5871

Belzona have developed a solution that provides thermal insulation to metal pipework, ductings and other industrial equipment whilst also displaying excellent corrosion resistance and eliminating corrosion under insulation (CUI).

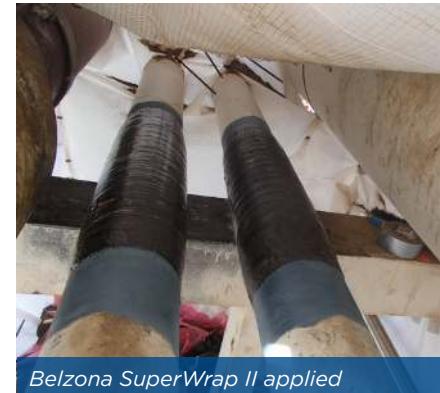
Belzona SuperWrap II applied

Following almost five decades of pipe wrap installations, in 2007 we added Belzona SuperWrap to the range, which is compliant with ASME PCC2 Article 4.1 and ISO/TS 24817. Every Belzona SuperWrap system is individually designed and applied by validated specialists. Repairs can be carried out to a variety of defects to restore pressurised pipeline and pipework integrity. In 2014, Belzona SuperWrap II was released, which exhibits greater strength and allows for a much more efficient application procedure, therefore reducing overall costs and downtime.

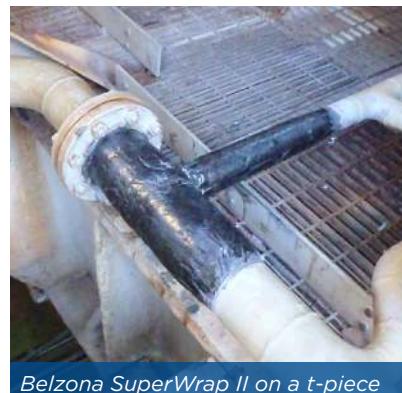
Belzona SuperWrap II on a t-piece

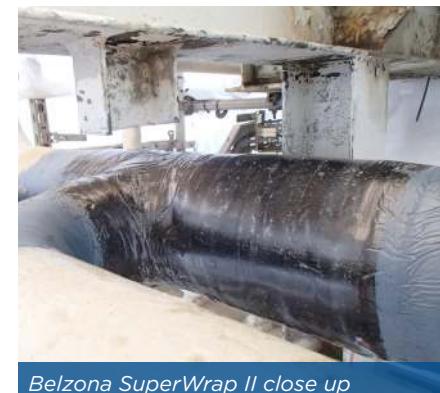
Belzona SuperWrap II close up

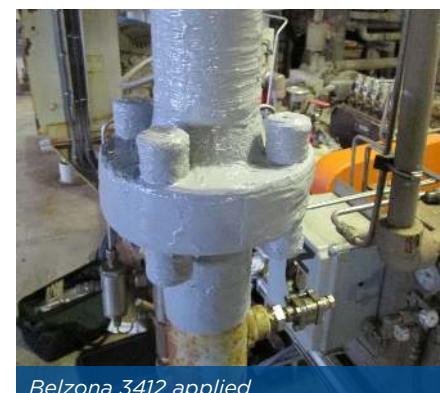
Belzona 3412 applied

Repairing flange crevice corrosion can be a very costly exercise, whereas common preventative measures in most cases are not 'inspection friendly'. The Belzona encapsulating membrane system introduced in 2014 seals bolted flange connections preventing corrosion. The liquid applied system includes a corrosion inhibitor and was designed to allow for periodic inspection, where flexible protection can be cut, peeled back and then easily resealed. To maintain Health and Safety standards, the system is hand applied, cures at ambient temperatures and can resist common corrosive media.

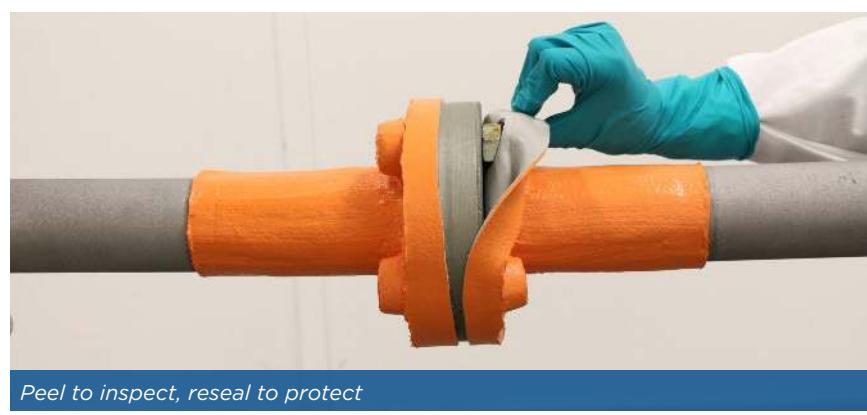
Peel to inspect, reseal to protect

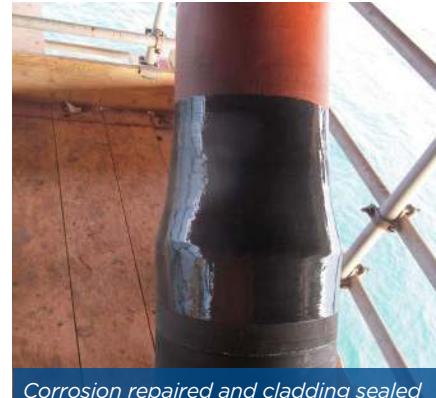
Corrosion repaired and cladding sealed

Rubber cladding does not offer permanent protection and tends to deteriorate after a few years in service, with sea water corroding the steel underneath the cladding. Belzona offers a complete system, which restores corroded metal and repairs cladding in situ, sealing the neoprene boot topping of the riser, thus preventing further water permeation. Due to proven longevity of cladding edge sealing, marine engineers specify Belzona flexible solution on new risers to prevent water ingress between the cladding and the metal.

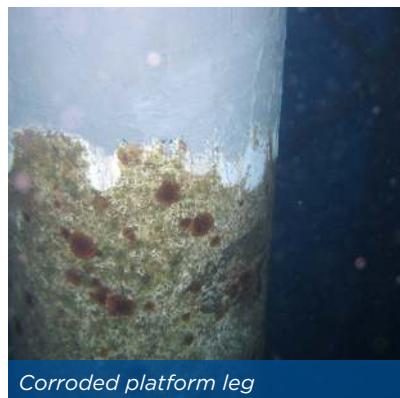
Corroded platform leg

Sea water movement with abrasive residues is capable of wearing away sacrificial protection and causing severe damage to the platform legs, particularly around the water line. Belzona surface-tolerant materials can be used to rapidly repair and prevent platform leg corrosion. Liquid-applied in situ and long lasting, the system forms a durable barrier between the substrate and the sea water.

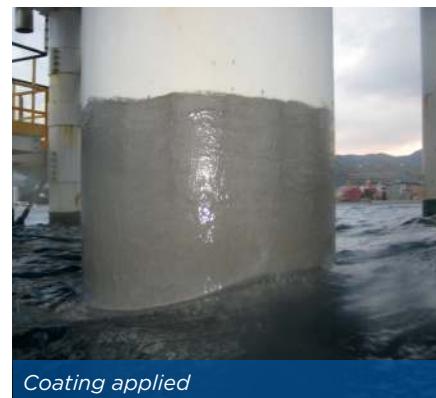
Coating applied

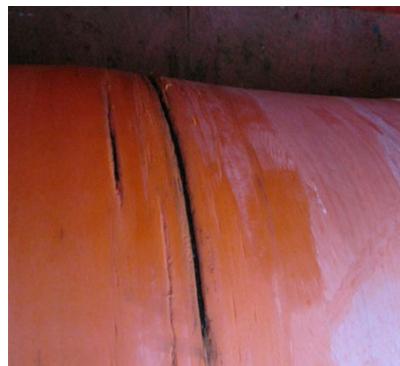
Hose damaged in transport

Hoses can be damaged in service or in transit and require a fast and durable repair solution. Belzona Elastomers adhere strongly to any type of hose and provide outstanding abrasion and impact resistance once the hose is put back in service. Belzona Elastomers are endorsed by reputable floating hose manufacturers as their recommended repair material. Corroded flange faces and internal surfaces can also be repaired and protected with the use of Belzona lining and flange face forming technology.

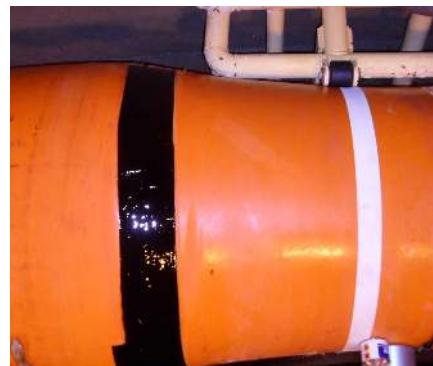
Belzona flexible repair

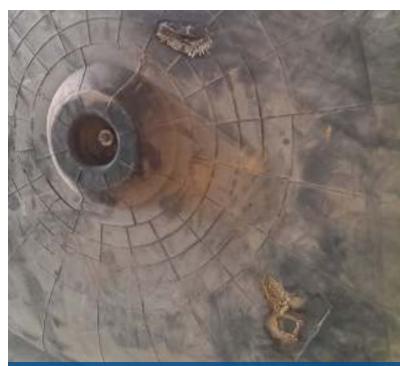
Deteriorated fender
