NATIONAL REGISTER OF HISTORIC PLACES
REGISTRATION FORM

historic name BANK OF EVERGLADES BUILDING

**BANK OF EVERGLADES, EVERGLADE CITY,
COLLIER COUNTY, FLORIDA**

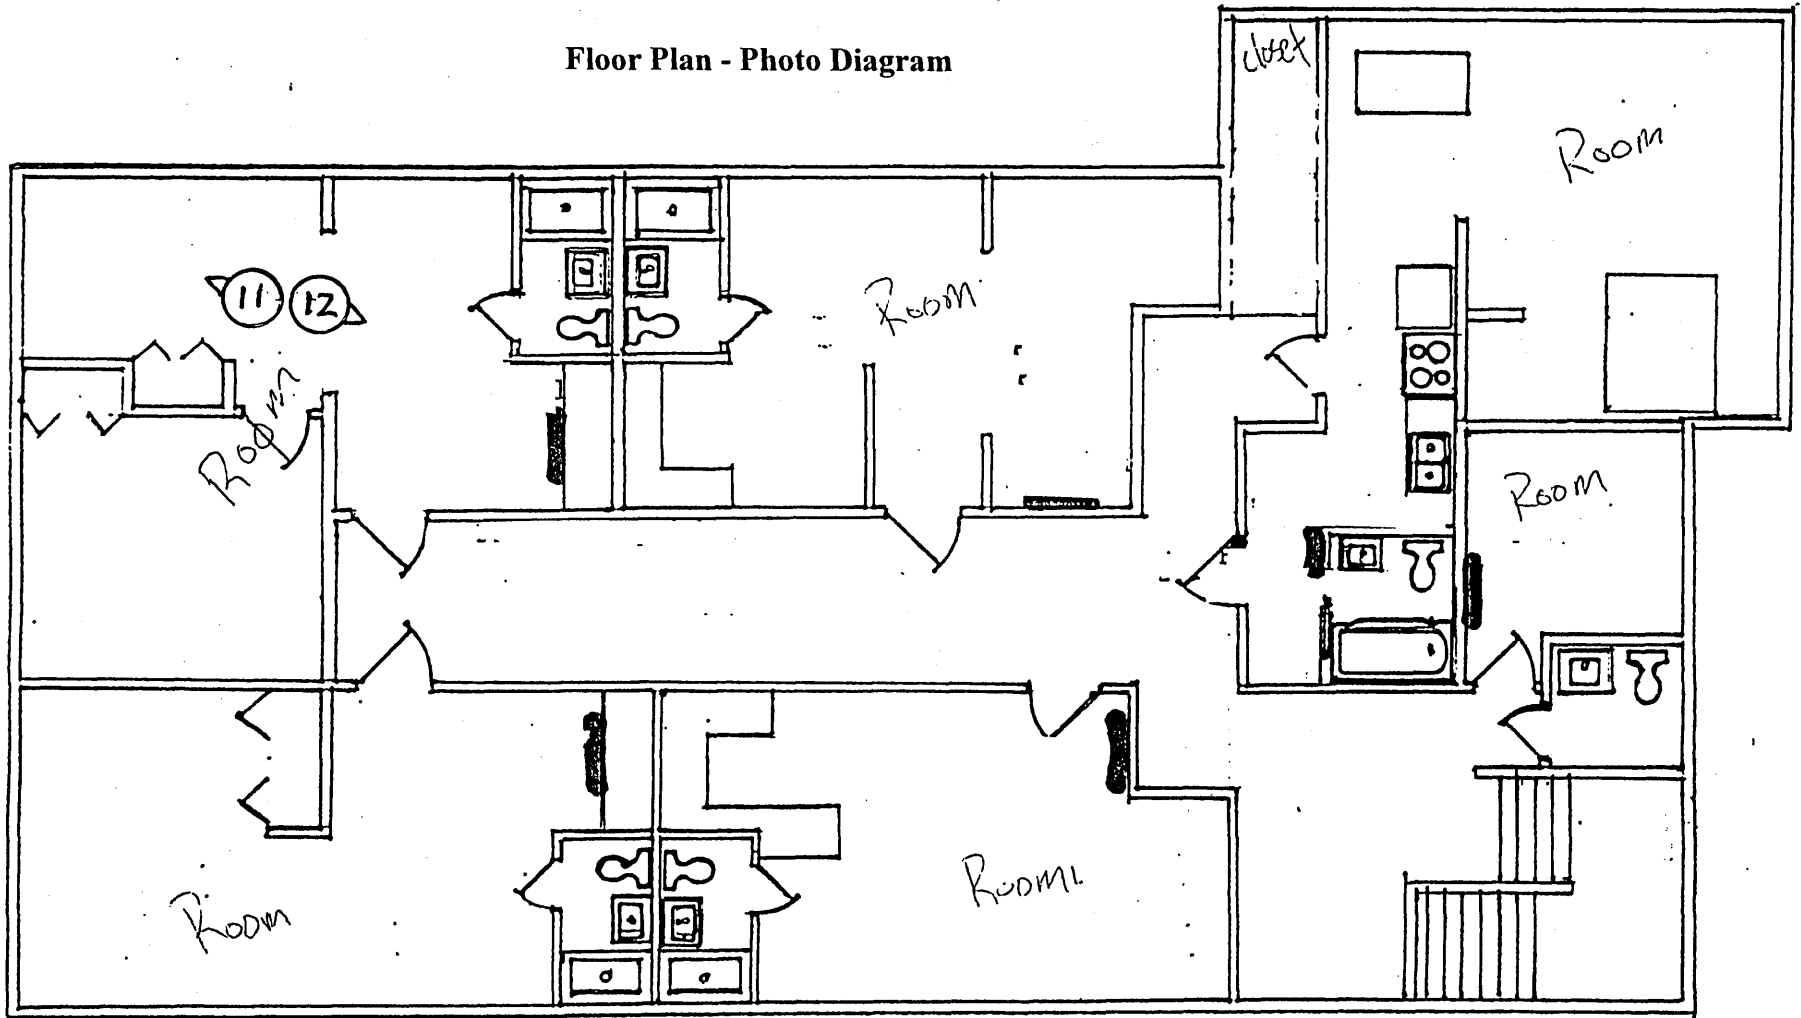
2nd Floor

central hall, five bedrooms with bathrooms, and one half-bathroom (Photos #11&12). The rooms along the hall originally were offices.
