Rasp Mine
Monthly Environmental Monitoring Report
September 2021

INTRODUCTION

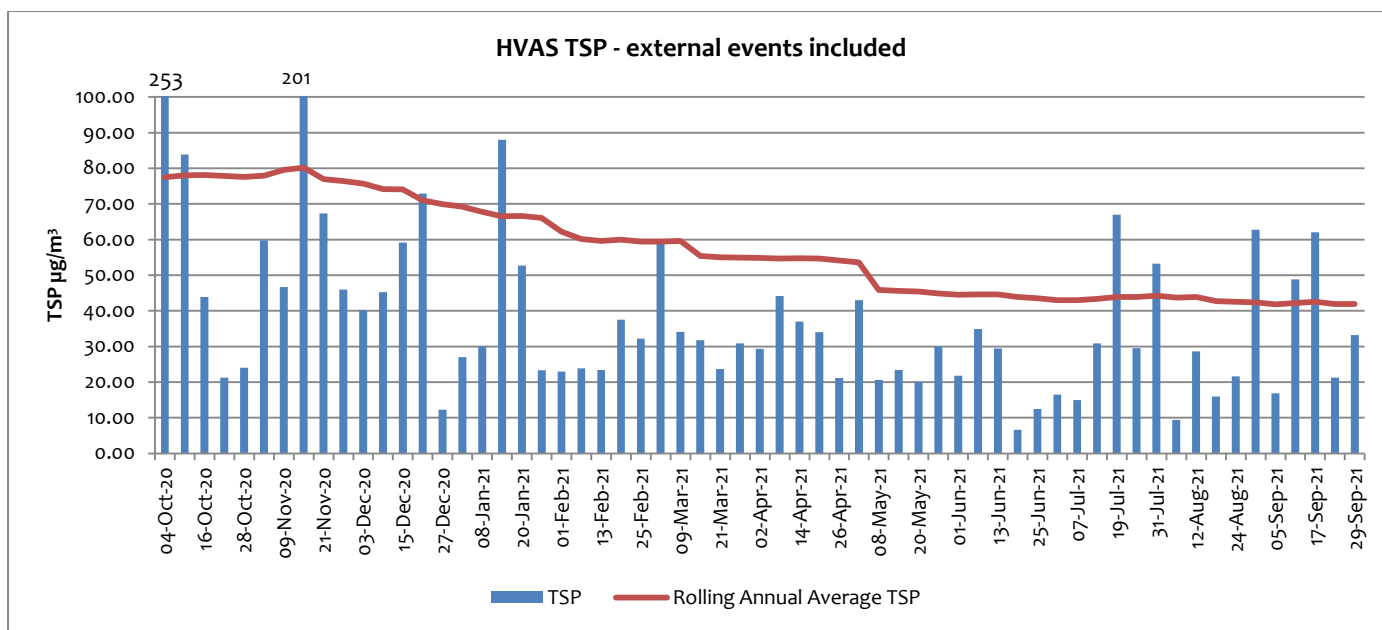
HVAS (EPL10) is located on the southern boundary of Rasp Mine and while limit criteria do not apply at this point, they do apply at the closest residential location.

TSP dust results at HVAS were elevated for the month of September compared to previous months. There were elevated TSP levels of 48.80 µg/m³ on 11 September and 62.00 µg/m³ on 17 September when winds were predominantly from the NW and WNW. The contribution of dust was likely from on-site locations on site as similar increases in dust were not recorded in monitoring equipment sited on the northern boundary of the site. Haul roads and operational areas are serviced by water carts although some areas may dry out between applications. The annual rolling average for TSP at this location is 41.93 µg/m³ at the end of September 2021, significantly lower than the average at the beginning of September 2020 which was 77.50 µg/m³.

The annual rolling average for TSP is determined using data with extreme dust events included.

Additional dust suppressant will be applied to trafficked and free areas which can contribute to dust lift-off. Water carts currently apply water to trafficked surfaces in these areas.

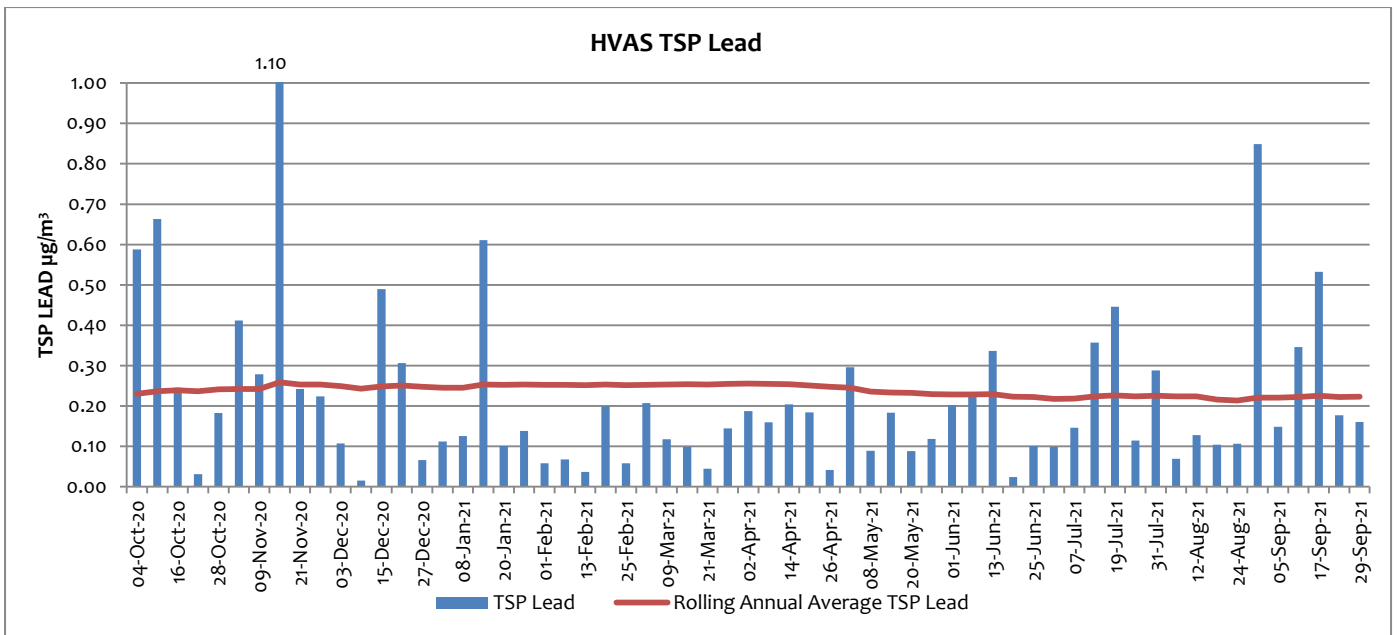
TSP Lead dust results at HVAS were elevated for the month of September compared to previous months. There were elevated TSP Lead levels of 0.35 µg/m³ on 11 September and 0.53 µg/m³ on 17 September when winds were predominantly from the NW and WNW. The contribution of TSP Lead was likely from on-site locations on site as similar increases in TSP Lead dust were not recorded in monitoring equipment sited on the northern boundary of the site. Haul roads and operational areas are serviced by water carts although some areas may dry out between applications. The rolling annual average for TSP Lead in September 2021 was 0.22 µg/m³ which is slightly lower than the rolling annual average of 0.24 µg/m³ for TSP Lead in October 2020.

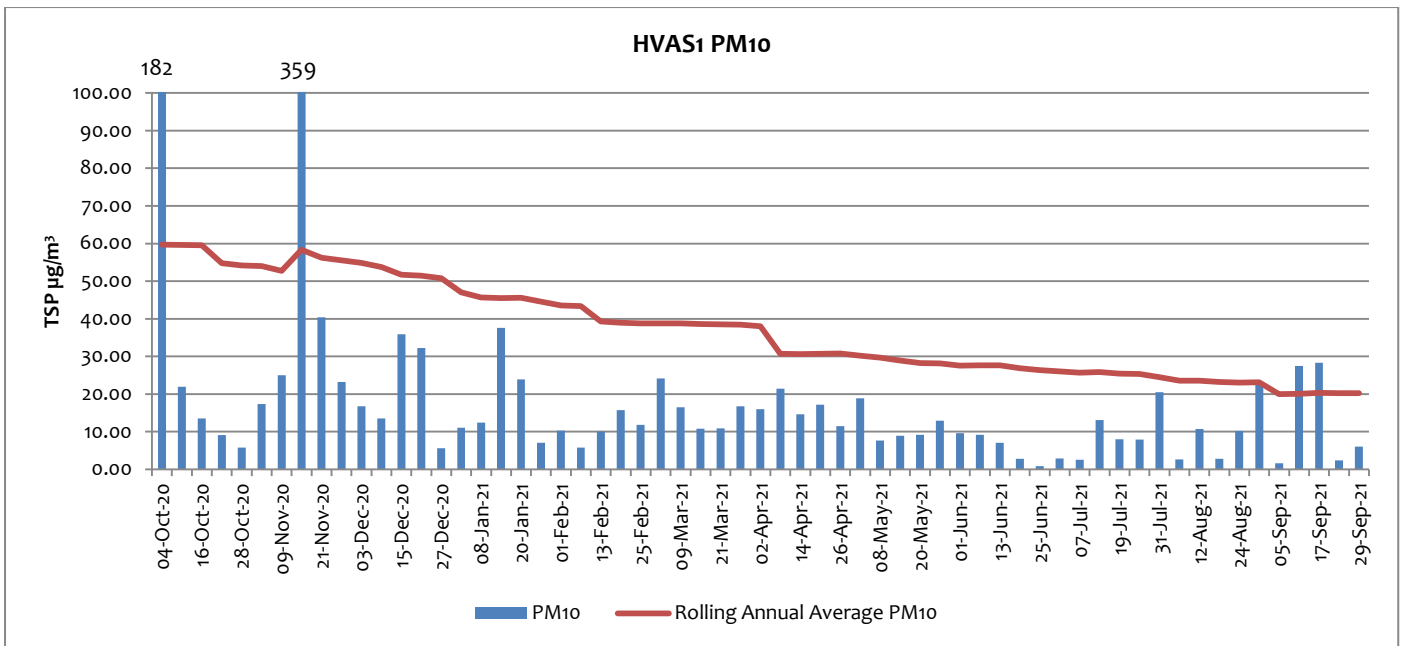
PM₁₀ dust results at HVAS1 were slightly elevated in the month of September. There were elevated PM₁₀ levels of 27.50 µg/m³ on 11 September and 28.30 µg/m³ on 17 September when winds were predominantly from the NW and WNW. The contribution of PM₁₀ dust was likely from on-site locations on site as similar increases in PM₁₀ dust were not recorded in monitoring equipment located on the northern boundary of the site. Haul roads and operational areas are serviced by water carts although some areas may dry out between applications. The annual rolling average for PM₁₀ dust at this location is 20.2 µg/m³ at the end of September 2021, significantly lower than the average at the beginning of October 2020 which was 59.7 µg/m³. External and extreme dust events are recorded in measurements.

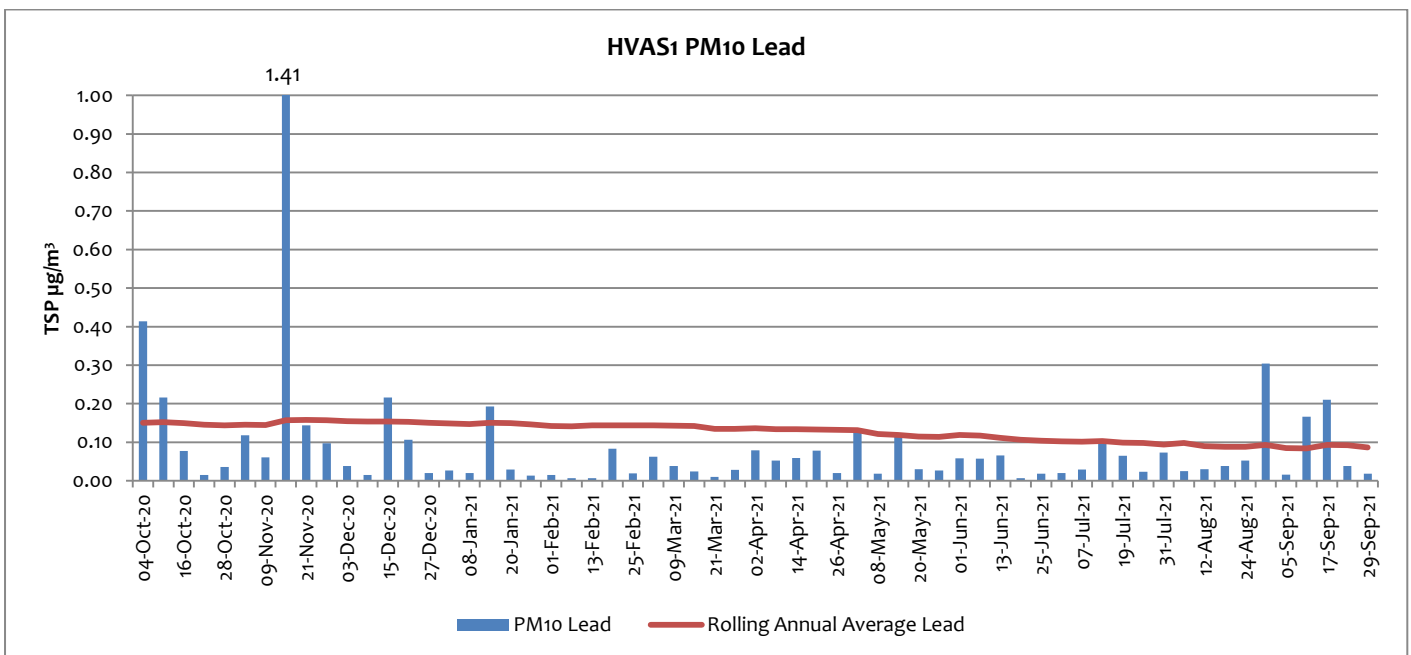
PM₁₀ Lead dust results at HVAS1 were slightly elevated for the month of September compared to previous months. There were elevated PM₁₀ Lead levels of 0.17 µg/m³ on 11 September and 0.21 µg/m³ on 17 September when winds

were predominantly from the NW and WNW. Elevated Lead results may have been due to the contribution from sources on site as monitoring equipment on the northern boundary of the site did not record elevated Lead levels to the same degree. Haul roads and operational areas are serviced by water carts although some areas may dry out between applications. The rolling annual average for PM₁₀ Lead in September 2021 was 0.09 µg/m³, down from 0.15 µg/m³ in October 2020.

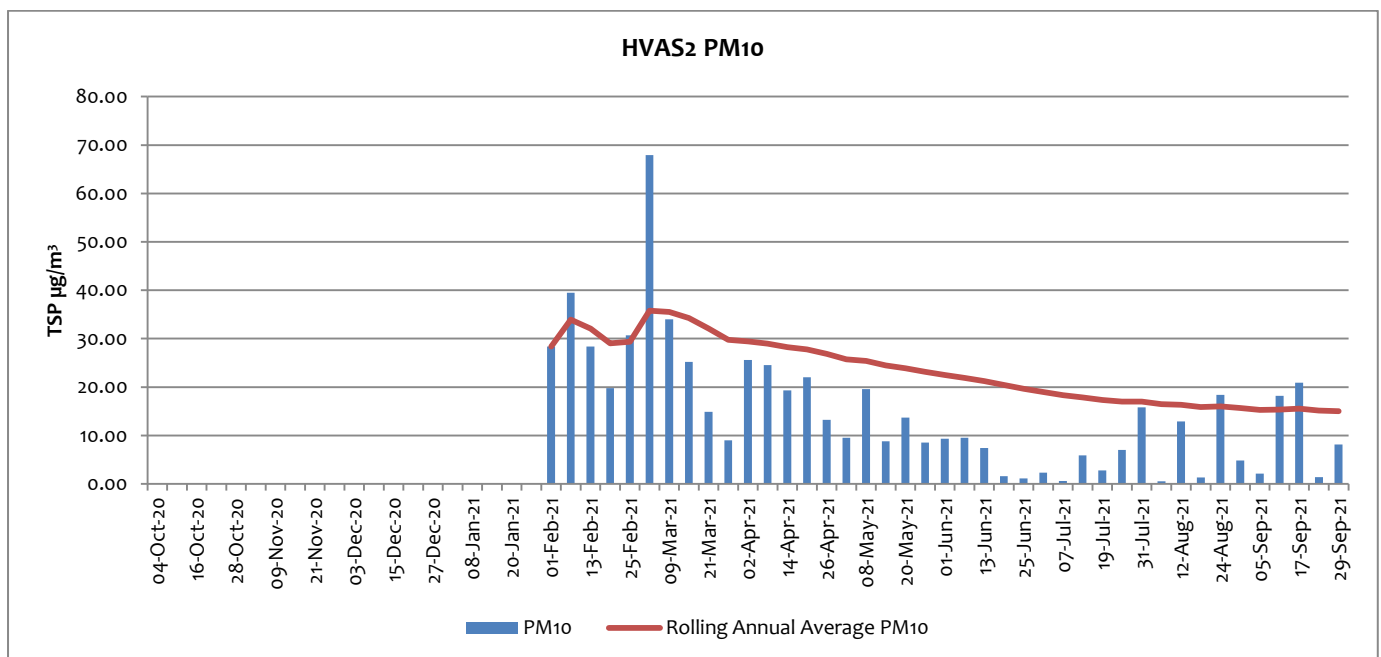
PM₁₀ levels were higher in September than in August. There were elevated PM₁₀ levels of 18.2 µg/m³ on 11 September and 20.90 µg/m³ on 17 September when winds were predominantly from the NW and WNW which suggests the dust came from offsite. The annual rolling average for PM₁₀ dust at this location is 14.99 µg/m³ at the end of September 2021, however due to the unit being reinstalled after 19 months decommissioned, annual rolling average is calculated using data from February to September 2021 only.

The annual rolling average for PM₁₀ dust is determined using data with extreme dust events included.

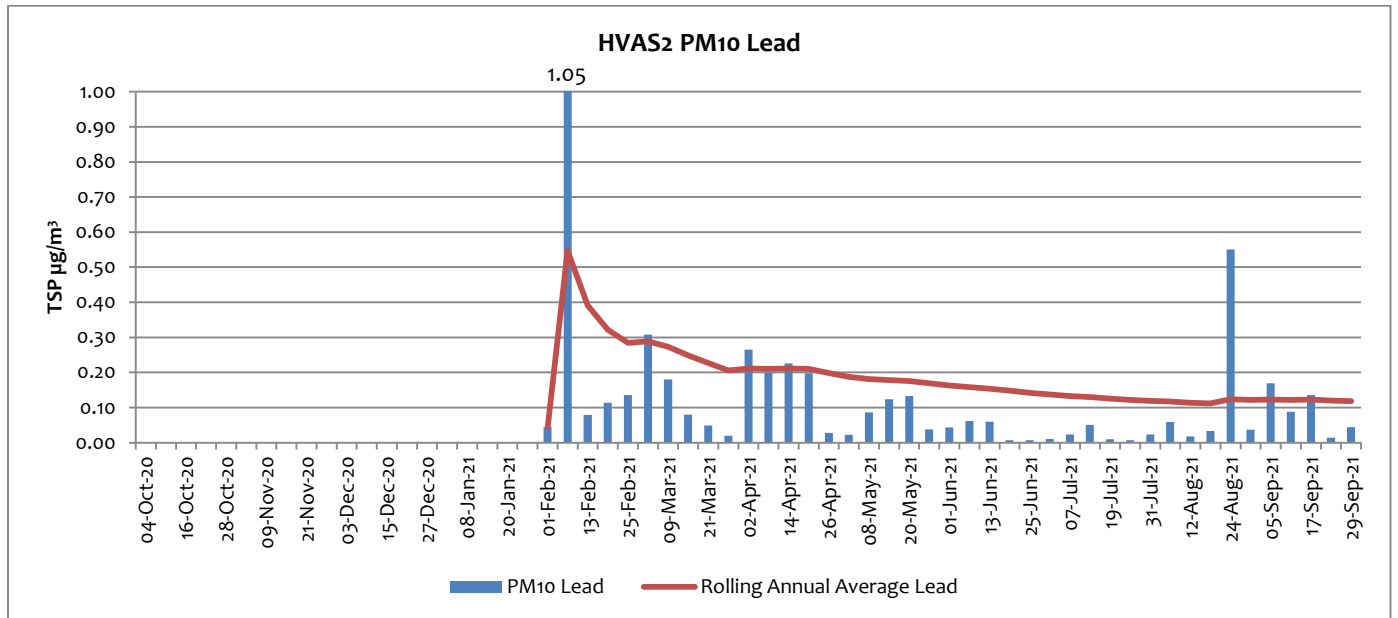
There were elevated PM₁₀ lead levels of 0.17 µg/m³ recorded on 5 September and 0.14 µg/m³ on 17 September when winds were predominantly from the NE and WNW which suggests the dust came from offsite when winds were from the South and so likely from offsite sources. The rolling annual average for PM₁₀ Lead in September 2021 was 0.12 µg/m³, however due to the unit being reinstalled after 19 months decommissioned, annual rolling average is calculated using data from February to September only.

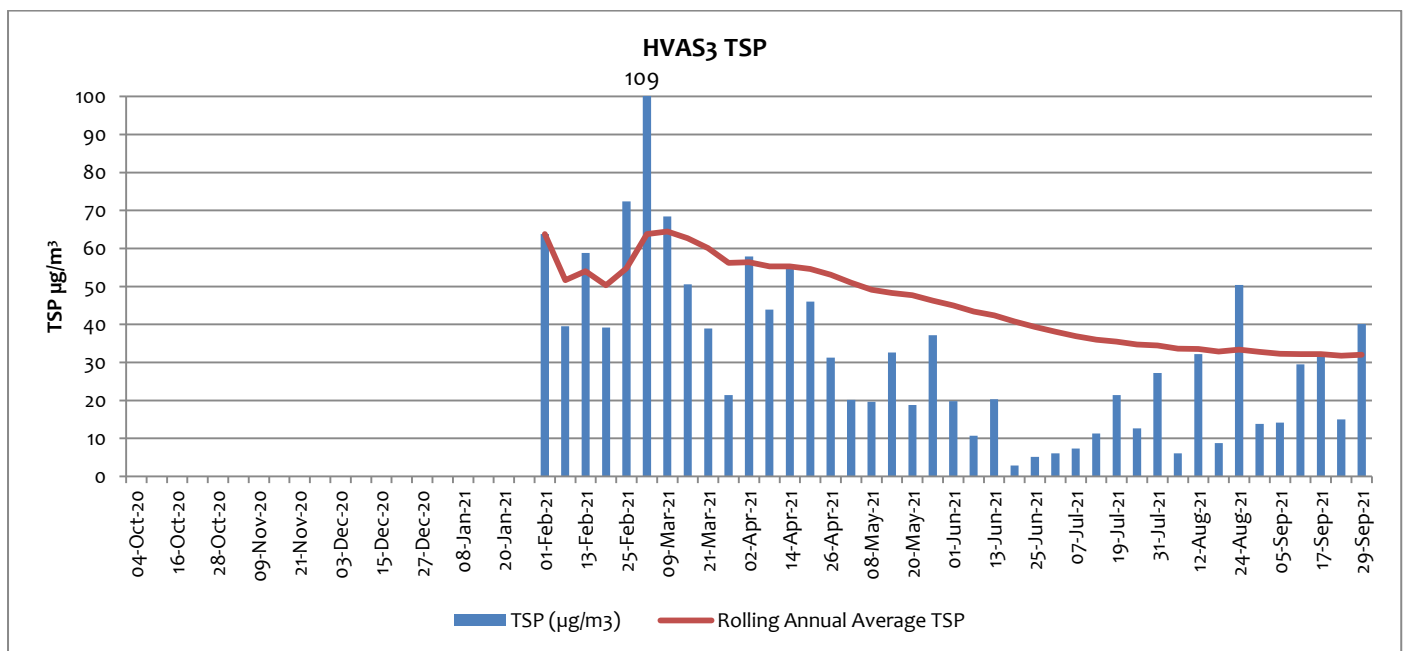
TSP levels were elevated in September with results of $28.50 \mu\text{g}/\text{m}^3$ on 11 September, $32.60 \mu\text{g}/\text{m}^3$ on 17 September, and $40.1 \mu\text{g}/\text{m}^3$ on 29 September when winds were from the NW, WNW, and SSE, respectively. The annual rolling average for TSP dust at this location is $32.00 \mu\text{g}/\text{m}^3$ at the end of September 2021, however due to the unit being reinstalled after 19 months decommissioned, annual rolling average is calculated using data from February to September 2021 only.

The annual rolling average for TSP is determined using data with extreme dust events included.

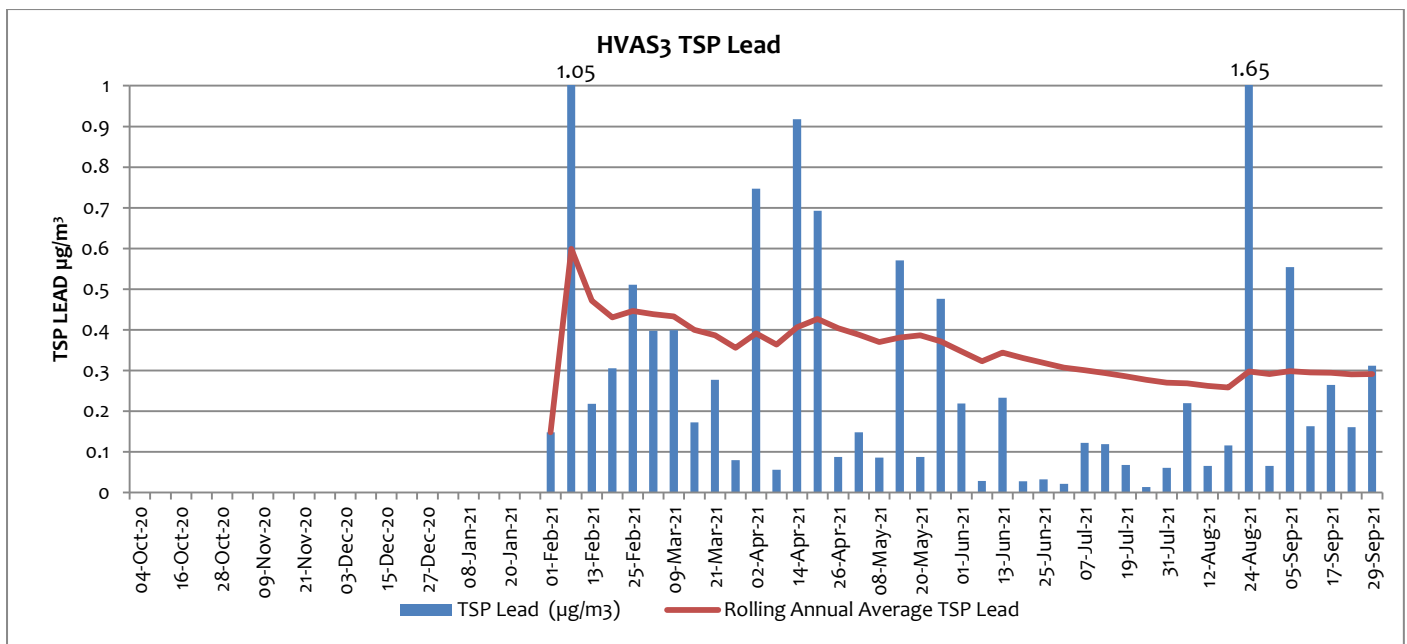
TSP Lead levels were elevated in September with results of $0.554 \mu\text{g}/\text{m}^3$ on 5 September, $0.265 \mu\text{g}/\text{m}^3$ on 17 September, and $0.312 \mu\text{g}/\text{m}^3$ on 29 September when winds were from the SSW, WNW, and SSE, respectively. The rolling annual average for TSP Lead in September 2021 was $0.29 \mu\text{g}/\text{m}^3$, however due to the unit being reinstalled after 19 months decommissioned, annual rolling average is calculated using data from February to September only.

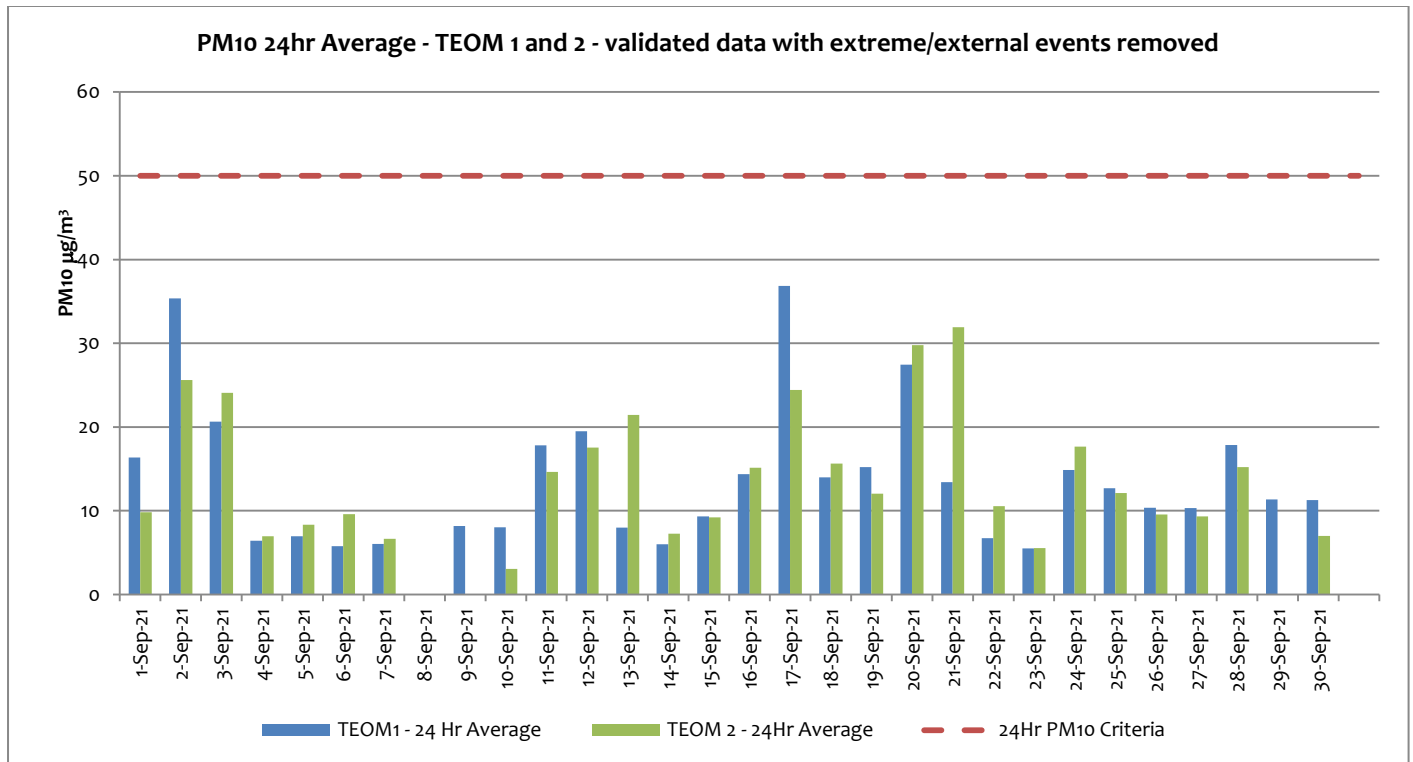
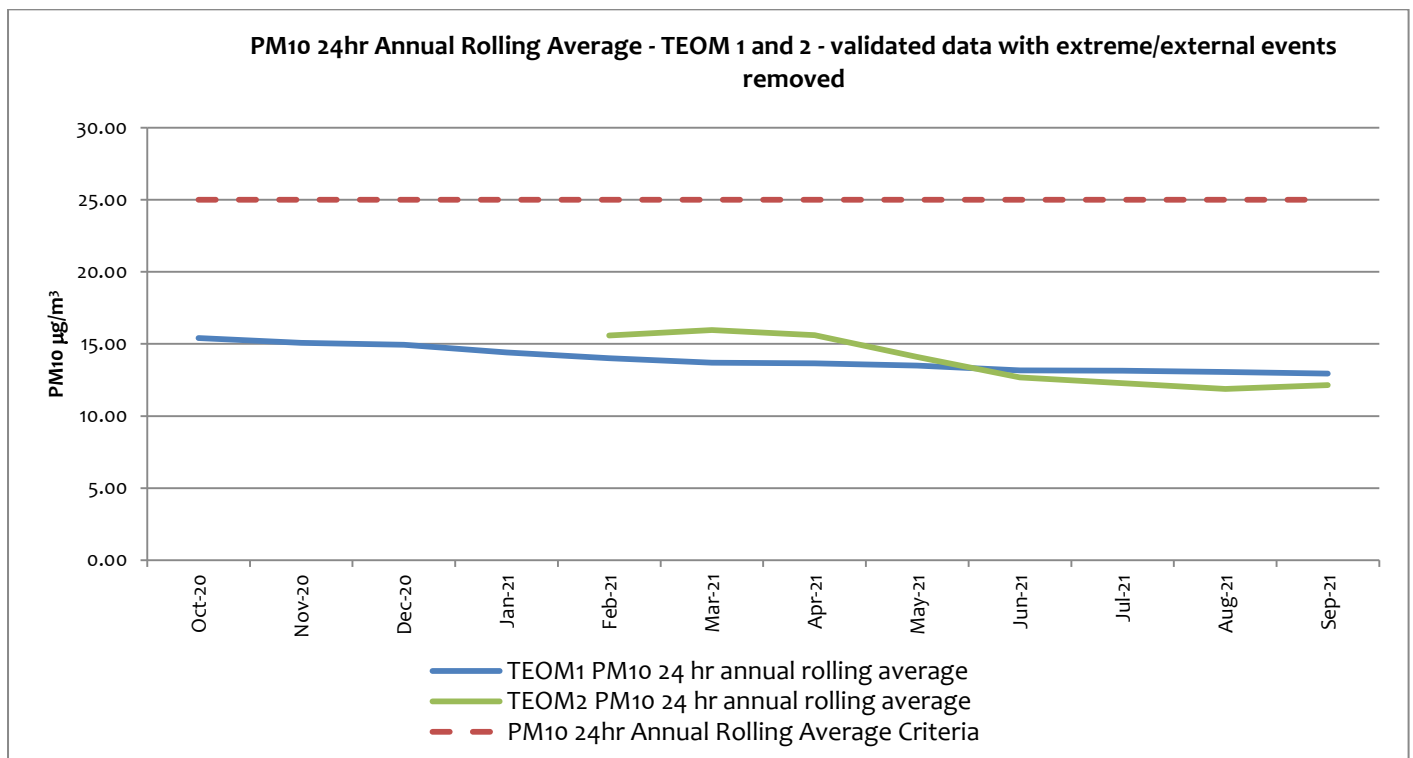
PM₁₀ dust levels at both TEOM units were low in the month of September. The filters were replaced in TEOM1 and TEOM2 on 8 September and both units stabilised on that day and the following. Servicing was conducted on TEOM1 on 27 September and on TEOM2 on 29 and 30 September.

The PM₁₀ 24-hour rolling annual average for data with external elevated dust events removed at September 2021 is 12.94 µg/m³ for TEOM1 and 12.14 µg/m³ for TEOM2.

The PM₁₀ 24-hour rolling annual average for both TEOM sites remain below the annual average criteria of 25 µg/m³.

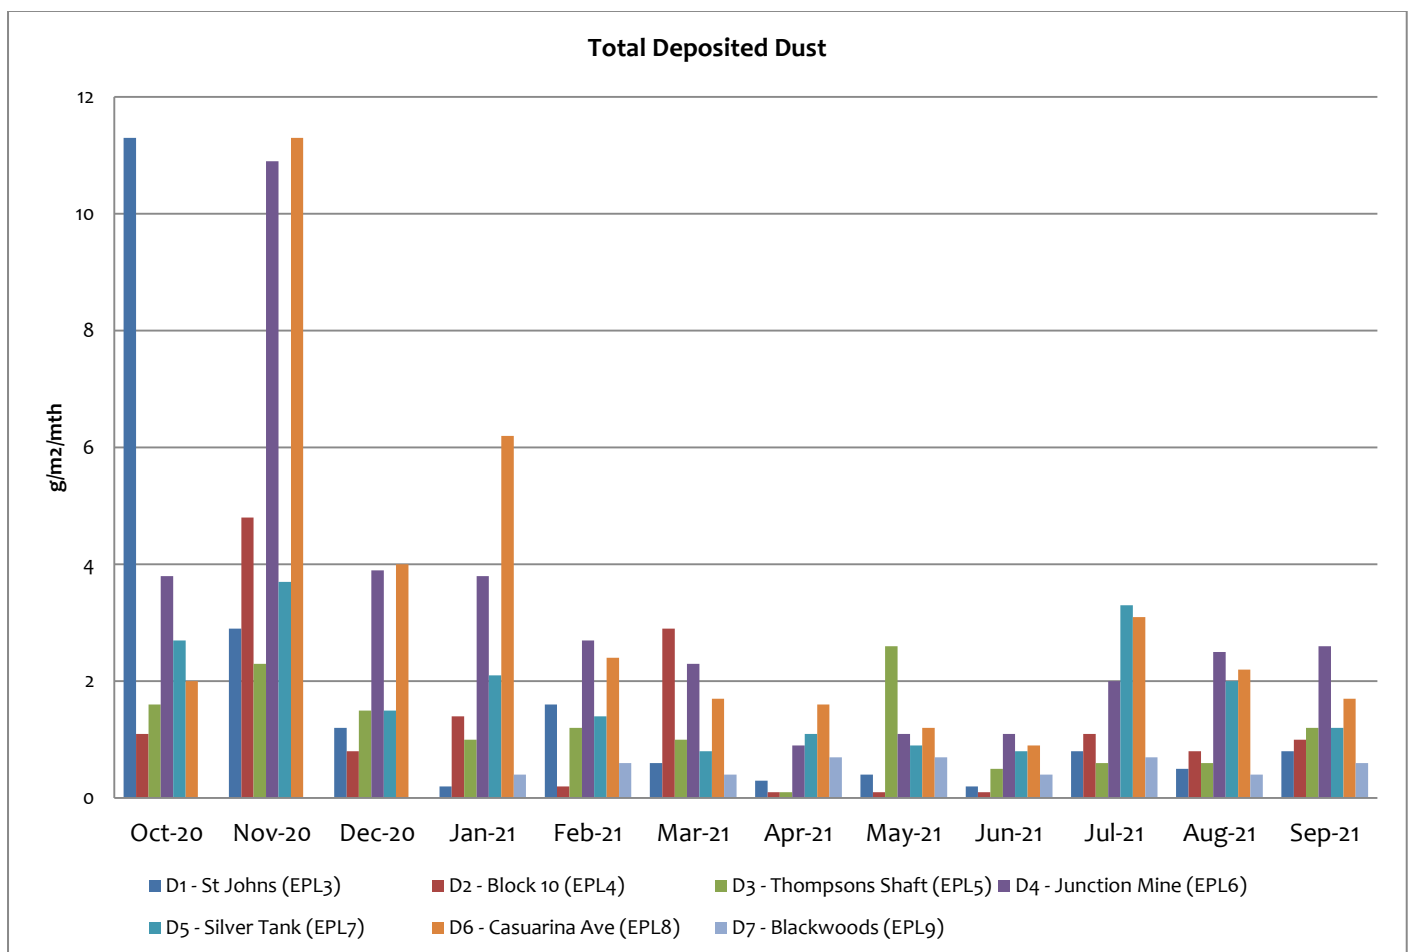
The dust levels recorded in Dust Gauges in September 2021 were slightly elevated compared to the previous months. The highest dust levels were recorded in the D4 Junction Mine gauge. The predominant wind direction for

September 2021 was from the SW as shown in the Wind Rose in Section 4. The D4 Junction Mine gauge was likely impacted by site activities.

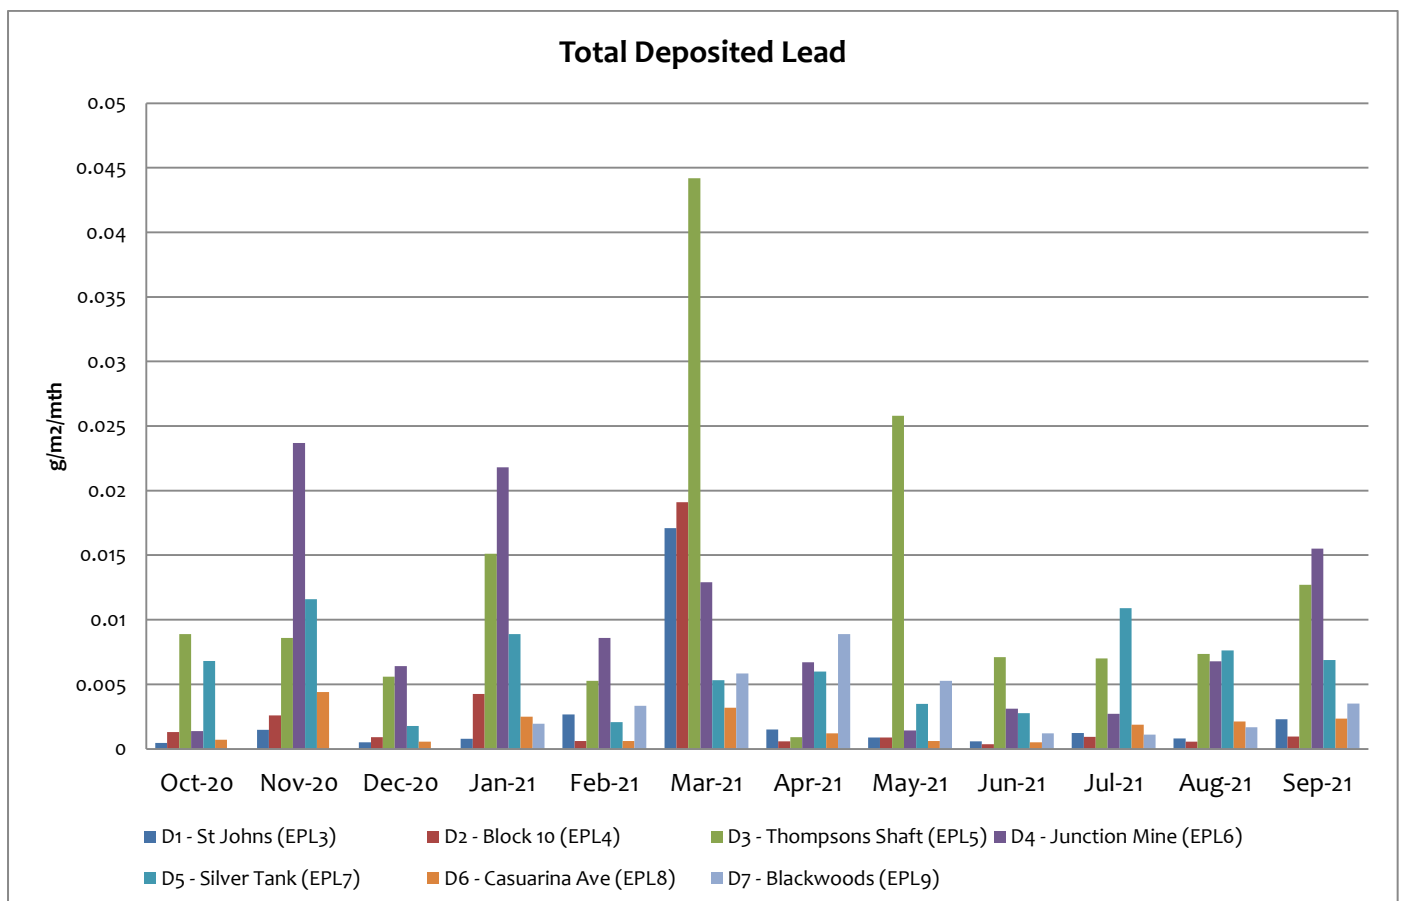
There are no guidelines for deposited lead dust. Lead results in September 2021 were highest in the D3 Thompsons Shaft and D4 Junction Mine gauges. The predominant wind directions for September 2021 was from the SW as shown in the Wind Rose in Section 4. Site activities around the Rail Loadout area may contribute to elevated Lead levels at D3 Thompsons Shaft, but only minimally as the concentrate containers are loaded with concentrate and their lids are fitted in an enclosed shed. In addition the loading area alongside the train is a concrete pad which is regularly swept and watered. A water cart will also attend to the haul road between the concentrate loading shed at the Mill and the rail loadout area when concentrate containers are being transported on site. Much of the off-site area NW of the D3 Thompsons Shaft gauges is bare of cover and characterised by historical mining activities.

Dust suppressant is applied to unsealed areas of the site and roads are frequently watered using water carts in an attempt to control dust emissions. The waste dump adjacent to the rail loadout is treated with dust suppressant to capture any loose dust accumulating on the lower batters and on the upper surface.

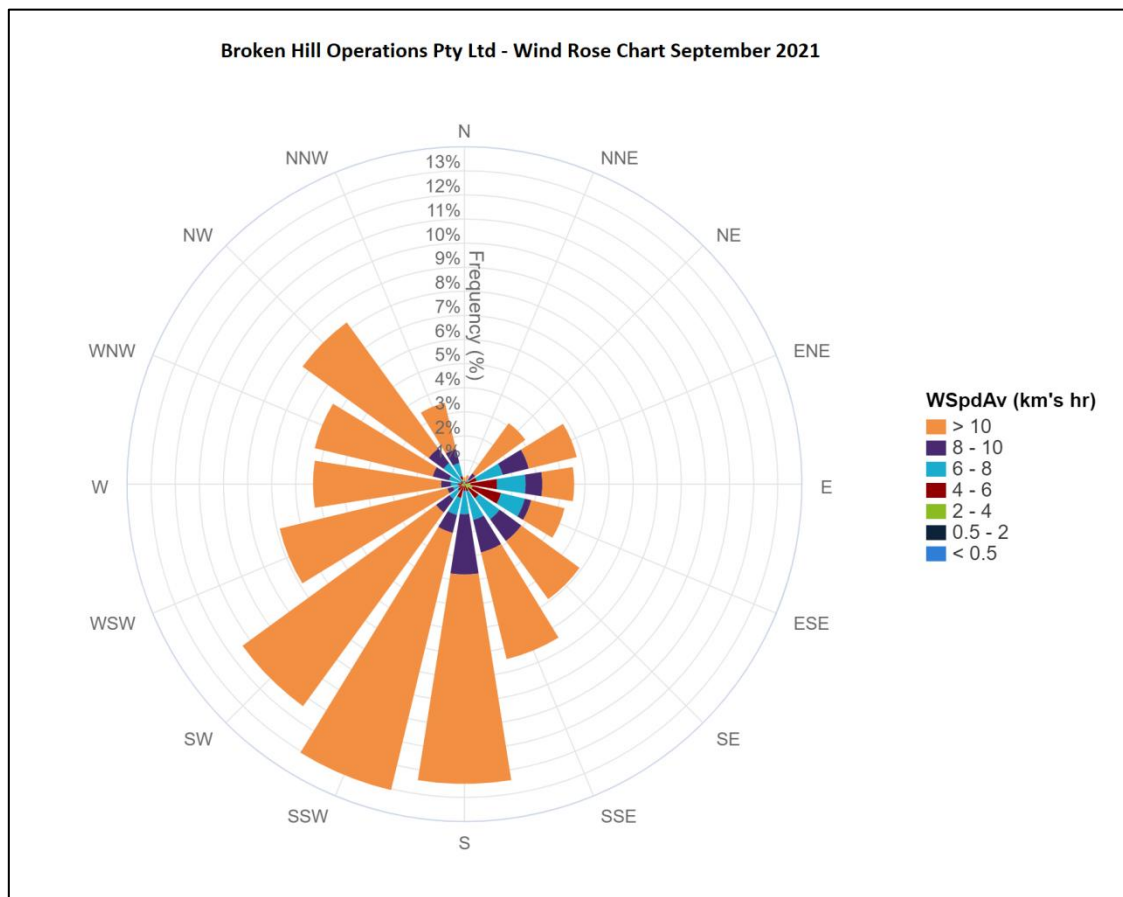
The windrose provided below indicates the predominant wind directions for the month of September was from the S to SW.
