Rasp Mine  
Monthly Environmental Monitoring Report  
October 2024

Broken Hill Operations Pty Ltd (BHOP) [a wholly owned subsidiary of CBH Resources Limited (CBH)] owns and operates the Rasp Mine (the Mine), which is located centrally within the City of Broken Hill on Consolidated Mine Lease 7 (CML7).

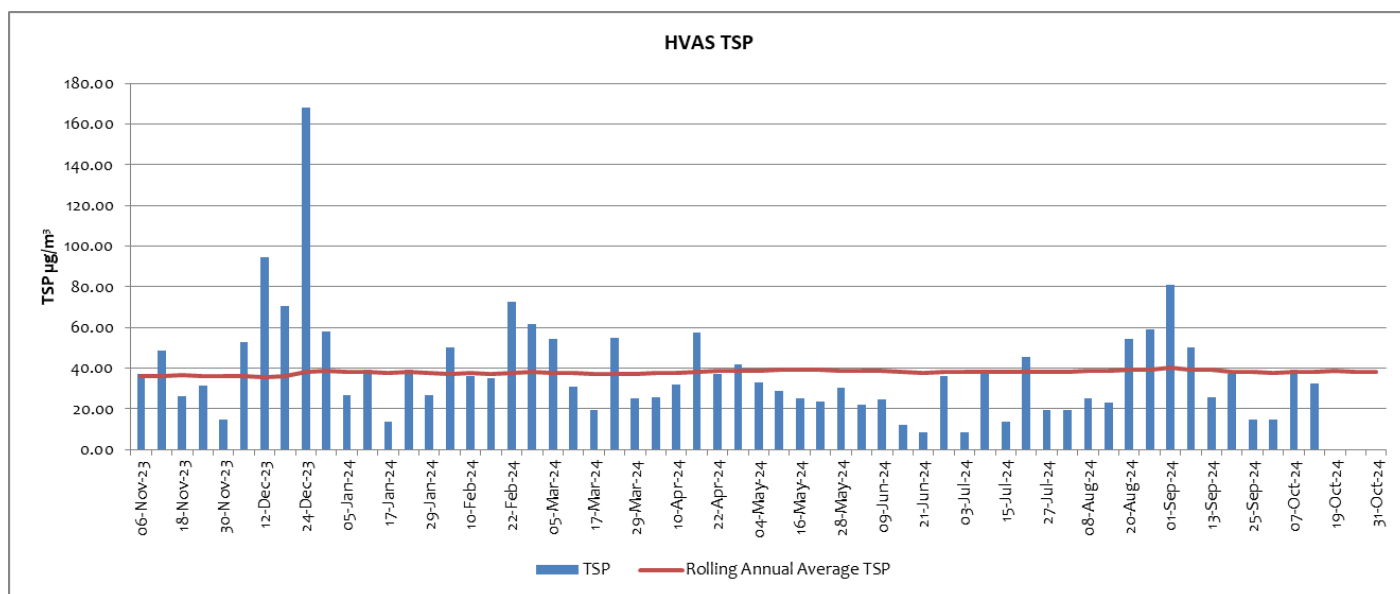
HVAS (EPL10) is located on the southern boundary of Rasp Mine and while limit criteria do not apply at this point, they do apply at the closest residential location.

TSP dust results at HVAS for the month of October were lower than in previous months. The highest TSP results for October were  $39.10 \mu\text{g}/\text{m}^3$  on 7 October when winds were predominantly from the SSW suggesting the dust had originated from off-site. HVAS TSP was unable to sample on 19, 25, and 31 October due to power outages. Water carts apply water to site roads daily and dust suppressant is applied to free areas and unsealed roads. The annual rolling average for TSP at this location is  $38.34 \mu\text{g}/\text{m}^3$  at the end of October, higher than the average at the beginning of November 2023 which was  $36.01 \mu\text{g}/\text{m}^3$ .

The annual rolling average for TSP is determined using data with extreme dust events included.

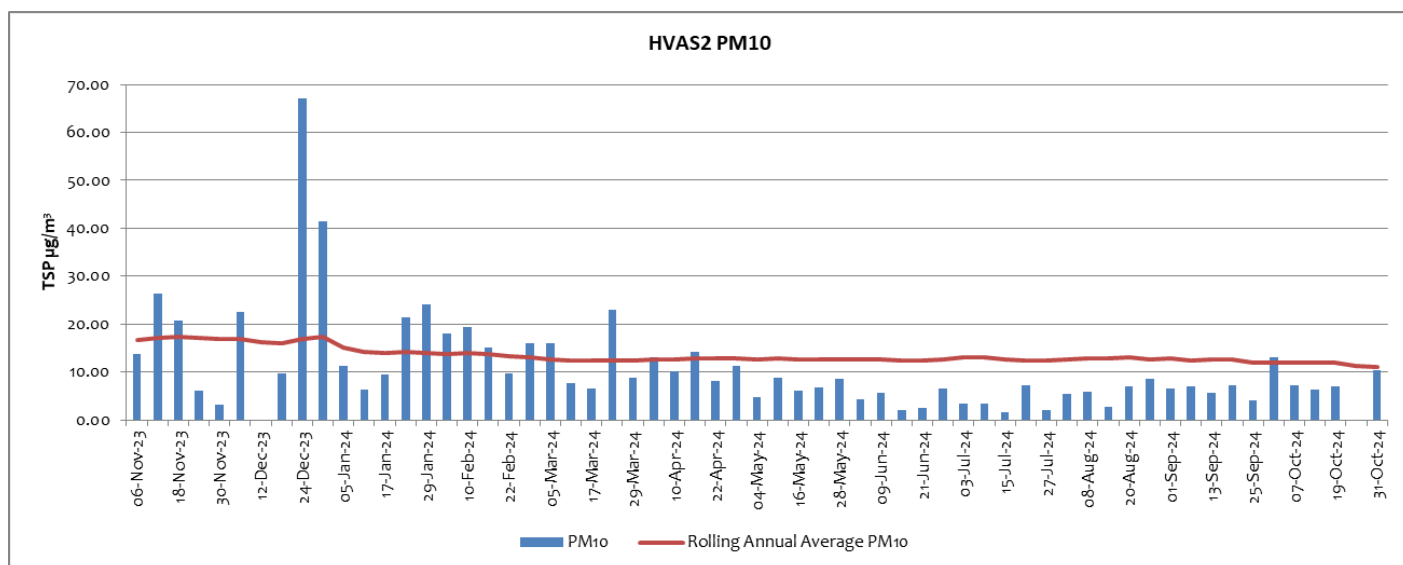
HVAS2 (EPL12) is located on the northern boundary of Rasp Mine and while limit criteria do not apply at this point, they do apply at the closest residential location.

In October the PM<sub>10</sub> levels at HVAS2 were consistent with previous months. The highest recorded PM<sub>10</sub> dust reading for October was 13.20 µg/m<sup>3</sup> on 1 October when winds were from the SSE suggesting contribution from on-site sources. HVAS2 was unable to sample on 25 October due to power outages. The surface of Blackwoods TSF2 is treated with dust suppressant and the TSF spray system has been installed. The annual rolling average for PM<sub>10</sub> dust at this location is 11.6 µg/m<sup>3</sup> at the end of October, down from 16.72 µg/m<sup>3</sup> in November 2023.

The annual rolling average for PM<sub>10</sub> dust is determined using data with extreme dust events included.

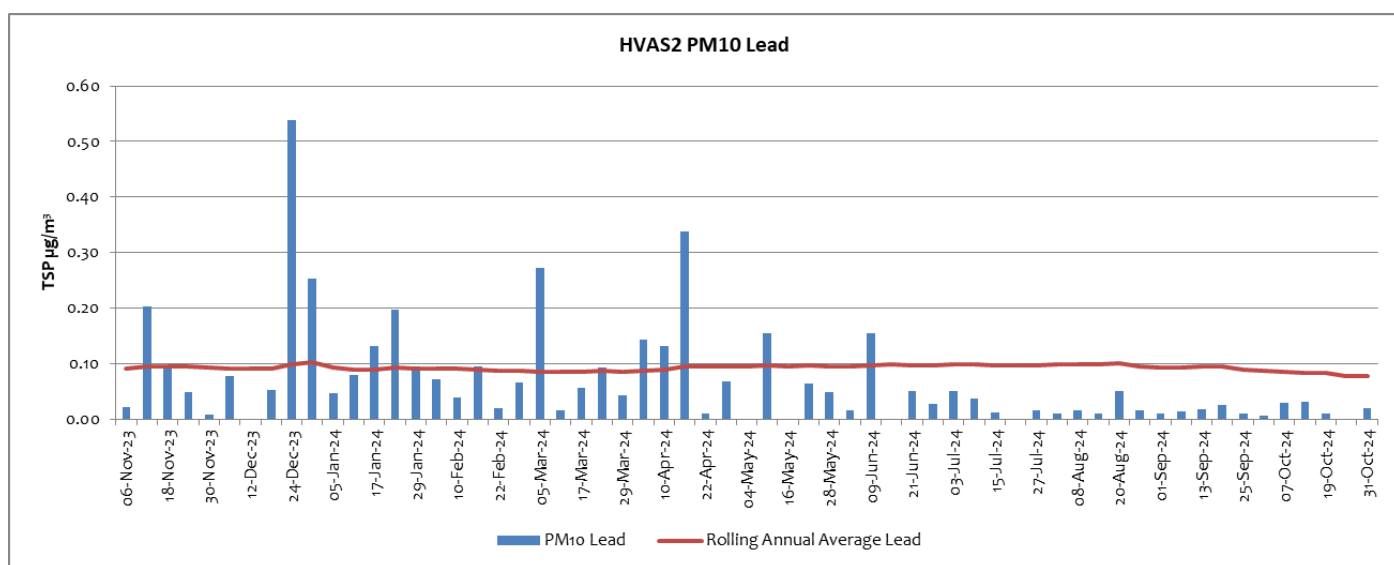
PM<sub>10</sub> lead levels in October were lower than previous months. The highest recorded PM<sub>10</sub> Lead dust reading for October was 0.03 µg/m<sup>3</sup> on 7 and 13 October when winds were from the SSW and NE, respectively, suggesting contribution from site activities on 7 October and off-site sources on 13 October. HVAS2 was unable to sample on 25 October due to power outages. The surface of Blackwoods TSF2 is treated with dust suppressant and the TSF spray

system has been installed. The rolling annual average for PM<sub>10</sub> Lead in October was 0.08 µg/m<sup>3</sup>, down slightly from 0.09 µg/m<sup>3</sup> in November 2023.

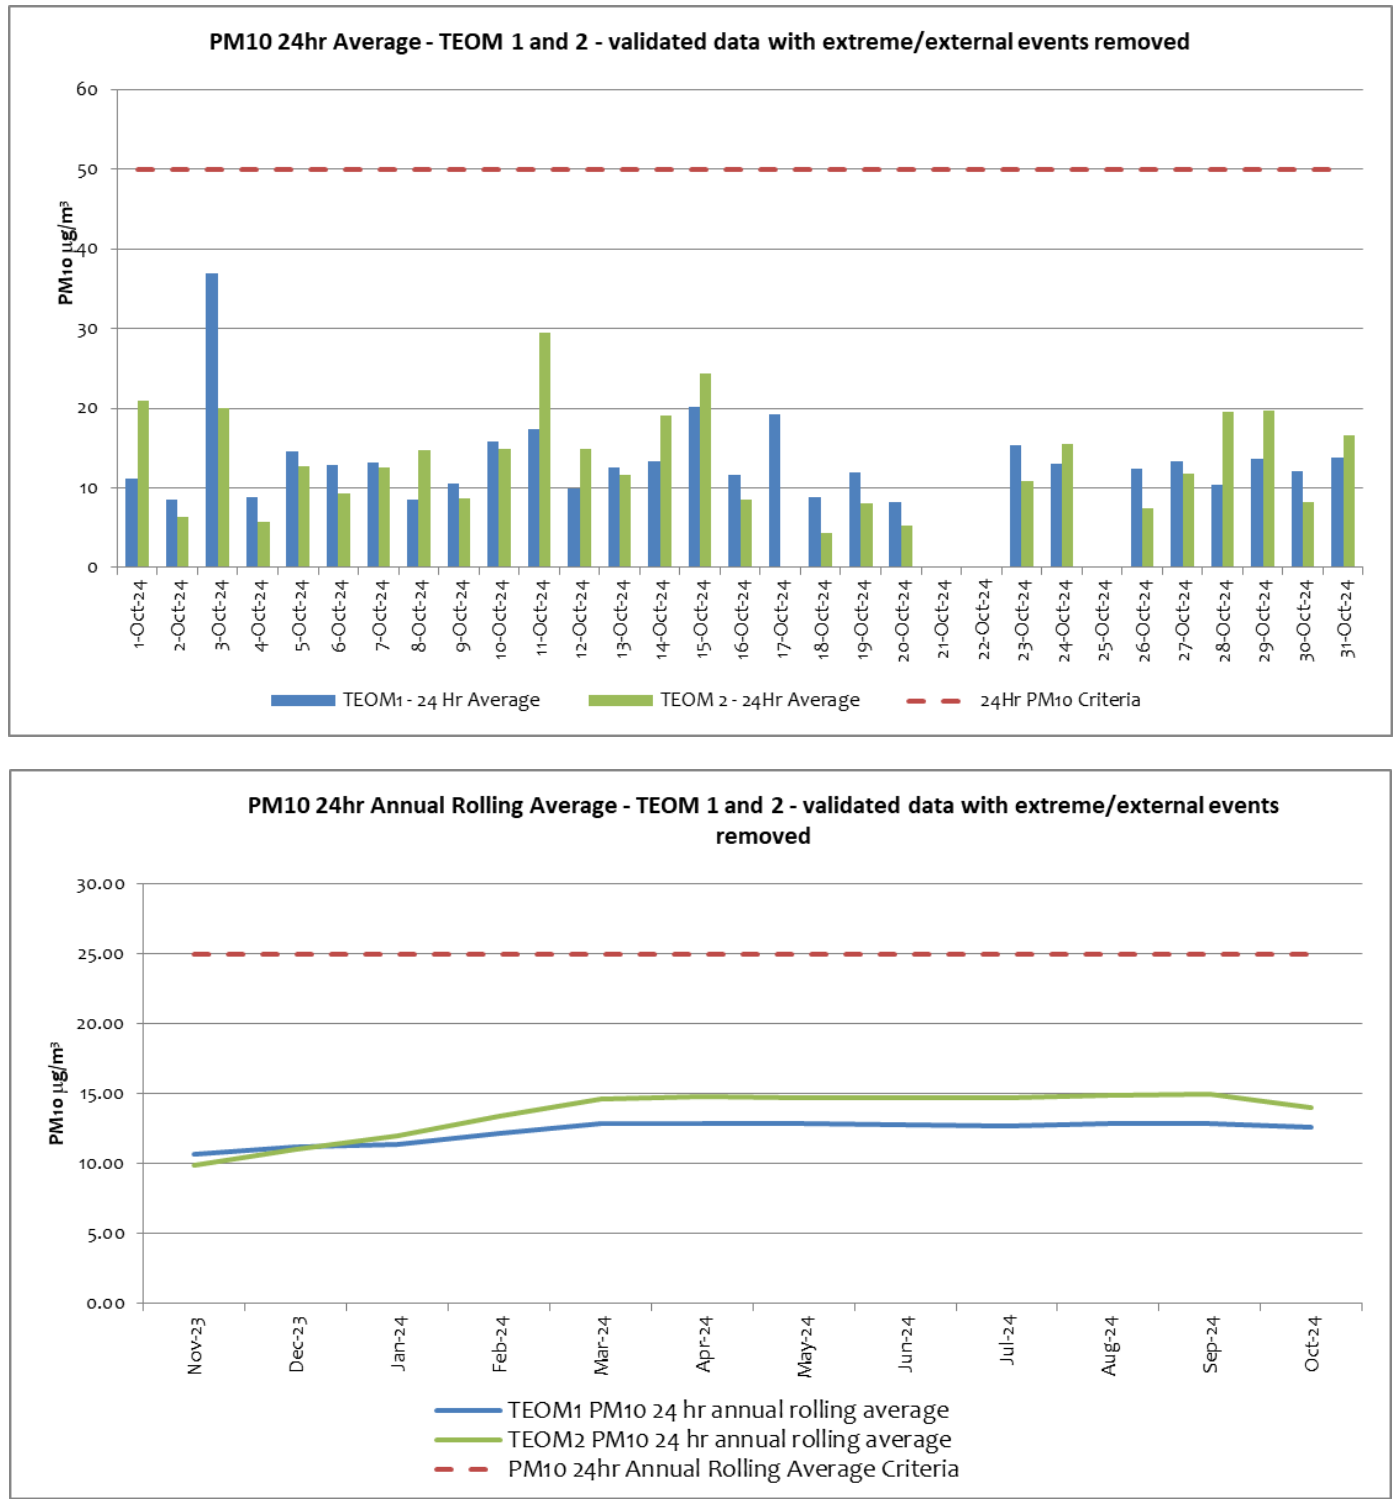
PM<sub>10</sub> monthly average dust levels at both TEOM units in October were higher than in previous months and there were no exceedences of daily limits except due to external events. Data collection at TEOM1 was interrupted on 21, 22 and 25 October due to power outages. Data collection at TEOM2 was interrupted on 17, 21, 22 and 25 October due to power outages.

The rolling annual average for PM<sub>10</sub> at TEOM1 with external dust events and invalid data removed for the period November 2023 to October 2024 is 12.64  $\mu\text{g}/\text{m}^3$ , higher than the rolling annual average of 10.66  $\mu\text{g}/\text{m}^3$  at the beginning of the annual period.

The rolling annual average for PM10 at TEOM2 with external dust events and invalid data removed for the period November 2023 to October 2024 is 14.01  $\mu\text{g}/\text{m}^3$ , higher than the rolling annual average of 9.87  $\mu\text{g}/\text{m}^3$  at the beginning of the reporting period.

The PM<sub>10</sub> 24-hour rolling annual average for both TEOM sites remain below the annual average criteria of 25  $\mu\text{g}/\text{m}^3$ .
