Rasp Mine  
Monthly Environmental Monitoring Report  
January 2020

Broken Hill Operations Pty Ltd (BHOP) [a wholly owned subsidiary of CBH Resources Limited (CBH)] owns and operates the Rasp Mine (the Mine), which is located centrally within the City of Broken Hill on Consolidated Mine Lease 7 (CML7).

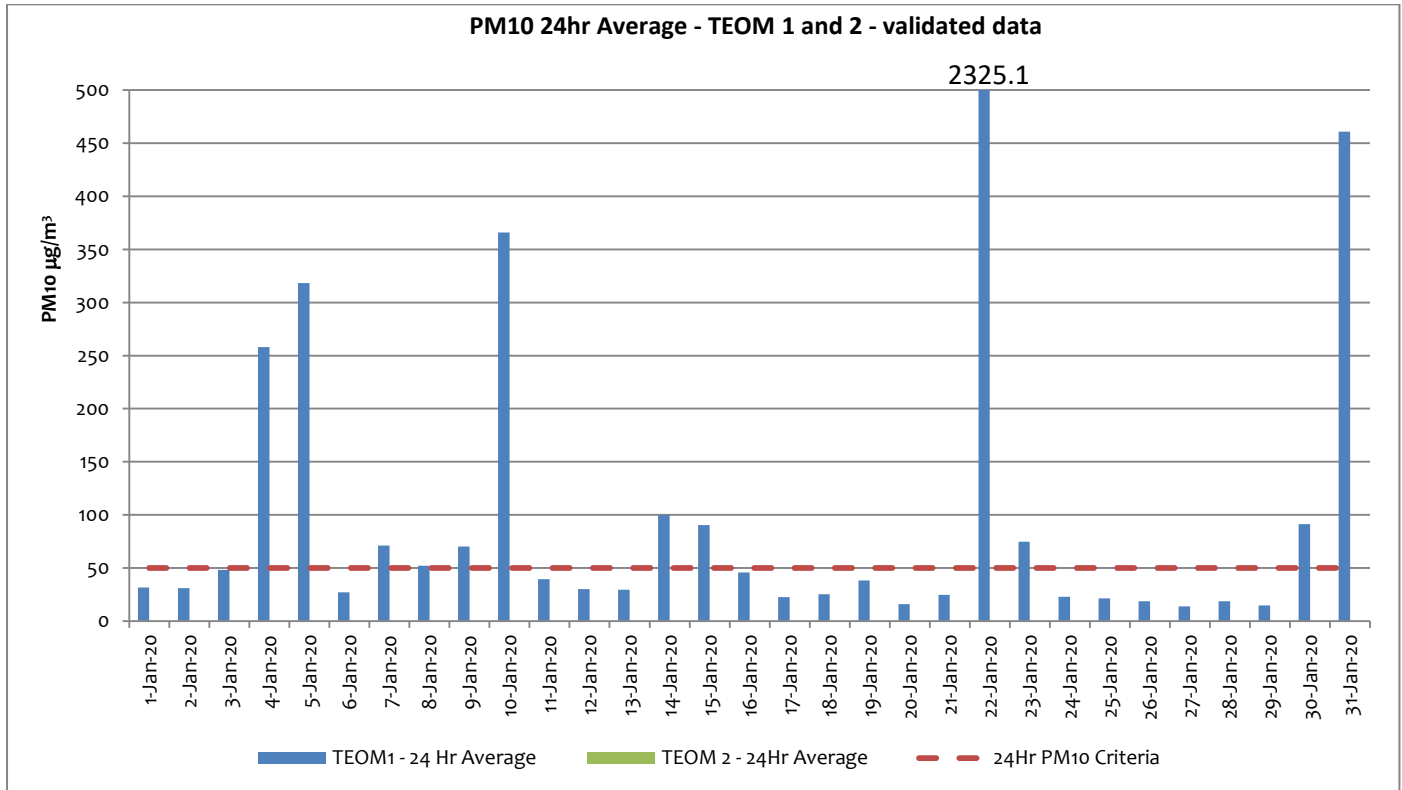
The graph below presenting validated data includes results impacted by dust storms and external events. Dust storms occurred throughout January and produced conditions where dust levels were elevated throughout each day. Dust storms occurred on 4, 5, 10, 22, and 31 January. On each of these occasions the wind was blowing from the South or SW, except for the 22<sup>nd</sup> when the predominant wind direction was WSW. On the 22<sup>nd</sup> the dust storm occurred from 9am to 2am the following morning and the highest reading for the day was 14,713  $\mu\text{g}/\text{m}^3$  at 7pm.

The PM<sub>10</sub> 24-hour rolling average for data with external elevated dust events removed at January 2020 is 17.71  $\mu\text{g}/\text{m}^3$  for TEOM1 and has remained at 20.52  $\mu\text{g}/\text{m}^3$  for TEOM2 as the rolling average has not been calculated while the unit has been decommissioned.

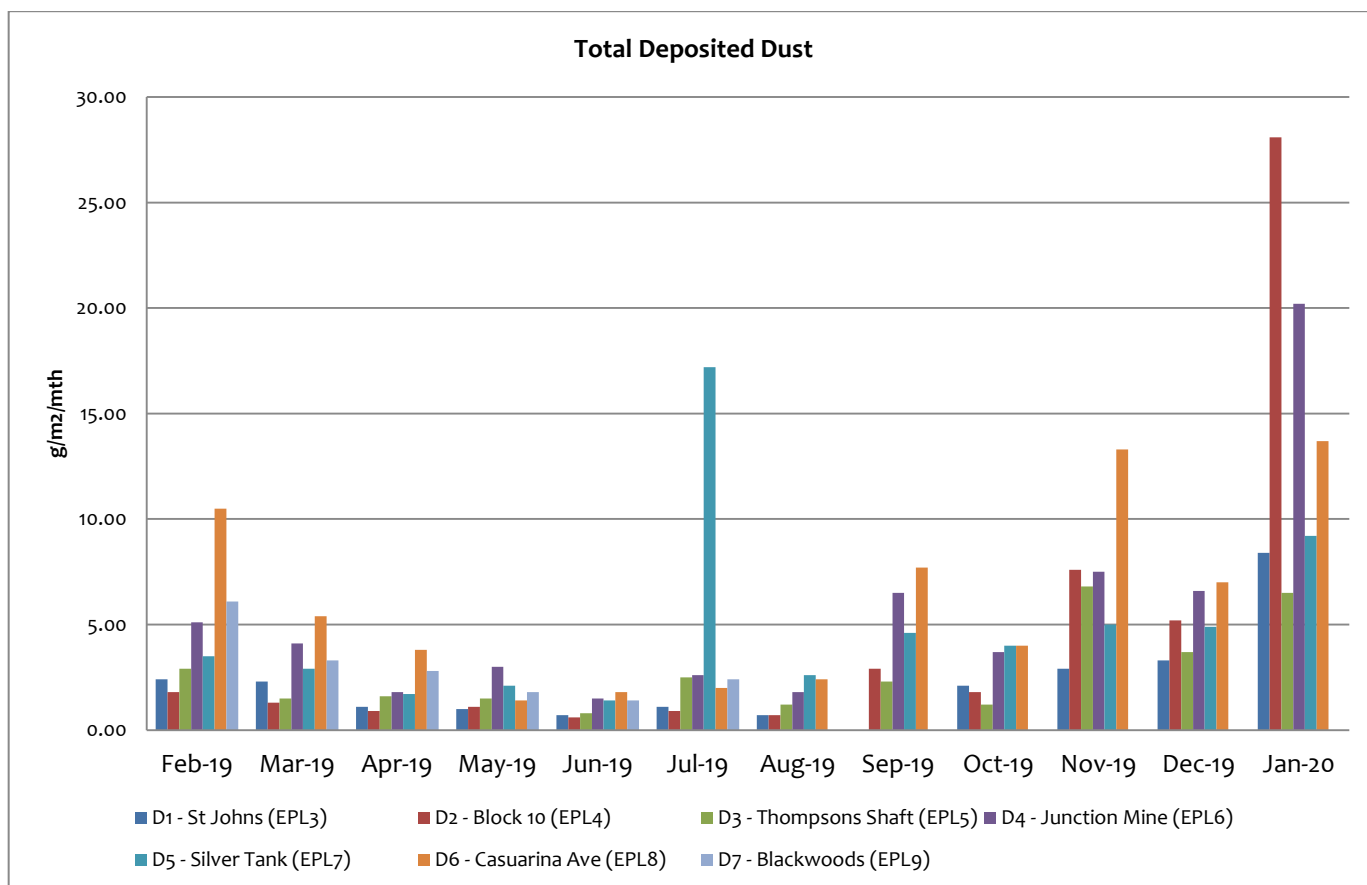
Dust results were elevated for all dust gauges in January, particularly D2 Block 10, D4 Junction Mine, and D6 Casuarina Avenue. Wind was predominantly from the South with dust storms throughout January. Construction works are being conducted on the Essential Water site where the D2 Dust Gauge is situated.

BHOP is not likely to have contributed significantly to the dust captured in these dust gauges.
