Rasp Mine
Monthly Environmental Monitoring Report
April 2021

Broken Hill Operations Pty Ltd (BHOP) [a wholly owned subsidiary of CBH Resources Limited (CBH)] owns and operates the Rasp Mine (the Mine), which is located centrally within the City of Broken Hill on Consolidated Mine Lease 7 (CML7).

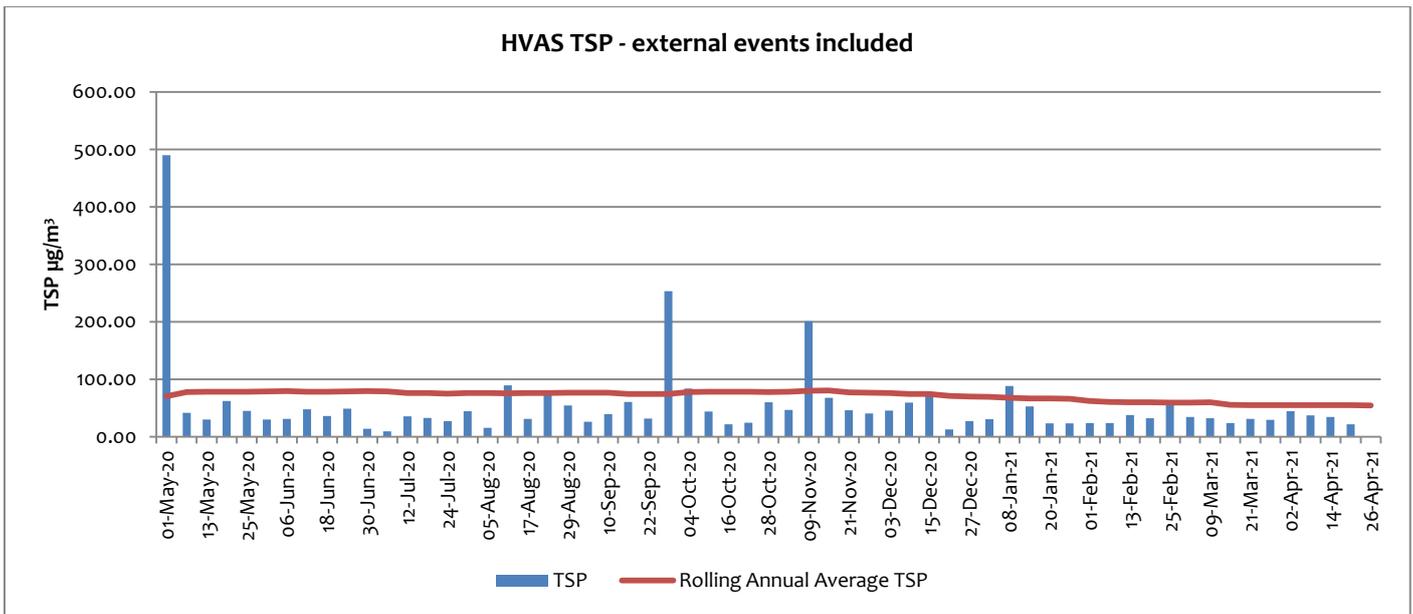
TSP dust results at HVAS were low for the month of April compared to previous months. The annual rolling average for TSP at this location is $54.17 \mu\text{g}/\text{m}^3$ at the end of April 2021, significantly lower than the average at the beginning of April 2020 which was $77.61 \mu\text{g}/\text{m}^3$. Minor rainfall and fewer extreme dust events than the previous year contributed to the low dust levels measured in April.

The annual rolling average for TSP is determined using data with extreme dust events included.

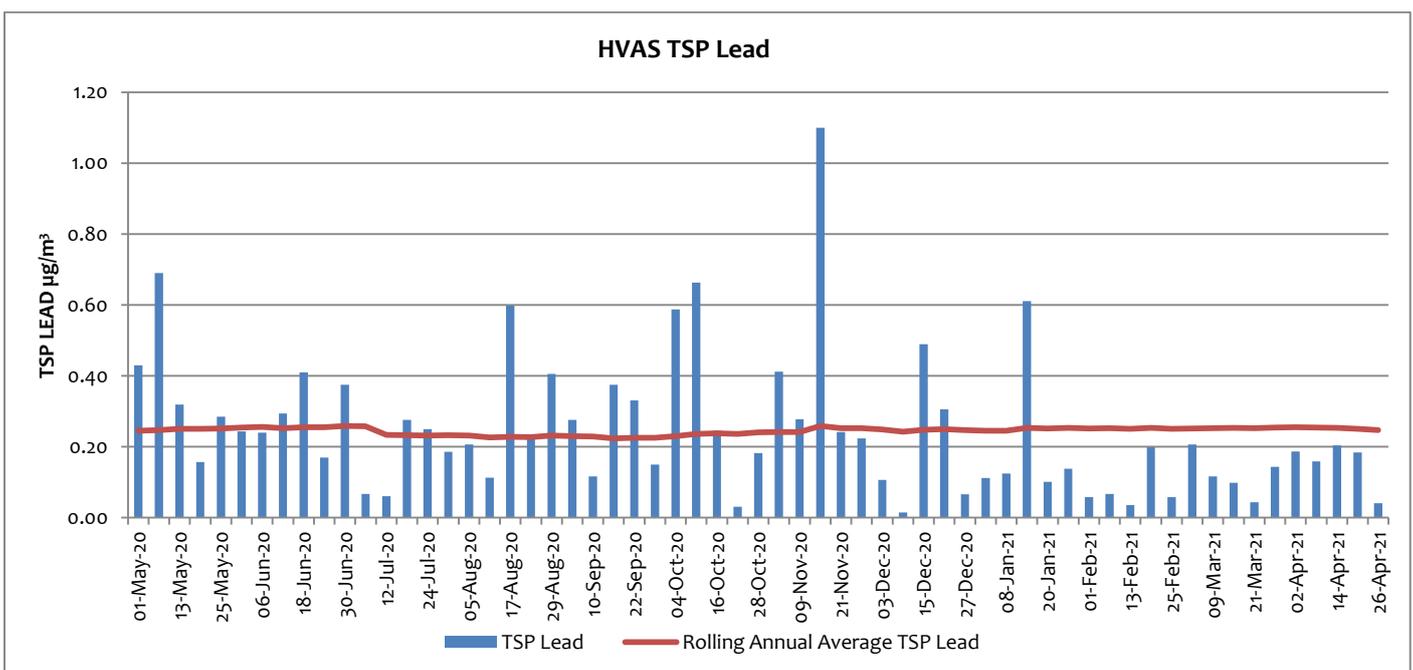
There were slightly elevated TSP Lead levels recorded in April compared to the previous three months. The predominant wind direction in April was from the South which suggests there was contribution of lead dust from off-

site sources. The rolling annual average for TSP Lead in April 2021 was $0.25 \mu\text{g}/\text{m}^3$, slightly higher than the level of $0.24 \mu\text{g}/\text{m}^3$ in May 2020.

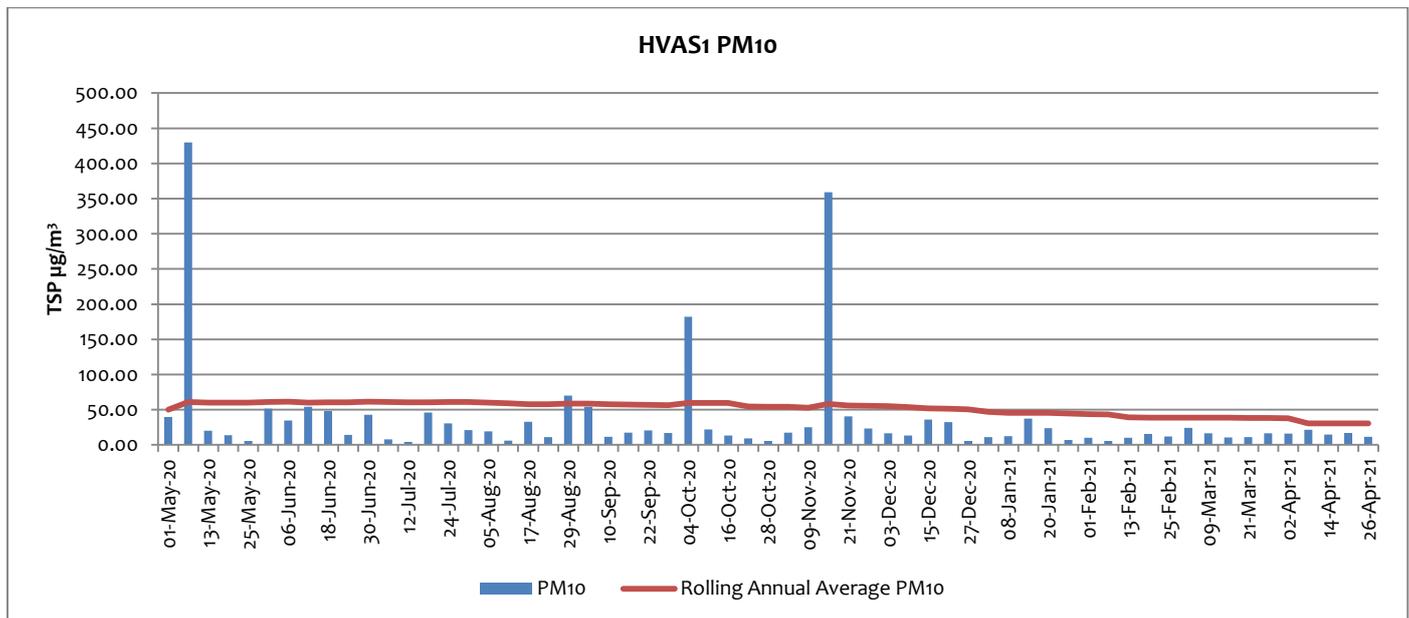
PM₁₀ dust results at HVAS1 were low for the month of April. The annual rolling average for PM₁₀ dust at this location is $30.8 \mu\text{g}/\text{m}^3$ at the end of April 2021, lower than the average at the beginning of May 2020 which was $50.0 \mu\text{g}/\text{m}^3$. External dust events are recorded in measurements.

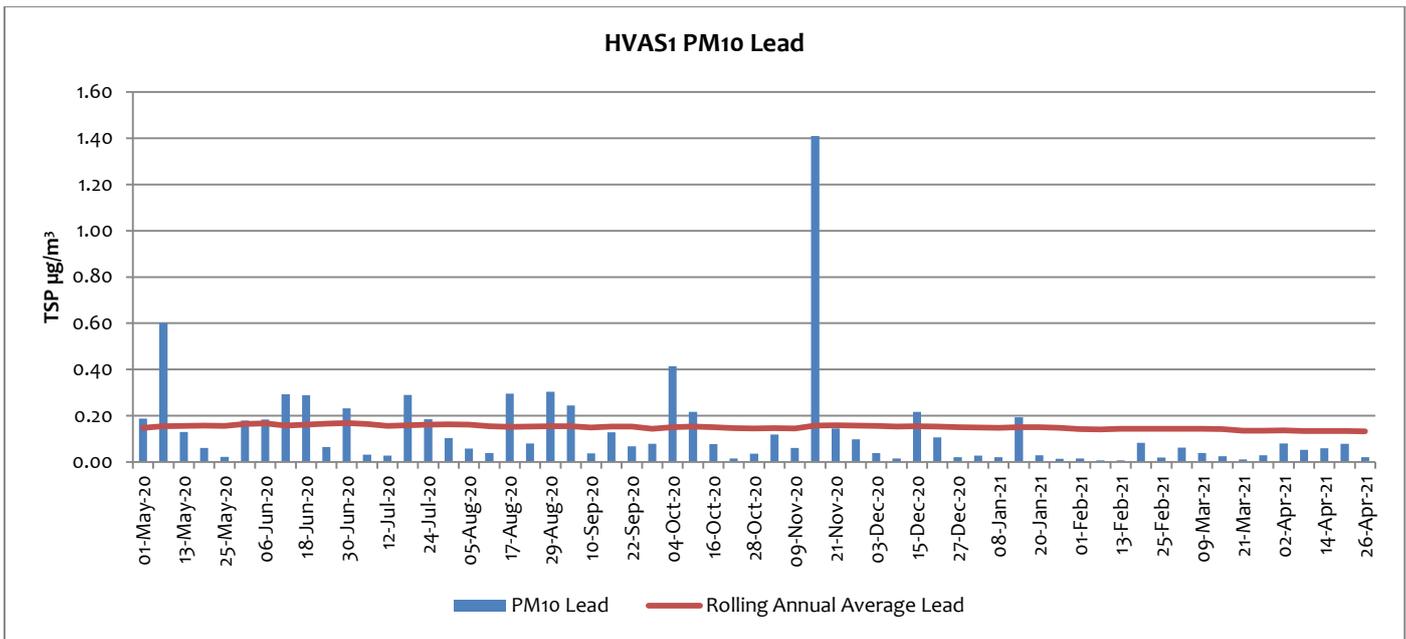
PM₁₀ lead levels were low in the month of April. The predominant wind direction in April was from the South and wind speeds were mild. The rolling annual average for PM₁₀ Lead in April 2021 was 0.13 µg/m³, down from 0.15 µg/m³ in May 2020.

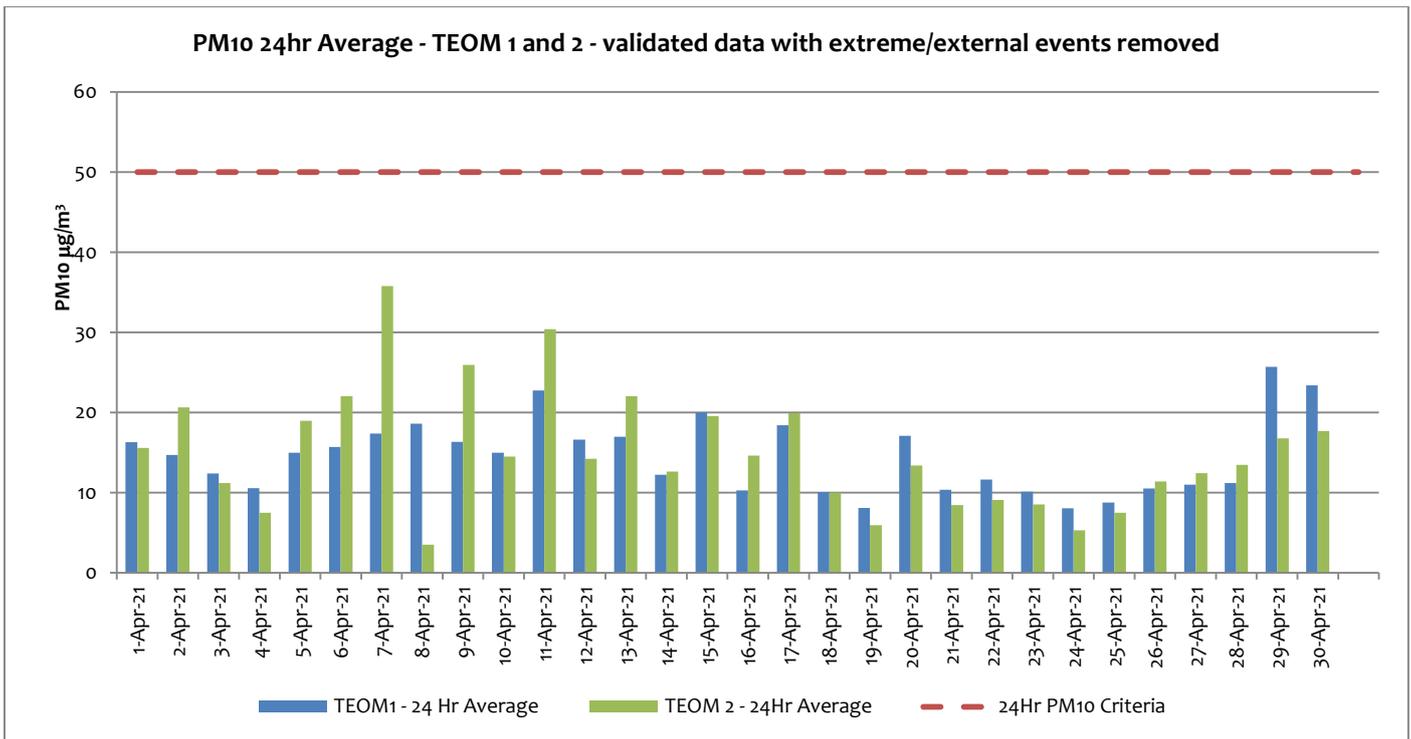
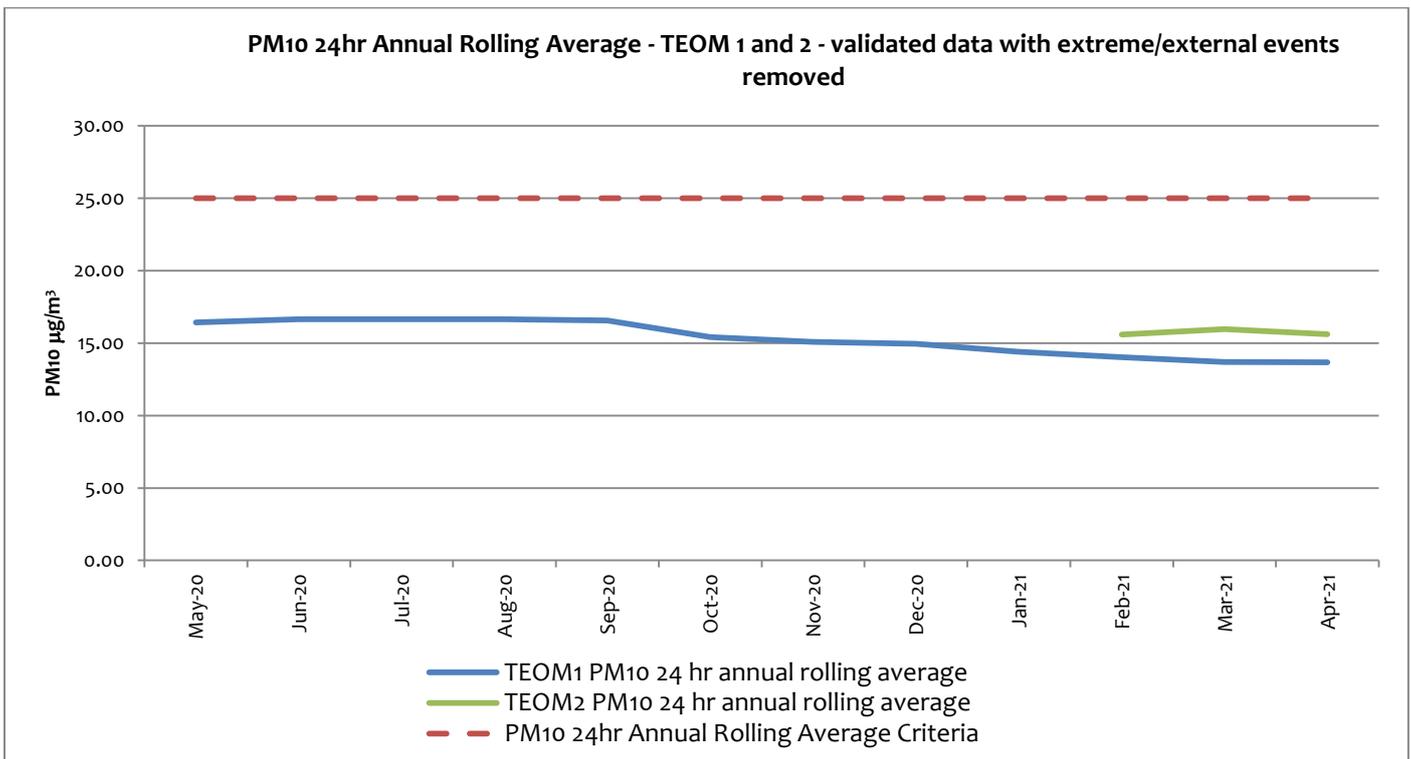
PM₁₀ dust levels at both TEOM units were low in the month of April. The PM₁₀ 24-hour rolling annual average for data with external elevated dust events removed at April 2021 is 13.67 $\mu\text{g}/\text{m}^3$ for TEOM1. The PM₁₀ 24-hour rolling annual average for data with external elevated dust events removed at April 2021 is 15.61 $\mu\text{g}/\text{m}^3$ for TEOM2. The PM₁₀ 24-hour rolling annual average for both TEOM sites remain below the annual average criteria of 25 $\mu\text{g}/\text{m}^3$.

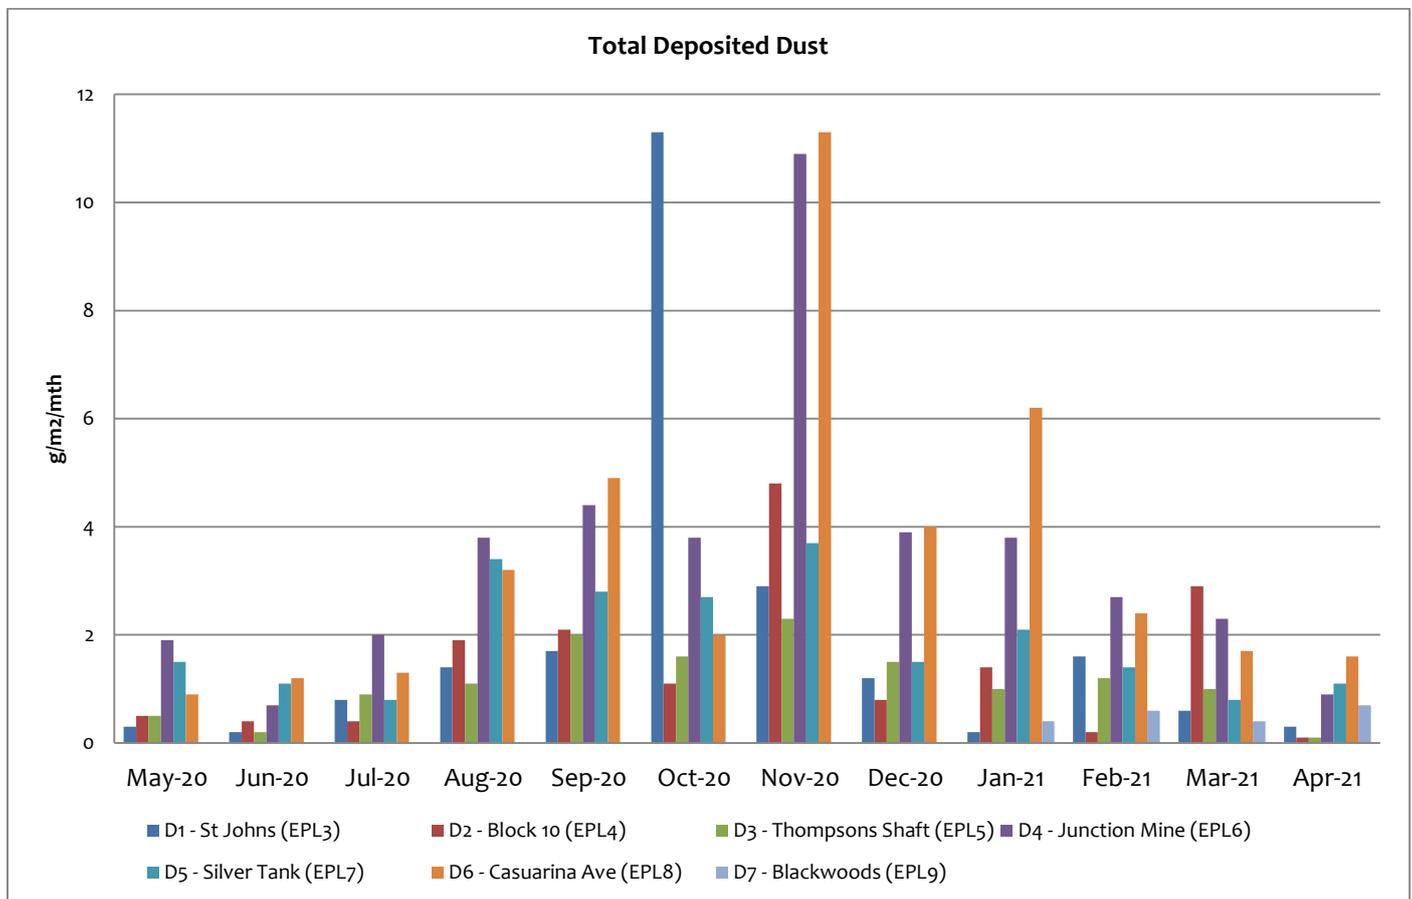
The dust levels recorded in Dust Gauges in April 2021 are low compared to the previous months. The highest dust levels were recorded in the D6 Casuarina Avenue gauge. The predominant wind direction for April 2021 was from the South as shown in the Wind Rose in Section 4.

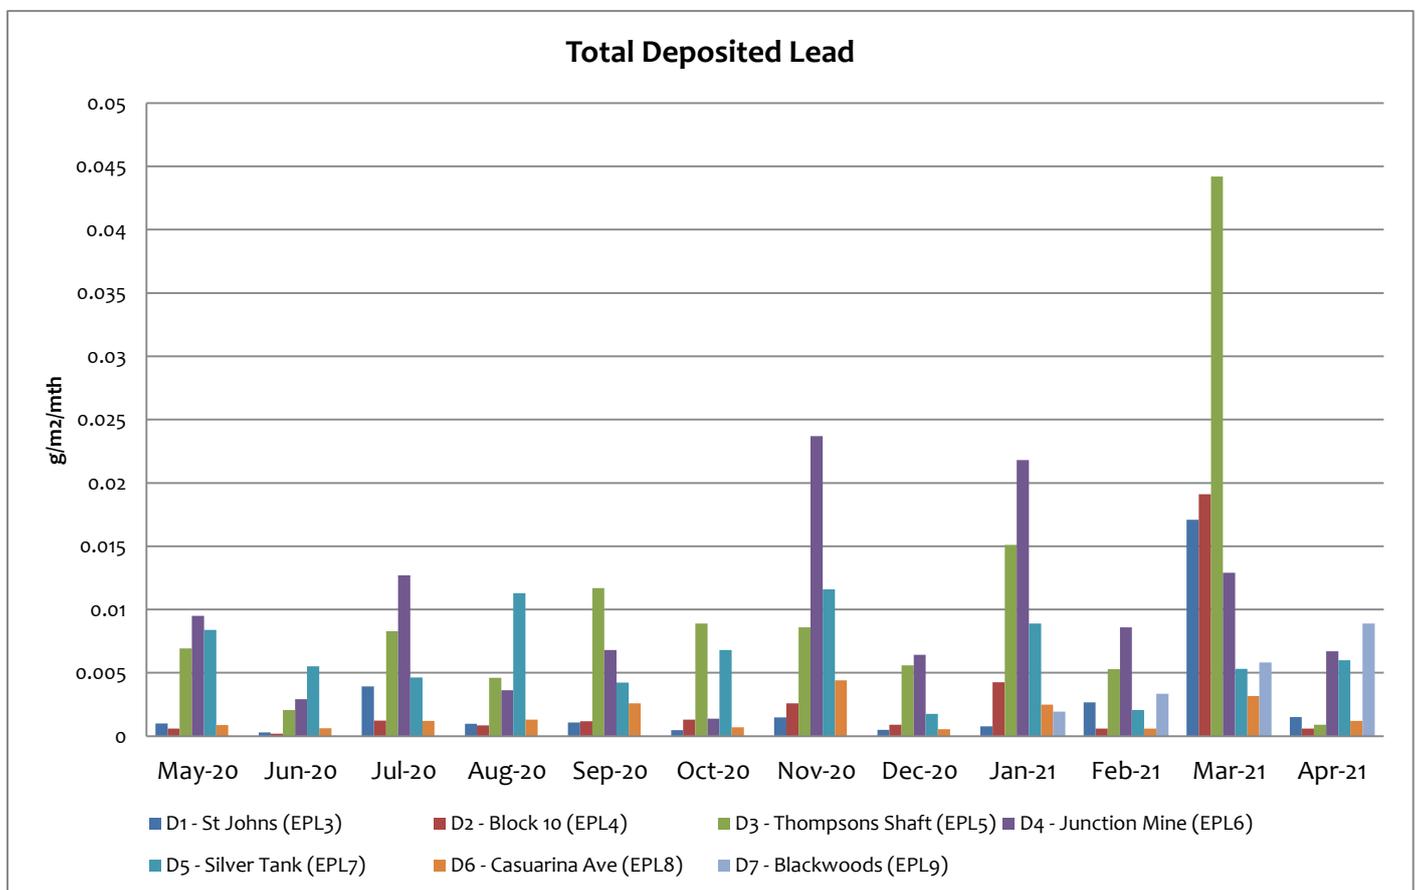
There are no guidelines for deposited lead dust. Lead results in April 2021 were highest in the D4 Junction Mine, D5 Silver Tank and D7 Blackwoods gauges. The predominant wind direction for April 2021 was from the South as shown in the Wind Rose in Section 4. Site activities around the Rail Loadout area may contribute to elevated Lead levels at D4 Junction Mine, but only minimally, as the concentrate containers are loaded with concentrate in an enclosed shed under negative pressure, and the loading area alongside the train is a concrete pad which is regularly swept and watered. A water cart will also attend to the haul road between the concentrate loading shed at the Mill and the rail loadout area when concentrate containers are being transported on site. The D4 Junction Mine site is north of the site and impacted by both on-site and off-site activities. Much of the area around the D4 gauges is bare of cover and characterised by historical mining activities. Elevated levels at D7 Blackwoods were potentially due to Embankment Construction activities and disturbance of the surface of TSF2 Blackwoods which have now been completed and are ready for installation of a TSF surface spray system. The D5 Silver Tank levels were likely impacted by dust from off-site sources due to the predominantly southern wind direction.

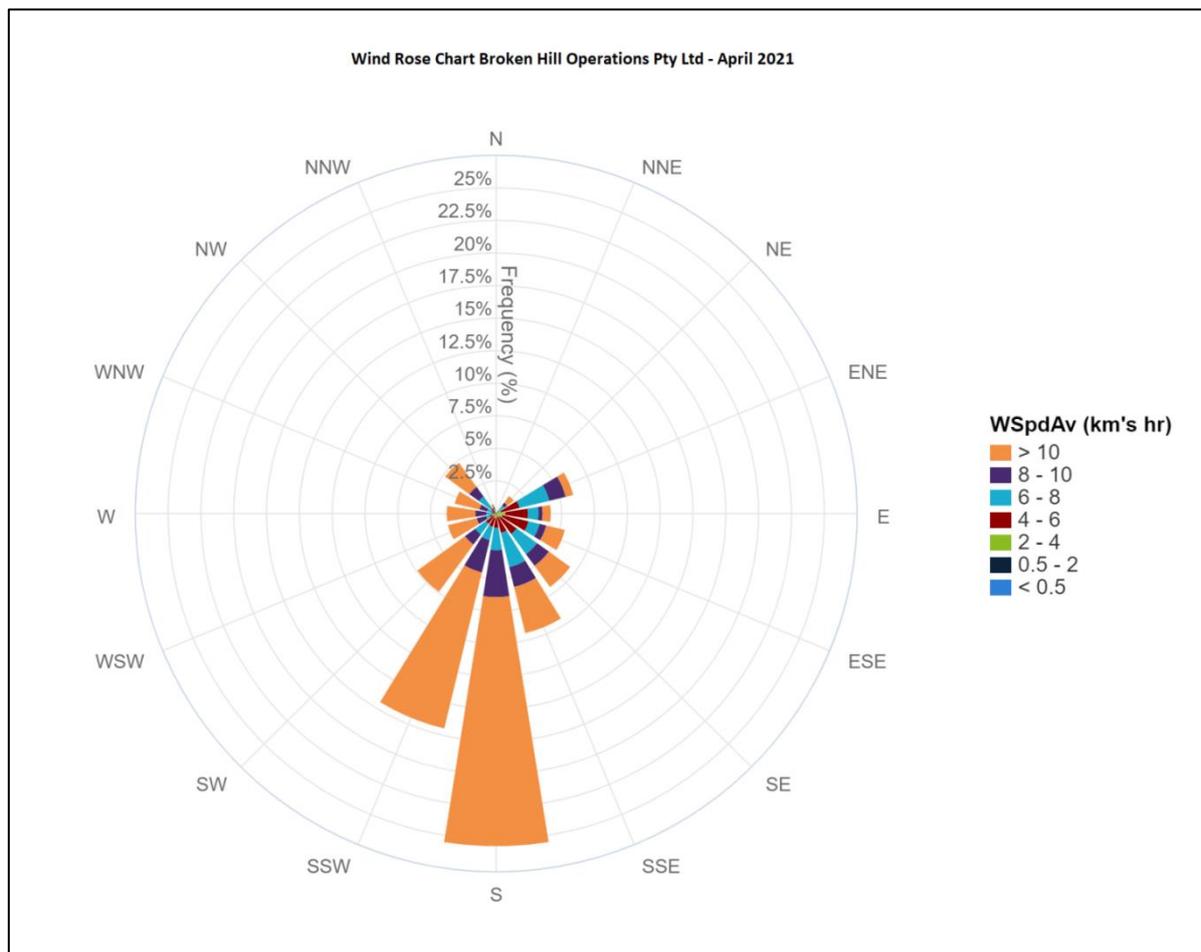
The windrose provided below indicates the main wind direction for the month of April was from the South.
