How To Properly Restore Neodent

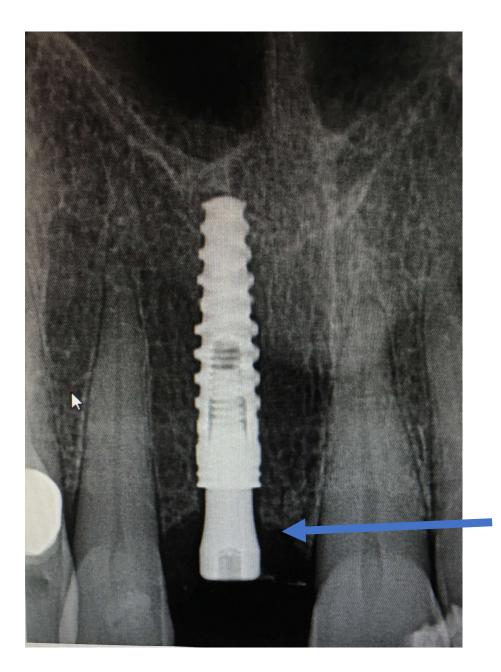
A typical result after 4 months of placement.

Bone grew over implant and implant is ready to be restored.

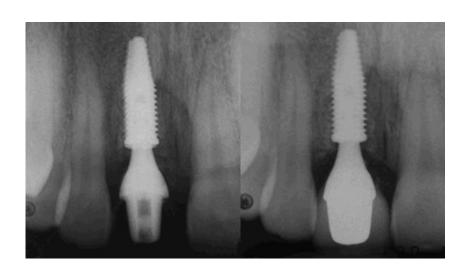
An abutment/tiBase that is too short will not be able to sit as it will hit the bone

Incorrect abutment/tiBase

Correct abutment/tiBase

tiBase too short
Crown does not sit properly

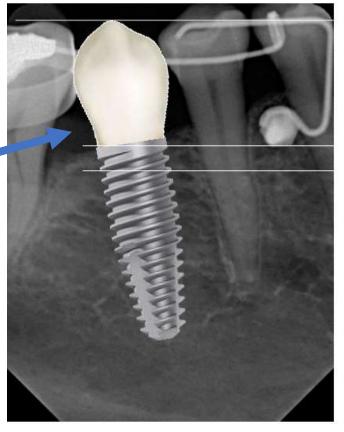
How other implant systems are restored

How Neodent implant system is restored

Food trap

Flat to flat connection (tri-lope) and bone level placement

→ Crestal bone loss

Platform switching, sub-crestal placement → Bone maintenance

Not a food trap

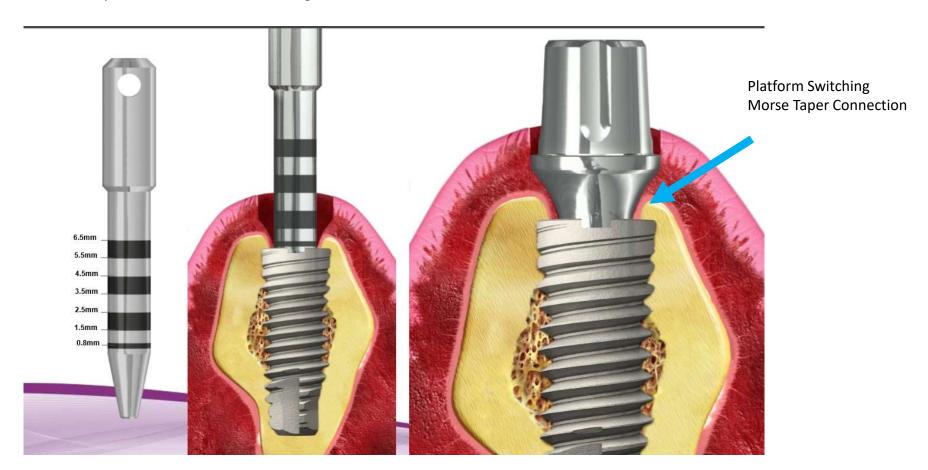
The neck of the implant is at bone level, sometimes first thread is also exposed.

The best way to let the lab know is to take a gingival height measurement tool and measure the gingival height, the let the lab know. Lab will choose an abutment or a tibase that is at least 1mm or 2mm shorter (to hide the margin of the crown)

Note: always take the buccal/facial readings

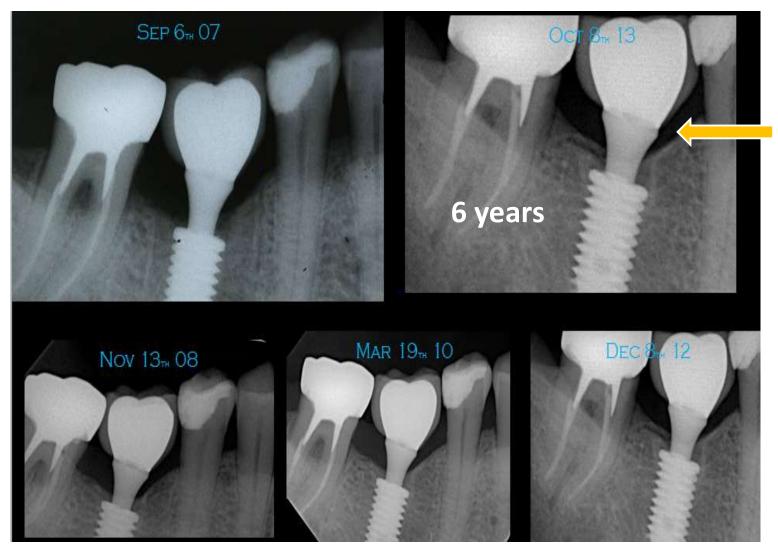
Not a "food trap" as bone and hard tissue attached to the implant and abutment.

3mm probing like a natural tooth

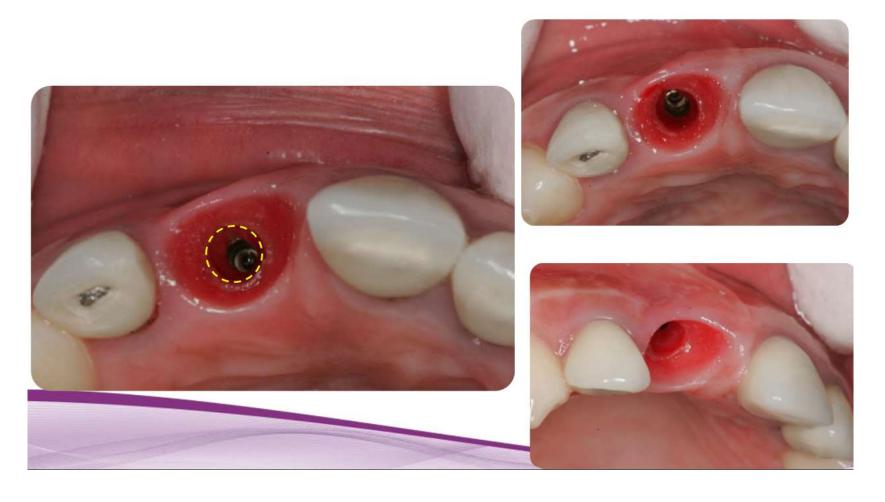
Perfect immersion profile with bone and hard tissue attached to the implant and abutment No space for food to get stuck
