1910 Flanders – Carburetor, Mat, & Safety

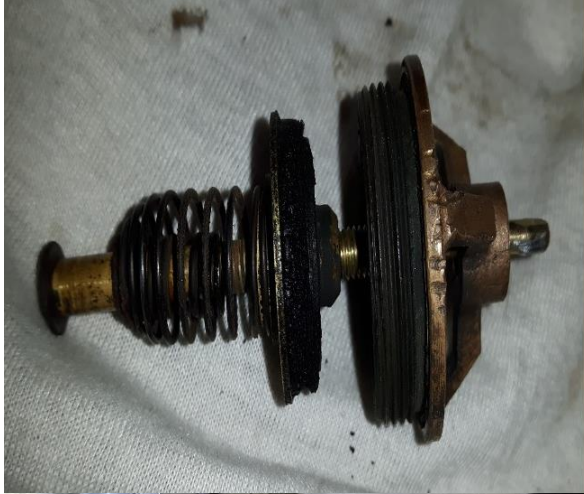
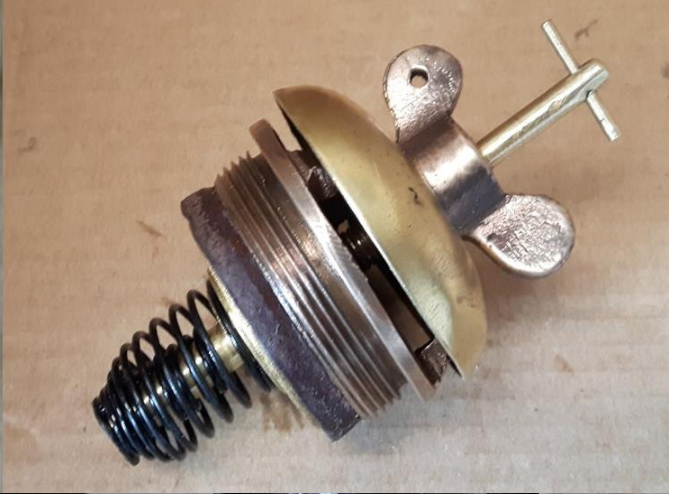
The auxiliary air valve on the carburetor uses a leather washer controlled by a double spring (a spring inside a spring). The washer had rotted away, allowing far too much air in on start-up. Leftover leather from my 15 Studebaker clutch replacement fit the bill. It now starts on the second pull (providing you “tickle” the carburetor first).

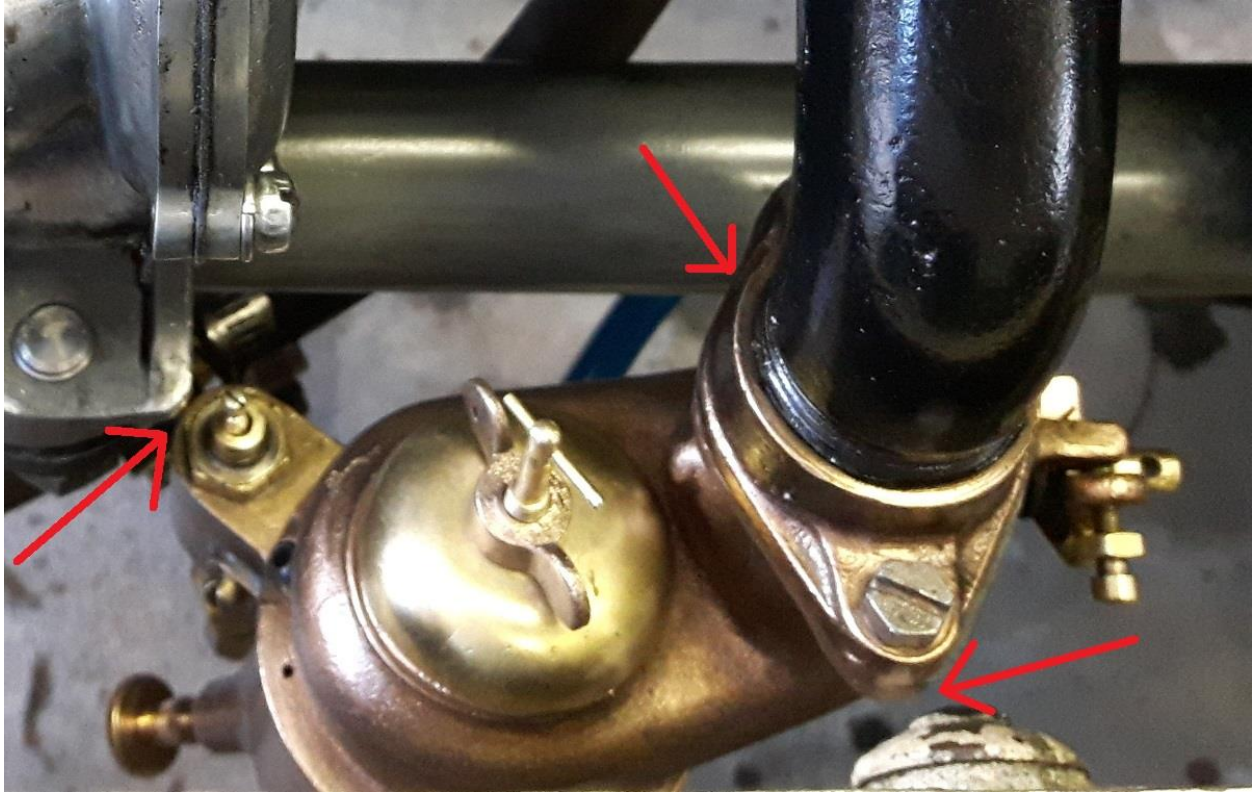
The 1910 Flanders Twenty 2-speed cars were fitted with a carburetor similar in design to the 1909 EMF 30. It was made specifically for this model but the area it needed to fit in was very restrictive. The red arrows I've added in the carburetor photo show the three places where clearance is minimal. I'm lucky to have the original since no other carburetor I've tried would both fit AND work with the original controls.

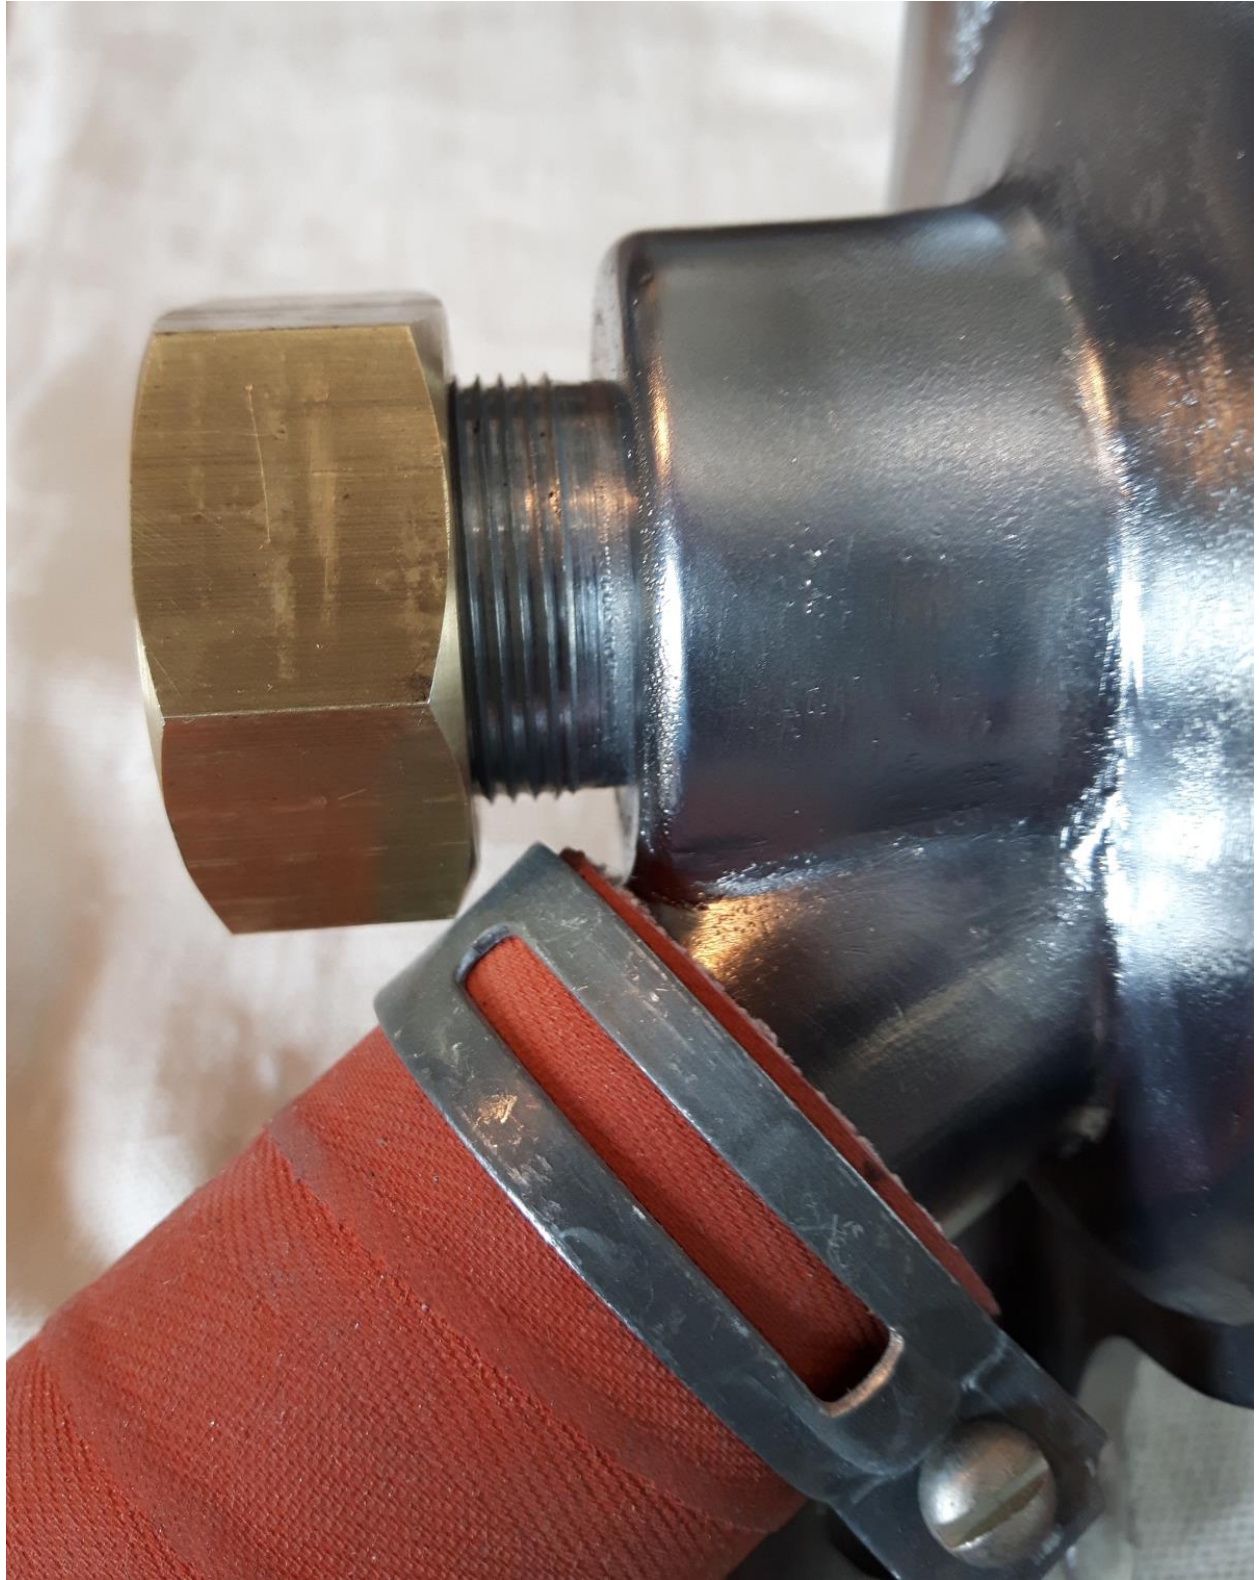
Space is at a premium in many places in the design of this model. The water pump hose photo shows the packing nut to hose clamp clearance.

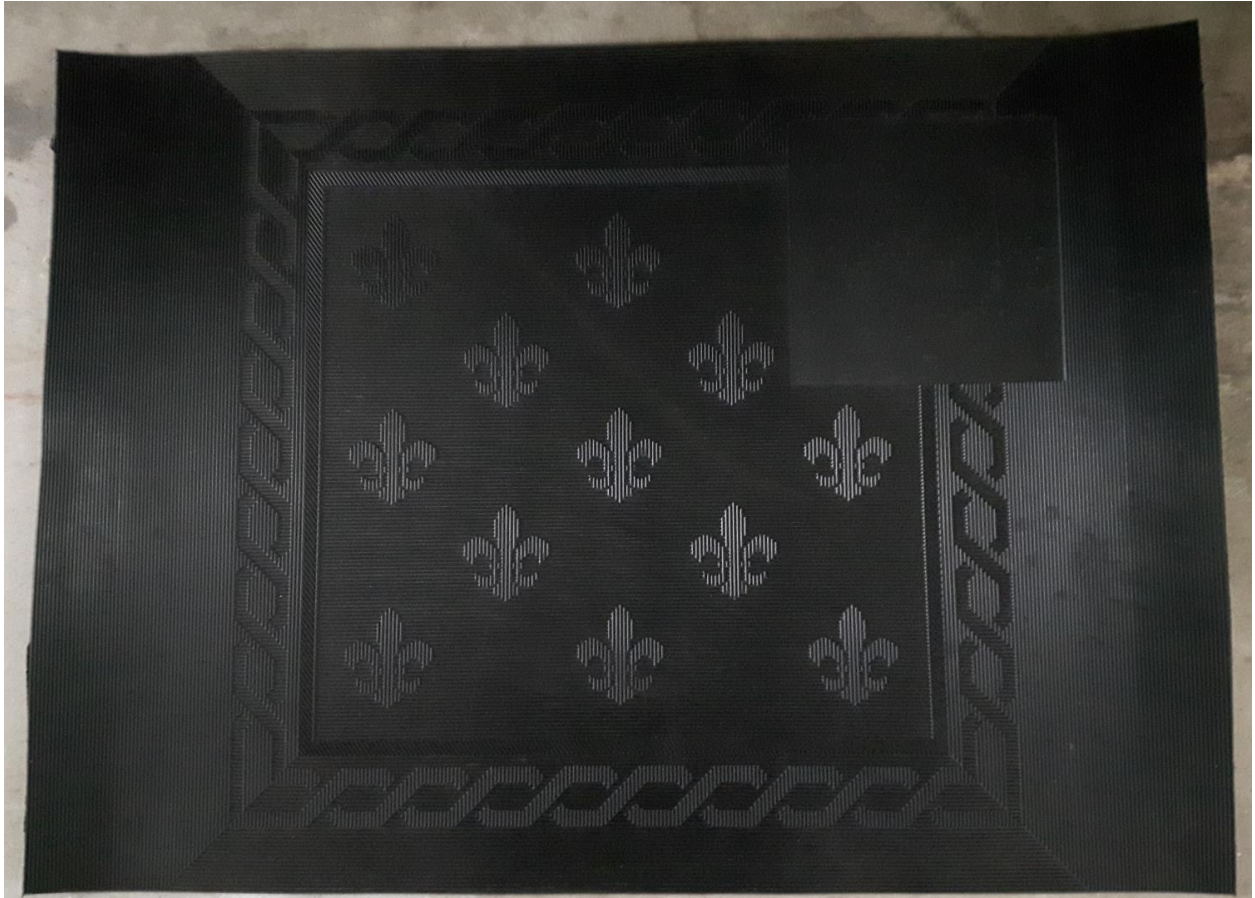
I was lucky to acquire one of the last in a run of Flanders reproduction rubber floor mats thanks to Daryl Kemerer and Floyd Jaehnert. These display the same fleur-de-lys design as found in the photos in the original parts book.

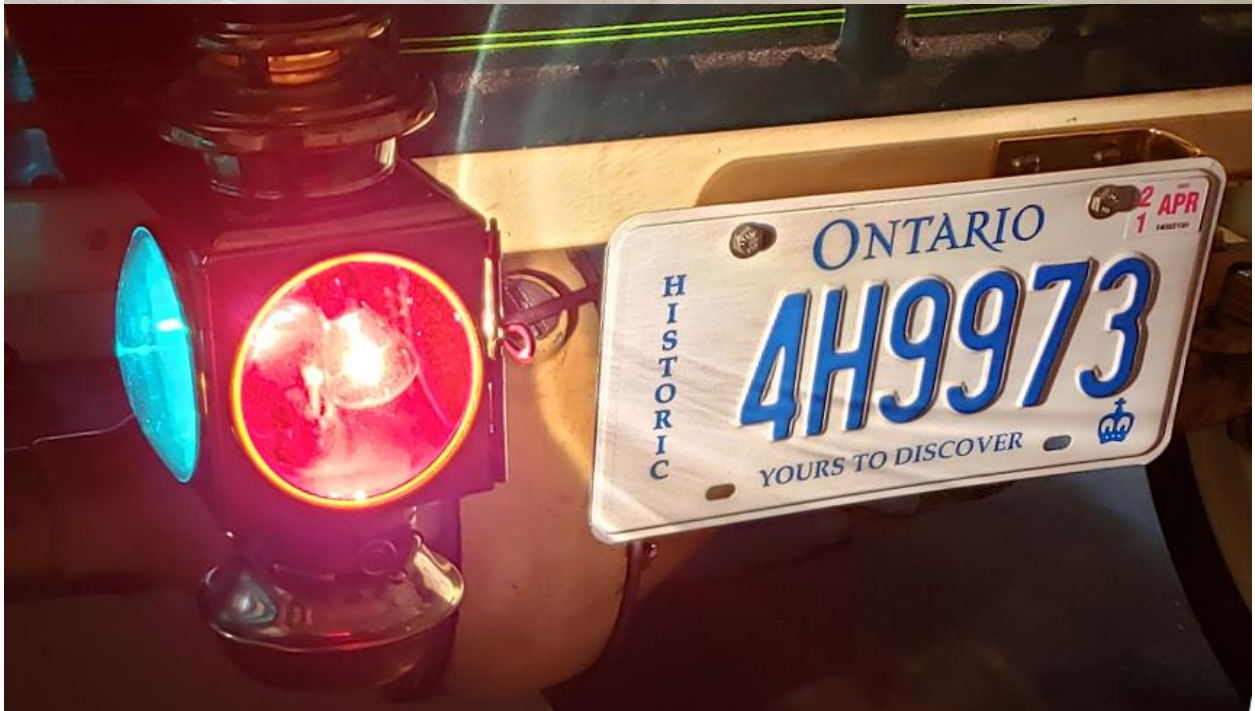
Finally, I decided if I'm going to be test driving that I'd better have a brake light. A Model A Ford brake light switch connected easily to the rear service brake lever and a headlamp bulb and socket from my 15 Studebaker was affixed to the inside of the tail lamp. Now, what's missing ...perhaps a seat belt?
