EPOXY MOISTURE CONTROL

Reducing bond failures caused by moisture vapor transmission

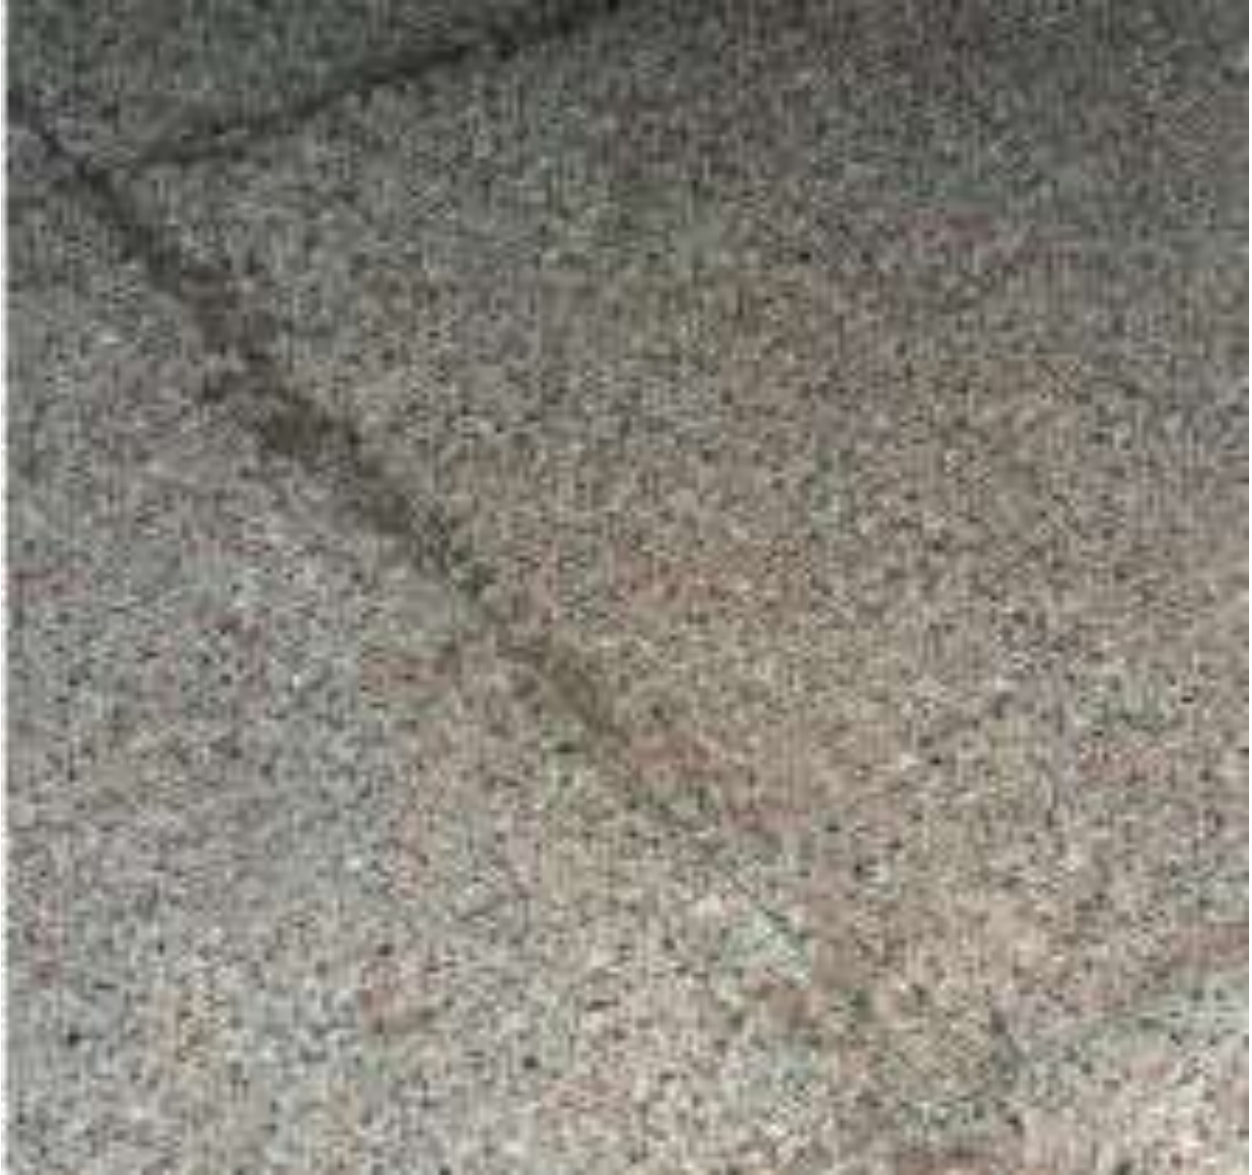
Photo 2 - Moisture Vapor Transmission through Polyacrylate Terrazzo Joints

Photos #1 and #2 show the effect of moisture vapor transmission on impermeable and permeable floor systems. Photo #1 is an epoxy terrazzo surface (impermeable) which has completely lost bond and has water lying in the exposed area. Photo #2 is also a

terrazzo surface, but in this case, it is a permeable, cement-based system. Moisture migration is plainly visible around the panels of terrazzo defined by zinc divider strips. Moisture is transmitting along the path of least resistance but is not affecting the bond or adhesion of the terrazzo to the concrete substrate.
