# AQUA-HOT SYSTEM

## Fluid Analysis

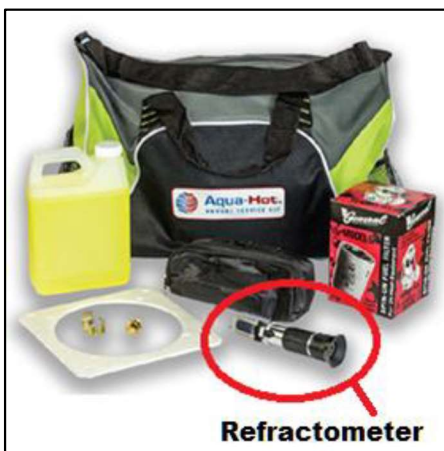
Figure 1: Aqua-Hot's Annual Service Kit with Refractometer

Aqua-Hot heating systems use one of two fluid types: Camco (*pink color*) or the Century (*green color*). The fluid used in your system may have been determined by the coach manufacturer and the production year. According to Aqua-Hot, mixing pink and green fluids produces a brown color that may be confused with corrosion, creating unnecessary service expense. Aqua-Hot recommends annual system maintenance and offers “Annual Service Kits” to perform this maintenance. Figure 1 shows a typical Annual Service Kit. Among other items, the Annual Service Kit includes a refractometer (*see red circled item*). Refractometers are used to measure freezing point and propylene glycol concentration of the coolant used in the system.

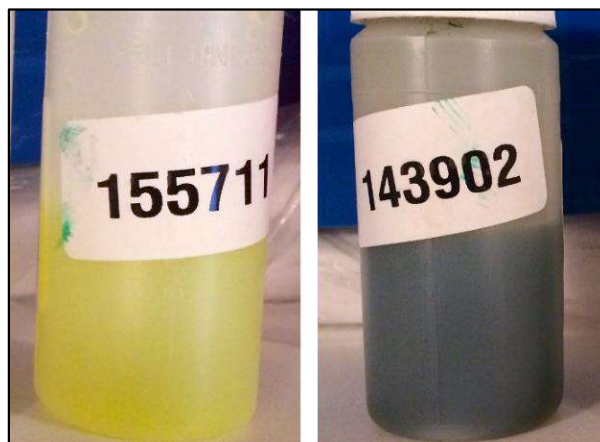
NRVIA inspectors offer complete fluid analysis on these critical systems. Our specialized testing offers a report with data, over and above what a refractometer reading offers. Our customers receive complete fluid evaluations that cover all of the fluid properties plus an assessment of possible internal system part wear. Figure 2 shows a comparison of new vs. used fluid. The sample on the left (#155711) is fresh unused Century fluid and the sample on the right (#143902) is the same fluid taken from the customer's system after only one year of service. In addition to showing severe levels of flaking and sludge, the sample also showed high levels of copper and tin.

Figure 2: New fluid and used fluid sample

In this case, the customer experienced poor heat distribution and later found one heating circuit to be completely blocked by system sludge that collected in a tubing bend under the floor. This amount of sludge can lead to clogged check valves and clogged tubing. Many of these systems have required system flushing, at a cost of up to \$600 or more, in order to rid the system of this sludge buildup.
