Chlorine Trifluoride Exposure and Reactivity Study

Air Products and Chemicals, Inc.
Allentown, PA

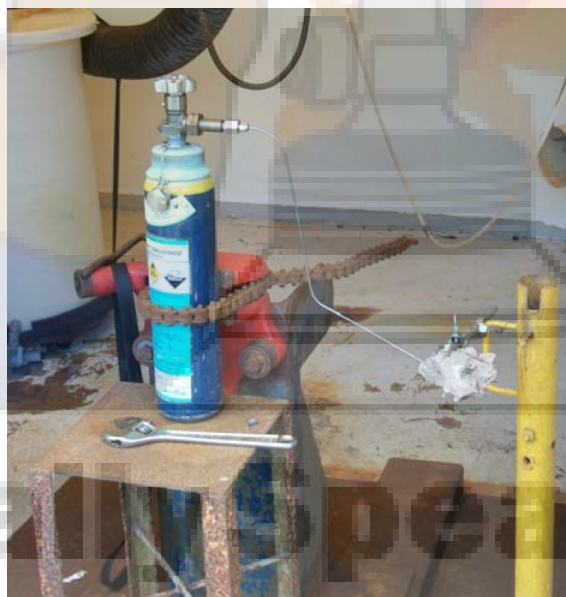
Figure 2: Chlorine Trifluoride Vapor-Phase Exposure Testing Apparatus

The vapor-phase exposure testing was conducted using a 51 cm (20 inch) long piece of 0.312 cm (0.125 inch) diameter stainless steel tubing connected directly to the cylinder with the use of a CGA-670 nut and nipple. The cylinder was mounted upright in the vertical position inside the vent booth on a metal stand. The outlet of the vapor discharge tubing was directed at the target piece, which was held by a laboratory clamp and stand (Figure 2). For added safety, a local vent snorkel was positioned behind the target piece to assist in fume removal. The flow of the vapor was controlled by manual operation of the cylinder valve.

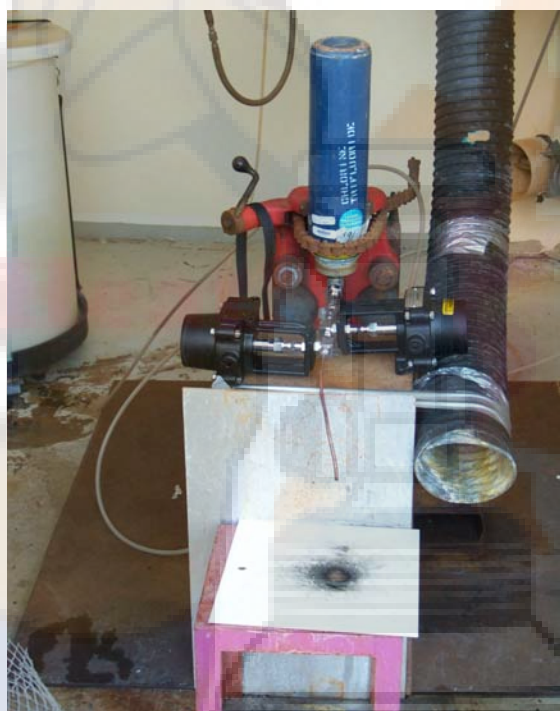
Figure 3: Chlorine Trifluoride Liquid-Phase Exposure Testing Apparatus

The liquid exposure testing was conducted by inverting the cylinder to access the liquid phase and mounting it above the metal stand. Two metal-to-metal seat pneumatic nickel valves were connected to the cylinder. The first valve was connected directly to the valve outlet. The second valve was coupled as close as possible to the first valve with

about 2.5 cm (1 inch) of 0.635 cm (0.25 inch) stainless steel tubing. The second valve discharged to a 20 cm (8 inch) length of 0.635 cm (0.25 inch) diameter copper tubing which directed the chlorine trifluoride to the target piece by gravity. The target pieces were positioned on the metal stand immediately below the tubing outlet. The testing was done by remote operation of the two pneumatic valves. The cylinder valve was opened admitting liquid chlorine trifluoride up to the first valve seat. The first valve was cycled opened and closed. This trapped approximately 2 ml of liquid between the pneumatic valves. When the second valve was opened the trapped liquid was dropped onto the target piece through the copper tube (Figure 3). The tests were conducted in this manner to limit the amount of liquid chlorine trifluoride available to the sample being exposed.

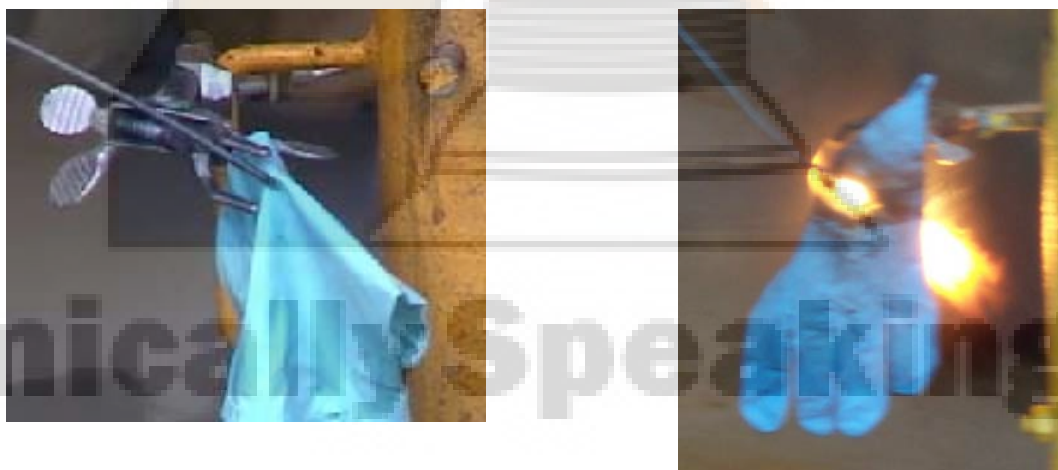
Figure 4: Vapor ClF_3 Exposure to Nitrile Gloves, Clean and Oil Contaminated

One of the most significant findings was how reactive chlorine trifluoride can be with common contaminants such as water or hydrocarbon (e.g., oil). In some cases where there was no reaction between liquid ClF_3 and the sample, if liquid contacted water or oil contamination near the test sample, the reaction heat was sufficient to ignite the sample material. This phenomenon was very evident in liquid exposure testing on contaminated nitrile gloves, used polyethylene tubing (Figures 4 and 5), and oil contaminated surfaces. Therefore, maintaining cleanliness with any materials that may come into contact with ClF_3 , and especially PPE, is of paramount importance.

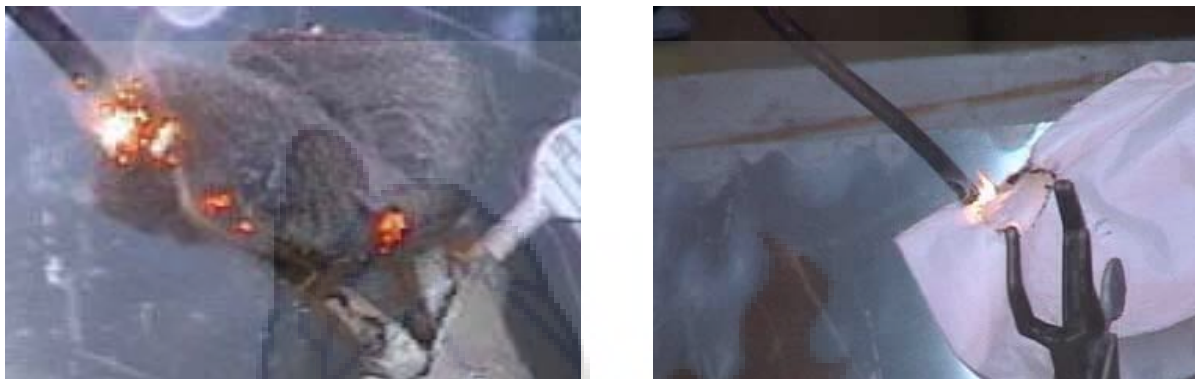
Figure 6: Residual Vapor Exposure on Steel Wool and Tyvek® Suit

Even trace amounts of chlorine trifluoride remaining in a tube that was not purged properly were sufficient to cause immediate reactions. Samples of steel wool, Tyvek®, and paper were against the end of a tube containing residual traces of ClF_3 vapor and the gas diffusing from the tubing caused an immediate reaction (Figure 6). This was also

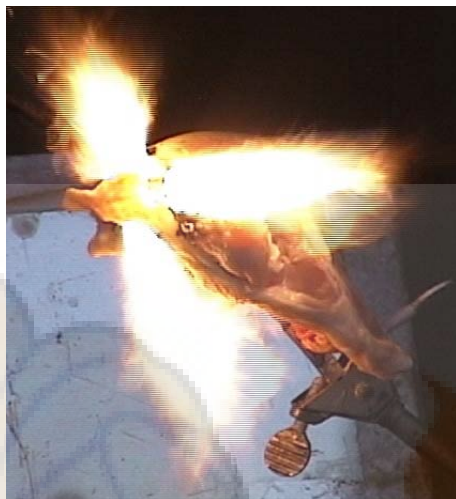
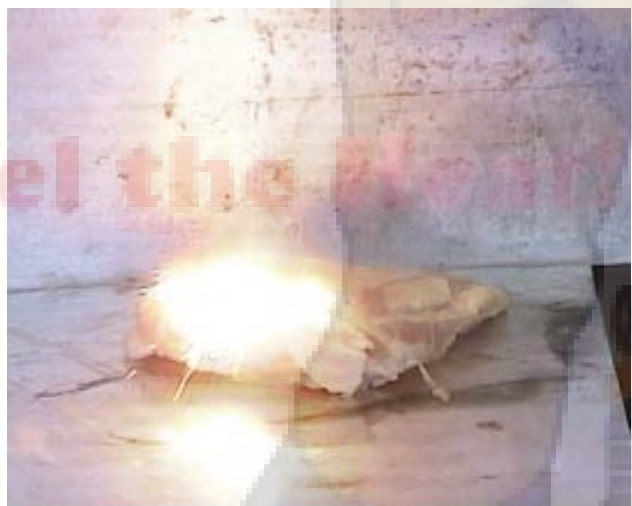
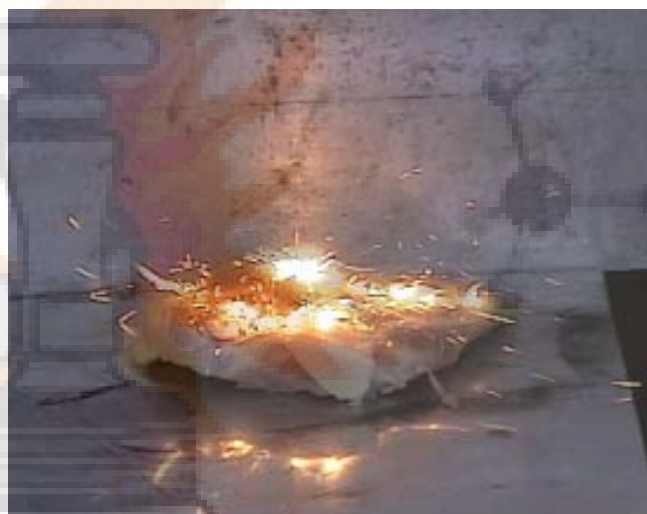
Figure 7: Vapor and Liquid Release on Raw Chicken

As a powerful oxidizer, liquid ClF_3 reacts immediately with any fuel, such as oil or fat. The most visually dramatic test was the liquid chlorine trifluoride exposure onto a piece of raw chicken. This test was conducted to observe the approximate reaction of ClF_3 contact on exposed skin. In slow motion on the video you can see the liquid contact the skin and immediately react dispersing smaller ClF_3 droplets around the point of contact area in a donut pattern. Even the gas release onto a piece of raw chicken created a very loud and intense flame (Figure 7).

Vapor Exposure

Liquid Drop First Contact

Liquid Splatter and Sparking
