## **DYNAMIC TESTING: AN EXPERIMENTAL APPROACH TO DEFECT IDENTIFICATION IN ADDITIVE MANUFACTURED PARTS**

A THESIS

In Mechanical Engineering

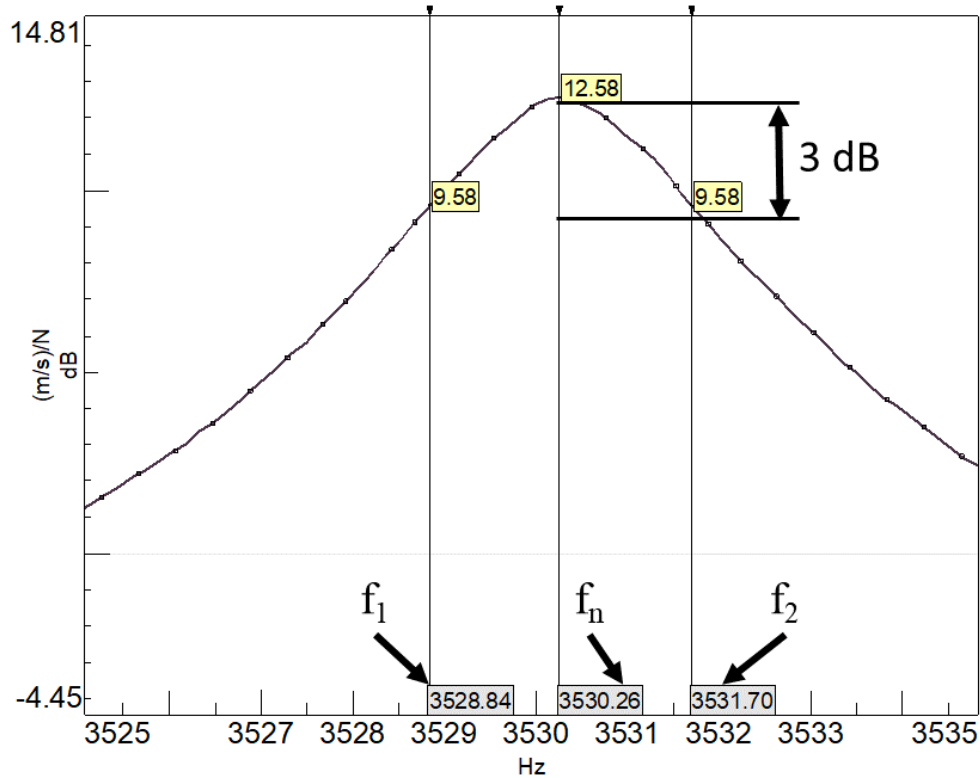
Fig. 7: Bar 26 from impact testing on nominal build example of the 3 dB down method

The damping values for both the build with defects and the nominal build were calculated as another method to determine differences between the two builds. The damping values were calculated using the 3 dB down or half power method [24]. This method uses the FRF plotted in dB to find the natural frequency ( $\omega_n$ ). From the natural frequency peak, the frequency values 3 dB down are selected. An example of the points taken from the FRF is shown in (Fig. 7). The natural frequencies,  $f_1$ ,  $f_n$ , and  $f_2$  in Hertz, can be converted to radians to obtain  $\omega_1$ ,  $\omega_n$ , and  $\omega_2$ .

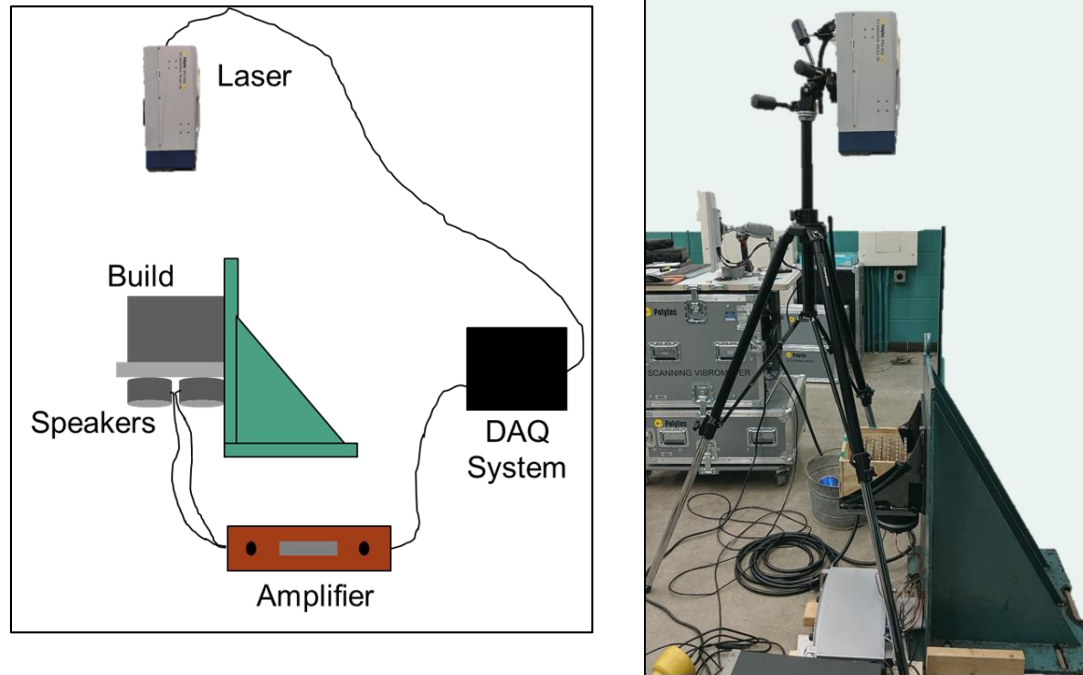
Fig. 13: Test 3 setup model (left) and Test 3 physical setup (right)

The third acoustic test consisted of changing the orientation of the plate from vertical to horizontal (Fig. 13). The horizontal position allowed sand to be added to the plate to reduce the contribution of plate modes. The other testing conditions remained the same as the second test.

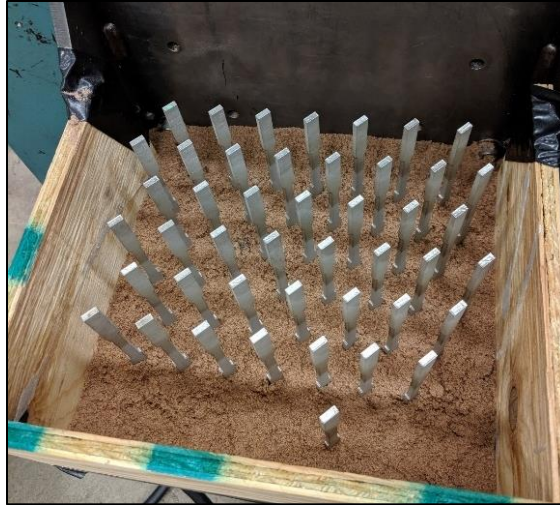
Fig. 14: Close-up of build plate with sand

A close-up of using sand on the plate is shown in (Fig. 14). The plate was tested nominal, with 0.5-inches of sand, and with 1.5-inches of sand. There was one test performed from 8,000-16,000 Hz to observe the range of the speaker excitation. Only the nominal plate was tested in this configuration, since some of the bars continued to show no axial mode at 9755 Hz due to the plate modes around this frequency.

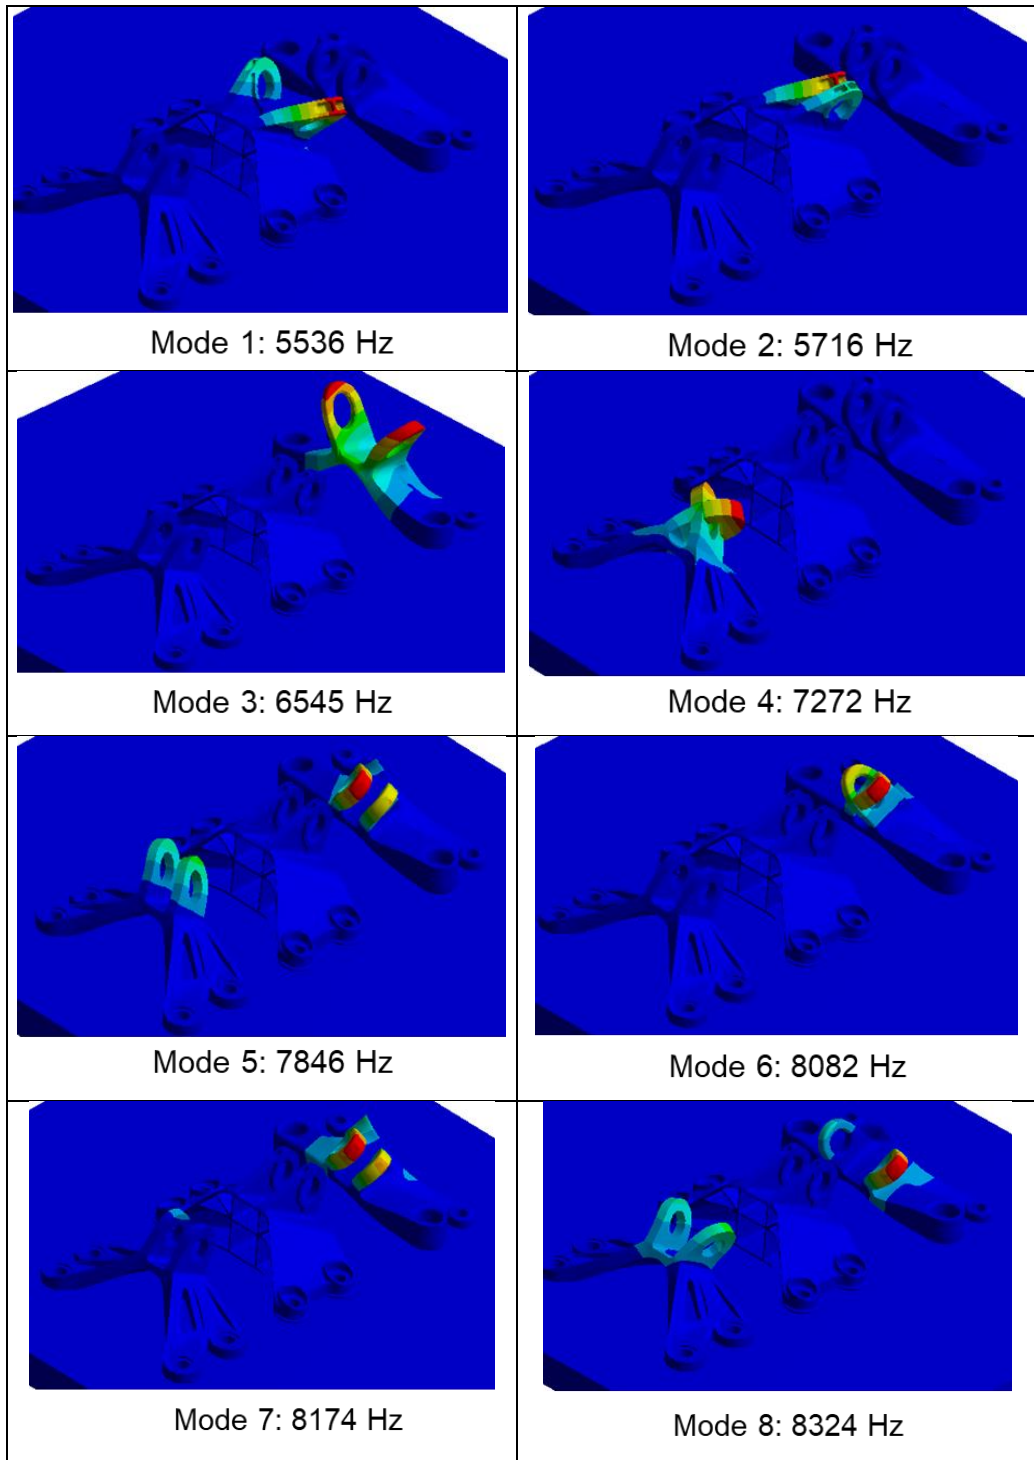
Fig. 18: FEA results for topology optimized brackets

The FEA for these parts was performed by MS&T. The first mode was at 5,536 Hz with the last mode of interest at 8,324 Hz (Fig. 18). The FEA model consisted of the brackets fixed to the plate without the support material. All significant modes appeared to be in the ears of the brackets. Bracket 1 and Bracket 3 have similar natural frequencies and motion for modes 5 and 8.

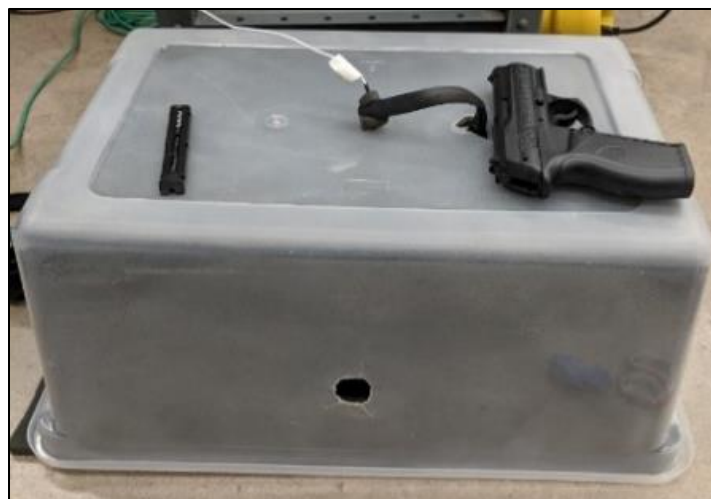
Fig. 20: Model of BB-gun testing (top) and physical test setup (bottom)

The setup for BB-gun testing is shown in (Fig. 20). The test was contained within two plastic totes lined with sheet metal in between. A hole was cut in the top for a light and microphone. Another hole was cut into the side of the tote in order to site the BB-gun at the brackets. Foam was placed over the build plate to reduce the effect of ricochets. A microphone with a windscreen was used to record the response. The first test used a PCB 130D21 microphone. The preliminary tests caused the microphone to overload. A different microphone was tried, PCB 426A05, but this microphone also overloaded.

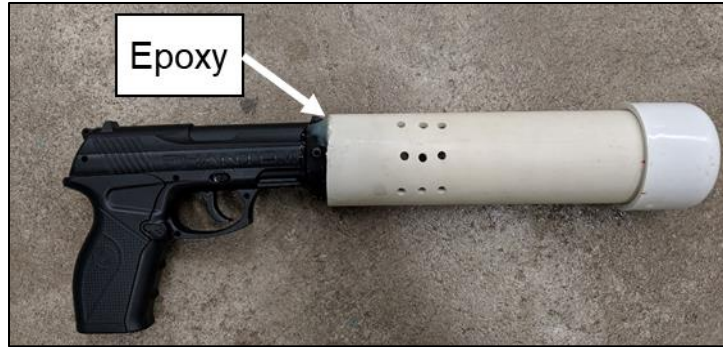
Fig. 21: BB-gun with muffer adapter

In order to reduce the microphone overload, a muffler was added to the BB-gun. The muffler consisted of a 3D printed plastic adapter piece connected to PVC pipe (Fig. 21). The adapter piece was epoxied to the PVC pipe.

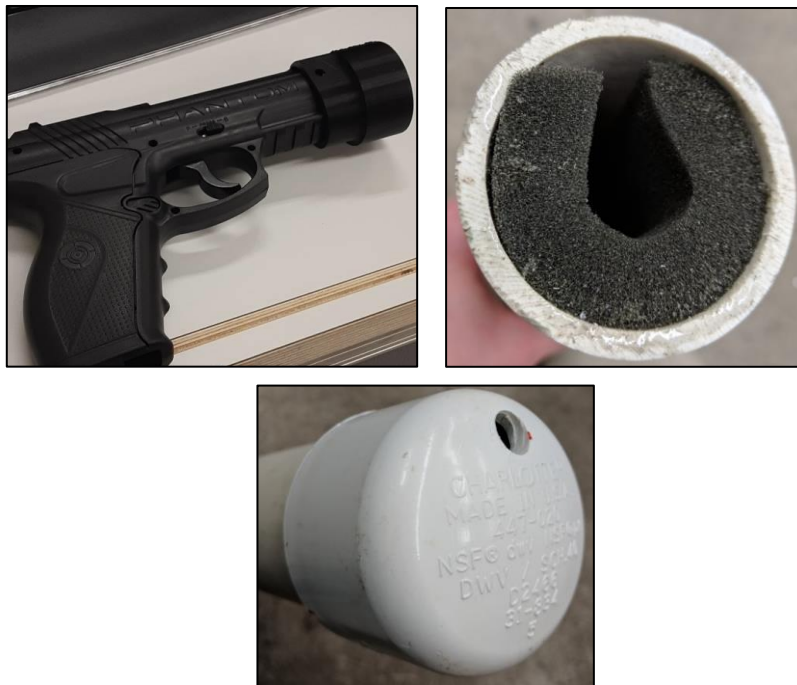
Fig. 22: Muffer adapter piece (left), foam added inside muffer (right), PVC end cap (bottom)

The PVC Pipe had foam glued to the inside and holes cut in the exterior (Fig. 22). The foam and holes allow the gases to spread out before entering the testing container which reduces the sound transferred into the test chamber. A PVC cap was placed over the end of the muffer with a hole cut into the top of it to allow the pellet to exit.

Neither microphone overloaded with the addition of the muffer. The first microphone (PCB Model: 130D21) was used in the results. The plate was tested both free on foam and fixed to the aluminum adapter plate (Fig. 22). The plate was tested in both configurations to determine where build plate modes were affecting the results.

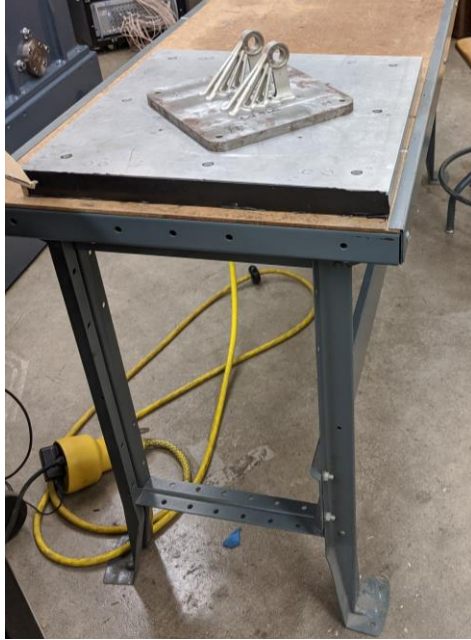
Fig. 27: Semi-fixed boundary condition for testing Airbus builds on table

The first test consisted of fixing (bolting) the brackets to the aluminum adapter plate placed on a table (Fig. 27). The aluminum plate was not fixed to the table and the table was not fixed to the floor. Since the aluminum plate was not fixed to the table, this was a semi-fixed boundary condition. The first five builds were tested with this boundary condition.

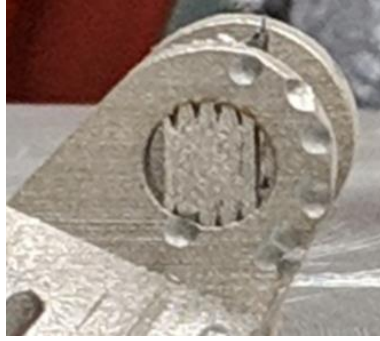
Fig. 68: Damage to parts from BB-gun testing

The BB-gun testing technique was destructive as there was some damage to the parts (Fig. 68). The use of a regulated air supply such as an air hose instead of the CO<sub>2</sub> cartridges could reduce the damage to the parts.
