# Ballistic Test Form-a-Wall

Test Date Feb 11<sup>th</sup> 2005

# Sterling Ballistic Test

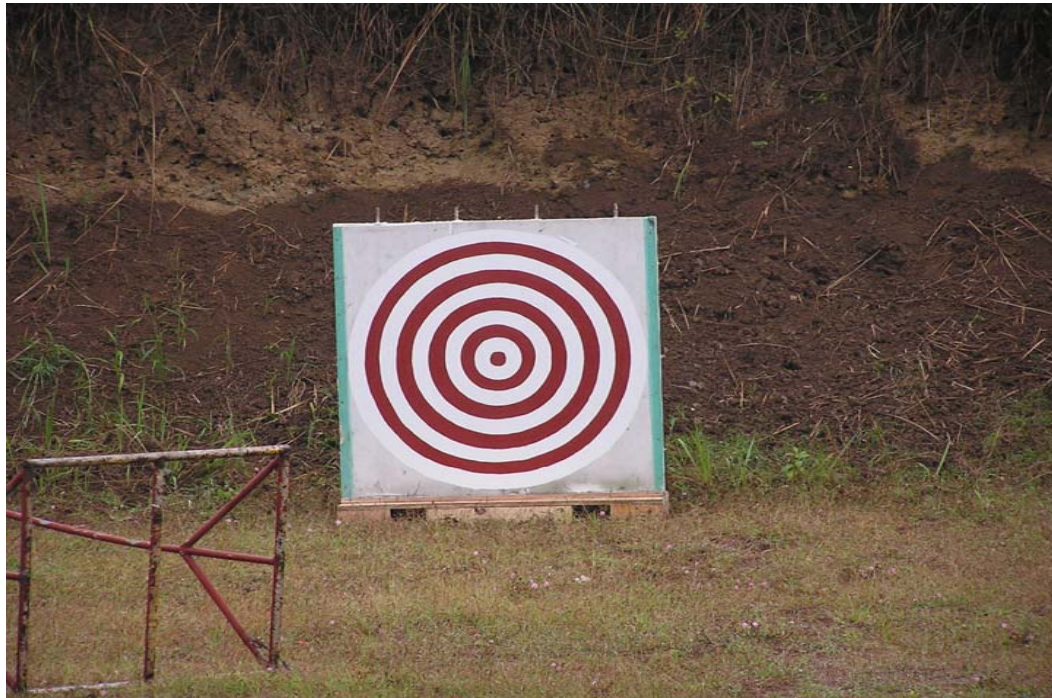
Test wall 114mm standard Form-a-Wall  
3,000 PSI concrete fill

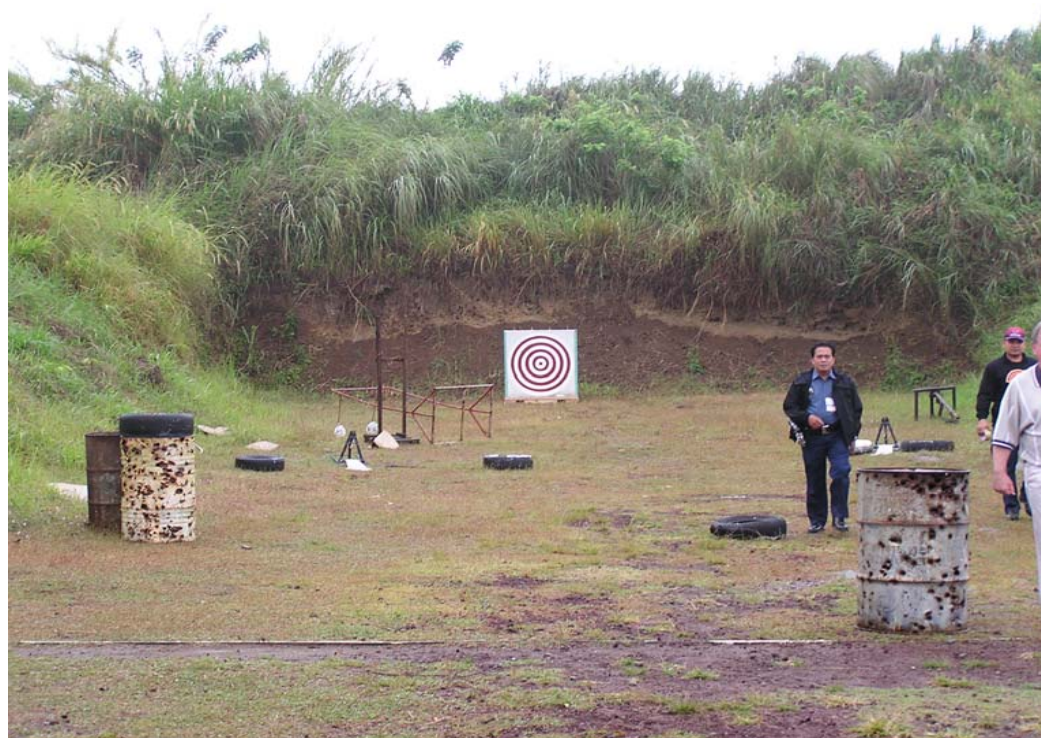
Test Distance 25mts

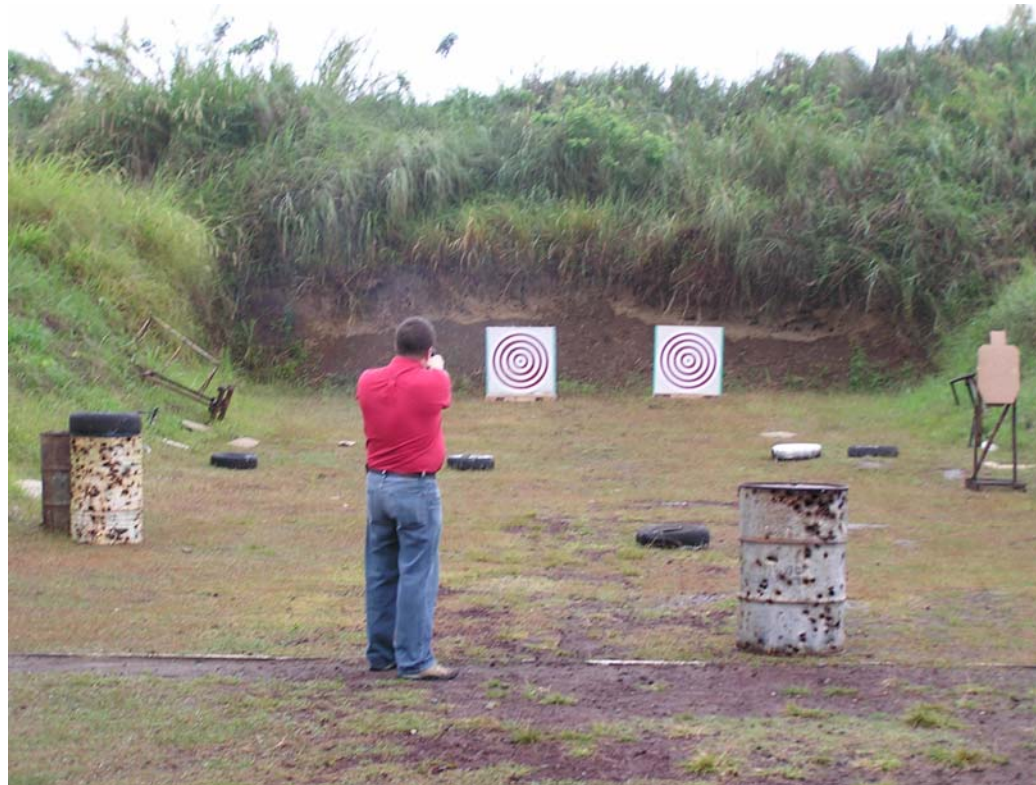
Test Distance 25mts 9mm Handgun

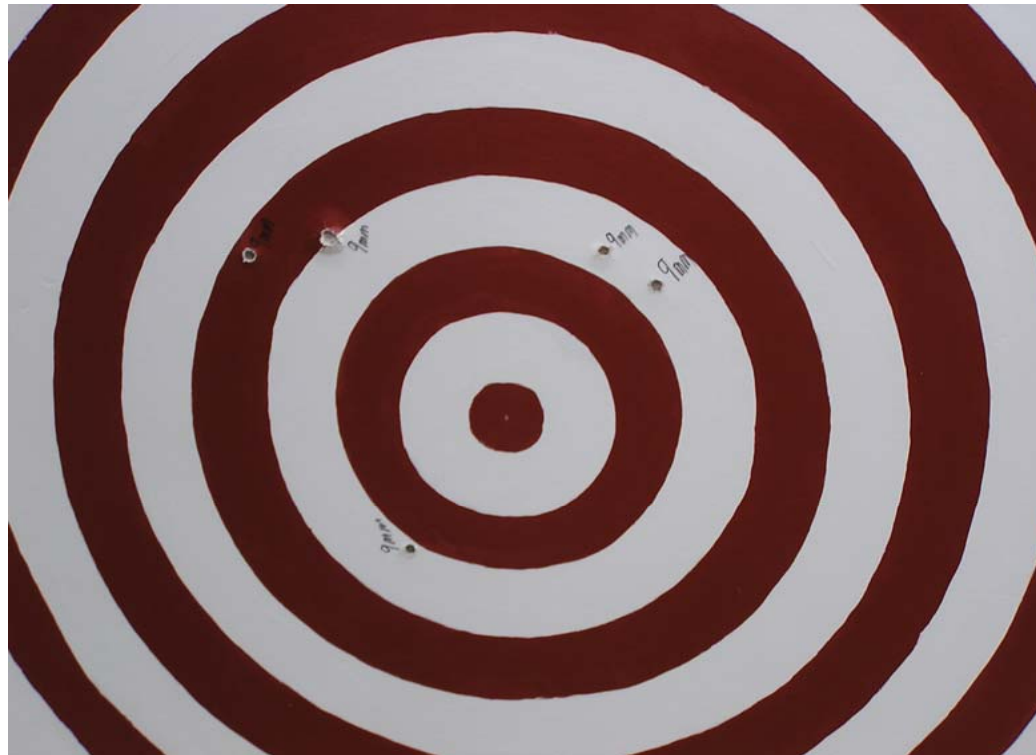
Test Distance 25mts 9mm Handgun Front View

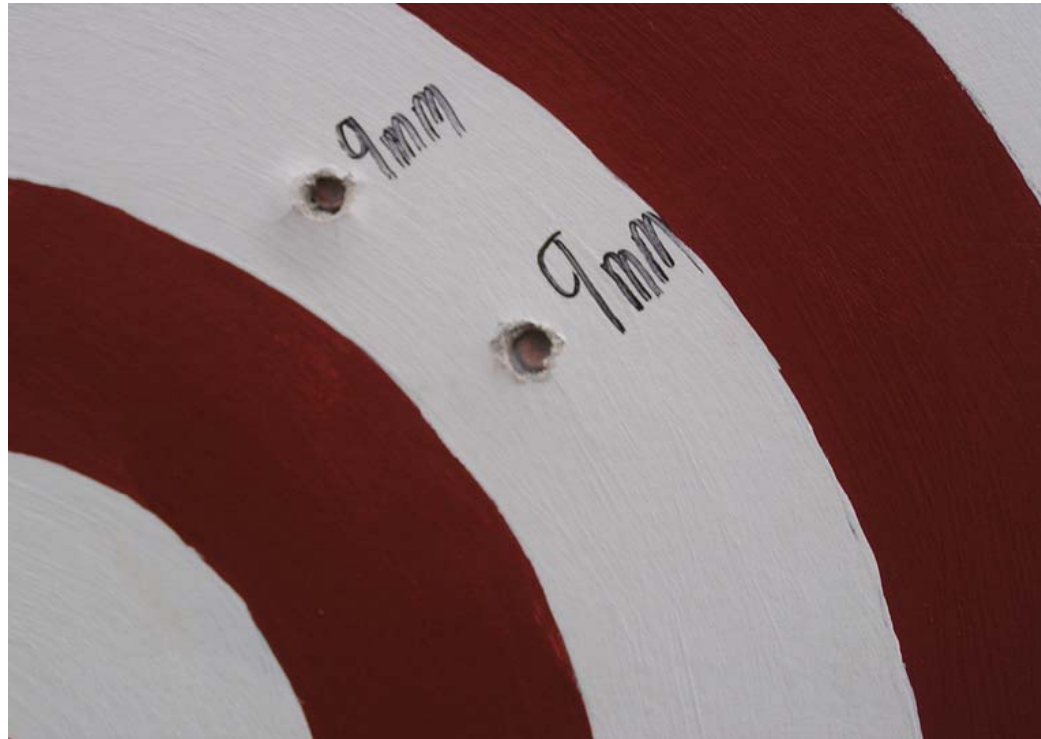
9mm slugs stopped and held by Concrete & cement sheet

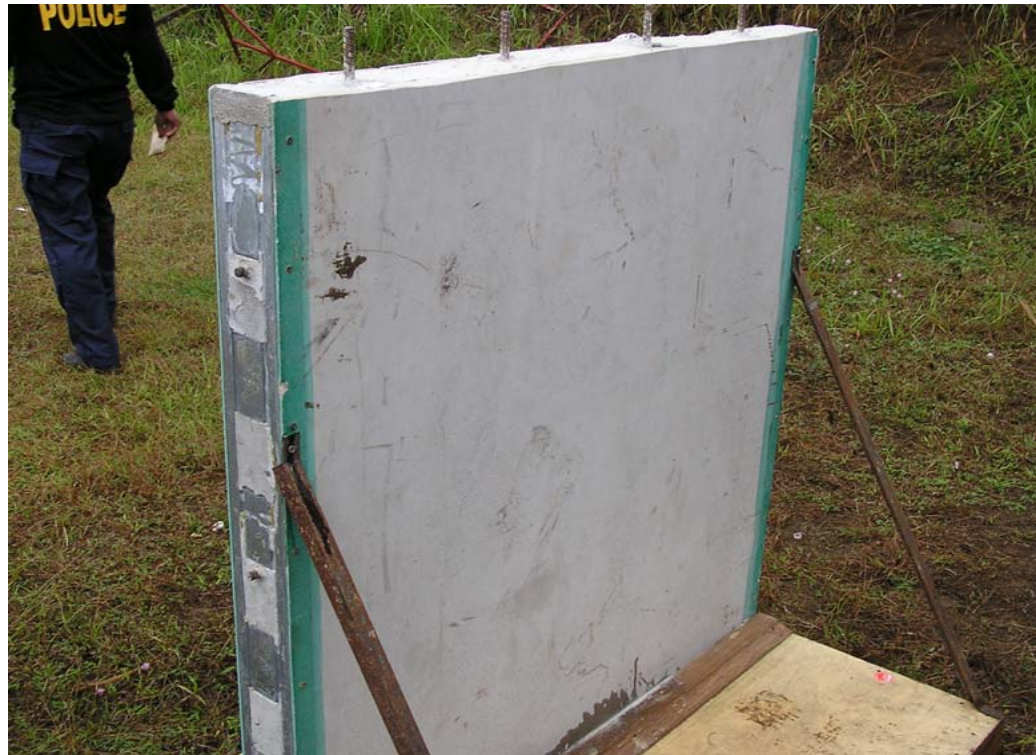
Rear of panel after 9mm test no damage

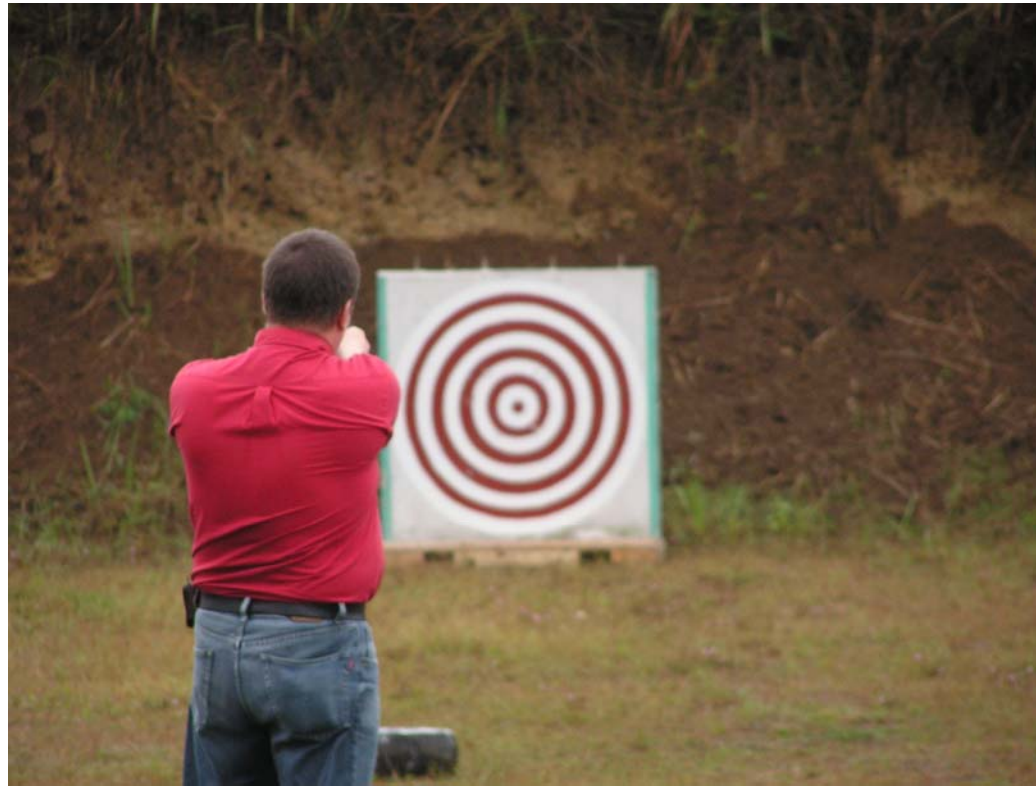
Test shots 45 Handgun at 25mts

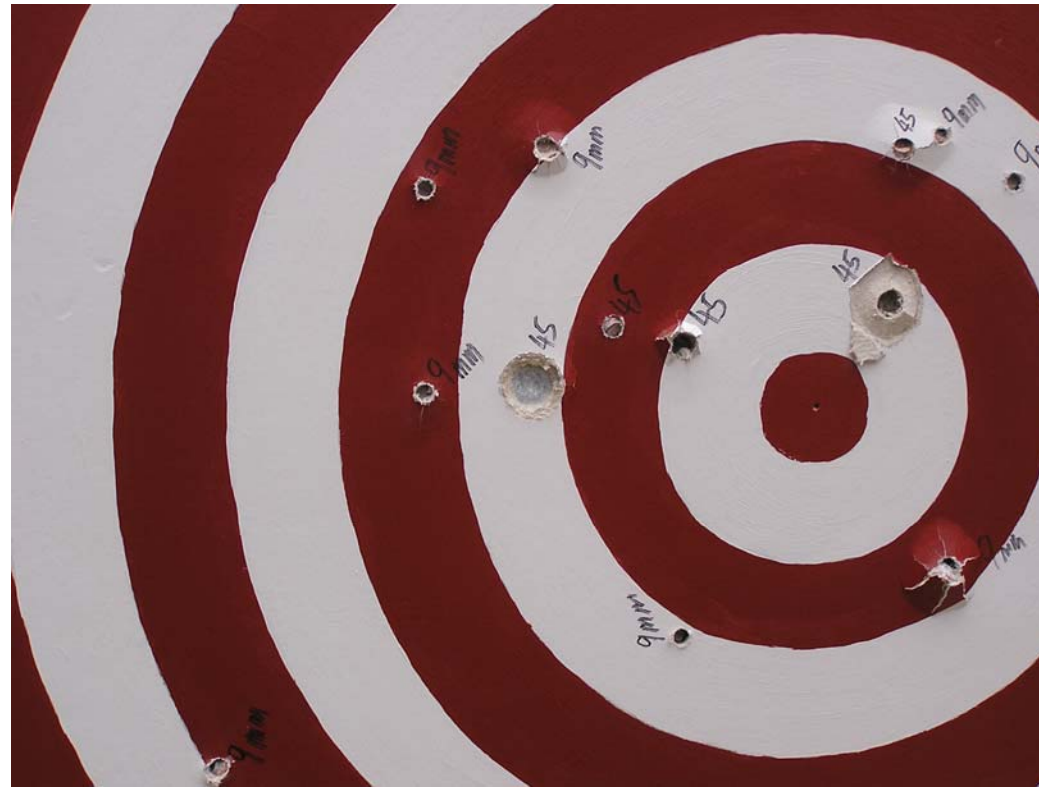
Test shots 45 Handgun at 25mts

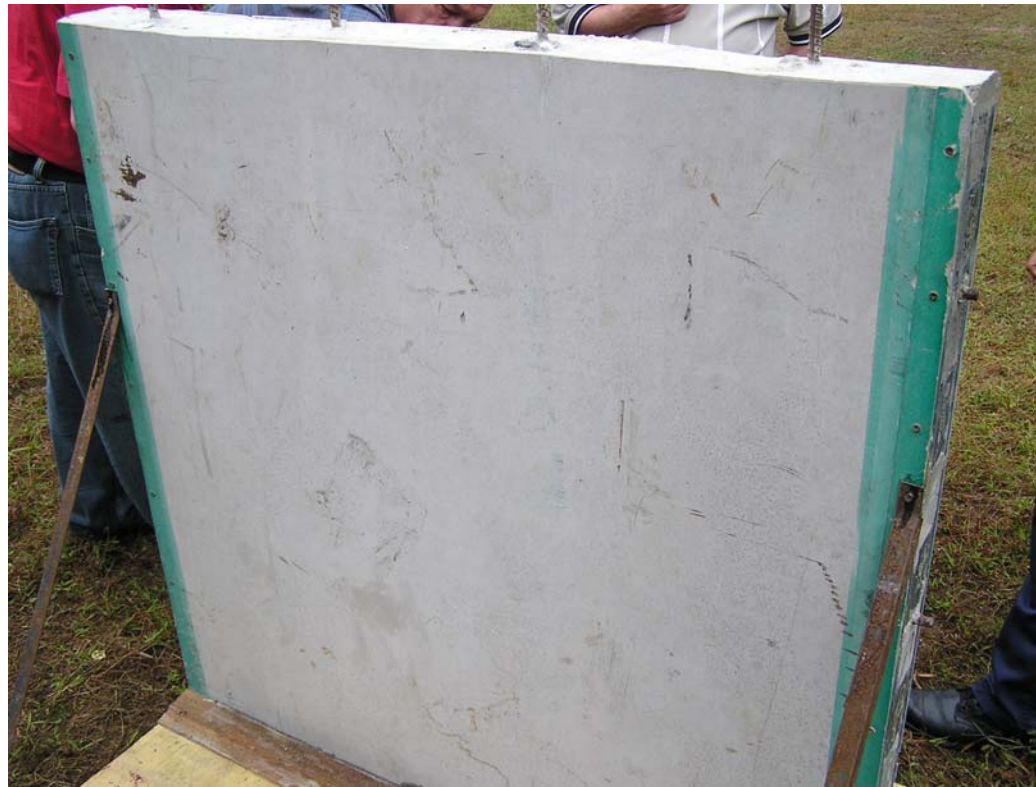
Rear of panel after 9mm & 45 test no damage

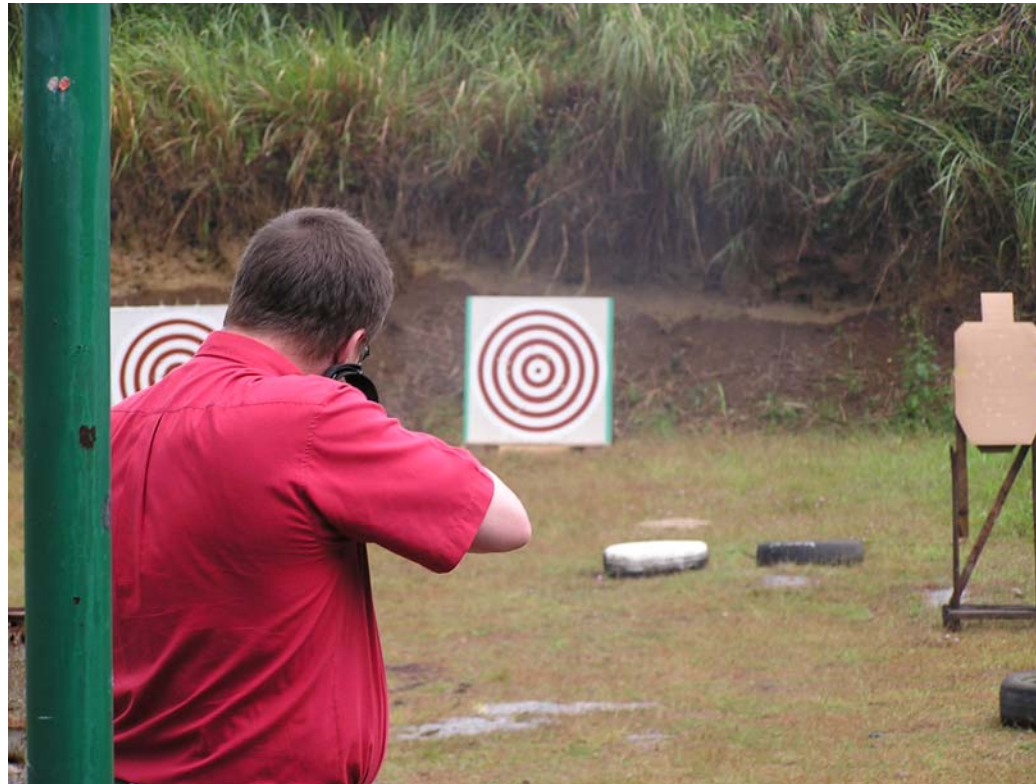
Test M16 at 25mts

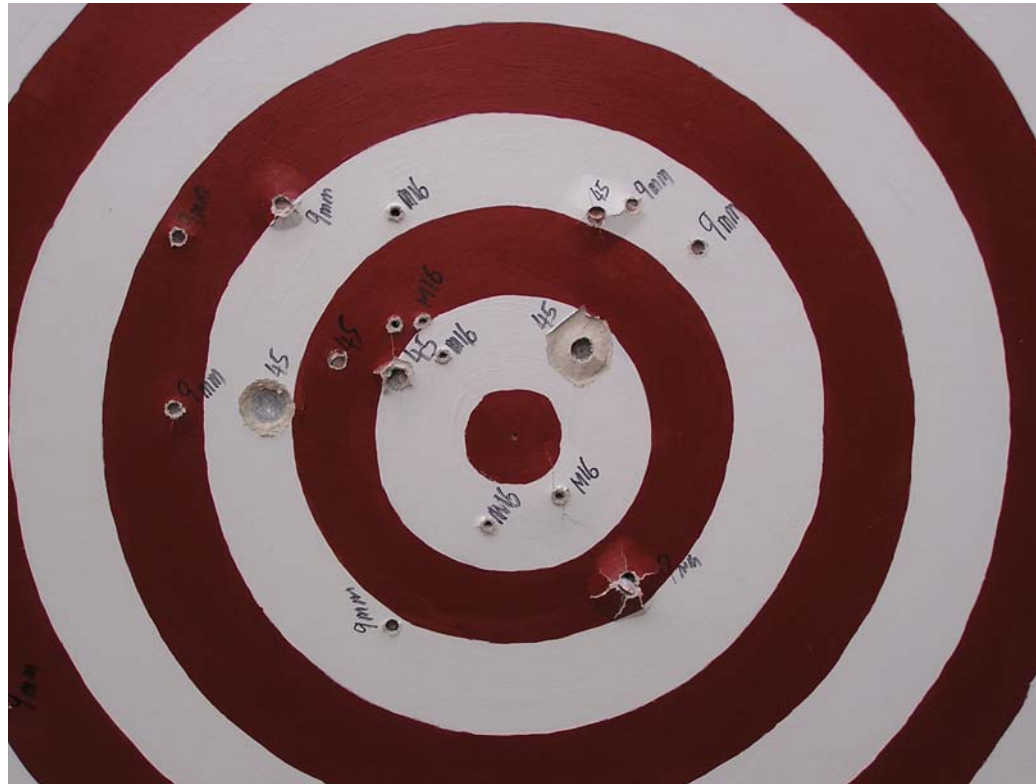
Test M16 at 25mts

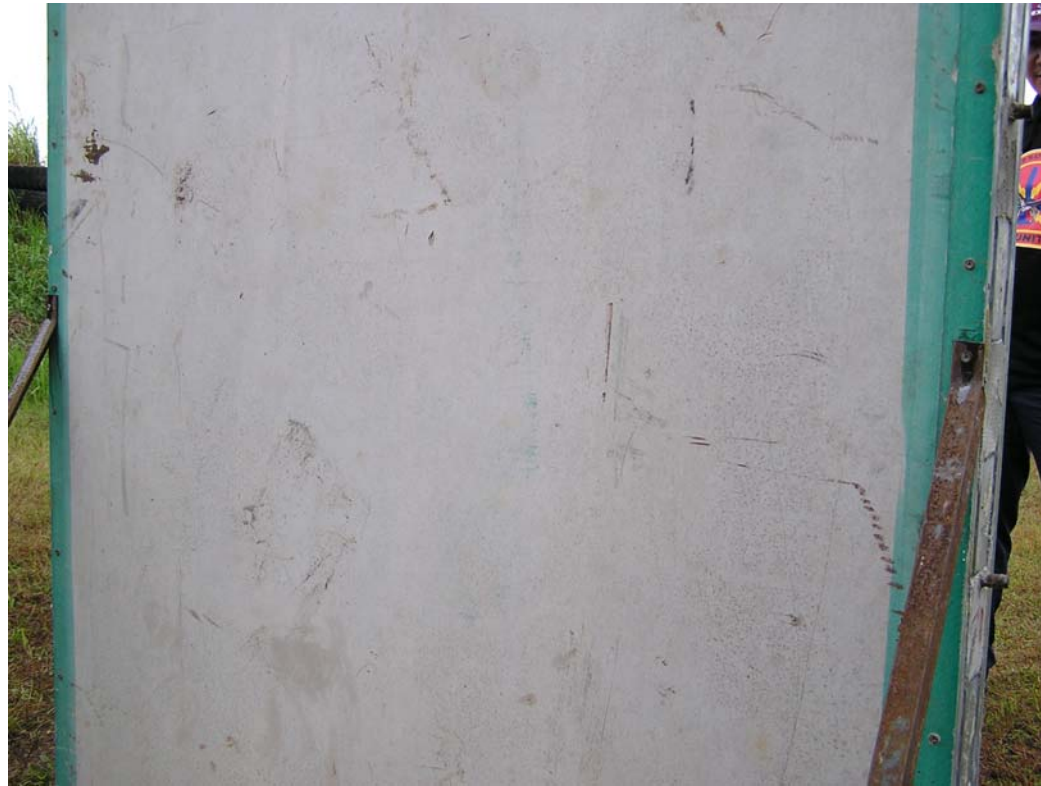
Test 9mm , 45 & M16 at 25mts Back of Panel

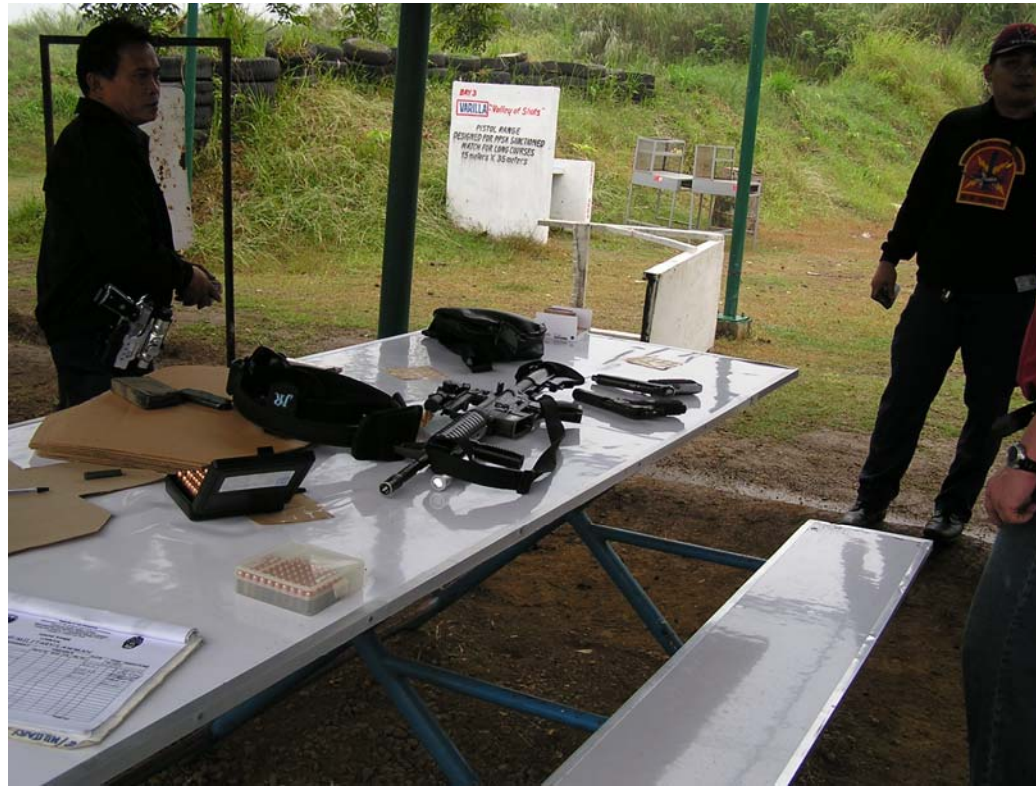
Test Guns
