Pre-Drywall Property Inspection Report

507 Summer Lane, Cartersville GA

Inspection Date:

2/20/2025

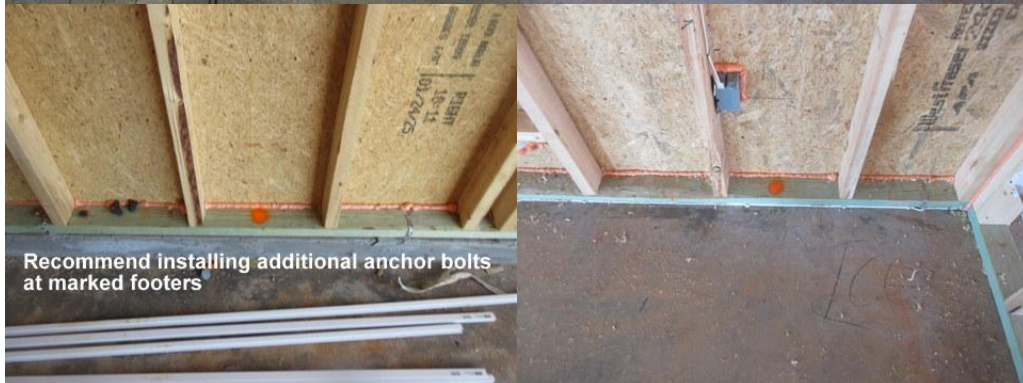
Recommend installing additional anchor bolts at marked footers

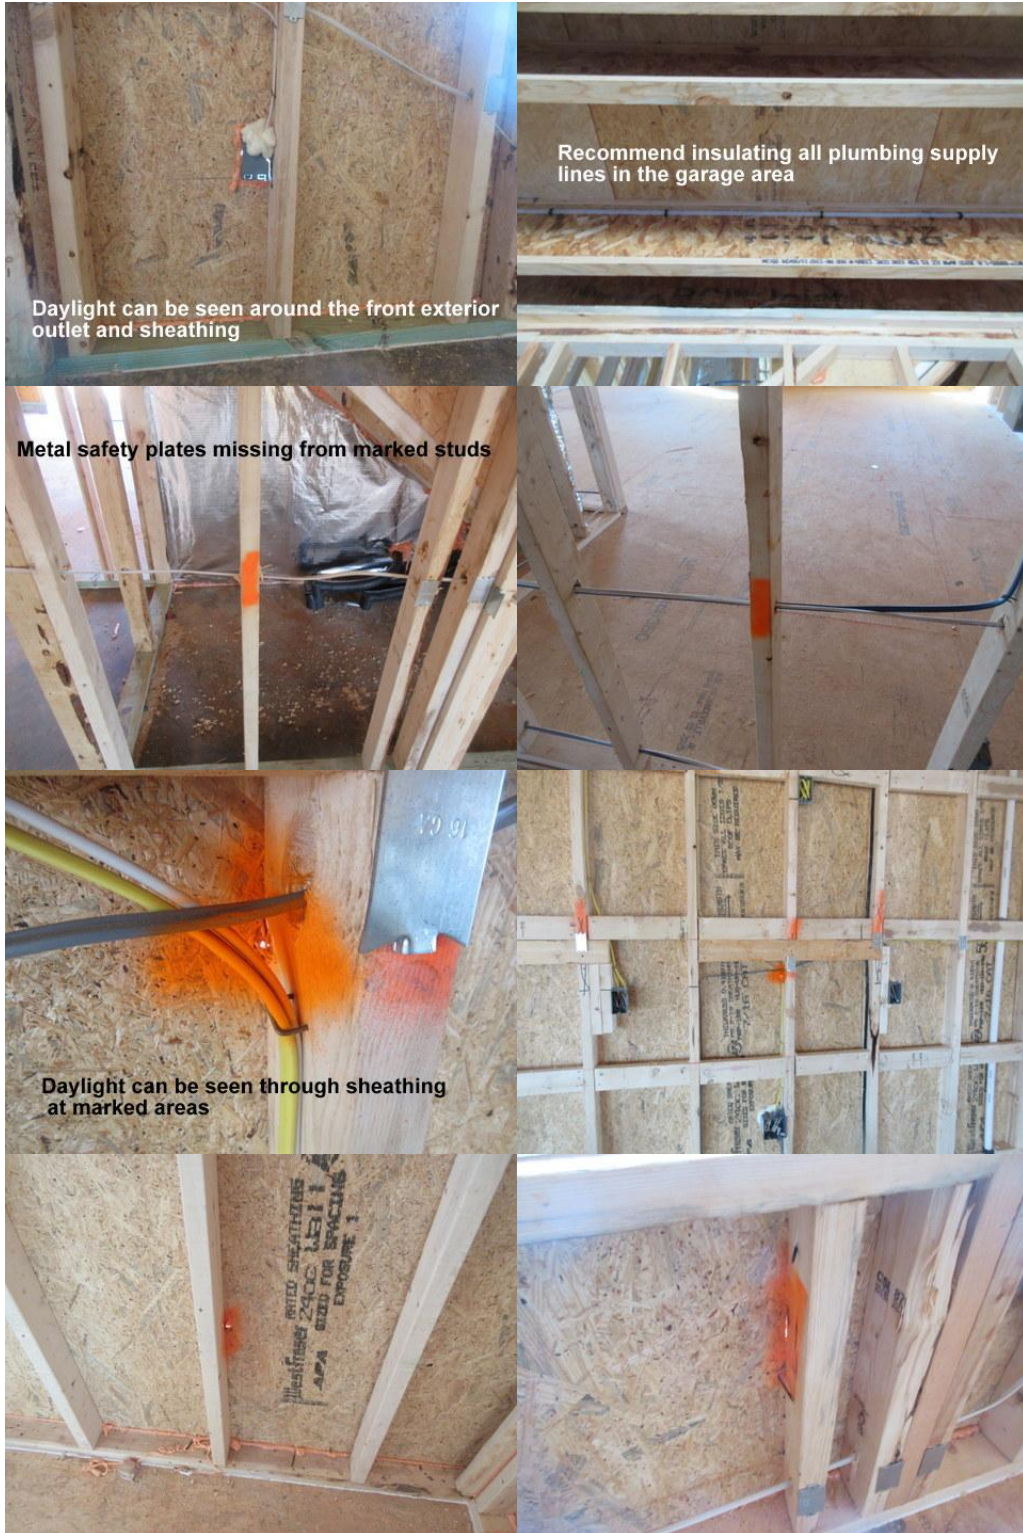
Recommend insulating all plumbing supply lines in the garage area

Daylight can be seen around the front exterior outlet and sheathing

Metal safety plates missing from marked studs

Daylight can be seen through sheathing at marked areas
