Pond 8 Procurement Process and Lessons Learned

R.B. Uhler October 25, 2020

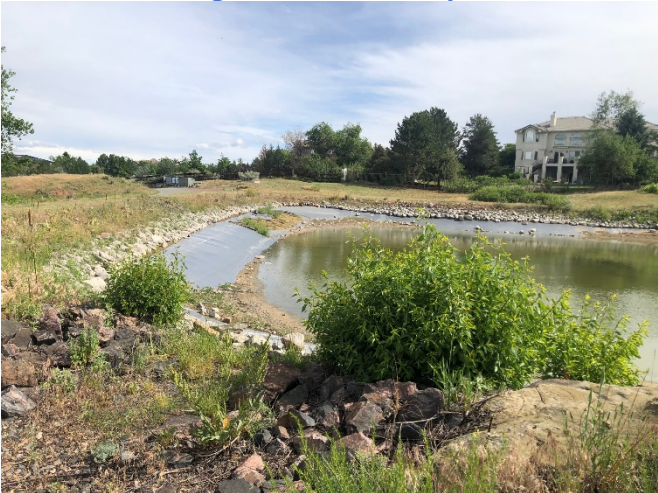
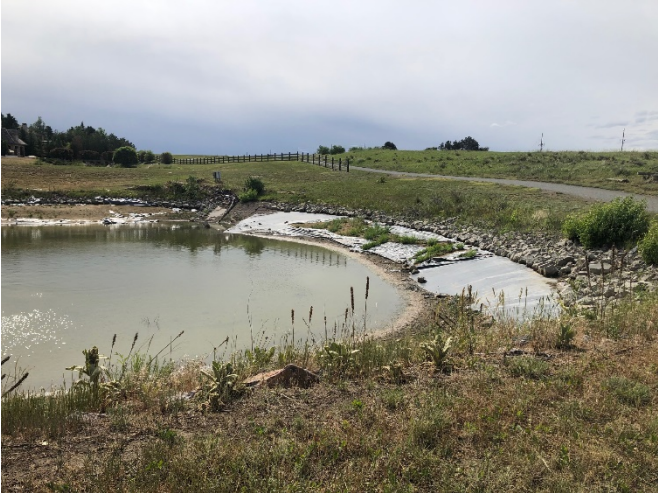
Starting condition, May 2020

Liner ripped starting condition, Pond 8 one-third full

At the start of the Pond 8 project the PVC side wall liner was badly ripped only allowing the pond to be about one-third filled (see photo). While engineering started, it was decided to drain the pond completely and allow the bottom sludges to sun dry to reduce wet volume. The bottom sludge turned out to be about 3 inches of fine silt combined with organics. After a month, it dried well in a crusted way to 2" depth but created significant odor. To eliminate odor and to accelerate the construction's starting point, it was decided to remove both the sludge and residual PVC liner by a separate contract. For the Pond 8 schedule this was a good decision for speed but probably cost \$3-4K more due to the mobilization of separate company. In the future, if time is less pressed, consideration should be given to including the demolition and disposal of the liner/sludge into a prime contract. To start with a partially filled pond, the old PVC liner in place and wet sludge, would have added about four weeks to the prime's schedule.

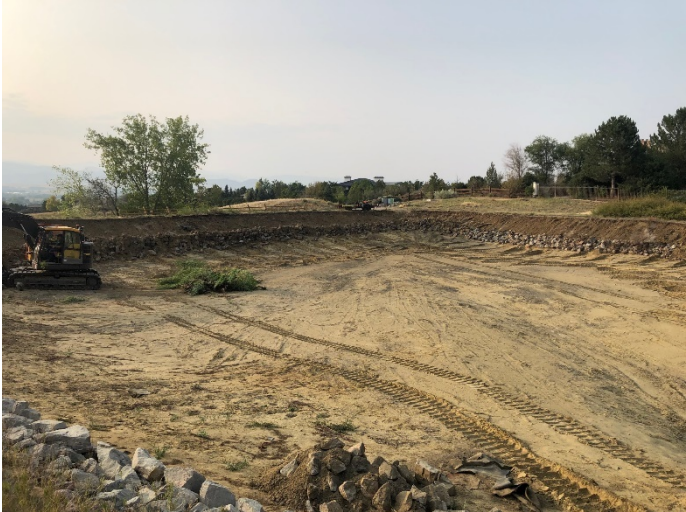
Post sludge and PVC liner removal

Sludge and old PVC liner removed, starting condition

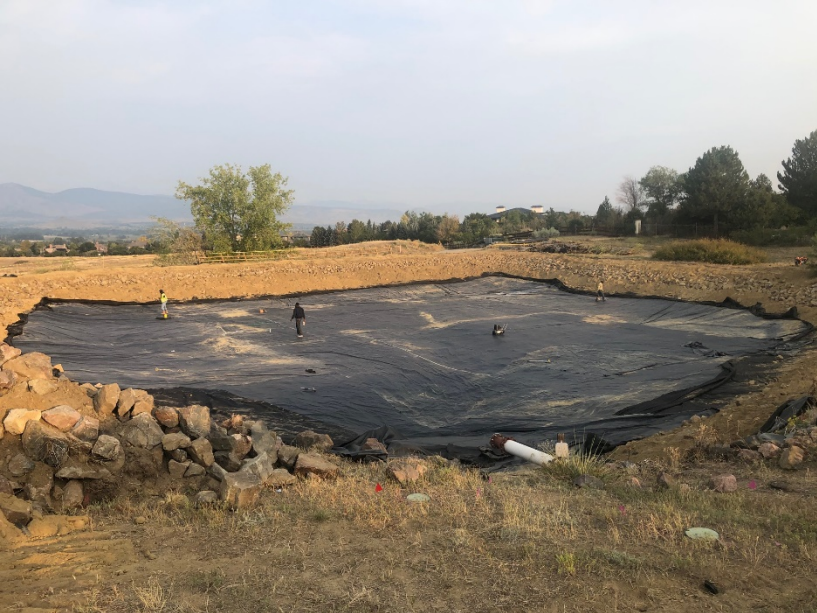
H2J Liner Installation Progress

Liner in place, rip-rap sides unfinished

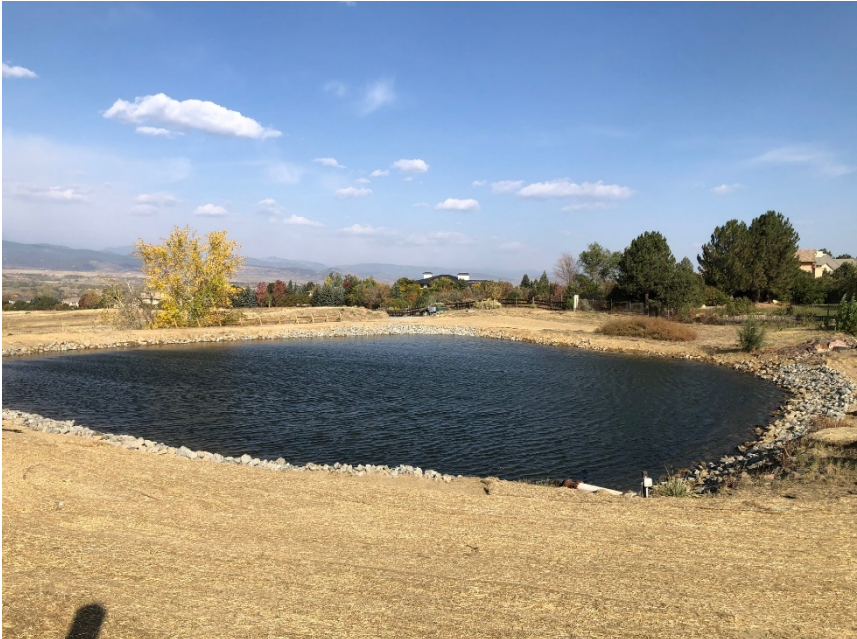
Completed project, October 2, 2020

Pond completed and full, vegetation seeding blankets surround
