Replacing the Speed Control Quadrant Roll Pin with a Bolt, 2 Star washers and a Nylock Nut

Originally Written by Bill Mayo (See June 13 2016 Update from Bill at the end)

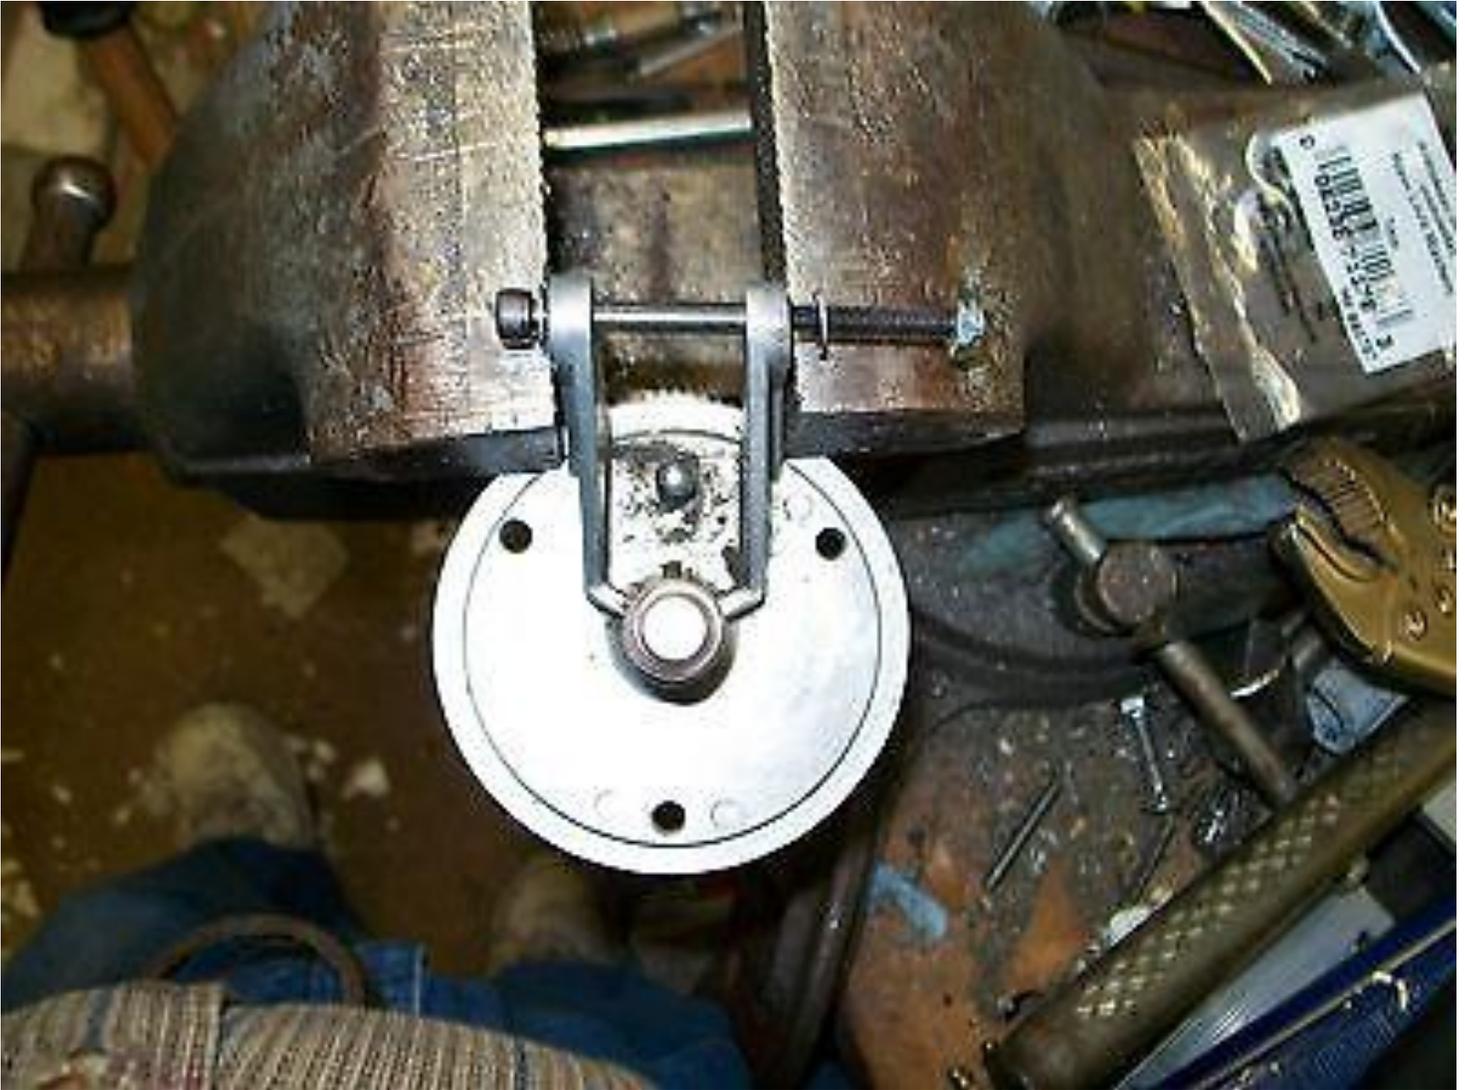
The one leg is bending on the speed control bracket.

I quickly found that allen head 10 32 X 2 1/2" bolt fits in the quadrant and legs without any drilling or shimming required.

I put a little wheel bearing grease in the quadrant hole and use an allen wrench to thread the bolt through the legs and quadrant.
