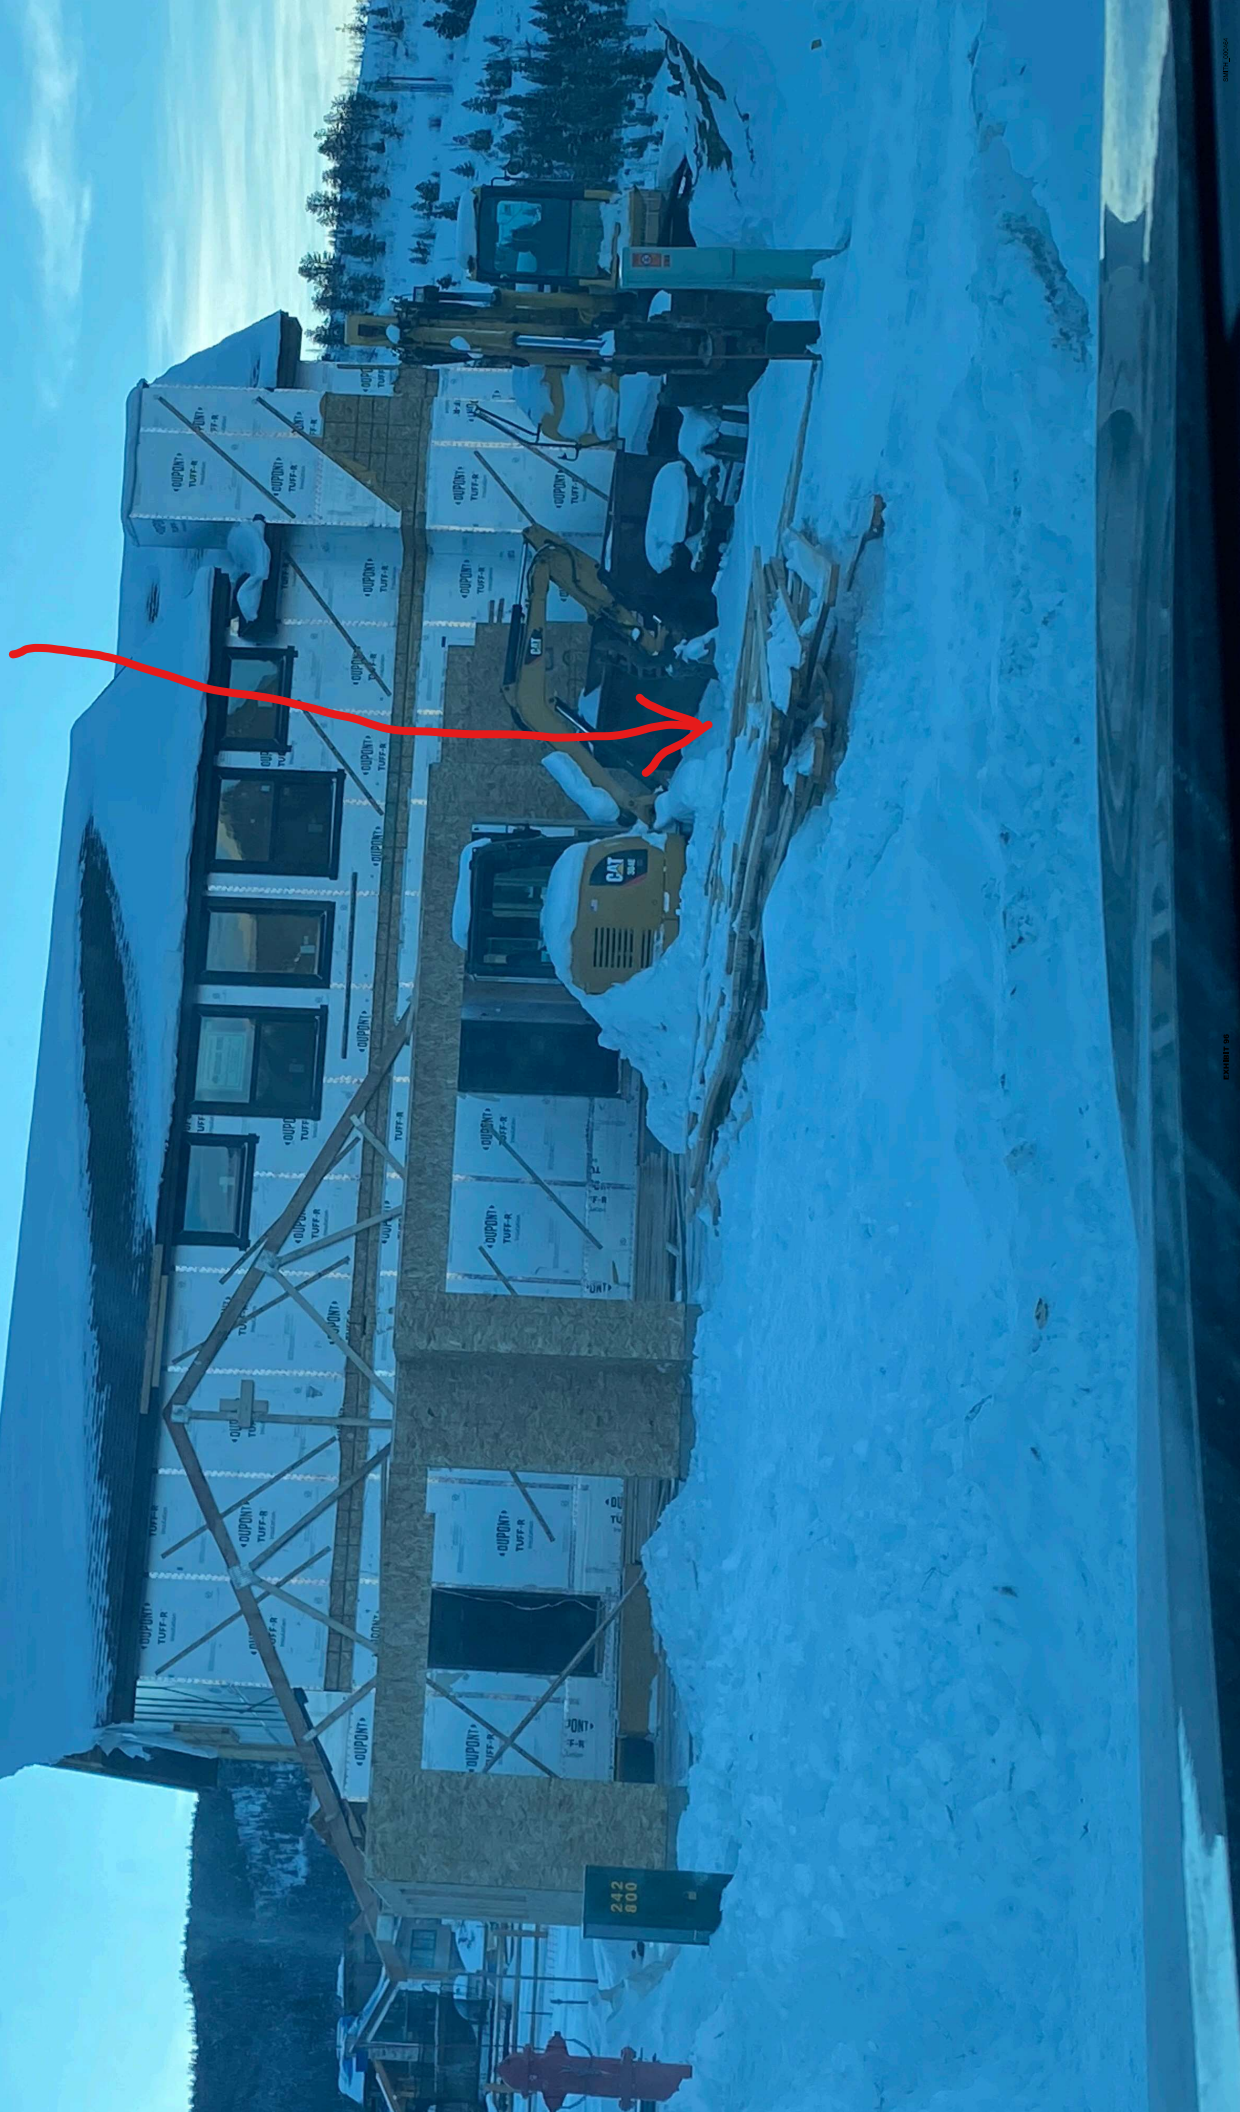
Garage roof trusses stored on site unprotected from the elements. They froze together into a solid block. Liscott used an excavator to break them apart. This broke 7 out of the 13 trusses used to build the garage. Instead of contacting us, Liscott went ahead and built the garage with these broken trusses. It wasn't until I visited the site and noticed the garage had been built with these broken trusses that Liscott admitted the damage. They stated that they had gotten repair instructions from the truss manufacturer and that the trusses could be repaired "good as new". Even given these instructions, Liscott failed to repair the trusses properly. We had to hire outside crew to make the proper repairs.
