Titan Corrosion Services, Inc.  
17911 Melissa Springs Drive  
Tomball, TX 77375

CIS, ILI & DOC

FROM STATION 0+00	TO STATION 13+84
JOB #0000	DRAWING NDI
	REV 0

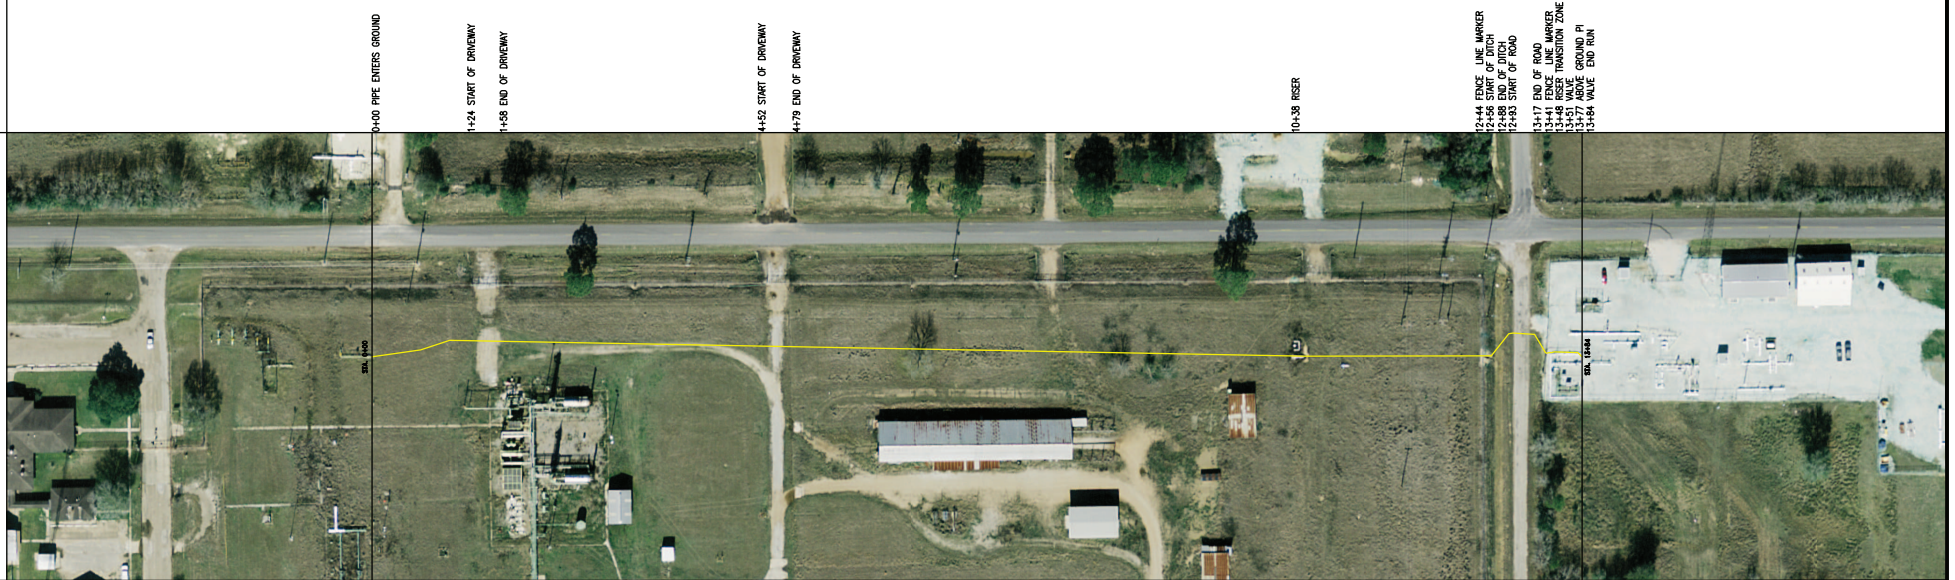
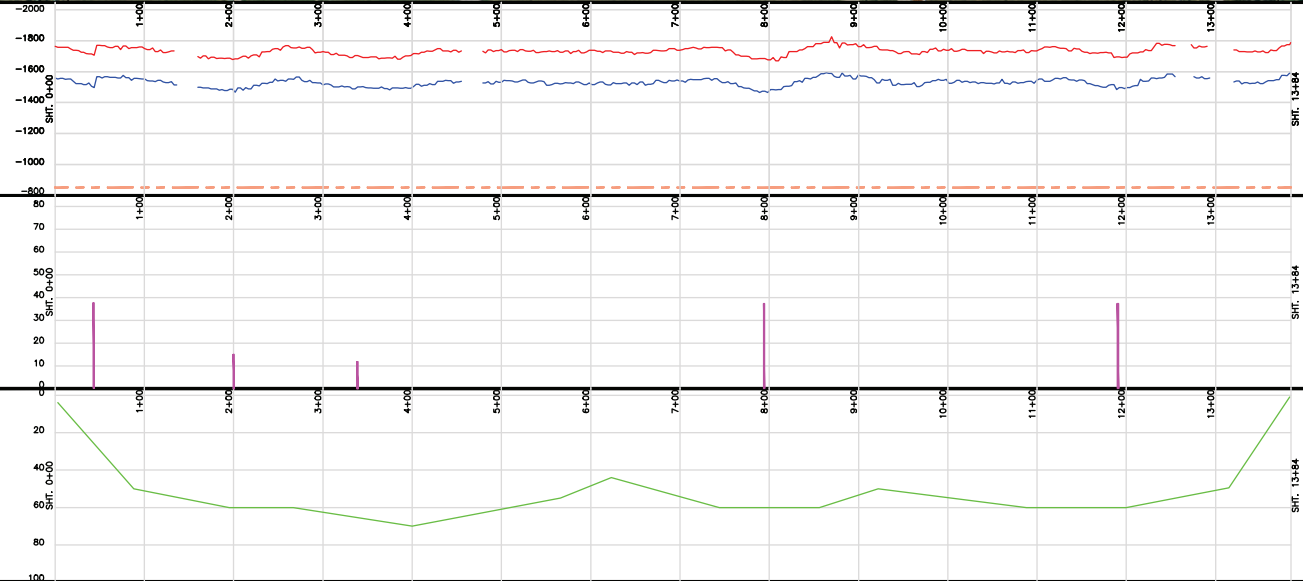
— P/S ON  
— P/S OFF  
— DEPTH  
— DEPTH %

DEPTH  
0+00  
20  
40  
60  
80  
100

ILI  
0  
10  
20  
30  
40  
50  
60  
70  
80

CIS  
-2000  
-1800  
-1600  
-1400  
-1200  
-1000  
-800  
-600

0+00 PIPE ENTERS GROUND  
1+24 START OF DRIVEWAY  
1+58 END OF DRIVEWAY  
4+52 START OF DRIVEWAY  
4+79 END OF DRIVEWAY  
10+38 RISER  
12+44 FENCE LINE MARKER  
12+44 EDGE OF DITCH  
12+88 END OF DITCH  
12+93 START OF ROAD  
13+17 END OF ROAD  
13+41 FENCE LINE MARKER  
13+41 EDGE OF DITCH  
13+45 WATER TRANSITION ZONE  
13+77 ABOVE GROUND PI  
13+84 VALVE END RUN
